Appendix E. Other Supporting Information

Biological Assessment

American Fork River Supplemental Watershed Plan #15 Utah County, Utah

February 2024

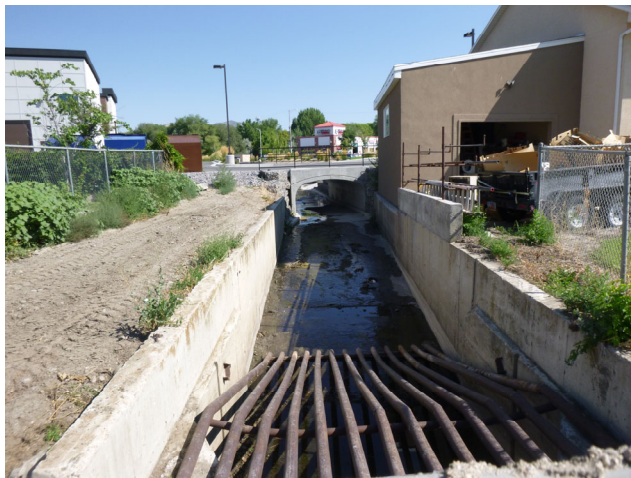
Figure 1 – General habitat conditions in the study area. Photo shows Dry Creek as a concrete lined channel, surrounded by uplands and residential and commercial developments.

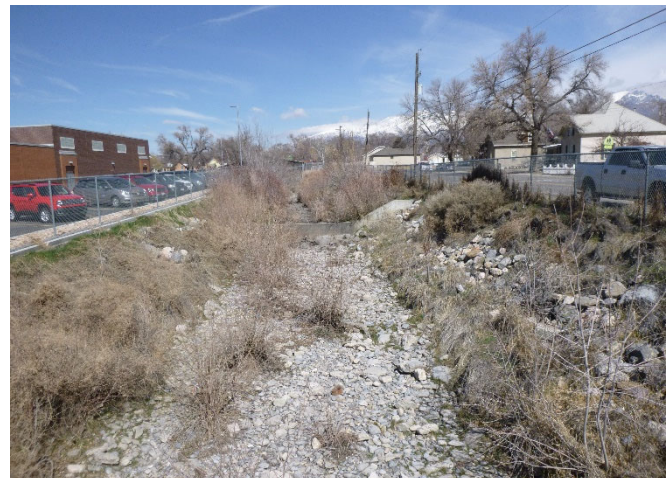
Figure 2 - General habitat conditions in the study area. Photo shows a dry segment of the American Fork River with steep banks and weeds.

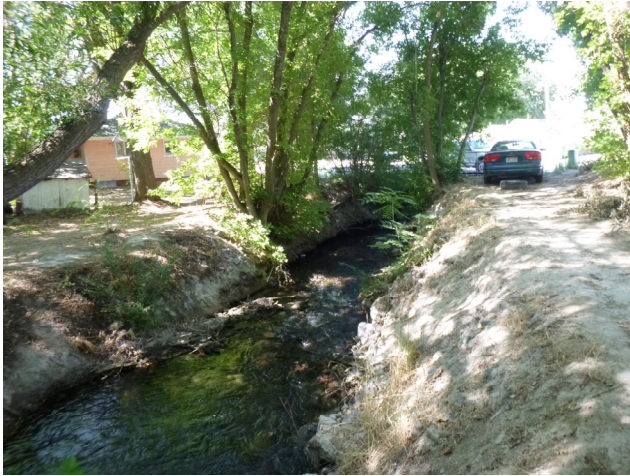
Figure 3 - General habitat conditions in the study area. Photo shows Waste Ditch with unvegetated, heavily shaded, steep banks.

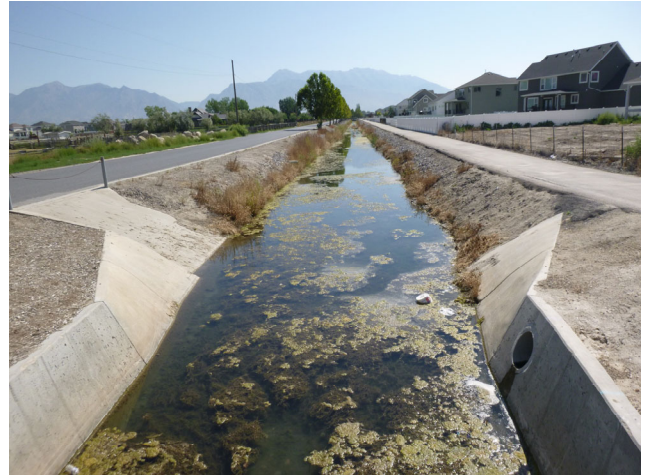
Figure 4 - General habitat conditions in the study area. Photo shows Waste Ditch with concrete lined and steep, gravelly banks.

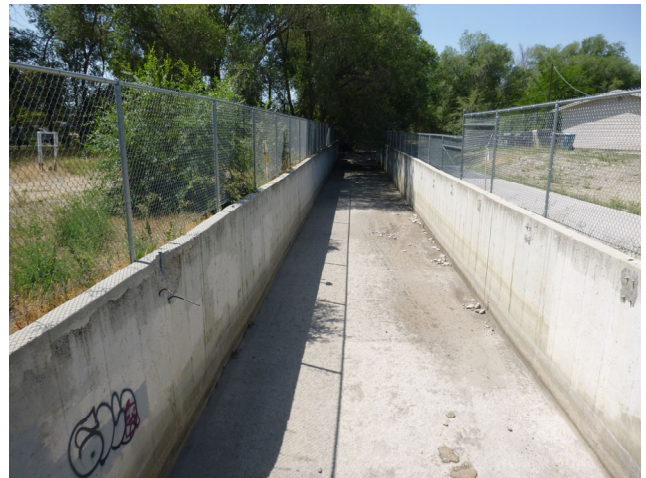
Figure 6 - General habitat conditions in the study area. Photo shows a dry, concrete lined segment of the American Fork River.

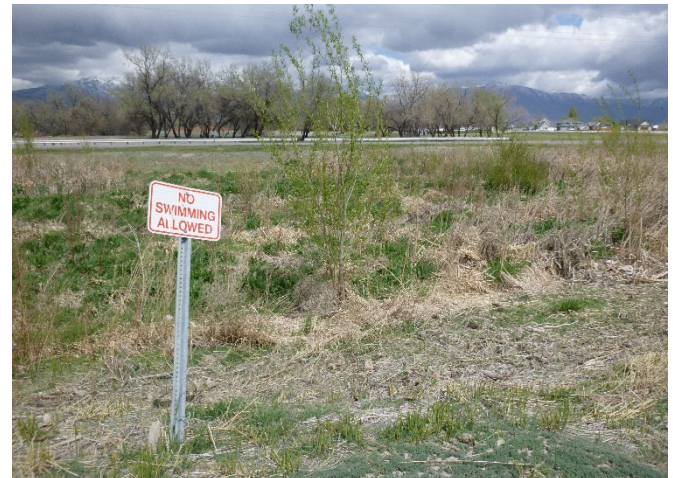
Figure 8 - General habitat conditions in the pond at Willow Park. A “No Swimming Allowed Sign”, and a cement water outfall structure (outside the photo frame) indicate that the area is usually inundated with water.

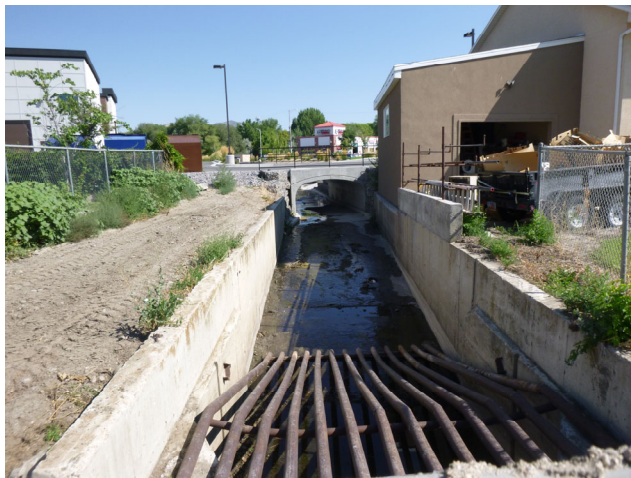
Figure 1 – General habitat conditions in the study area. Photo shows Dry Creek as a concrete lined channel, surrounded by uplands and residential and commercial developments.

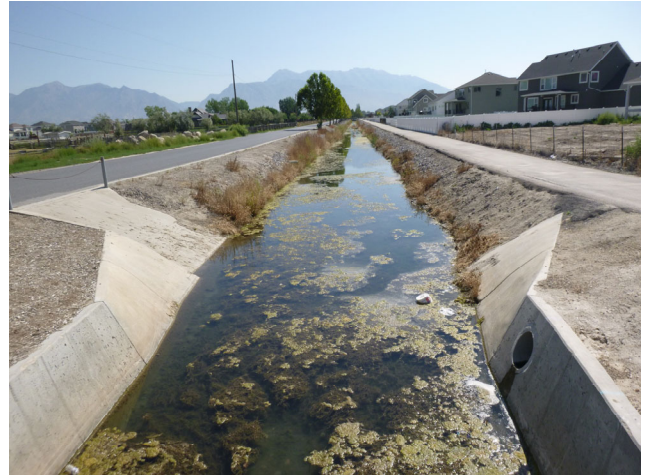
Figure 4 - General habitat conditions in the study area. Photo shows Waste Ditch with concrete lined and steep, gravelly banks.

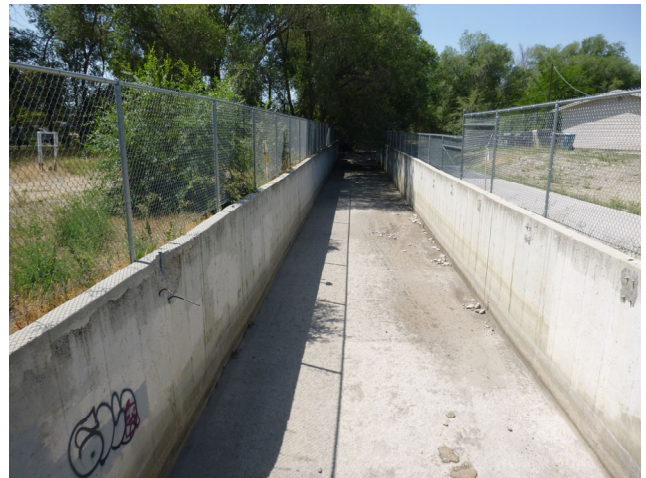
Figure 6 - General habitat conditions in the study area. Photo shows a dry, concrete lined segment of the American Fork River.

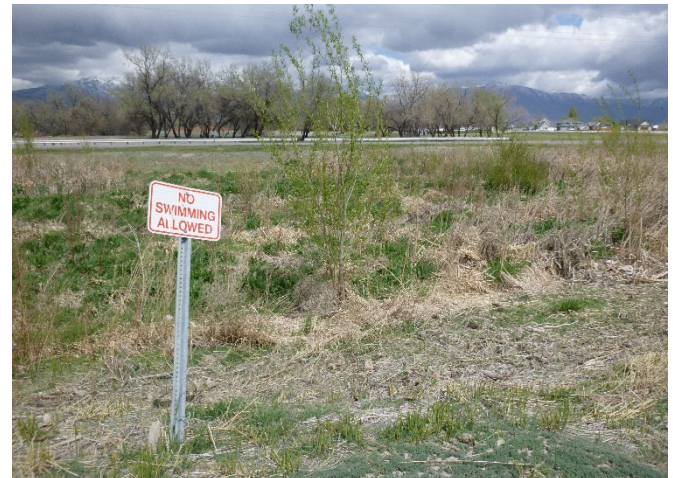
Figure 8 - General habitat conditions in the pond at Willow Park. A “No Swimming Allowed Sign”, and a cement water outfall structure (outside the photo frame) indicate that the area is usually inundated with water.

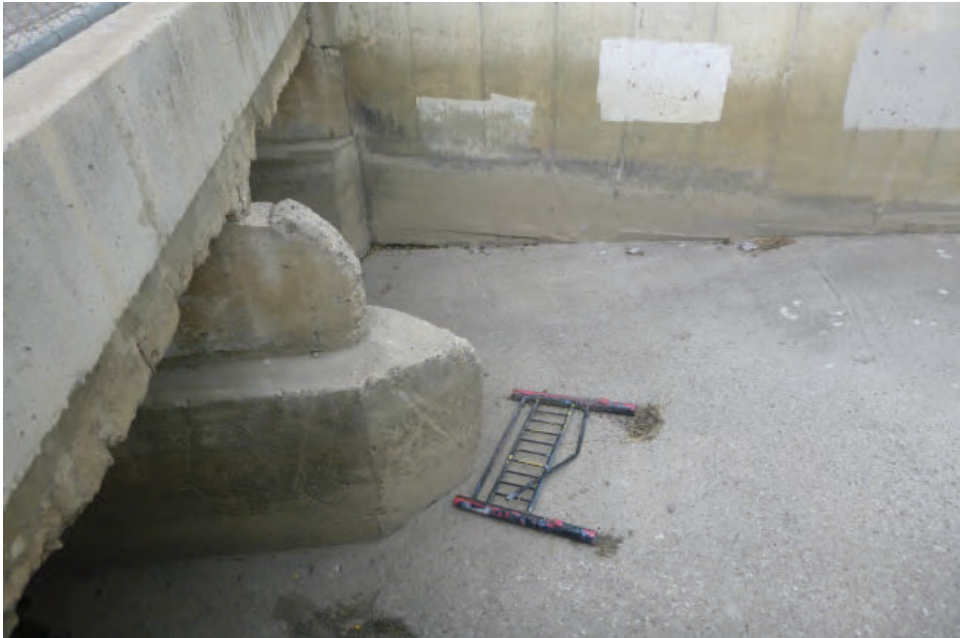
Horrocks recommends this bridge as not eligible for the NRHP as significant alterations occurred in 1985 as well as smaller, more recent efforts to shore it up. The box culvert below this bridge is deteriorating and American Fork City

Figure 6. Detail of box culvert for Bridge 049001D, looking east.

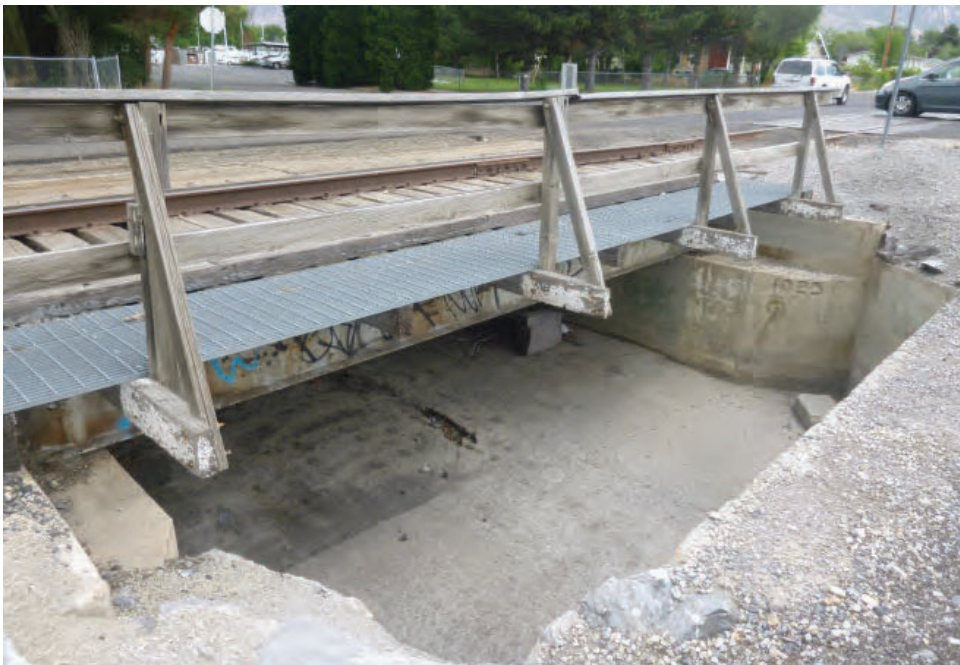
Figure 7. Overview of the previously unrecorded box culvert bridge and the UPRR, looking northeast.
