Henry's Fork Salinity Control Area
Monitoring and Evaluation Report
2022

Wildlife/Wetland Value Assessments and Habitat Replacement Projects

Follow-up Wetland Assessments of Irrigation Projects

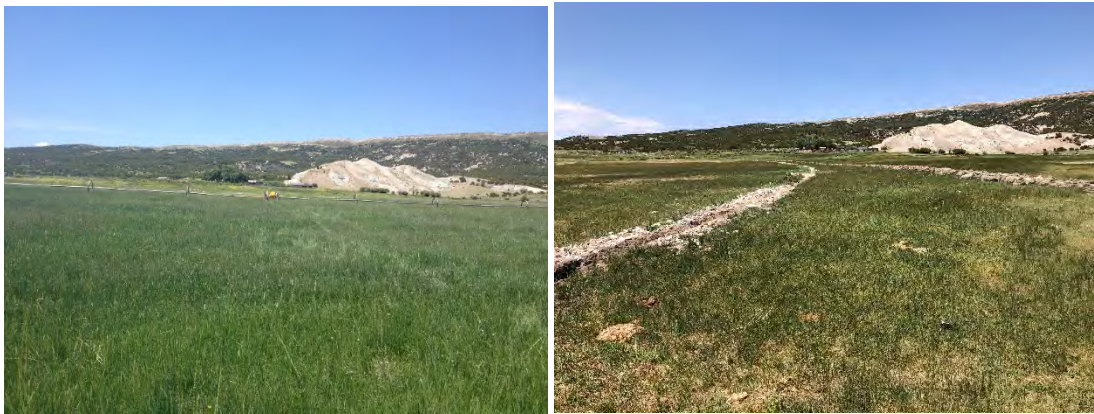
- R. Slagowski Pivot was installed in November 2015. A site visit was completed the end of June 2021. There appeared to be wetland characteristics still present on the 5 acres previously assessed, though it had been recently grazed. Since the conditions had not changed noticeably, photos were taken and the follow-up assessment was postponed for the following year.

Photo 1: Southern end of field in June 2015 (left) and June 2021 (right) with wetland characteristics still present.

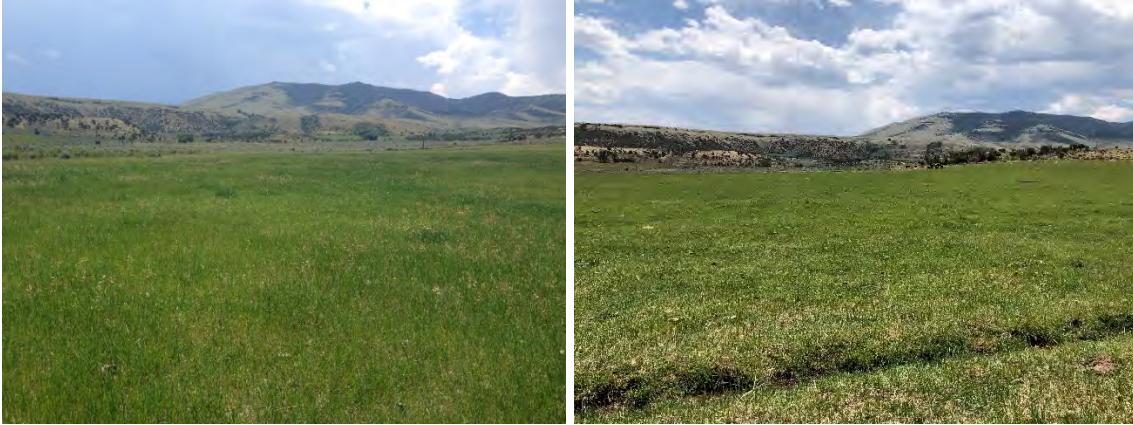
- D. Slagowski pivot was installed in September 2016. A site visit was completed in June 2021. There appeared to be wetland characteristics still present on the 1.02 wetland acres previously assessed. Since the conditions had not changed noticeably, photos were taken and the follow-up assessment was postponed for the following year.

Photo 2: Eastern toe-slope of field facing south June 2015 (left) and June 2021 (right) with wetland vegetation still present.

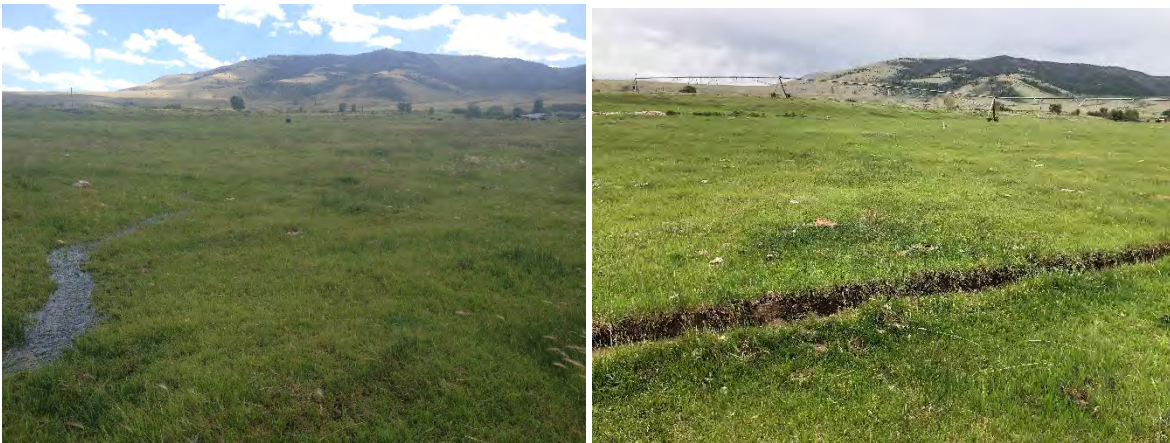
- Crowther pivot was installed in September 2016. A site visit was completed in June 2021. There appeared to be wetland characteristics still present, though not as saturated with water, on the 2.95 wetland acres previously assessed. Since the conditions had not changed noticeably, photos were taken and the follow-up assessment was postponed for the following year.

Photo 3: Eastern toe-slope of field facing south July 2015 (left) and June 2021 (right).

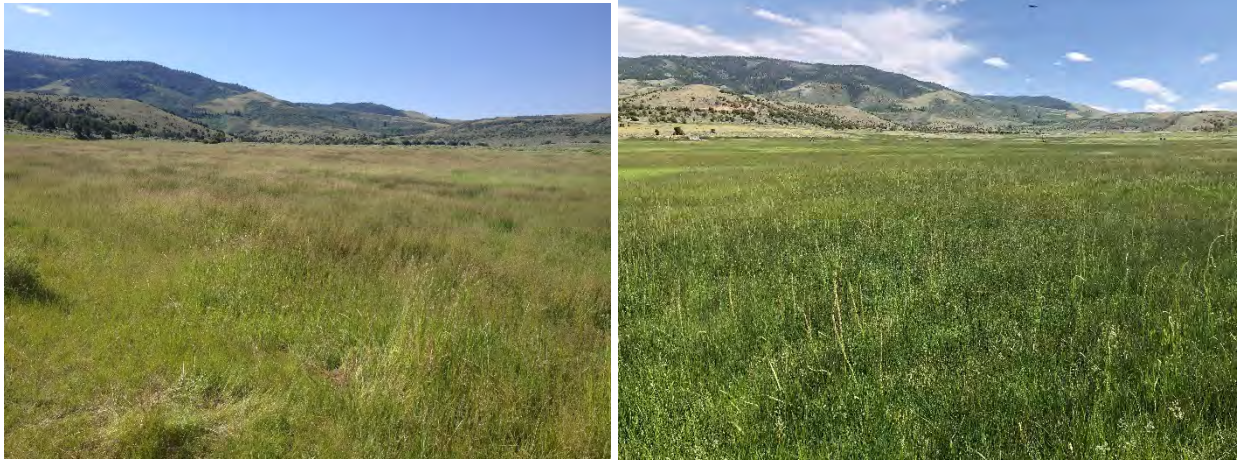
- M. Beck center pivots were installed in September 2016. A site visit was completed in June 2021. There appeared to be wetland characteristics still present on the 83.5 wetland acres previously assessed. Since the conditions had not changed noticeably, photos were taken and the follow-up assessment was postponed for the following year.

Photo 4: Center of western pivot field facing south June 2016 (left) and June 2021 (right).

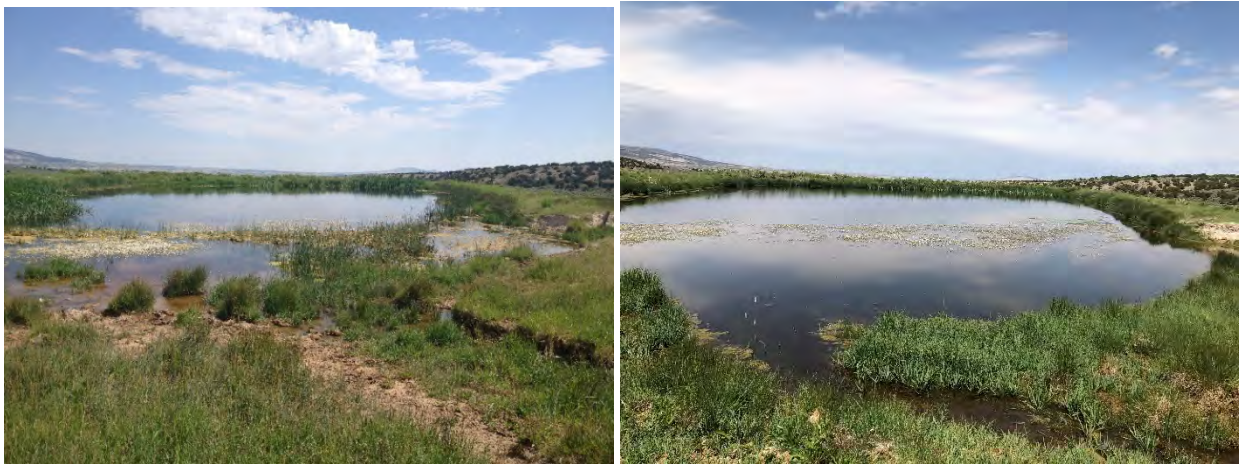
Photo 5: Pond located at north end of field June 2016 (left) and June 2021 (right).

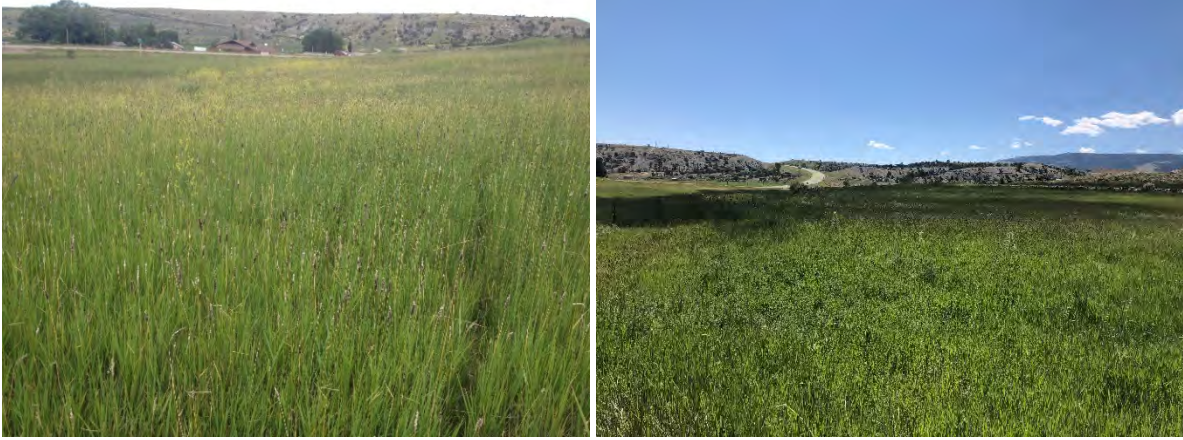
- Thomas pod-lines were installed in March 2017. A site visit was completed in July 2021. There appeared to be wetland characteristics still present on the 1.3 wetland acres previously assessed at the northeastern toe of the slope. Since the conditions had not changed noticeably, photos were taken and the follow-up assessment was postponed for the following year.

Photo 6: The northeastern toe of the pasture July 2015 (left) and July 2021 (right).

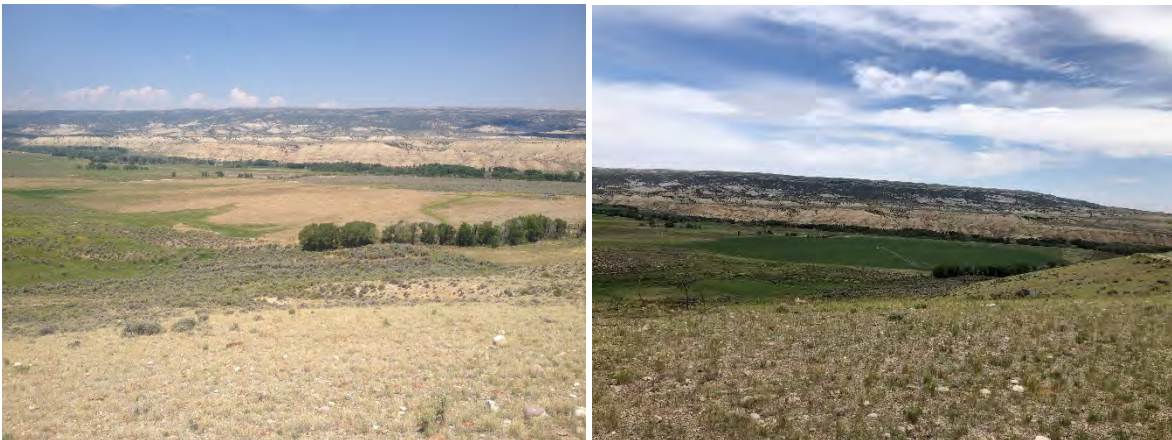
- Anderson pivot and gated pipe were installed November 2017. A site visit was completed in June 2021. Both fields still contained wetland vegetation along the irrigation ditches. Thistle, yellow sweet clover and white-top present. Noticeable changes were found on approximately 15 acres of the 26.1 wetland acres assessed due to new plantings and recent haying in 2020, but those changes were less noticeable in 2021. The field now contains hay grasses, alfalfa and some wetland vegetation. Photos were taken and a follow-up assessment will occur next year to fully capture those changes.

Photo 7: Anderson pivot field overview facing north July 2017 (left) and June 2021 (right).

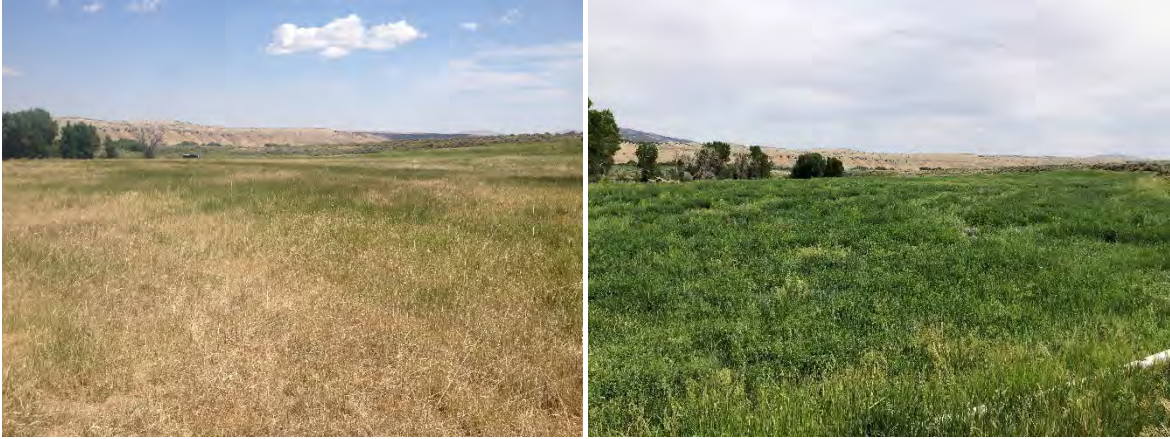
Photo 8: Anderson gated pipe field facing north July 2017 (left) and June 2021 (right).

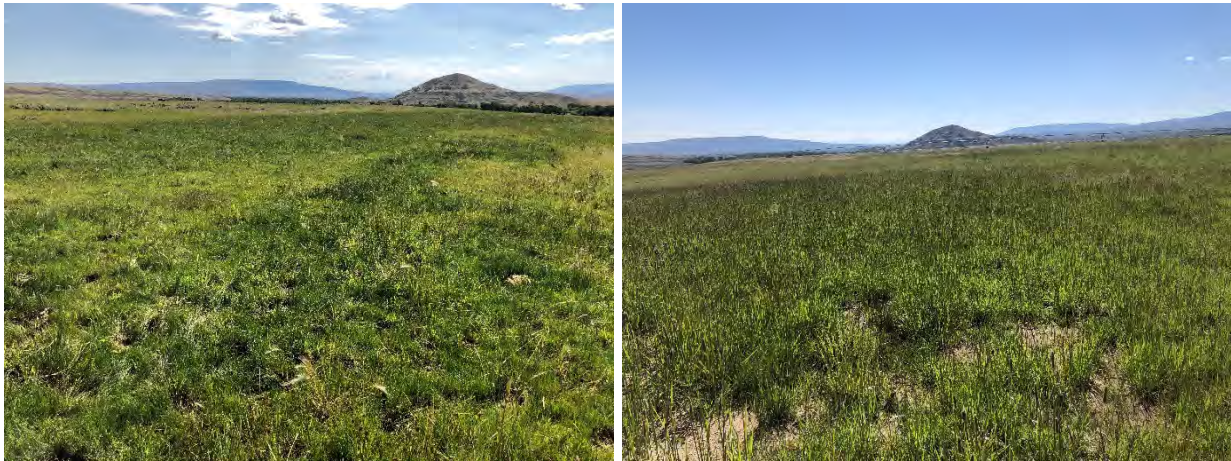
- DR Livestock North Pivot was installed in November 2017. A site visit was completed in July 2021. Wetland characteristics still present in the 3.4 acres assessed on the north and south sides of the field. Rushes, sedges and hay grasses were found in most of the field, with patches of sagebrush. It was grazed recently. Since the conditions had not changed noticeably, photos were taken and the follow-up assessment was postponed for the following year.

Photo 9: West end of DR Livestock north pivot July 2018 (left) and July 2021 (right).

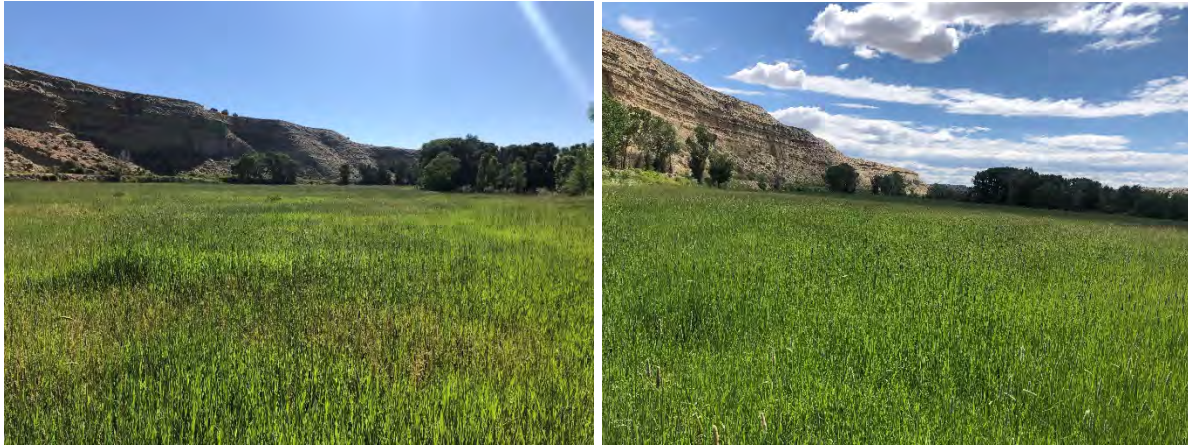
- Petersen Ranch Pod-lines and Gated Pipe were installed fall of 2019. A site visit was completed June 2021. The north field where gated pipe was installed still contains rushes, sedges, hay grasses and saturated soils throughout the area. The south field where pod-lines had been installed had recently been hayed, so vegetation identification was difficult. Since the conditions had not changed noticeably, photos were taken and the follow-up assessment was postponed for the following year.

Photo 10: South end of north gated pipe field July 2019 (left) and June 2021 (right).

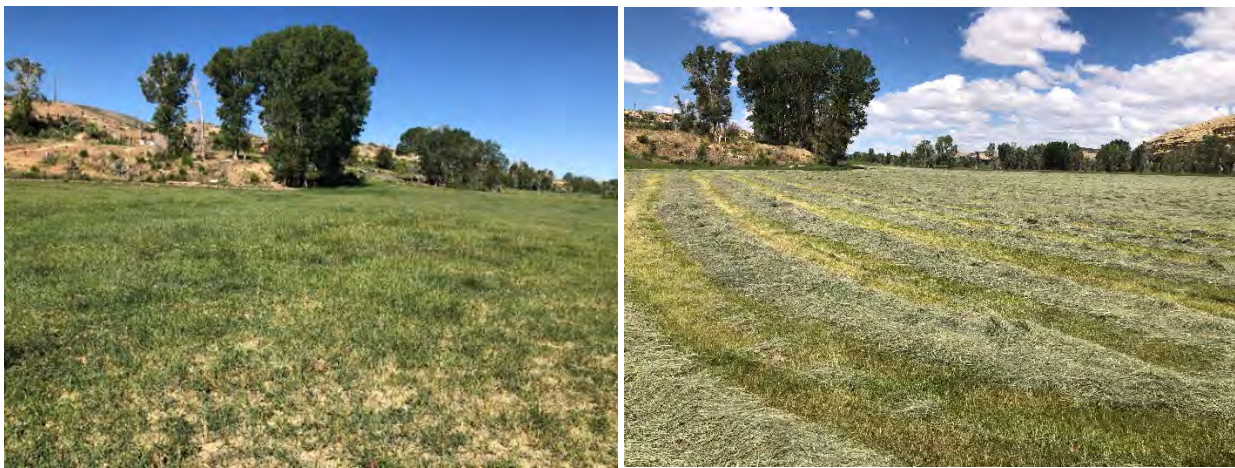
Photo 11: Souwestern section of the south pod-line field July 2019 (left) and June 2021 (right).

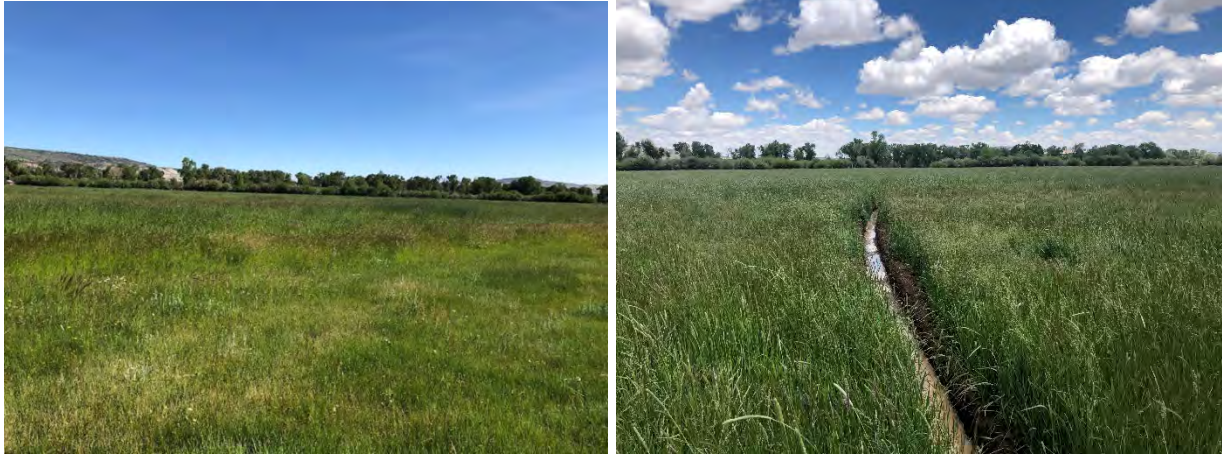
- D. Beck Ranch Pivots were installed fall 2019. A site visit was completed in June 2021. Wetland characteristics were still present in the 31 acres assessed in the eastern pivot field. Hay/meadow grasses, sedges, rushes, arrowgrass and saturated soils were still present. Since the conditions had not changed noticeably, photos were taken and the follow-up assessment was postponed for the following year.

Photo 12: Southern end of the eastern pivot field July 2019 (left) and June 2021 (right).

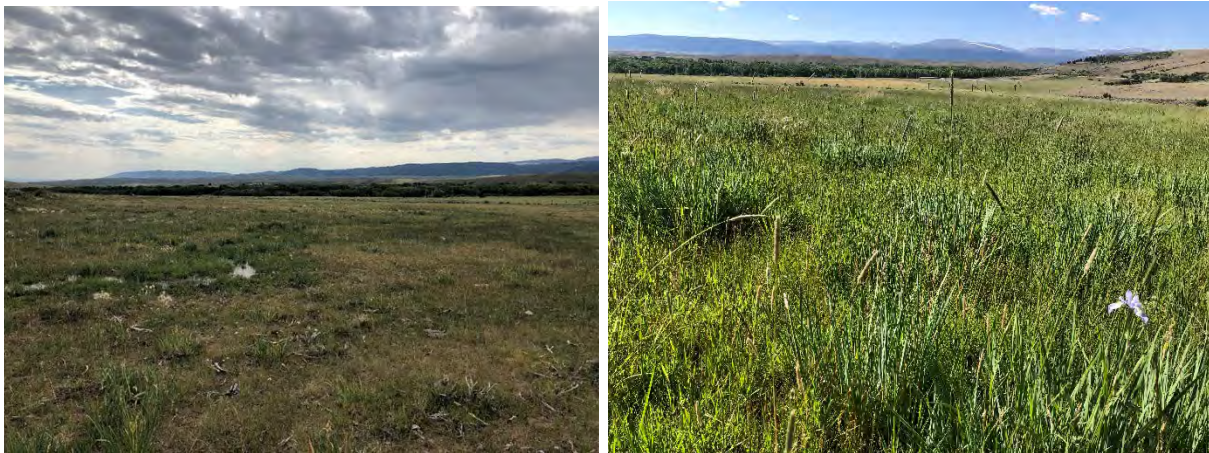
- DR Livestock Pivots 2 & 3 were installed fall 2019. A site visit was completed in July 2021. Wetland characteristics were still present in the 2.6 acres assessed in the #2 field. Saturated soils in depressions, wild iris, rushes and sedges still present. Since the conditions had not changed noticeably, photos were taken and the follow-up assessment was postponed for the following year.

Photo 13: Northwestern corner of pivot field #2 near irrigation ditch, July 2019 (left) and July 2021 (right).

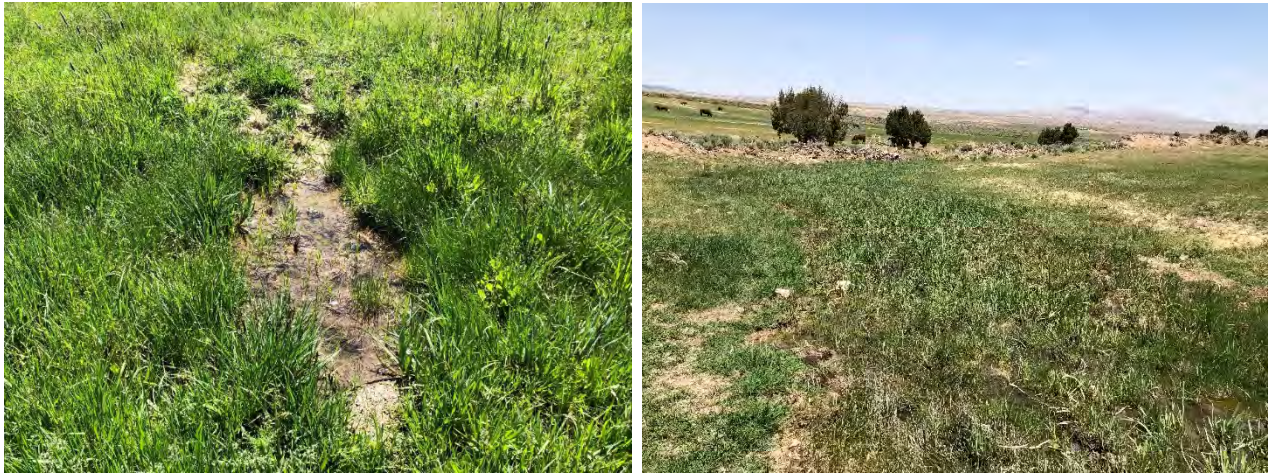
- S. Slagowski Pod-Lines were installed spring of 2020. A site visit was completed June 2021. Wetland habitat was still present on the 0.83 acres assessed. Standing water still present in draw, as well as rushes, sedges and saturated soils. Since the conditions had not changed noticeably, photos were taken and the follow-up assessment was postponed for the following year.

Photo 14: Draw in pod-line field with standing water and wetland vegetation present, July 2019 (left) and June 2021 (right).

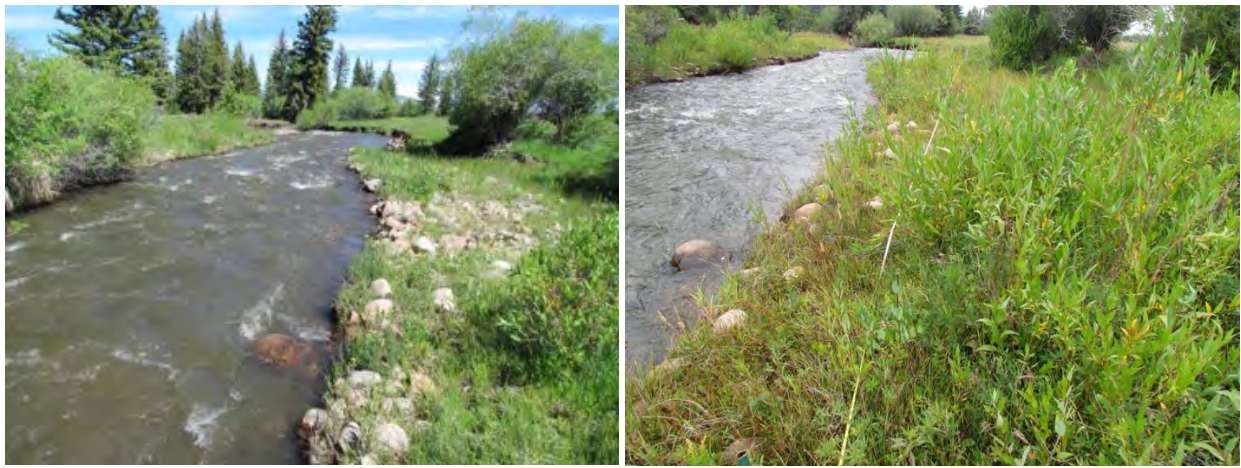
No habitat replacement projects were completed in 2021. The Molly Bullock and House Pasture riparian fence projects were surveyed to document vegetative changes. No wetland assessments were completed since the fencing has only been in place a few years. The monitoring results are promising with a narrowing channel and increased willow and other riparian species growth. Vegetative monitoring will continue to occur annually to document changes. Below are photos documenting the changes found in the Molly Bullock riparian fence and the House Pasture fence.

Photo 15: Photopoint for the Beaver Creek Molly Bullock pasture comparing June 2017 (left) prior to fencing and September 2021 (right), three years after fencing was completed.

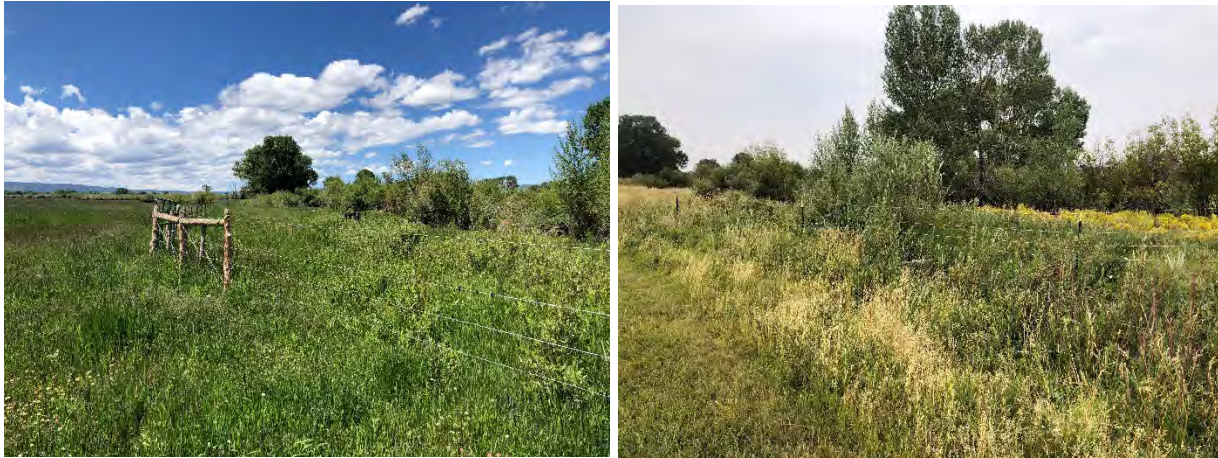
Photo 16: House Pasture riparian fence June 2020 (left) and Sept 2021 (right), two years after fencing was completed.
