# Henry's Fork Salinity Control Area Monitoring and Evaluation Report

# Fiscal Year 2023

## Wildlife/Wetland Value Assessments and Habitat Replacement Projects

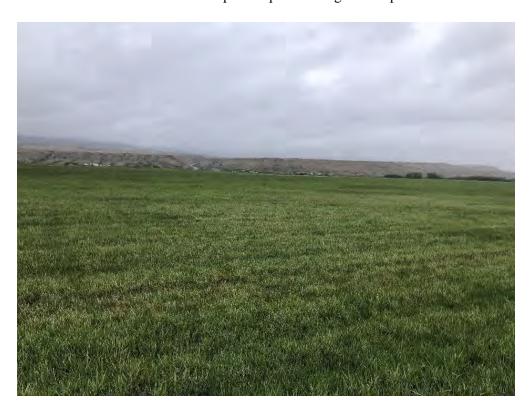
Photo 1: Southwestern end of the field facing north, June 2023.

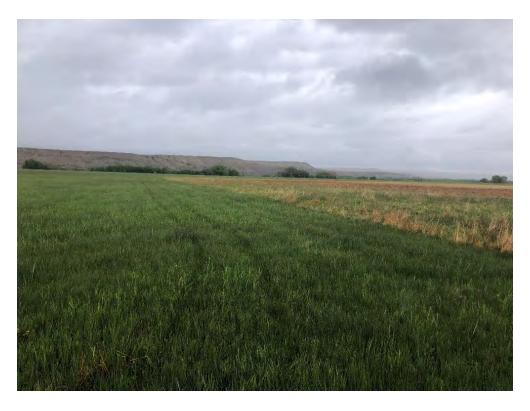
Photo 2: Southeastern edge of wheel-line location where seasonal changes to permanent water regime, June 2023.

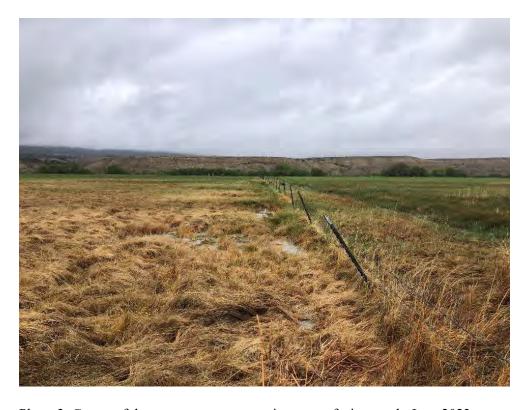
Photo 3: Center of the permanent water regime acres facing north, June 2023.

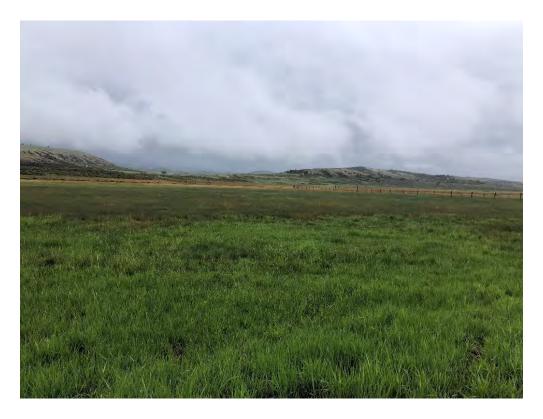
Photo 4: Northeastern section of the field facing southwest, June 2023.

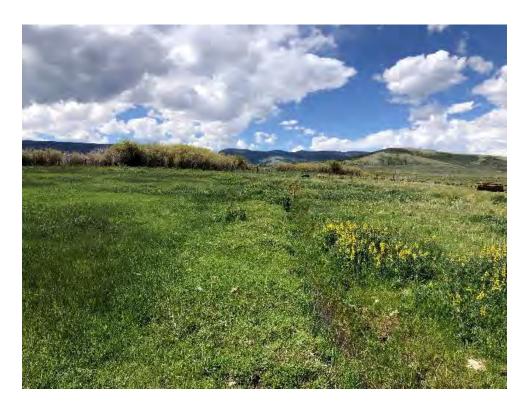
Photo 5: Southwestern end of the field where the irrigation reservoir will be located, June 2023.

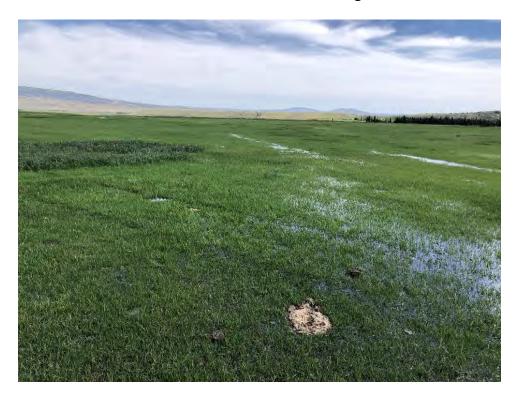
Photo 6: Southeastern section of the field with standing water present, June 2023.

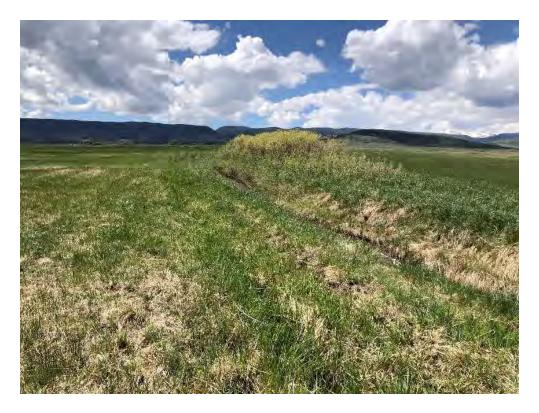
Photo 7: Center of the field facing south near main irrigation ditch, June 2023.

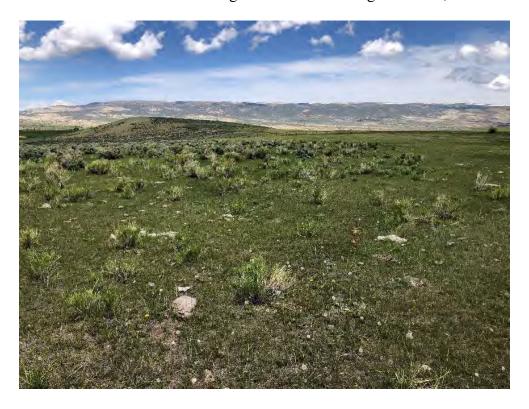
Photo 8: Northwestern edge of field that contained upland habitat that was not included in wetland assessment, June 2023.

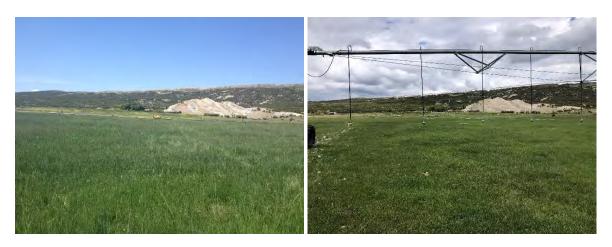
• R. Slagowski Pivot was installed in November 2015. A site visit was completed in June 2023. Wetland characteristics were still present on the 5 acres previously assessed. Photos were taken and the follow-up assessment was postponed for the following year.

Photo 9: Southern end of field in June 2015 (left) and June 2023 (right).

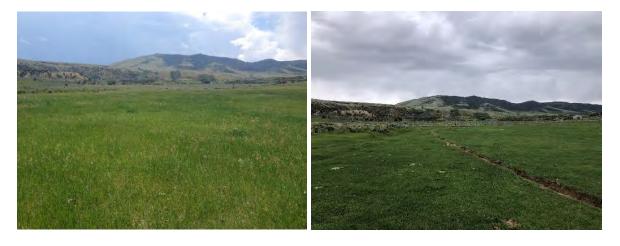
• D. Slagowski pivot was installed in September 2016. A site visit was completed in June 2023. There appeared to be wetland characteristics still present on the 1.02 wetland acres previously assessed. Since the conditions had not changed noticeably, photos were taken and the follow-up assessment was postponed for the following year.

Photo 10: Eastern toe-slope of field facing south June 2015 (left) and June 2023 (right).

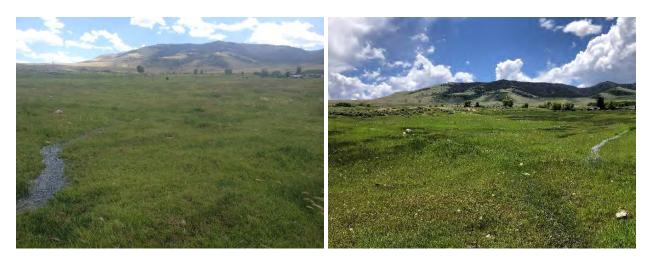
• Crowther pivot was installed in September 2016. A site visit was completed in June 2023. There appeared to be wetland characteristics still present on the 2.95 wetland acres previously assessed. Since the conditions had not changed noticeably, photos were taken and the follow-up assessment was postponed for the following year.

Photo 11: Eastern toe-slope of field facing south July 2015 (left) and June 2023 (right).

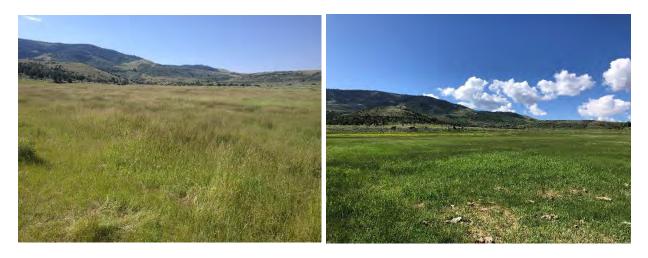
M. Beck center pivots were installed in September 2016. A site visit was completed in June 2023. There appeared to be wetland characteristics still present on the 83.5 wetland acres previously assessed. Since the conditions had not changed noticeably, photos were taken and the follow-up assessment was postponed for the following year.

Photo 12: Center of western pivot field facing south June 2016 (left) and June 2023 (right).

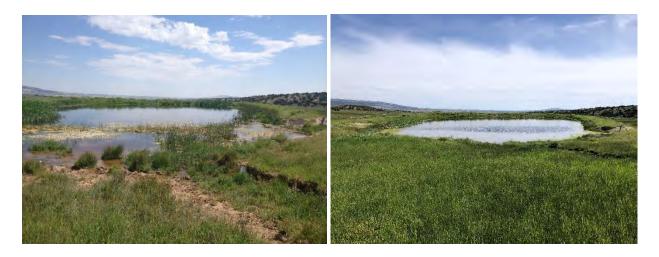
Photo 13: Pond located at north end of field June 2016 (left) and June 2023 (right).

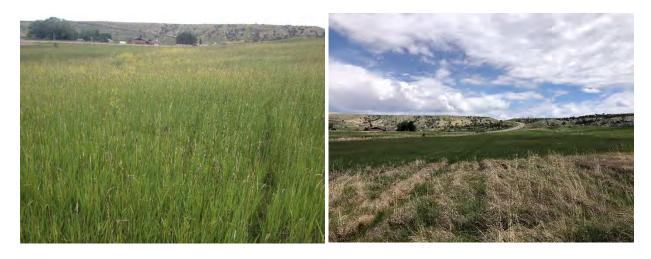
• Thomas pod-lines were installed in March 2017. A site visit was completed in June 2023. There appeared to be wetland characteristics still present on the 1.3 wetland acres previously assessed at the northeastern toe of the slope. Since the conditions had not changed noticeably, photos were taken and the follow-up assessment was postponed for the following year.

Photo 14: The northeastern toe of the pasture July 2015 (left) and June 2023 (right).

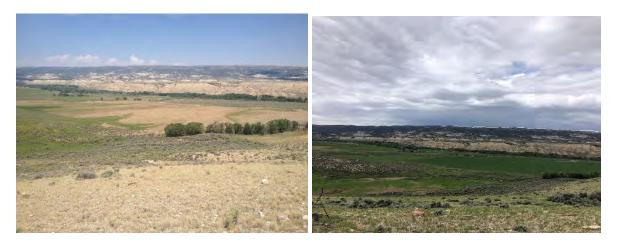
• Anderson pivot and gated pipe were installed November 2017. A site visit was completed in June 2023. Both fields still contained wetland vegetation along the irrigation ditches. Thistle, yellow sweet clover and white-top present. Noticeable changes were found on approximately 15 acres of the 26.1 wetland acres assessed due to new plantings and recent haying in 2020, but those changes have become less noticeable. The field now contains hay grasses, alfalfa and wetland vegetation. Photos were taken and a follow-up assessment will occur next year.

Photo 15: Anderson pivot field overview facing north July 2017 (left) and June 2023 (right).

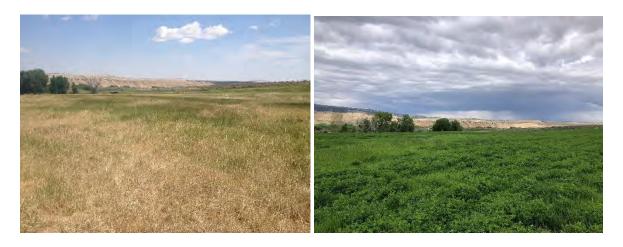
Photo 16: Anderson gated pipe field facing north July 2017 (left) and June 2023 (right).

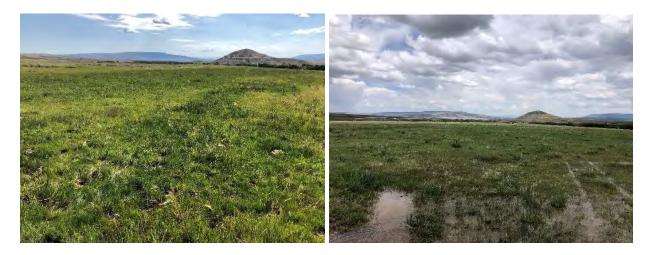
• DR Livestock North Pivot was installed in November 2017. A site visit was completed in June 2023. Wetland characteristics still present in the 3.4 acres assessed on the north and south sides of the field. Rushes, sedges and hay grasses were found in most of the field, with patches of sagebrush. Since the conditions had not changed noticeably, photos were taken and the follow-up assessment was postponed for the following year.

Photo 17: West end of DR Livestock north pivot July 2018 (left) and June 2023 (right).

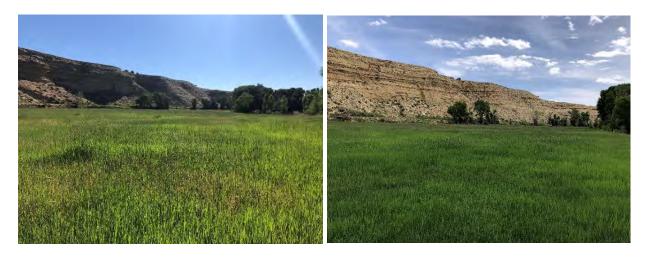
• Petersen Ranch Pod-lines and Gated Pipe were installed fall of 2019. A site visit was completed June 2023. The north field where gated pipe was installed still contains rushes, sedges, hay grasses and saturated soils throughout the area. The south field where podlines had been installed had recently been hayed so an assessment was not completed. Since the conditions had not changed noticeably, photos were taken and the follow-up assessment was postponed for the following year.

Photo 18: South end of north gated pipe field July 2019 (left) and June 2023 (right).

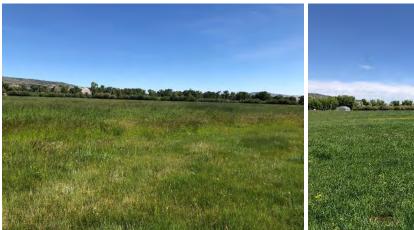
• D. Beck Ranch Pivots were installed fall 2019. A site visit was completed in June 2023. Wetland characteristics were still present in the 31 acres assessed in the eastern pivot field. Hay/meadow grasses, sedges, rushes, arrowgrass and saturated soils were still present. Since the conditions had not changed noticeably, photos were taken and the follow-up assessment was postponed for the following year.

Photo 20: Southern end of the eastern pivot field July 2019 (left) and June 2023 (right).

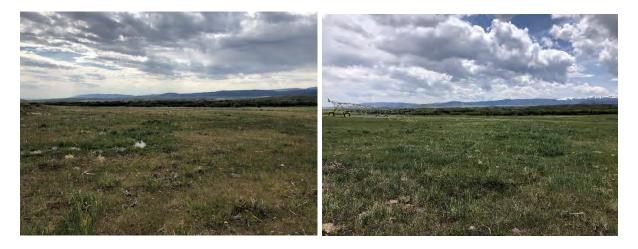
• DR Livestock Pivot #2 was installed fall 2019. A site visit was completed in June 2023. Wetland characteristics were still present in the 2.6 acres assessed in the #2 field. Saturated soils in depressions, wild iris, rushes and sedges still present. Since the conditions had not changed noticeably, photos were taken and the follow-up assessment was postponed for the following year.

Photo 21: Northwestern corner of pivot field #2 near irrigation ditch, July 2019 (left) and June 2023 (right).

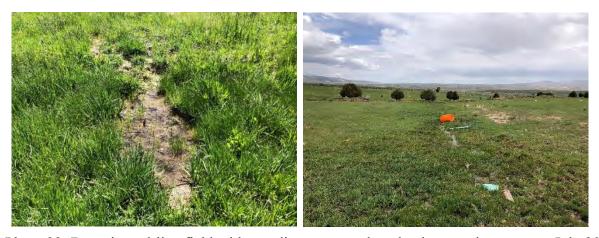
• S. Slagowski Pod-Lines were installed spring of 2020. A site visit was completed June 2023. Wetland habitat was still present on the 0.83 acres assessed. Standing water still present in draw, as well as rushes, sedges and saturated soils. Since the conditions had not changed noticeably, photos were taken and the follow-up assessment was postponed for the following year.

Photo 22: Draw in pod-line field with standing water and wetland vegetation present, July 2019 (left) and June 2023 (right).

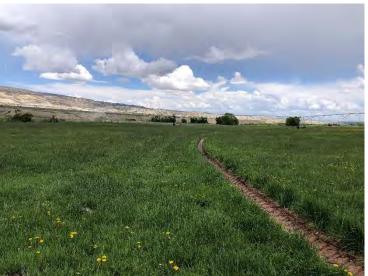
• Taylor Ranches Pivot was installed January 2021. A site visit was completed June 2023. Wetland vegetation and saturated soils were still present on the 23.1 acres assessed.

Photo 23: Center of field facing northeast with wetland characteristics present, June 2020 (left) and June 2023 (right).

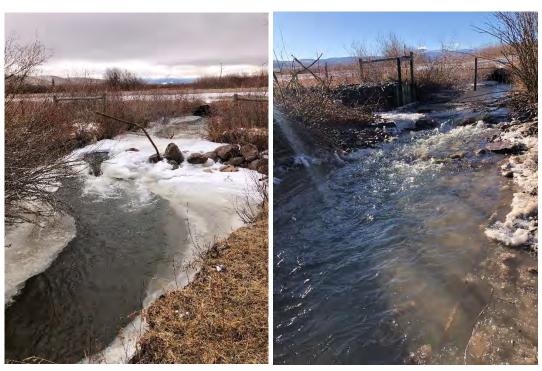
The Donahue diversion was also improved in December 2023. It is located on Poison Creek of the Henry's Fork near Lonetree, Wyoming. It similarly was a push-up dam that reduced fish passage and increased sedimentation to the system. It was improved to a rock-vane structure that reconnected an estimated 4 stream miles for Colorado River cutthroat trout and other native fish species. **9.98 habitat values were accrued with this project.**

Photo 25: Donahue diversion before construction (left) and after improvements (right), December 2023.
