Hole in Mountain SNOTEL Rebuilt in New Location

Reno, Nevada – Dec. 13, 2016 – Hole in Mountain SNOTEL, south of Wells, Nevada in the East Humboldt Mountains, was rebuilt in a new location and brought back online on October 20, 2016. The weather station had not reported data since it was destroyed by an avalanche on December 23, 2015. This was the second avalanche to hit the SNOTEL. The first avalanche was in February 1986, after which the site was rebuilt in the original location. This time, the station was moved about 450 feet south and located behind a small ridge to protect the site from future slides.

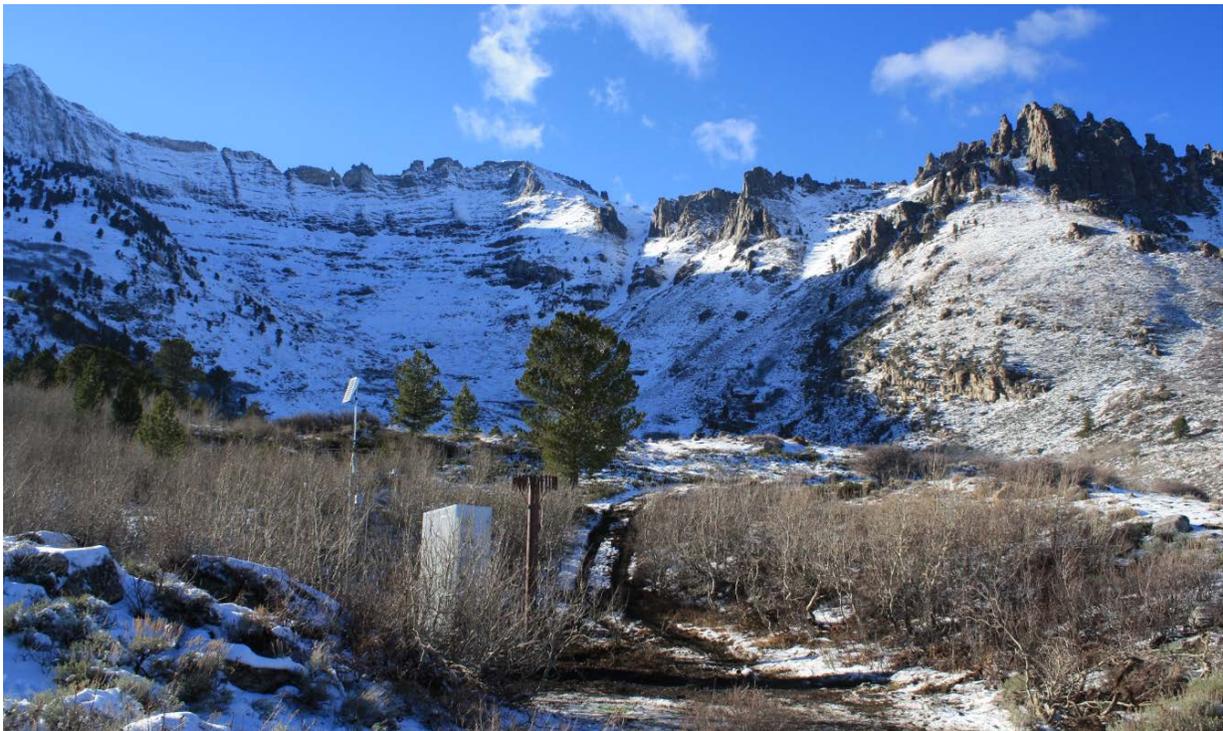
Photo 1: Hole in Mountain SNOTEL in its new location. The site is tucked behind a small ridge about 450ft south of the original location. This new location will keep future avalanches from impacting the site. Photo taken October 2016.

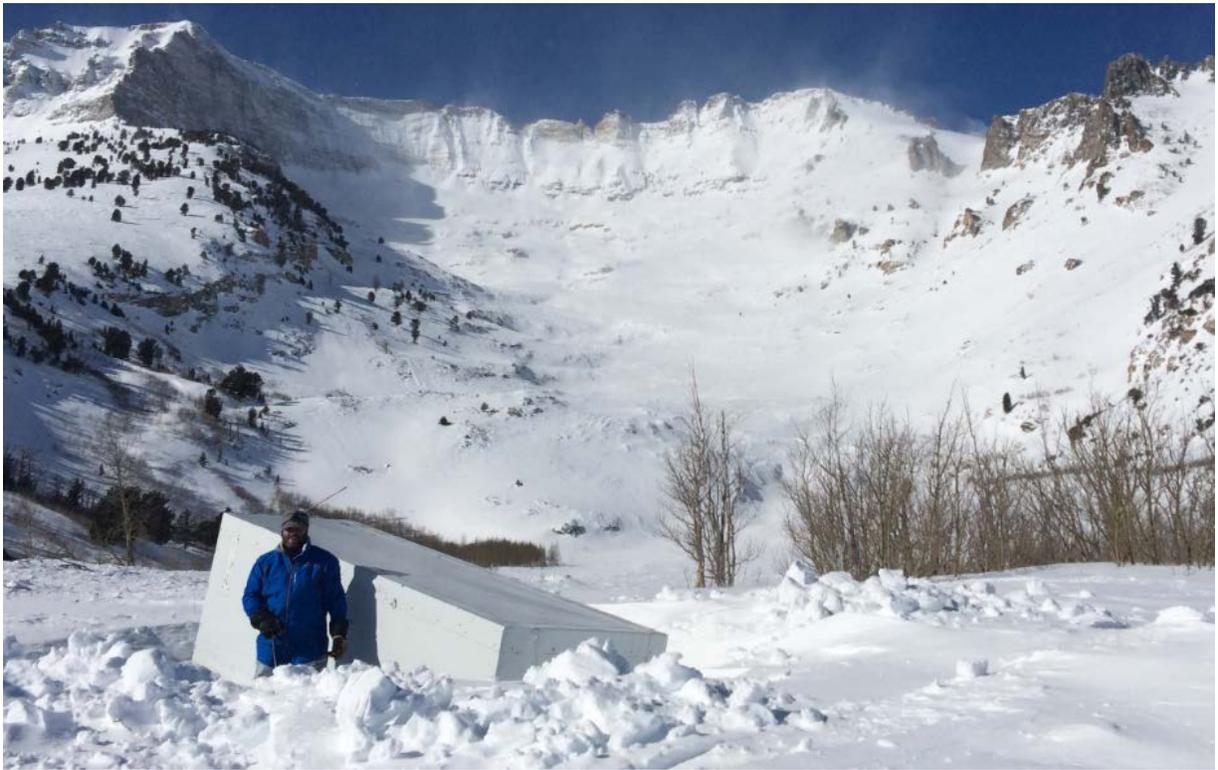
Photo 2: Damaged observed at Hole in Mountain SNOTEL after avalanche. The SNOTEL shelter, which houses the site's electronics, was swept 200 feet downhill of its foundation. Photo taken January 2016.
