# Watershed Rehabilitation Progress Report February 2018

## The Watershed Program: Providing Multiple Benefits to Communities for Over 70 Years

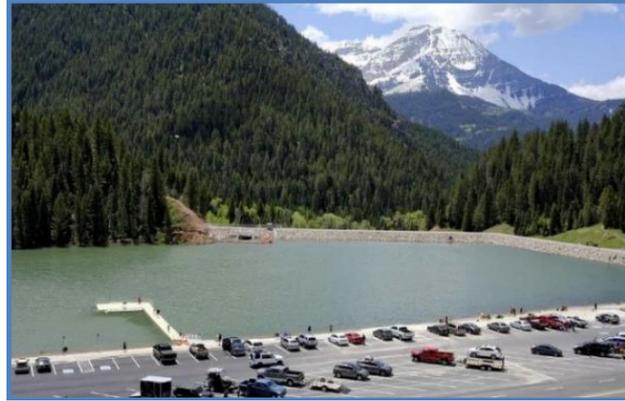
*The Tibble Fork Dam provides flood protection, a water supply and a popular recreational area.*

The dam no longer met the current dam safety standards and because of the risk of loss of life downstream if the dam failed it was rehabilitated to current safety standards. Rehabilitation extended the life of the dam and its benefits for another 71 years. Work on the project started in 2016 and was completed in 2017.

Rehabilitation included raising the dam crest by 15 feet, replacing the existing auxiliary spillway with a concrete/covered box inlet and raising it by 13 feet and other improvements.

Rehabilitating the dam also provided the opportunity to double the size of the surface area of the lake and adding 120 acre feet of water storage.

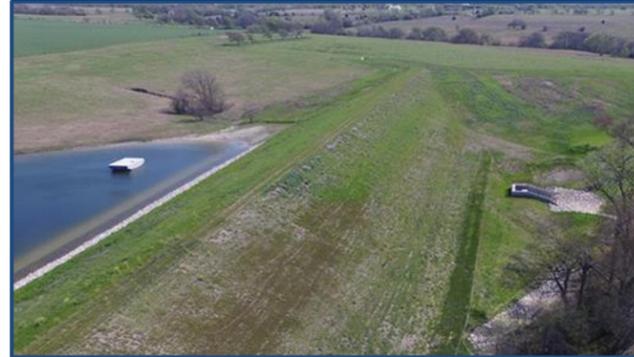
*East Fork Above Lavon Dam No. 2A after rehabilitation project was completed.*

The East Fork Above Lavon Dam No. 2A was originally constructed in 1958 in a then-rural area of Collin County, Texas. The dam had exceeded its 50-year design life span. This aging structure required rehabilitation to extend its service life, increase sediment storage, and was upgraded to meet current dam safety standards for a High Hazard potential dam to protect a growing population downstream.

The work included replacing the principal spillway with a more modern, less maintenance design; widening and armoring the auxiliary spillway to accommodate additional flows; and improving the dam's slope to avoid slides and facilitate maintenance. An innovative aspect of the dam's design included armoring the auxiliary spillway with articulated concrete blocks, covering with top soil and seeding it for a grass cover in lieu of a constructing an overtopping spillway with roller compacted concrete.

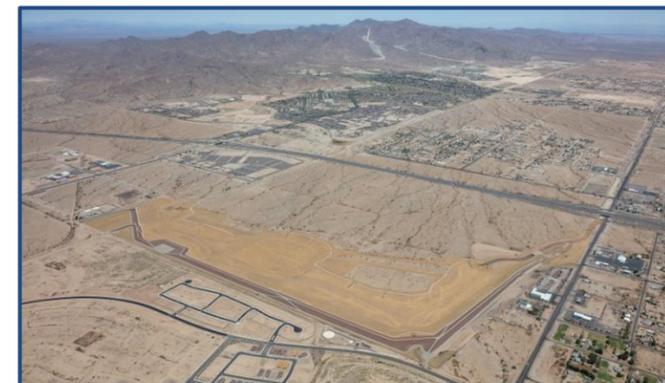
Aerial view of White Tanks No. 4 Flood Retarding Structure

The Arizona Department of Water Resources (state agency with regulatory authority) classified the dam as having safety deficiencies and it needed corrective action to bring it into compliance with federal and state dam safety standards and performance requirements. Deficiencies included transverse cracking of the embankment, inadequate left and right spillways, and unprotected corrugated metal pipe outlets.

The rehabilitation consisted of raising the dam embankment, grading of the flood pool to remove a large borrow area pit, widening and extending the existing flood structure to 1.6 miles and adding upgrades, including an architecturally and structurally enhanced concrete auxiliary spillway, drop inlet structures with realigned inflow channels and a new concrete principal spillway outlet structure.

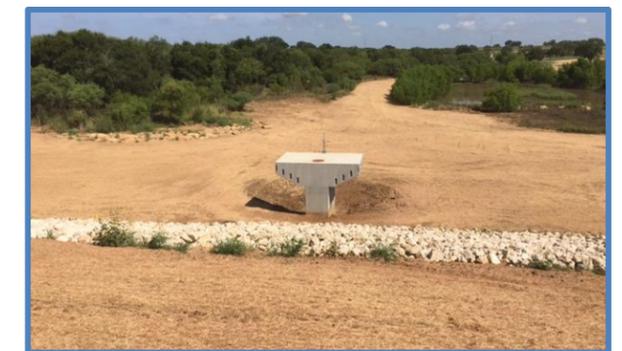
Barnitz Creek Watershed Dam No. 5

The dam was originally designed and constructed as a Low Hazard potential dam to protect agricultural lands from flooding. It was designed with a 50-year design life and was over 60 years old when it was rehabilitated.

The dam was reclassified to a High Hazard potential dam in 2008 due to a risk of loss of life, state highway, four county roads downstream, and changes in state dam safety criteria.

The project consisted of removing the existing 14-inch diameter principal spillway conduit and replacing it with a 30-inch diameter reinforced concrete conduit with a new concrete inlet. The top of the dam was raised 6.3 feet. The auxiliary spillway crest elevation was raised 4.9 feet with auxiliary spillway flows on both sides of the embankment. One of the auxiliary spillways is 130 feet in width and the other 60 feet in width. A riprap plunge basin was installed to dissipate energy at the of the principal spillway outlet.
