Economics of Gully Erosion and Stabilization: Last Resort Farm Spring 2018

Name: Last Resort Farm

Location: Monkton, VT

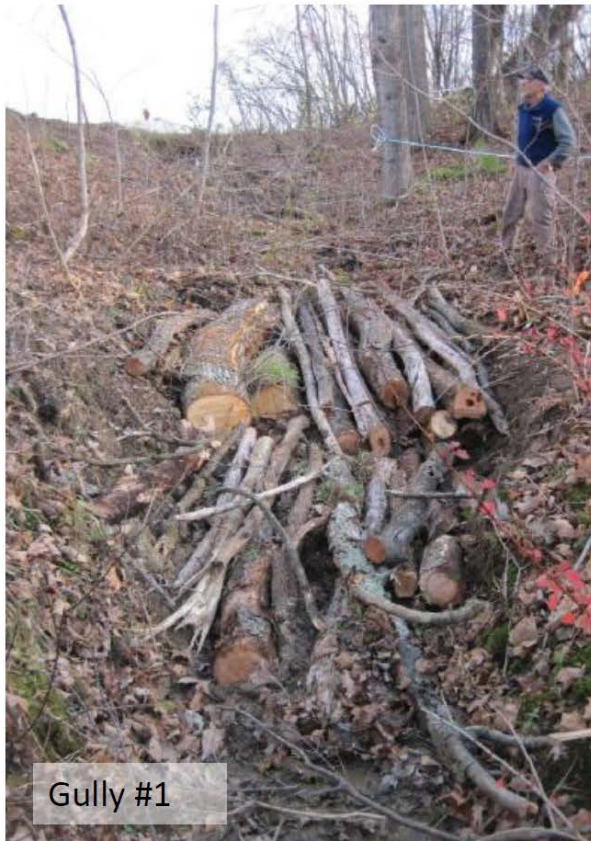
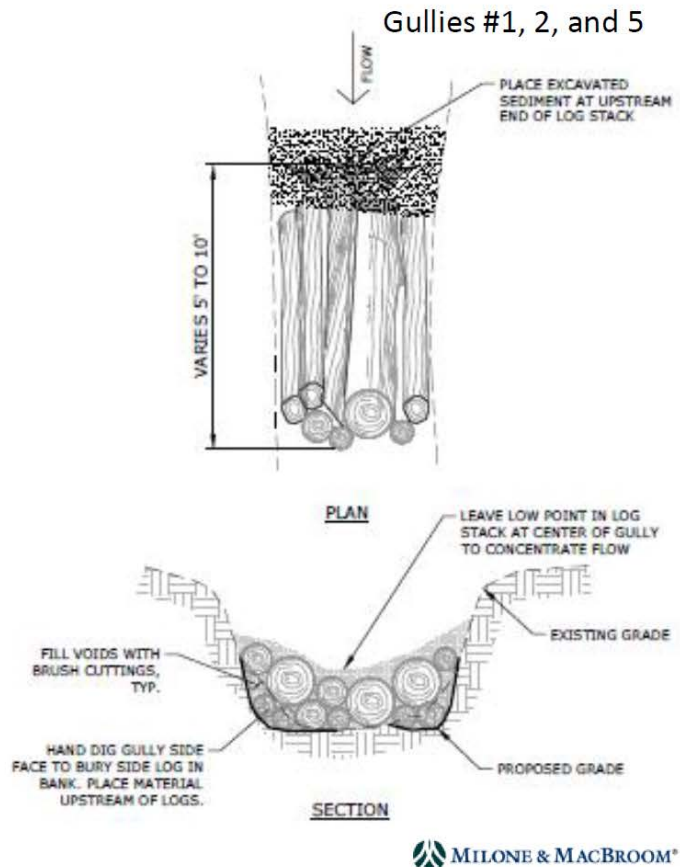
Figure 2. Photo of Gully 1 and Engineering Design for “Soft Practice” Gullies.

Log Stack

LCA received funding from [Vermont Agency of Natural Resources \(ANR\) Ecosystem Restoration Program](#), to install ‘soft engineering’ practices for four of the gullies (Gullies 1, 2, 5 & 6). Also referred to as ‘engineering with nature,’ it is an alternative to more conventional materials, such as stone (rock-lined). LCA believes that this approach offers landowners the option of treating smaller gullies before they become a bigger problem, which if left untreated, may need more expensive (rock) treatment in the future. These gullies were treated with on-site softer, hand-placed natural materials, including brush and logs, and grading and gully shaping to accept the wood and reduce water velocity. In addition to repairing the majority of all of the gullies with natural log materials, stone was installed at the top of Gully 1 and Gully 5. Stone was installed at the top of a third gully (Gully 1) to stop the gully’s head-cut. Stone was limited to the steep entrance of the gully to make the steep transition from the field elevation to the lower part of the gully and dissipate high water velocities coming from the field. MMI engineers provided technical and construction oversight from 2014 to 2015.

The benefits of this approach include a more natural appearance, reduced initial cost, cooler surface waters flowing to Pond Brook, and less soil compaction and disturbance. However, with log decomposition, soft practice gullies may require more frequent maintenance. Although maintenance may be required more frequently, the maintenance cost and technical knowledge needed is very low. The building and maintenance of these practices meshes well with ongoing sugarbush improvements, as extra limbs or culled trees can be added to the gullies to refresh the wood. The intent is for these gullies to naturalize over time by capturing and holding sediment and allowing vegetation to begin to grow.

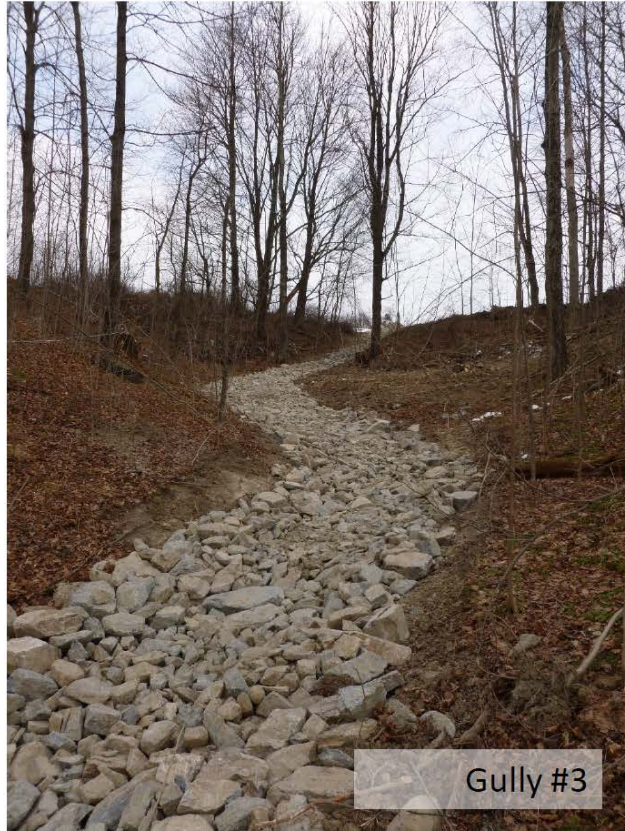
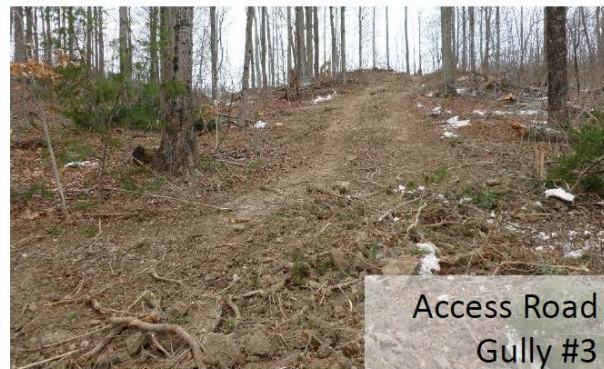
Figure 2. Photo of Gully 3 and Design Specifications for “Hard Practice” Gullies.

Gullies #3 and #4

NRCS Rock-lined Waterway

- 12” stone and 24” stone over geotextile fabric
- Treats full length of gully regardless of degree of erosion
- Installed with excavator
- Separate access road through forest to move rock

The USDA Natural Resources Conservation Service (NRCS) provided technical and financial assistance to help stabilize two of the gullies using the more traditional engineering practices and materials. These two gullies had the most immediate impact on the fields above. Through NRCS' Environmental Quality Incentives Program (EQIP), rock-lined waterways were installed along the length of two most critical gullies (Gullies 3 & 4). The benefits to this approach include proven success in combating erosion, and a longer life span due to the durability of the materials. In addition, rock riprap lined waterways are better at withstanding increasing occurrence of high intensity/low probability storm events (less frequent than once in a hundred years).
