# Monroe County Success from the Field

## New Landowners Help Save Dam for Wildlife

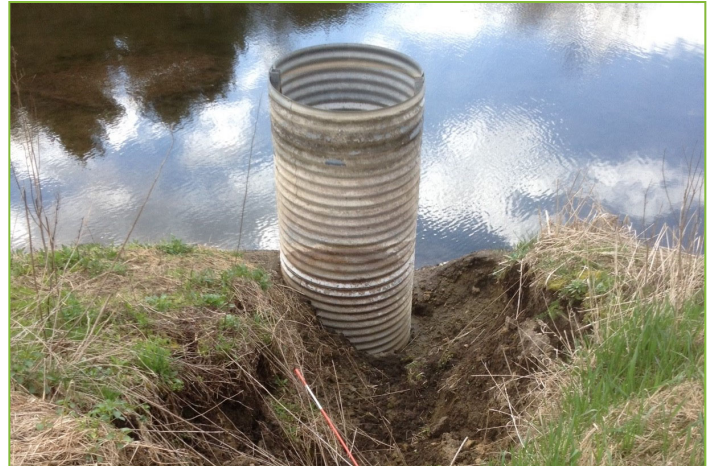
**Above:** The dam in 2017, showing the gully washing out along the berm. The vertical pipe is set below the top of the berm so water would leave through the pipe rather than over the top of the berm if the horizontal pipe plugged or couldn't carry water fast enough.

The previous owner suggested Jennifer contact the NRCS about the problem with the dam. Jennifer had never worked with USDA staff before, but she made a phone call and NRCS was willing to partner in the repair project. "The application process was easy and Dan Gunderson, NRCS Civil Engineering Technician, was great to work with," explained Jennifer. After soliciting four bids, the landowner chose and hired a contractor to complete the construction. The contractor spent about three and a half weeks on-site for the repairs. One evening during construction, the area received five inches of rain, enough to make the site muddy and slippery. Rain delayed the project a few times because the soils need to be compacted while working. Dams that are built to NRCS standards are expected to last at least 15 years. There will always be maintenance that is up to the landowners, such as inspecting the dam after every storm event, keeping the pipe clear of debris, removing debris and sediment from storms and keeping the berm mowed and free of woody plants.

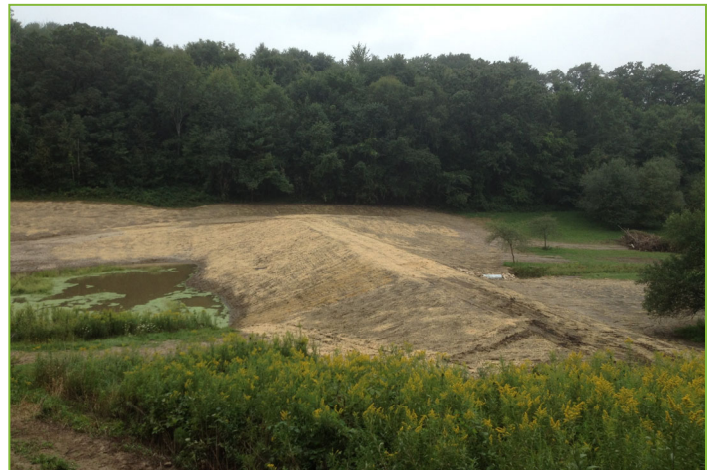
**Below:** After repairs are done, the embankment and borrow area are seeded and mulched.
