Natural Resources Conservation Service

Buffalo, Wyoming MLRA Soil Survey Office

The Minnow Pond Investigation Report

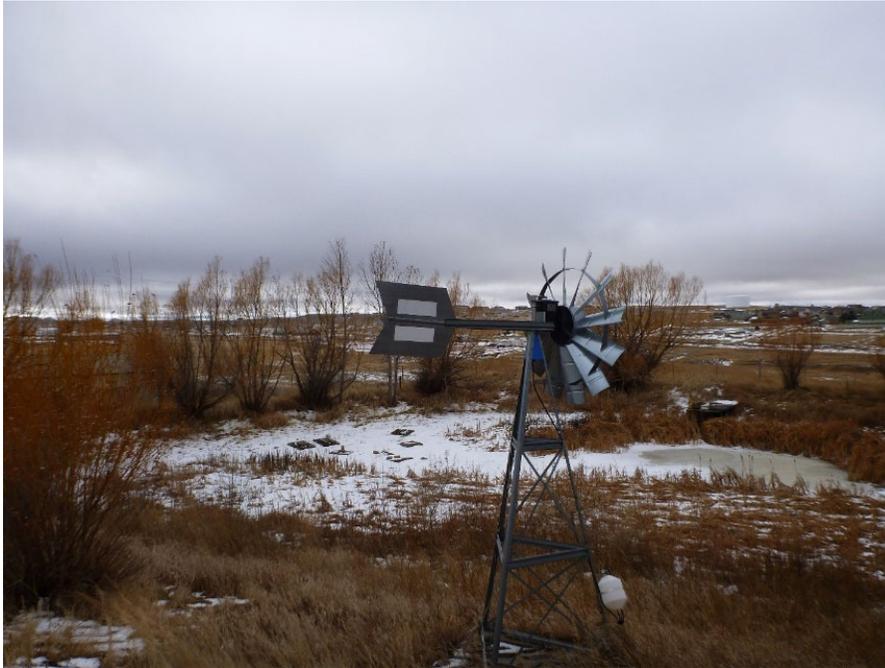
The current condition of the minnow pond at the Wyoming ranch.

As shown in photos on the following page, the dam around the minnow pond amounts to a berm that appears to have been created by bulldozing the existing raw shale into place. A PVC liner did not last and was replaced with a layer of bentonite clay by the current owner. This berm is currently overgrown with cottonwood and tamarisk. Looking at the orthophotos, seeps are clearly visible across the road below the dam, likely forming from the pond water seeping on and along the shale paralithic contact. The size of the seeps has increased with time, and the water that once produced minnows for fishing is now growing pasture grass.

In MLRA 58B, the pedogenic accumulations of salt primarily consist of calcium carbonate or gypsum. The soils in this area were mapped Cromack-Fairburn-Ucross. We also found Sabatka, a similar soil formed in non-acidic shale. If the berm can be made legally and physically viable again, we recommend the trees be removed and to install a PVC liner thick enough to support the weight and resist the sharpness of the deer hooves that penetrated the original liner.

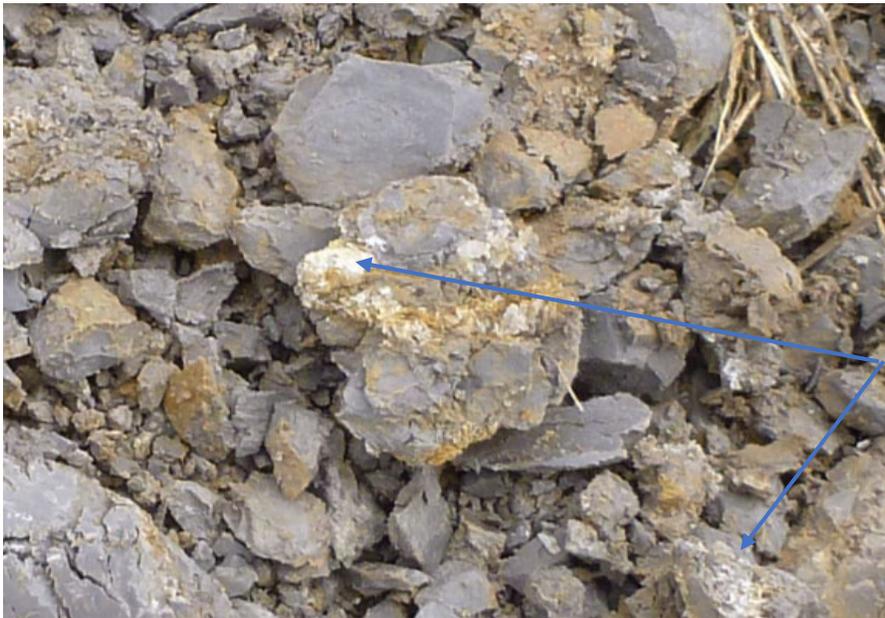
Pedogenic gypsum: note the blue arrows. This raw, chippy shale parent material is found at a depth of 20-40" in the soil just north of the pond.

We made *visual observations* of plant responses to an expanding water source. We tested for *gypsum* by checking white concentrations with a diluted hydrogen chloride (HCl). If acid is dropped onto calcium carbonate (CaCO₃), it produces bubbles of carbon dioxide. *Electrical conductivity (EC)* also was tested. Gypsum is more soluble than CaCO₃ and this is evidenced by a higher EC.
