Hole-In-Mountain Avalanche

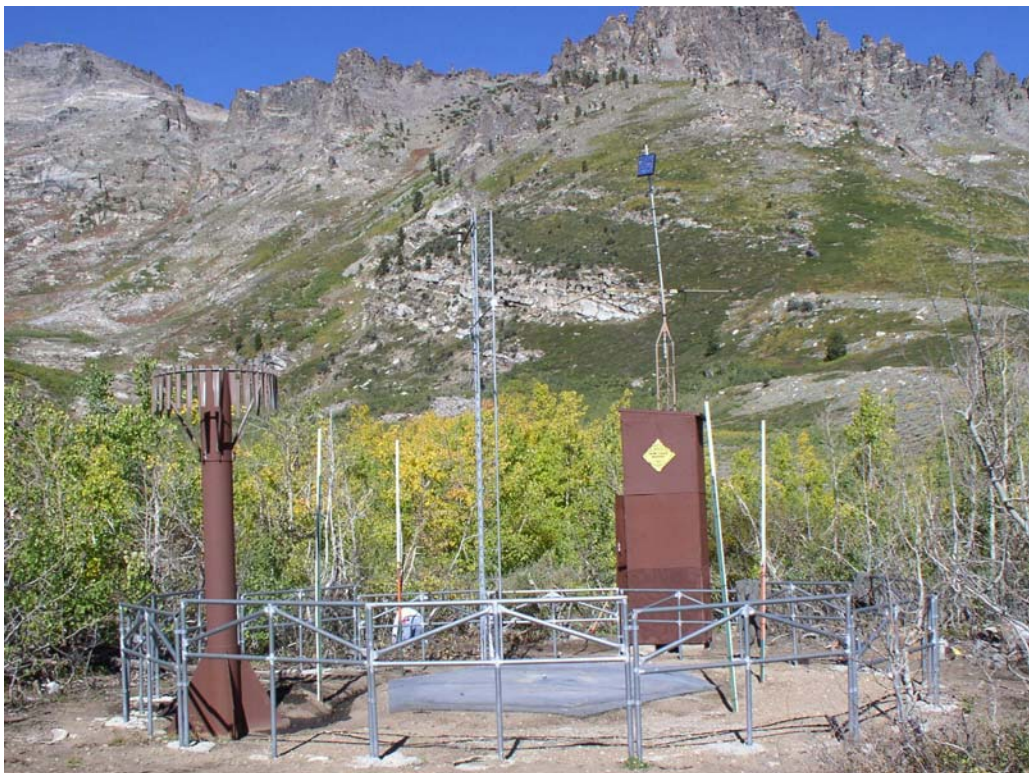
As you can see from the photo, this site lies on a bench just east of the East Humboldt Range at an elevation of 8,100 feet. Hole in the Mountain Peak rises to 11,306 feet just to the west of it. Vegetation is primarily young aspen along the bench and low growing shrubs on the steeper mountain side. A prime recipe for an avalanche.

Sometime after the Midnight reading was received on February 18, an avalanche let loose on the steeper slope above the site, came rushing down through the aspen grove, whose bare branches in the winter would do little to slow or stop the snow, hit the site and off it went.
