United States Department of Agriculture | **Natural Resources Conservation Service** | **11 Campus Boulevard Suite 200 Newtown Square, PA 19073**

Subject: Eng – Ground-Penetrating Radar (GPR) Field Assistance **Date:** 1February 2000

Purpose:
A ground-penetrating radar survey was conduct on slopes adjacent to Jersey Valley Lake on the West Fork of the Kickapoo River to help determine the condition of the underlying sandstone bedrock. It was hoped that the GPR survey would provide additional information on the amount of rock material to be removed by "common excavation" and/or "ripping" methods.

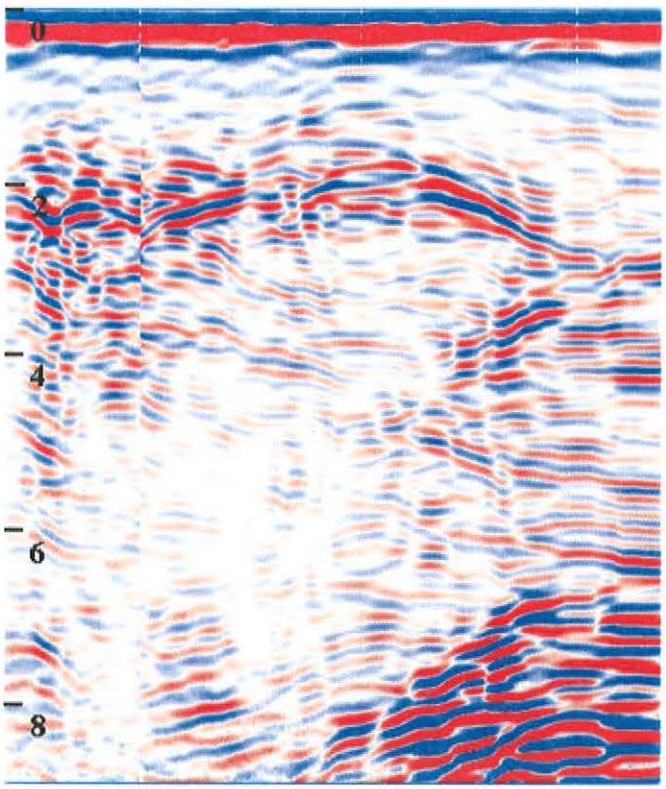
Figure 21A. GPR Profile #7. Depth Scale is in m.

In the lower right-hand corner of Figure 2, at an estimated depth of 7 to 9 m, high amplitude reflections signify contrasting materials within the bedrock.
