United States Department of Agriculture
Soil Conservation Service
Northeast NTC
160 East 7th Street
Chester, PA 19013

Subject: Geophysical surveys of animal waste lagoons in South Carolina, 25 June - 2 July & 10 - 15 July 1988

Date: September 19, 1988

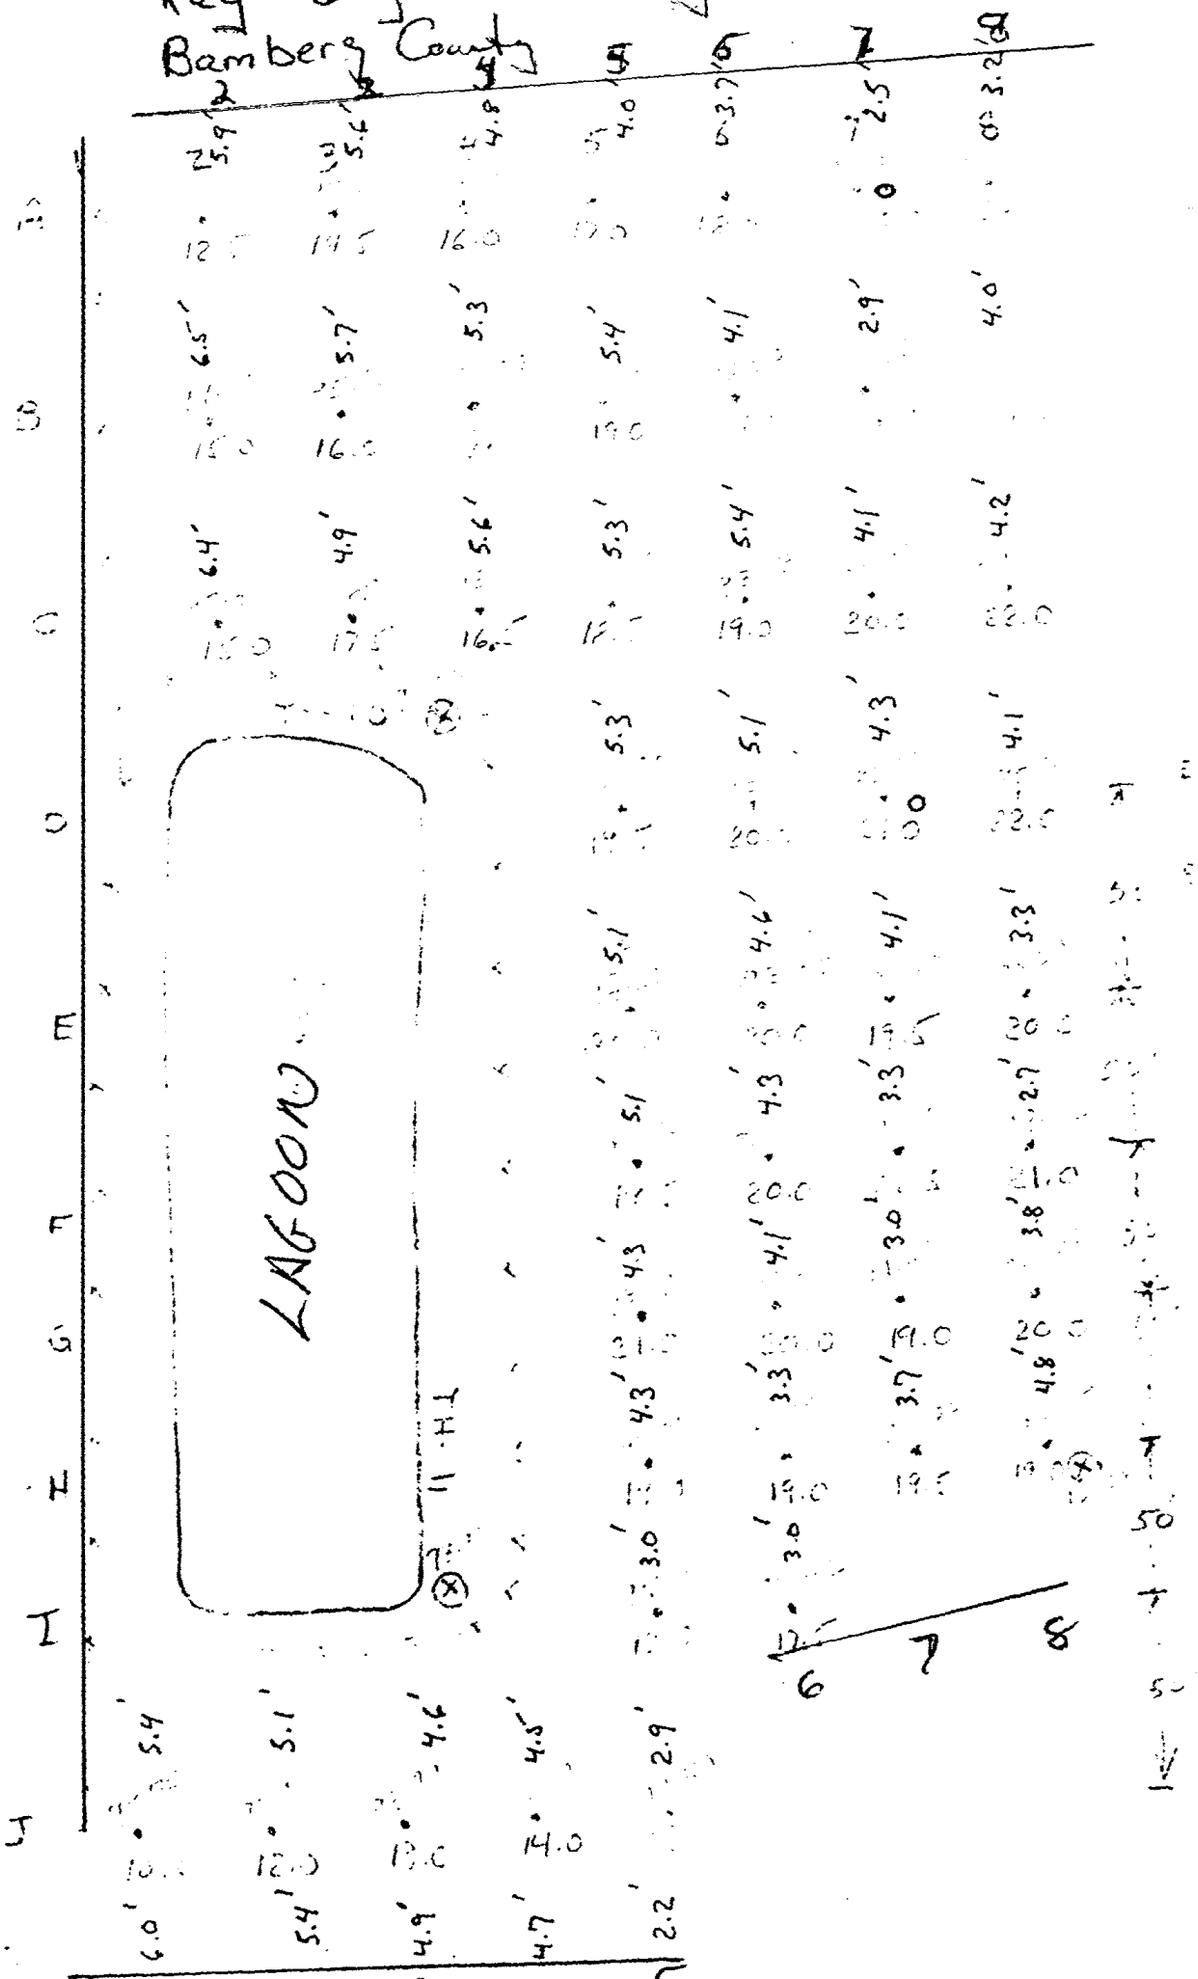
Fig 11

Both EM and GPR techniques worked well at this site. No discernible pattern was observed in the data (see Figures 10, 11, and Table 7). Variations in EM values do not appear to be related to the lagoon and are probably related to variations in the particle size, degree of saturation, and thickness of underlying strata. The Bt horizon forms a limiting layer (to the through flow of water and radar penetration) which, though variable in depth, is continuous across the the survey areas. In Figure 10, the radar image of this horizon is apparent between depths of 1 and 1.8 meters. Figure 10 is from grid line 6. At this site, the GPR provided interpretable imagery to depths of about 3 meters.
