Environmentally Sensitive Maintenance on Agricultural Roads to Reduce Nutrient and Sediment Pollution in the Kishacoquillas Watershed

Prepared for the U.S. Department of Agriculture Conservation Innovation Grant Program

FINAL REPORT

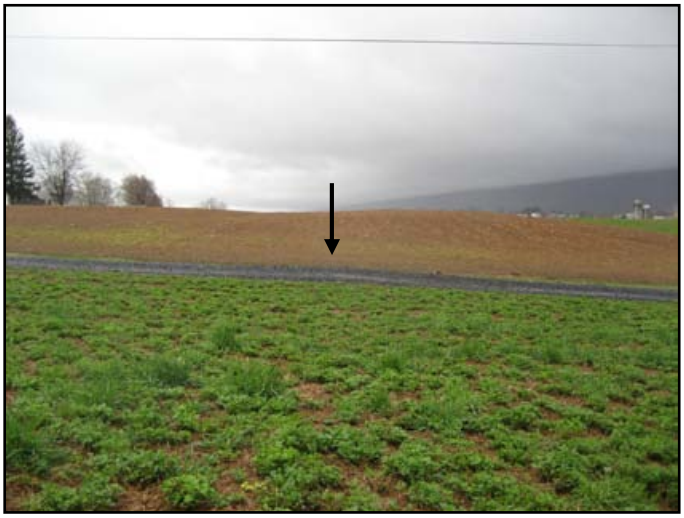
Figure 4.2: Although gradebreaks are difficult to see in still images, notice the slight rise in road elevation in the center of the image.

Implemented ESM Practices: The original plan specified the installation of two new 15" crosspipes, complete with headwalls and endwalls. The intent was to divide the drainage coming to the lane and disperse it as evenly as possible into the surrounding fields. However, the landowner was greatly concerned about any additional water entering the crop fields downslope of the road. A compromise was reached that eliminated the crosspipes in favor of a more traditional approach with an emphasis on surface water control. Therefore, in an effort to employ basic ESM principles, a new grass lined swale was constructed up-slope and parallel to the road to capture water that had been previously entering the roadway and running down the surface of the road. The new swale was connected to an existing drainage feature originally built to direct field run-off away from the house and barn. PennDOT 2RC aggregate material was added to the road surface to elevate it above the new swale and to establish center-crown. Two Grade Breaks were installed on the lane to prevent water from flowing down the road surface and to disperse road surface drainage evenly into the downslope field.

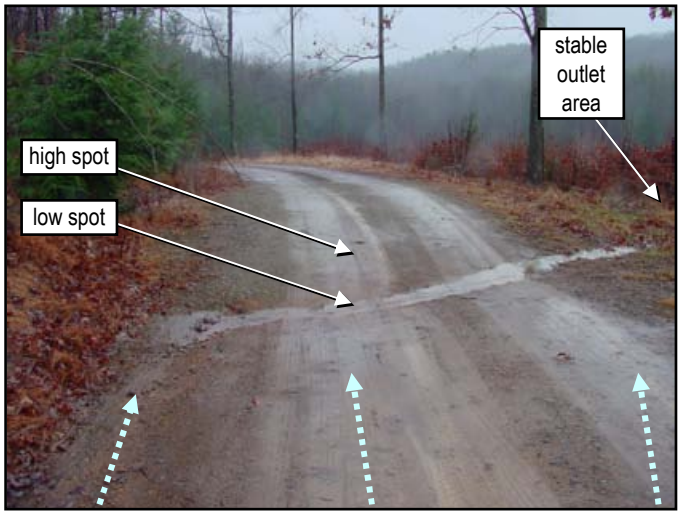
This *broad based dip* in Huntingdon County is located on an access road that is only open to the public for hunting season. This low-use road is ideal for *broad based dips* instead of crosspipes to reduce long term maintenance. The dip pictured here collects road and ditch water and directs it from left to right across the road.
