## Appendix D-10

### Class III Cultural Resources Survey

North Branch Park River Cart Creek Site 1

Park River Joint Water Resource District

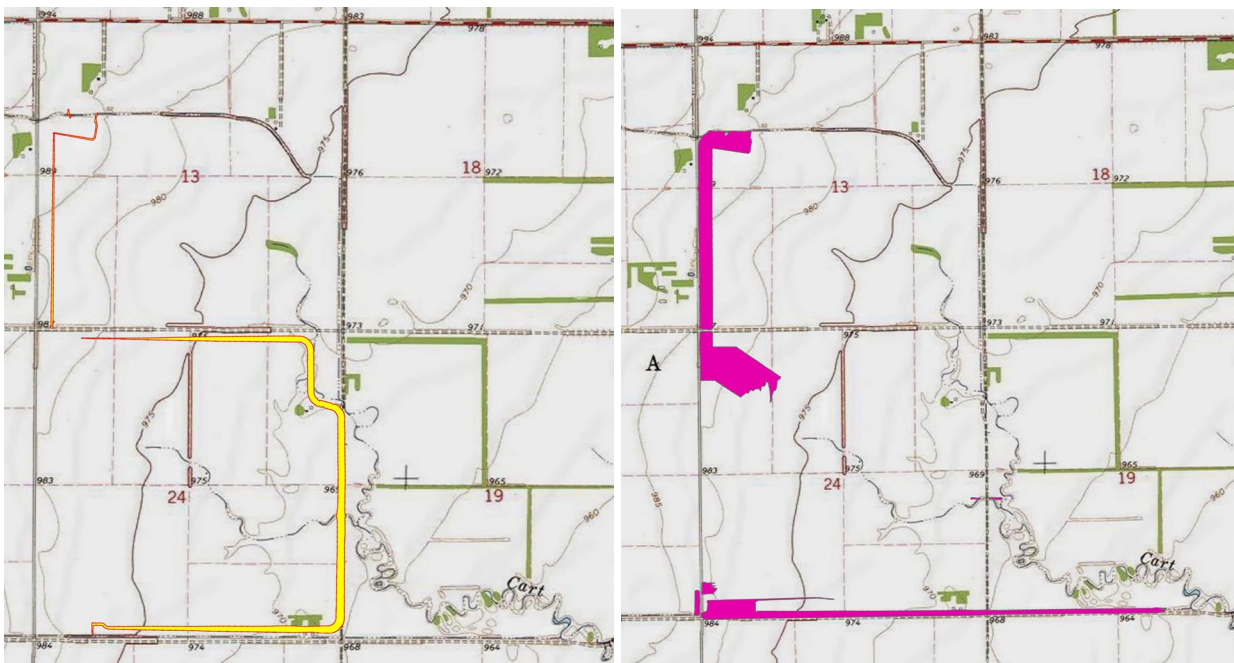
Figure 1: Embankments (left) and Excavation (right) areas.

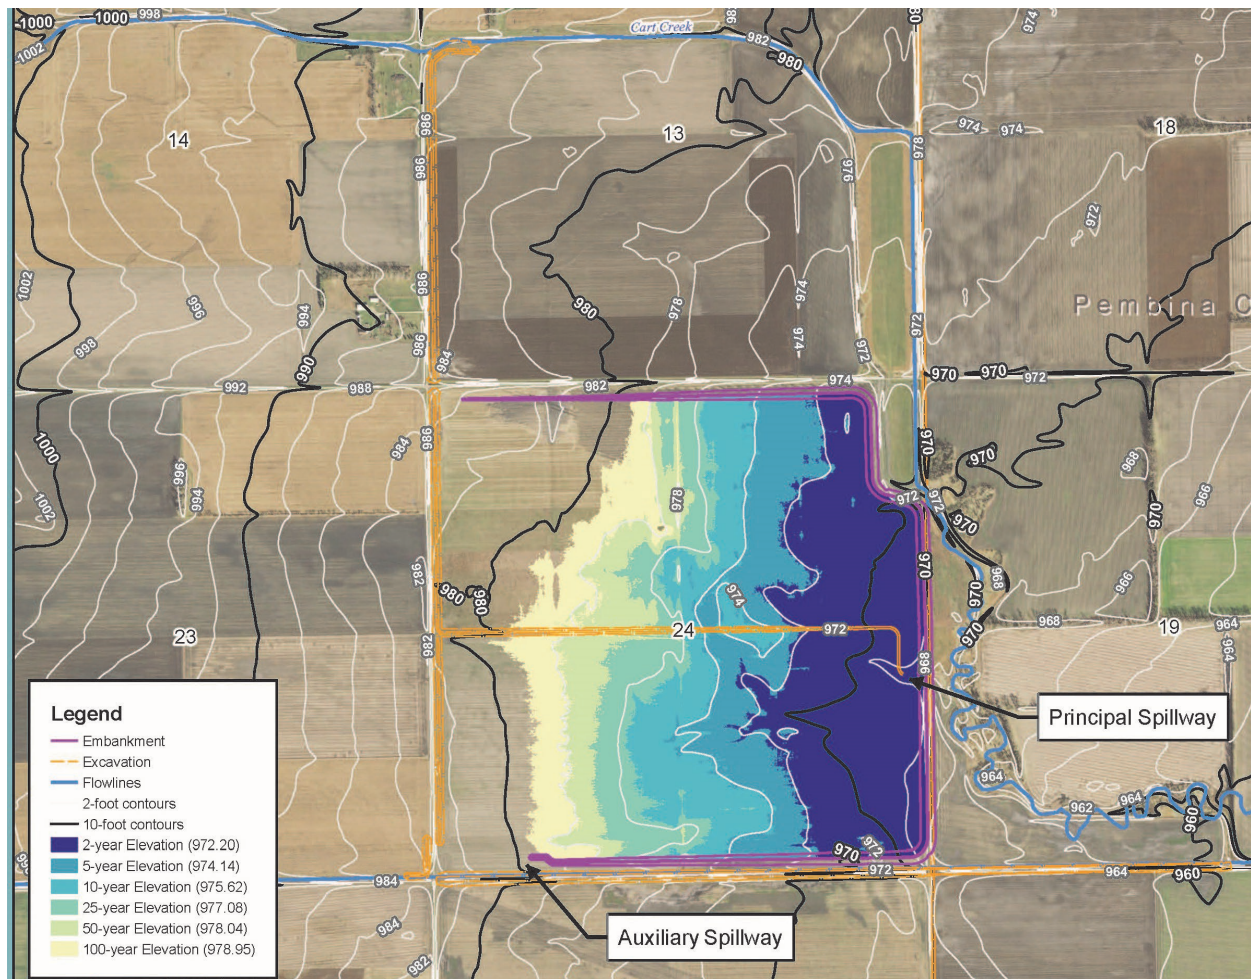
Figure 2: Section 24 Inundation zone.  
Source: Houston Engineering.

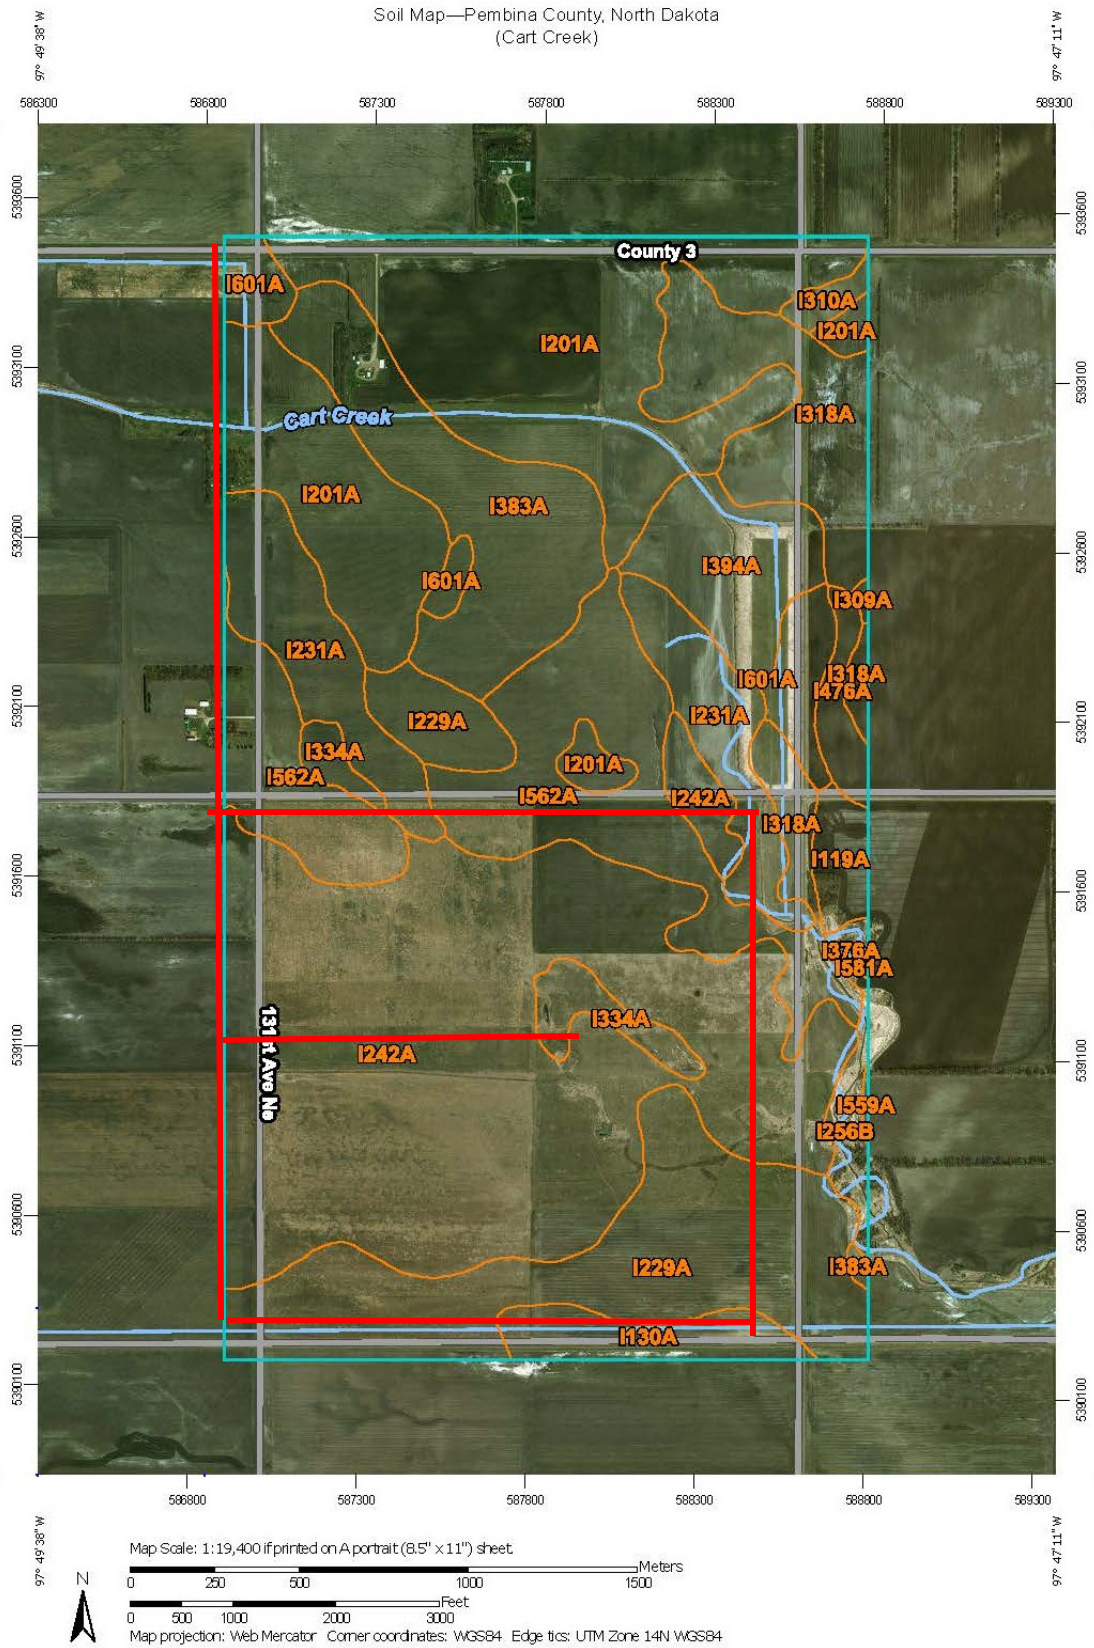
Figure 3: Soil Map with APE highlighted. Not to scale. Reference only.  
Image Source: <https://websoilsurvey.sc.egov.usda.gov>

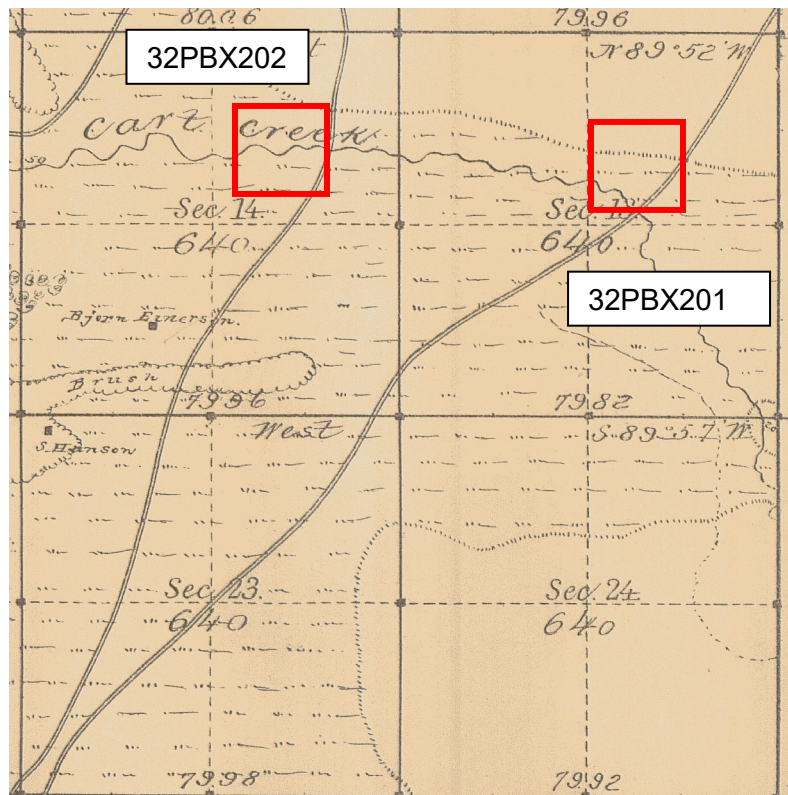
Coded sometime near 1986, 32PBX202 is described with "Site Type 48: Railroad Grade and Tracks" and "Context 29: Roads, Trails and Hwy". 32PBX201 lists only "Site Type 48: Railroad Grade and Tracks" and no context code. Closer inspection of the site forms reveals that 32PBX202 is the location and description of a portion of the Ridge Trail whereas 32PBX201 describes the intersection of the Tongue River Trail and Ridge Trail. Both are marked on the GLO 1881 map (Figure 4).

Figure 4: 1881 GLO map with 32PBX201/32PBX202 highlighted.  
Data Source: North Dakota State Historical Society Archives

The 1881 GLO map shows that the Ridge Trail crosses the APE at the boundary of SW  $\frac{1}{4}$  SW  $\frac{1}{4}$  of Section 13 and the SE  $\frac{1}{4}$  SE  $\frac{1}{4}$  of Section 14 (Figure 4). No evidence of the trail was observed. The construction of 131<sup>st</sup> Avenue NE and decades of agricultural use (Figure 8) have obliterated any remnant of the trail.

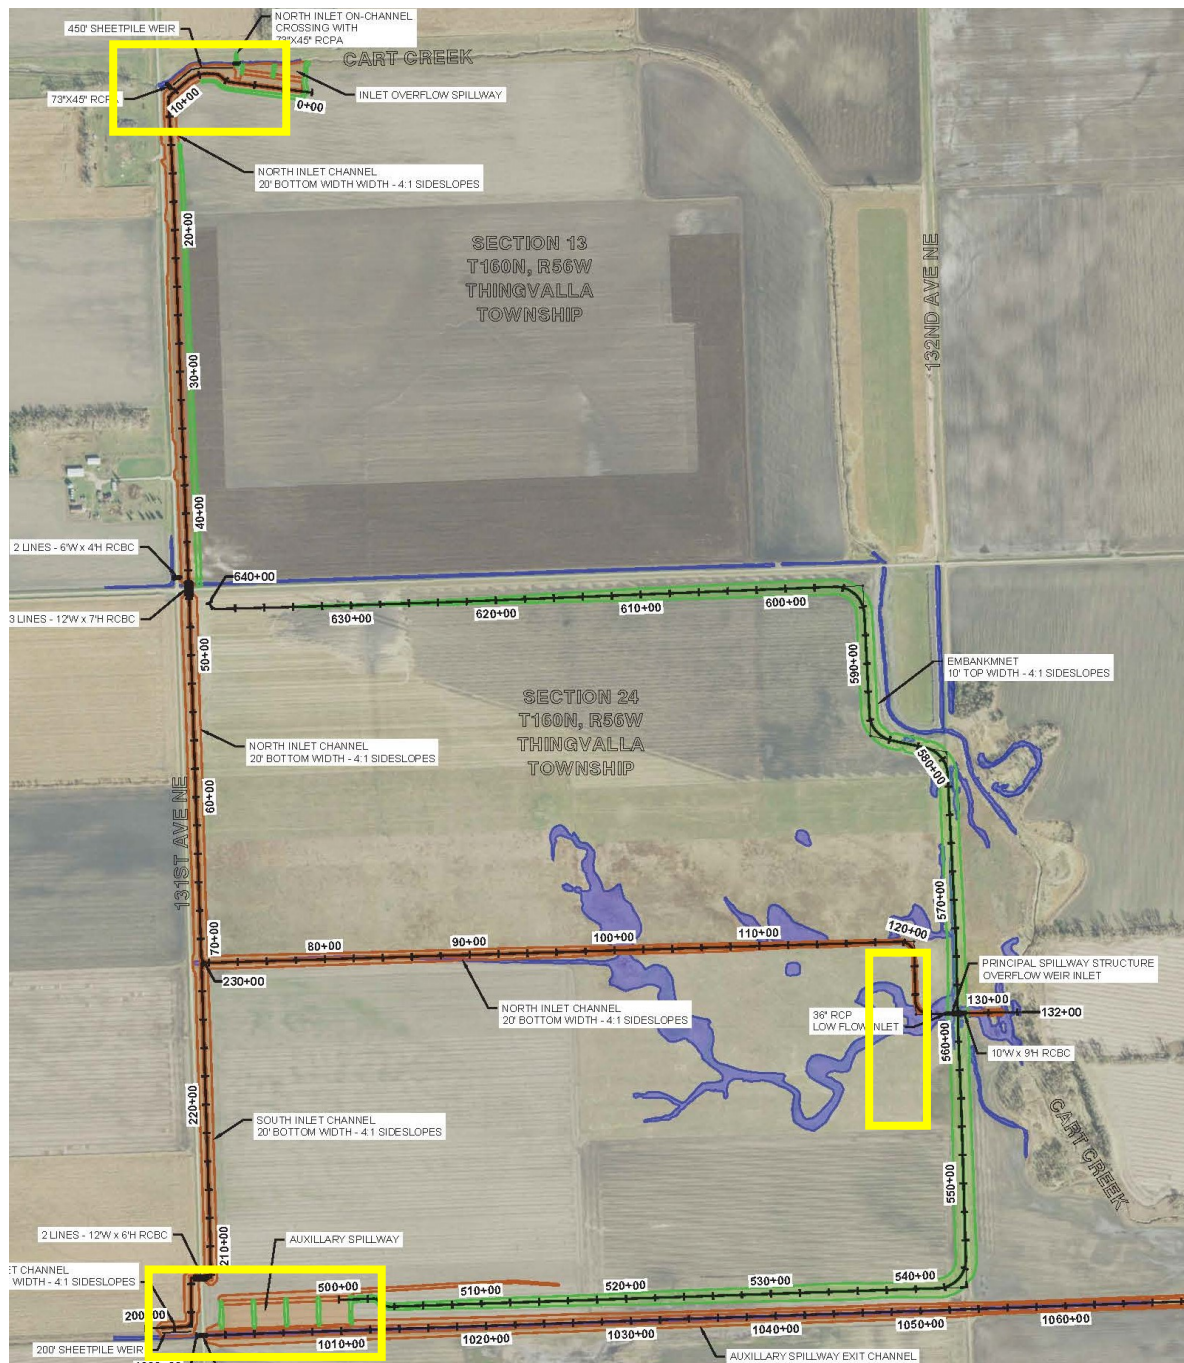
Engineering plans show three areas of focus due to the degree of ground disturbance (Figure 7):

- North Inlet Channel/Overflow Spillway
- Principal Spillway Structure
- Auxiliary Spillway Structure

Figure 7: Design Plans showing areas of focused investigation.
