APPENDIX D-2
GEOTECHNICAL ENGINEERING REPORT

North Branch Forest River Dam #1 (Bylin Dam)
Walsh County, North Dakota

Greenwood Village, Colorado
January 20, 2021
Revised February 28, 2022

**GEOTECHNICAL ENGINEERING REPORT
NORTH BRANCH FOREST RIVER DAM # 1 (Bylin Dam)
WALSH COUNTY, NORTH DAKOTA**

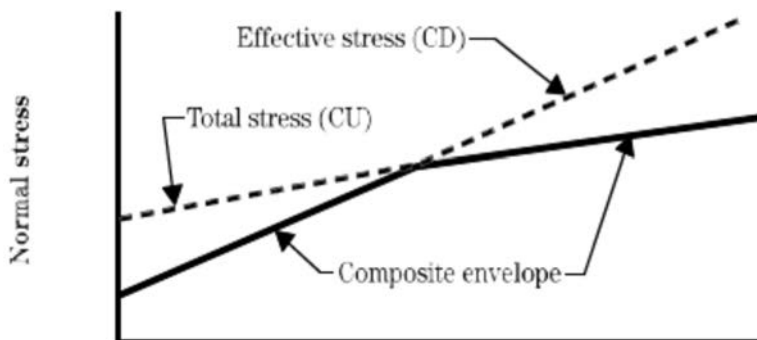
Figure 3. Composite Shear Strength Envelope

- 1) The normal stress, σ_N , is the normal stress coordinate of the intersection of the effective stress and total stress failure envelope (TR-60 (USDA NRCS, 2019) Figure 5-2 is replicated as Figure 3) and is calculated with the equation:

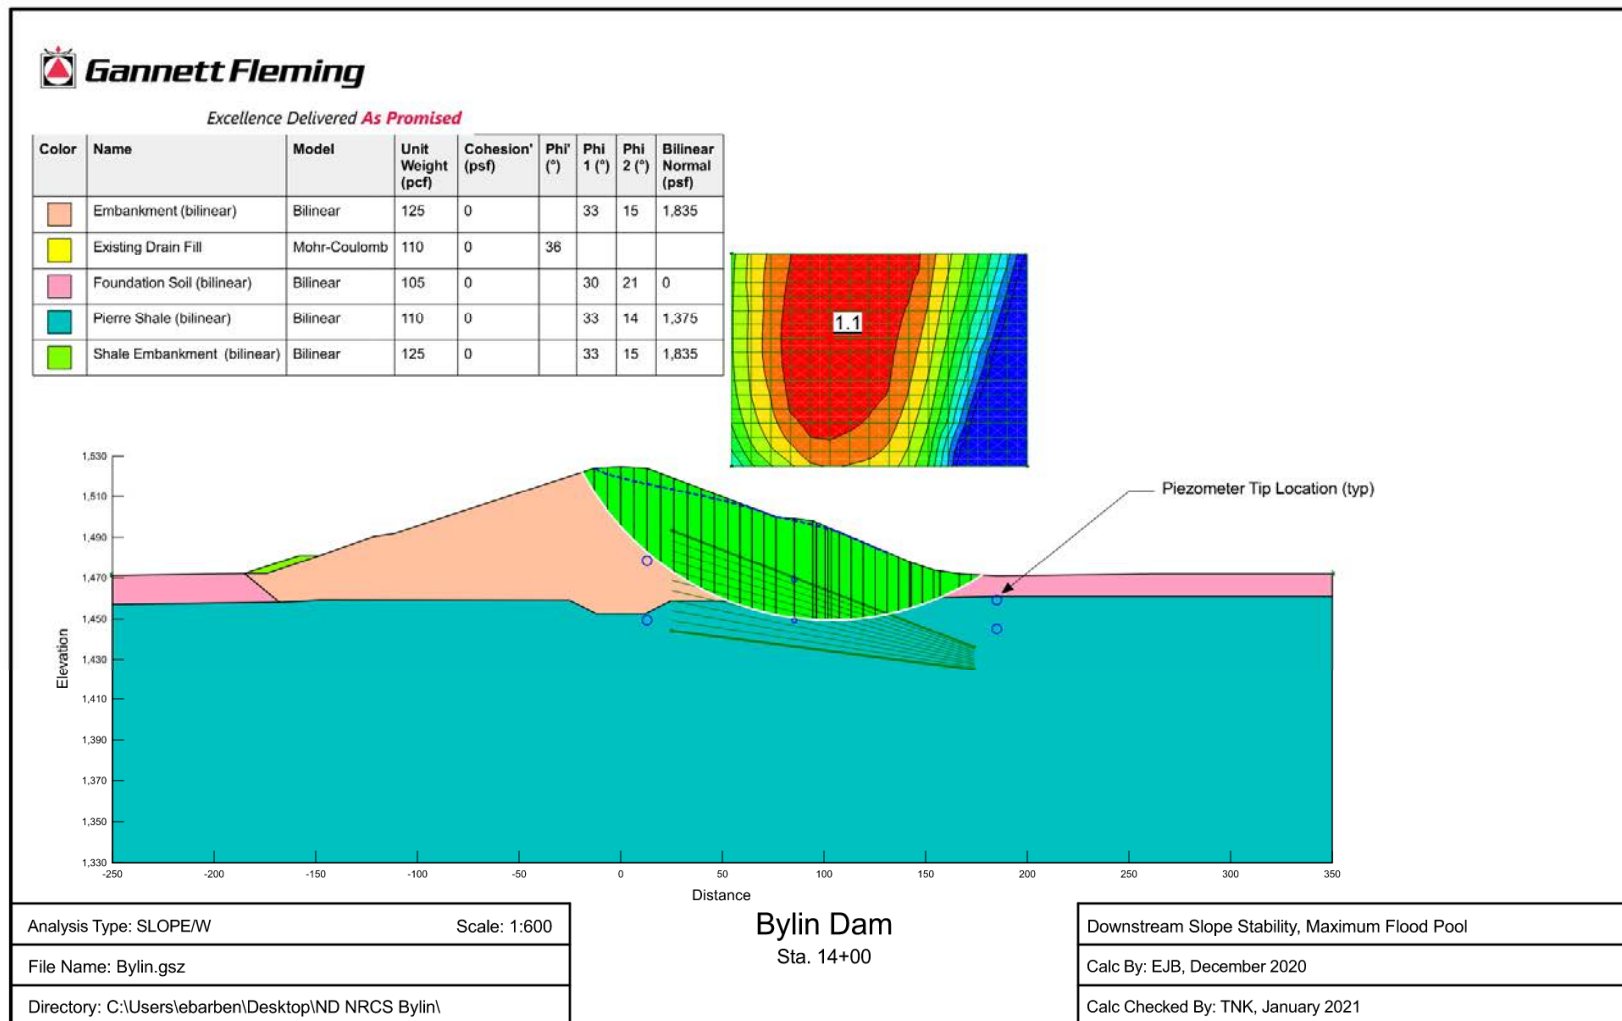
Exhibit 10. Downstream Slope Stability, Maximum Flood Pool

improvements or modification of the downstream slope to improve slope stability during the maximum flood surcharge event is recommended.

Due to potential overtopping during the PMF event, the existing embankment geometry was modified to include increasing the dam crest to El. 1527.7, i.e., a three to four foot raise, and a flattened downstream slope. To meet the requirements of TR-60 (USDA NRCS, 2019) for embankment stability during the flood surcharge pool condition, the downstream slope is proposed to be modified to 3H:1V from the dam crest to the mid-height at which point there is a 20-foot wide bench which transitions to a 4H:1V slope to the embankment toe. A three-foot thick,

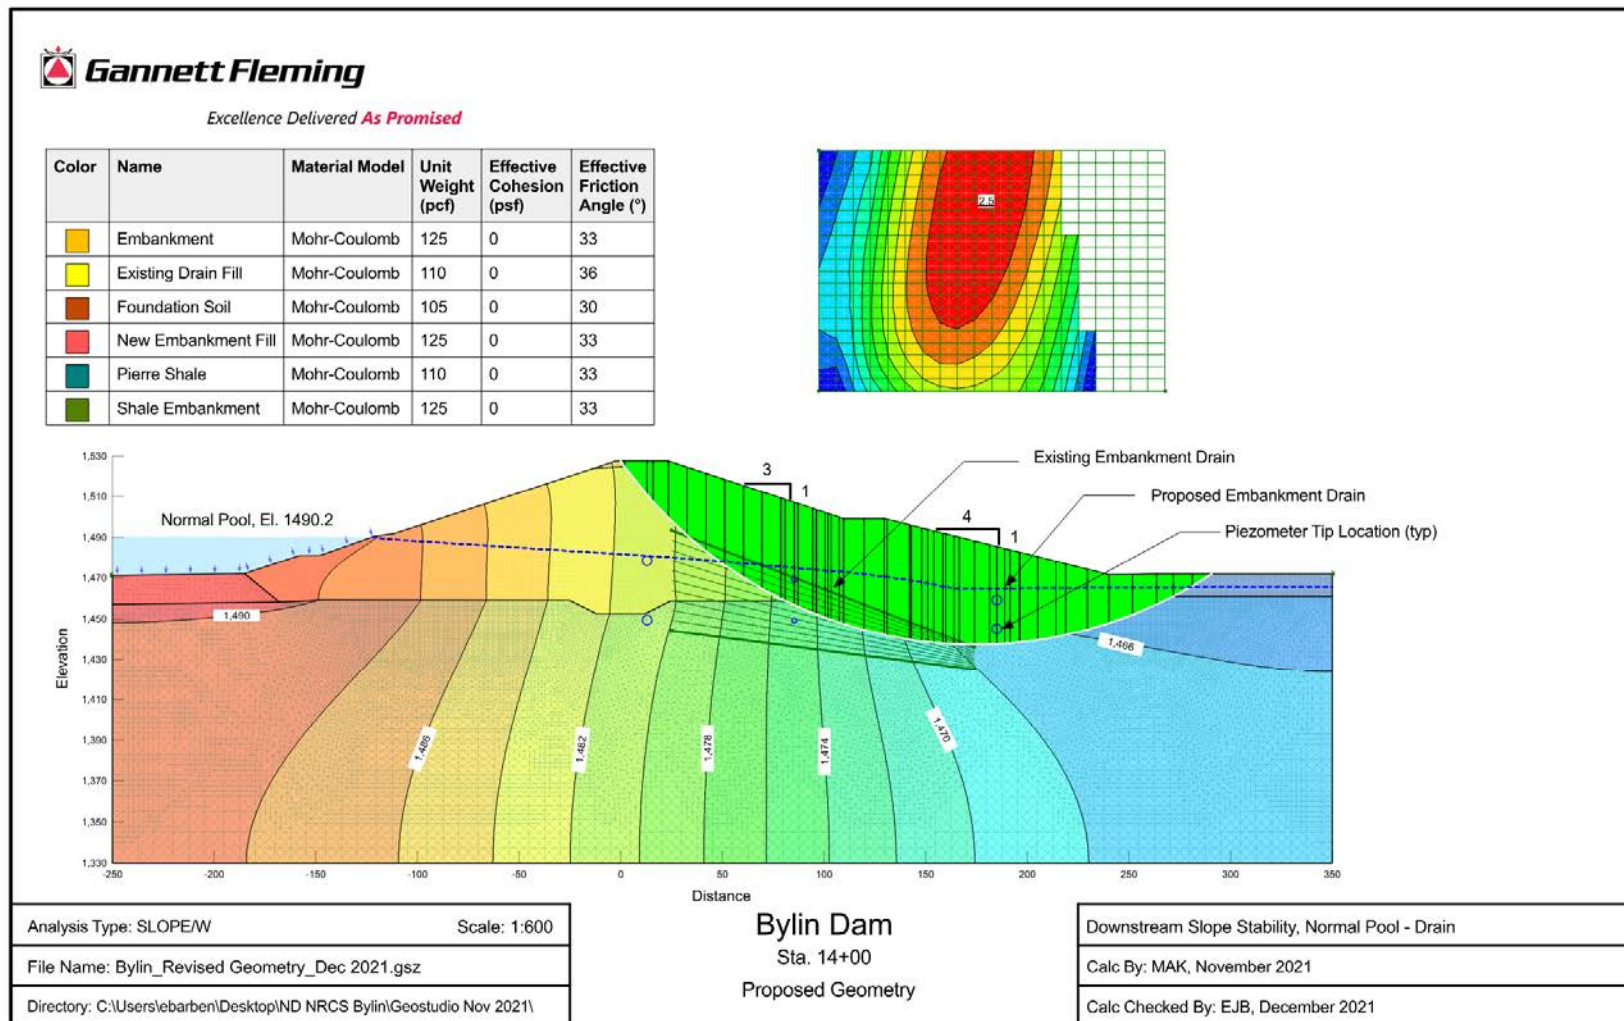
Exhibit 12. Downstream Slope Stability, Normal Pool, Proposed Geometry

measured horizontally, chimney drain was also incorporated to reduce pore pressures within the embankment. Results of the stability analyses for the proposed geometry are summarized in Table 19 and detailed in Exhibits 12 and 13. Screen captures from the slope stability models performed to assess the proposed conditions are provided in Figures 7 and 8.
