## Appendix E.2 Engineering Assessment Reports

### Birdwood Engineering Assessment Report Summary

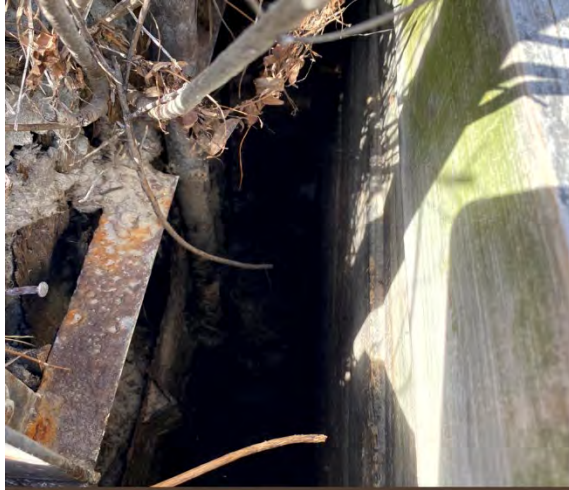
*Figure 13. Screw Gate Deterioration*

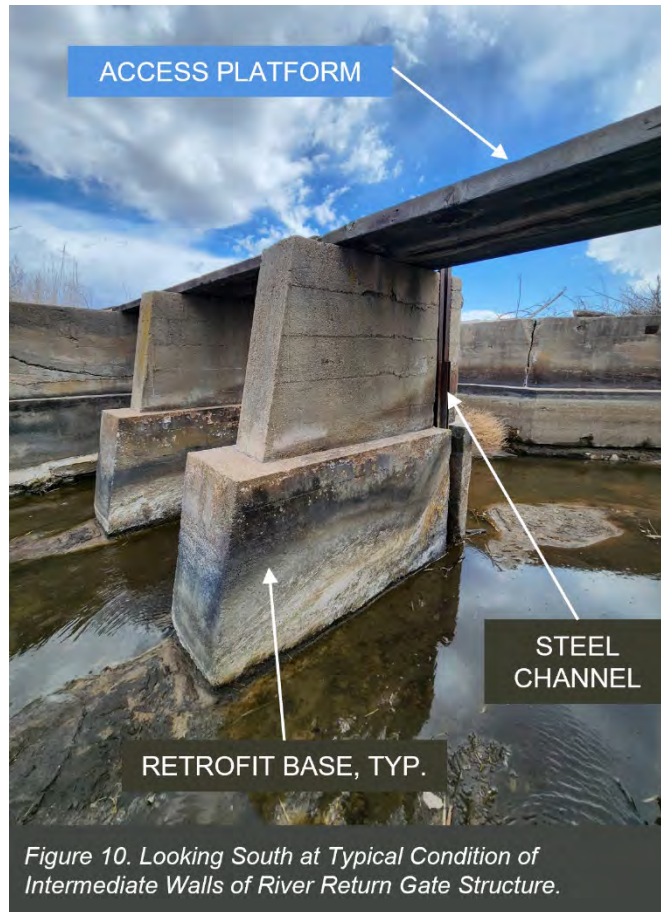
The bases of all walls have been previously repaired and these repairs are in fair condition. All walls exhibited minor concrete cracking, concrete spalling and water staining, with some walls exhibiting more significant or widespread damage. The interior return gate walls appear in good

condition with minor concrete spalling and erosion of the concrete surfaces near the flowline. The return gate end walls are in worse condition. The west end wall exhibits the most extensive damage. The feeder canal wall segment exhibits cracking and spalled concrete, while the portion of the wall through the return has failed above the elevation of the repaired base (Figures 6 and 7). Large vertical and longitudinal cracks have developed beyond the stop log channel causing the wall to rotate inward several inches (Figure 6). Similar longitudinal cracking was seen in the eastern return structure wall (Figure 8) but at the time of the inspection, no noticeable deflection of the wall face was noted. Both end walls appear to have extended further toward the Platte River channel in the past but either failed or were intentionally removed near the end of the concrete apron. Remnant pieces of concrete now act as riprap along the outlet bank (Figures 7 and 8).

*Figure 10. Looking South at Typical Condition of Intermediate Walls of River Return Gate Structure.*

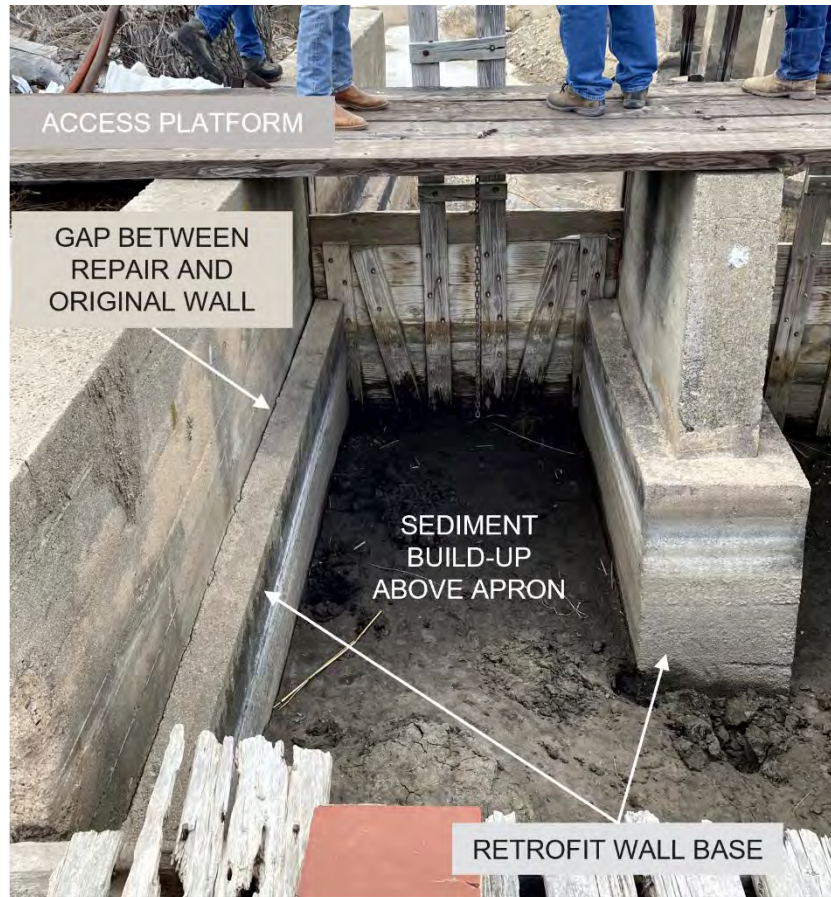
Figure 15. Looking at canal gates from downstream side.

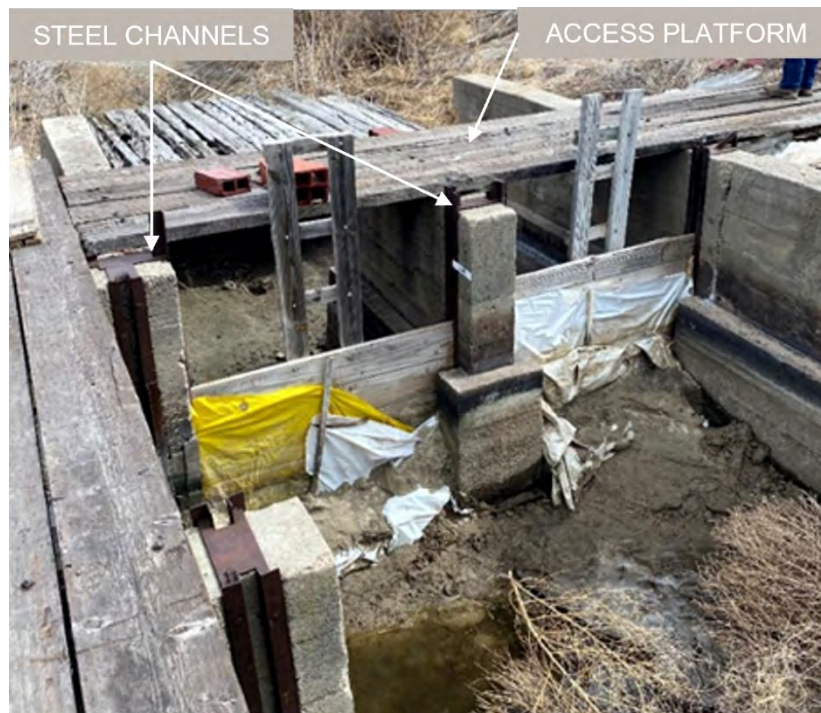
*Figure 17. Looking East towards Canal Gate Structure – Upstream side*

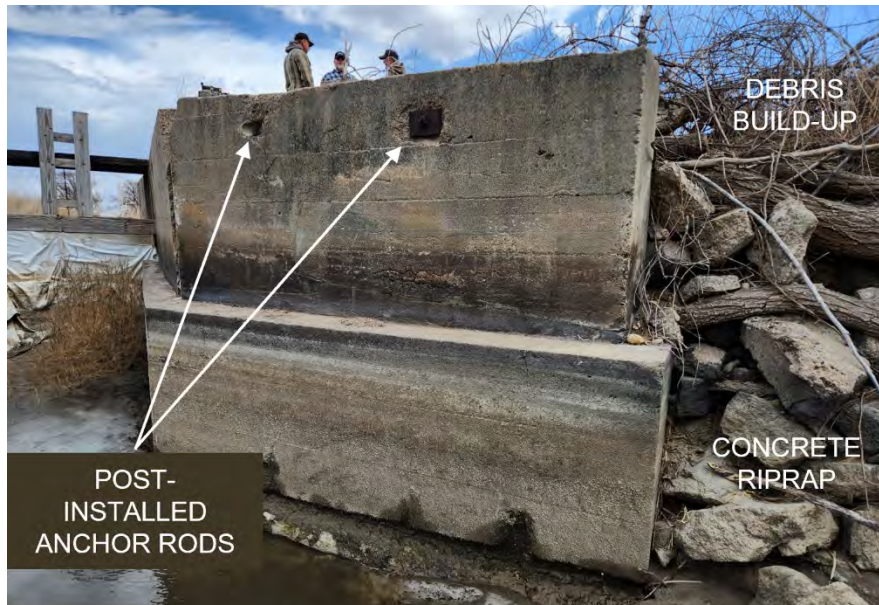
At the inlet side of the canal gate structure, the southern sidewall has a large vertical crack at the location where it bends out into the southern bank of the feeder canal (Figures 18 & 19). It also appears this wall had started to rotate into the canal in the past. Anchor rods were installed through the wall to restrain the movement. Significant erosion has also occurred at the end of this wall. Concrete riprap has been placed at the end to prevent further erosion (Figure 20).

*Figure 20. Southeast Retaining Wall of Canal Gate Structure.*

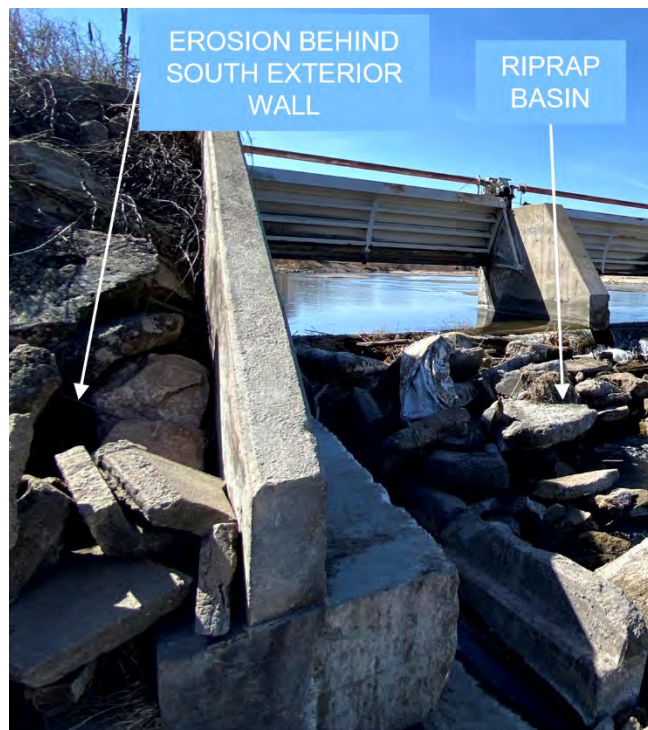
Figure 5. South Wall Erosion

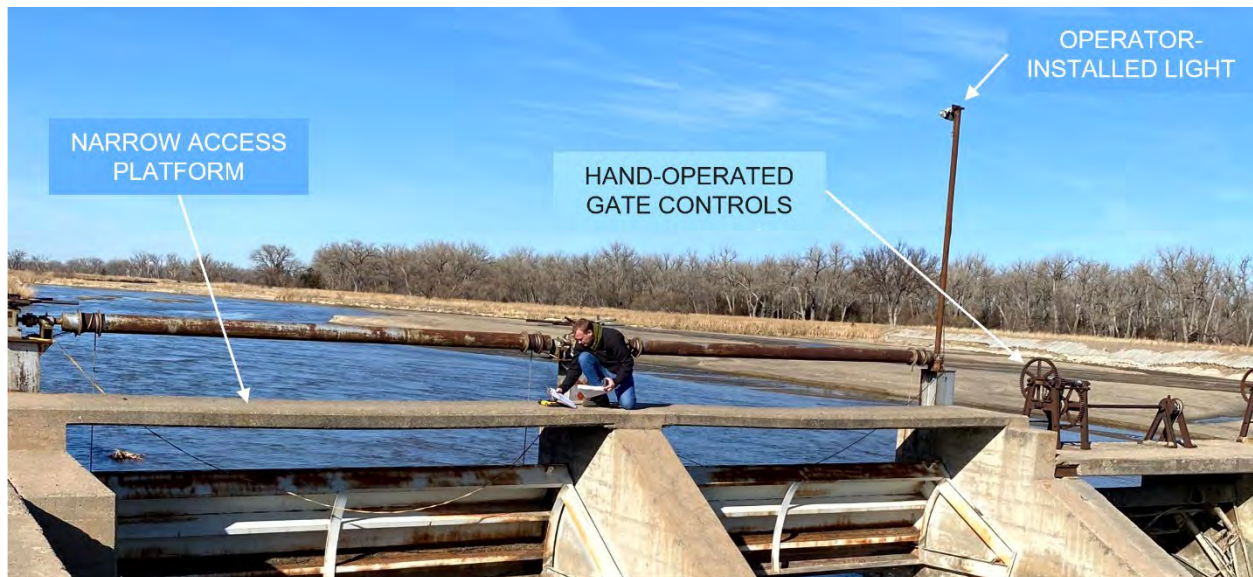
Figure 2. Looking Northwest Toward River Gate Structure – Downstream End

The original river control gates consist of two 16'-0" wide cells with a concrete apron floor and concrete access platform. The downstream end of the concrete apron drops approximately 1'-0" at the outlet of the control gates and extends approximately 10'-0" downstream before terminating as shown in Figure 6. The concrete apron thickness could not be determined due to the presence of water in the channel. The access platform across the cells consists of a cast in place concrete slab that is used to operate the control gates as well as reach the spillway structure to the north. Equipment to raise and lower the gates is mounted to the top of the walls. The south and intermediate walls are 1'-10" thick concrete walls, and the north wall is 1'-3" thick. Walls are flat at the top before sloping down to the concrete apron on the downstream end as shown in Figures 4-6. Based on conversations with the operator, and based on construction methods used for similar gates, it is believed these walls are supported by timber piling. An additional 1'-6" thick retaining wall at the south end of the structure extends 28'-0" downstream from the structure before turning at a 30° angle and extending 7'-6" into the riverbank. The retaining wall was cast behind the wall of the gate structure, and the color of the concrete is different from the gates, therefore it is assumed this wall was constructed after the original gates. The upstream river channel elevation is managed with steel radial gates attached to the walls of the structure (Figures 2-4). Radial gates are adjusted by a gear and pulley system that can be raised or lowered by hand operated equipment mounted to the access platforms (Figure 5). Radial gates are lowered to check up the main channel water surface elevation and facilitate the diversion of water to the irrigation canal through the canal structure gates. A retrofit light to assist with nighttime operations was present at the transition from the original gates to the newer gates (Figures 2 and 3).

1. Install stairs or a ladder at the transition from the original and newer main channel gates to allow for easier and safer access between the two.
2. Add additional lighting to assist with nighttime operations.
3. Update current gates and equipment of the river gate and canal gate structures to allow for automated operation.
4. Add 42" tall handrail to all access platforms.

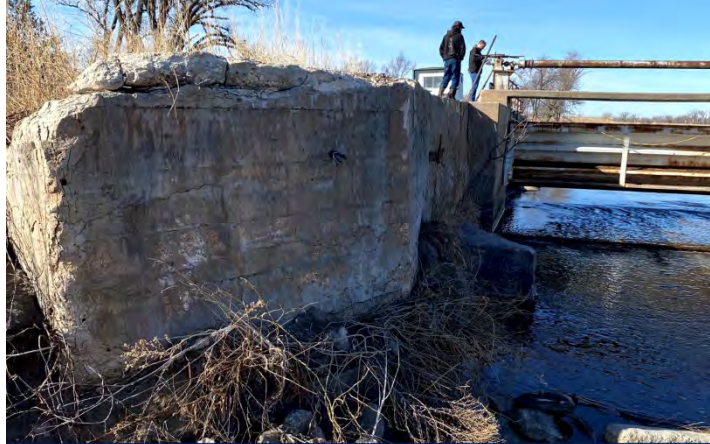
Figure 7. Retaining Wall at South Embankment – Downstream End

All walls exhibited minor concrete cracking, concrete spalling and water staining, with some walls exhibiting more significant or widespread damage (Figure 7). The retaining wall south of the original gates exhibited a large vertical crack near the connection to the gate structure (Figure 11). Concrete spalling and delamination are present throughout the entire face of the wall. A steel plate that appears to be part of a tie back that is buried in the soil beyond the back of the wall is present at the midpoint of the wall. This tieback was likely installed to prevent outward rotation of the retaining wall. The concrete base of the retaining wall has a thicker region that was likely poured to mitigate undermining of the wall. A small tree and other small

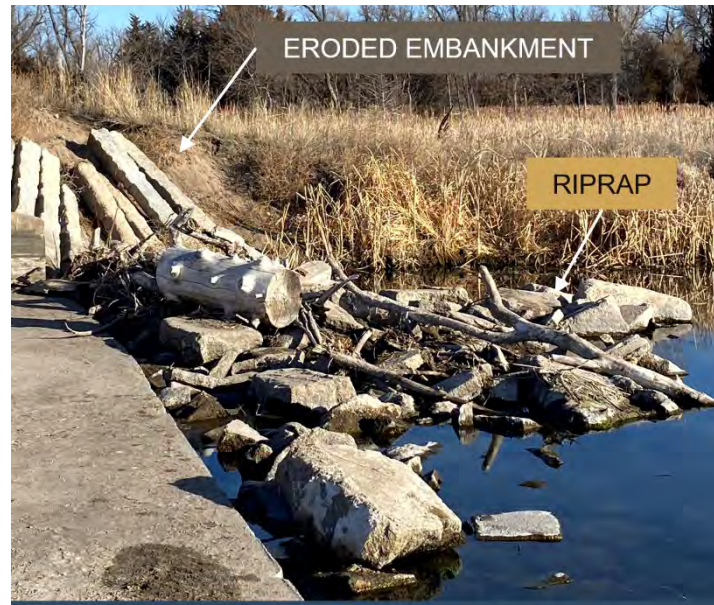
Figure 13. North Embankment – Downstream End

The spillway and its components are generally in good condition with minor concrete damage, concrete staining, water seepage and environmental buildup present. Built-up riprap is present towards the north end of the slab. It was unclear if the slab has been undermined at the upstream or downstream ends. The concrete apron exhibited minor concrete cracking at various locations, but environmental buildup prevented the entire surface of the slab from being investigated. Larger cracks were present at construction joints between slab sections and minor concrete spalls were present on slab corners at construction joints (Figure 14). Water was present at construction joint locations. It was unclear if water was present because it has migrated up through the cracks from the bottom of the slab, because it has pooled up due to cracks and spalls forming low points, or because of water seepage through construction joints in the upstream weir wall. Environmental build up is present over a large portion of the south end of the slab and extends to the north into the channel. Environmental build up includes large portions of trees and layers of dirt built up on the surface of the slab and in the channel (Figures 13 & 15).

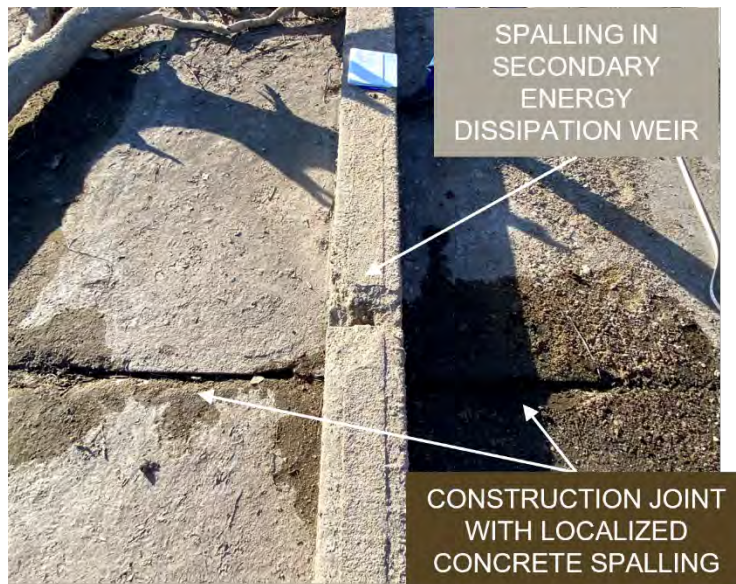
Figure 14. Secondary Energy Dissipation Weir Joint

damage to the primary overflow weir wall, with spalling and cracking centered at construction joint locations (Figure 14). Environmental build-up was present on all faces (Figure 15).

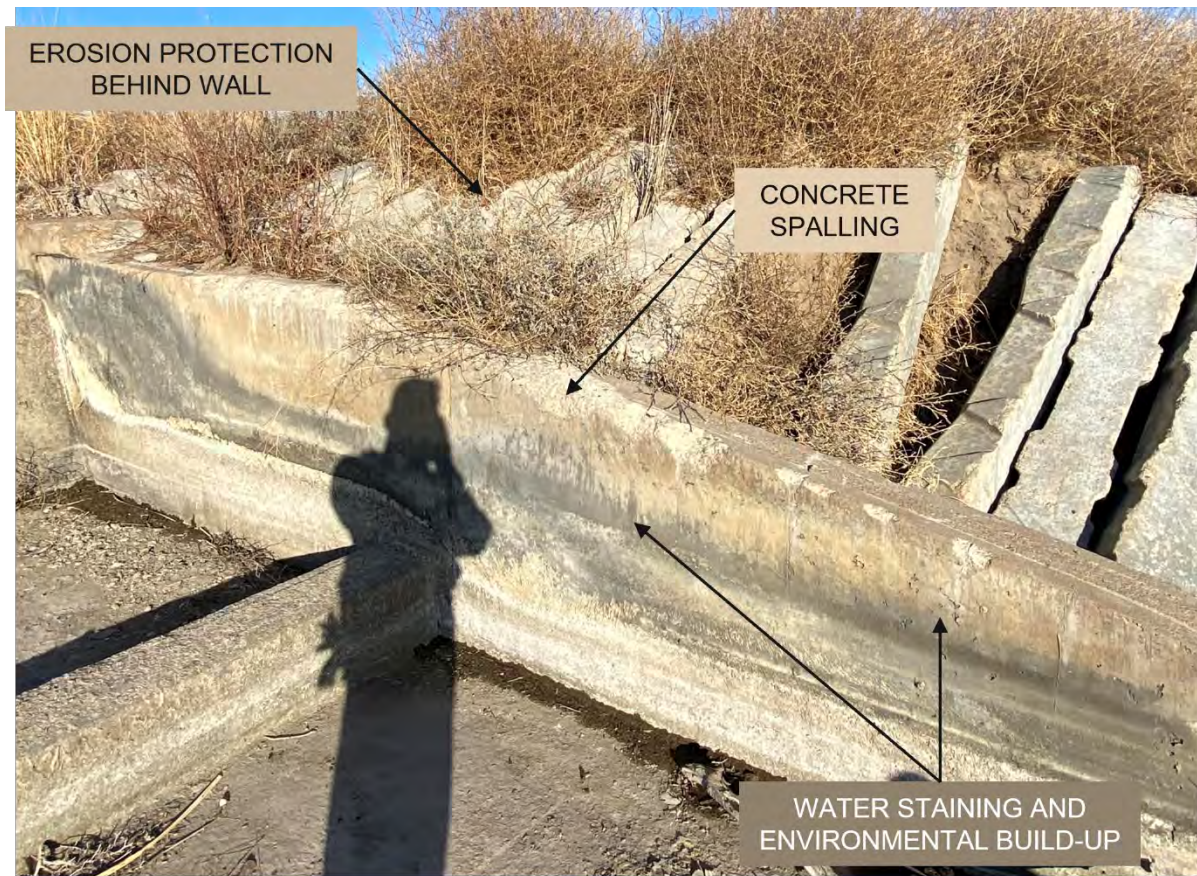
Figure 17. Retaining Wall at North Embankment – Downstream End

The north retaining wall exhibited concrete spalling along its top corner, and in small regions of its front face (Figure 17). Environmental buildup and concrete staining on the front face of the wall are present throughout the length of the wall. Environmental buildup at the base of the wall appeared to be saturated, however it was unclear if this was due to water pooling in this region, or if water has migrated through the base of the wall. The slope behind the retaining wall has begun to erode, leaving a sloped region down to the base of the wall. Attempts to mitigate the erosion have been made by placing concrete railroad ties behind the wall as a method of bank stabilization (Figure 17).

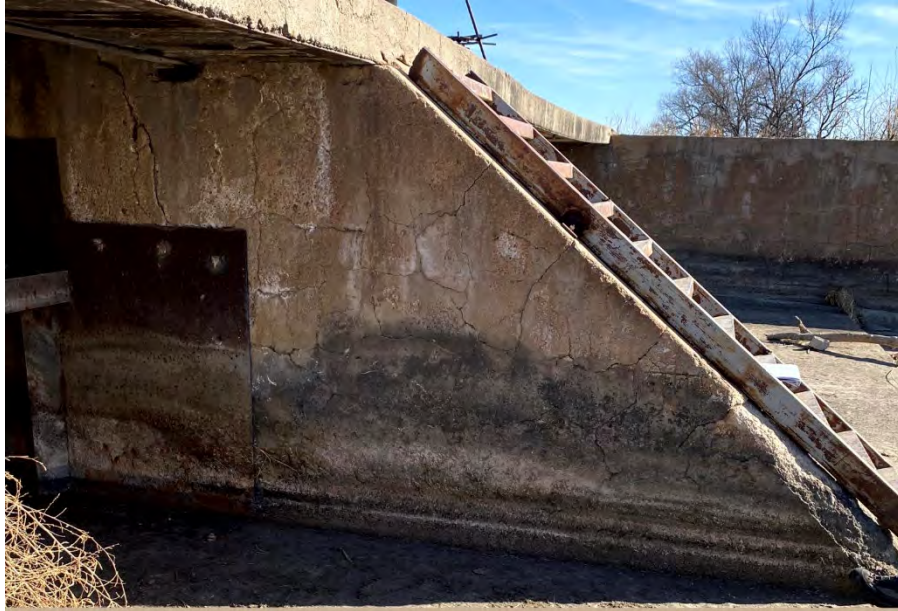
*Figure 21. Intermediate Wall of Canal Gate Structure – Downstream End*

The faces of all diversion structure walls exhibited extensive map cracking, spalling and water staining (Figure 21 and 24). A steel cover plate has been attached to the west faces of the intermediate and east exterior walls as a repair method (Figure 23). The ditch operator noted that water flows between the exterior wall cover plate and the wall during high flow events. The access platforms exhibited noticeable deflection and transverse cracking in the top slab near the interior and exterior walls (Figure 22).

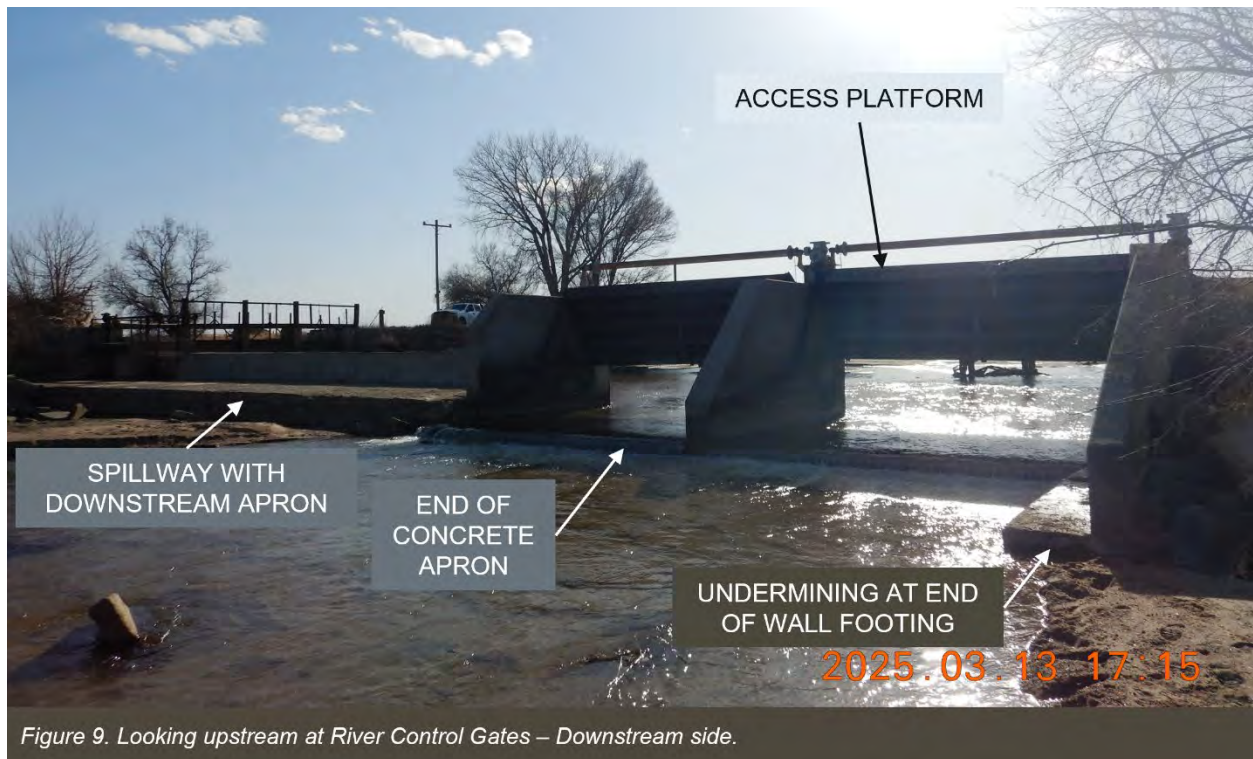
Figure 9. Looking upstream at River Control Gates – Downstream side.

Overall the river gate structure is in good condition with only minor concrete cracking and localized concrete spalling noted. Scour holes and undermining are present along the northern side wall at both the up and downstream ends (Figures 8 and 11). Based on the observed grading adjacent to the north wall, it appears a drainage swale currently exists behind the wall which may be the source of the noted erosion issues. There was also some observed undermining of the outlet end of the concrete apron (Figures 7 and 9). Exact limits of undermining could not be determined due to water flow at the time of inspection.

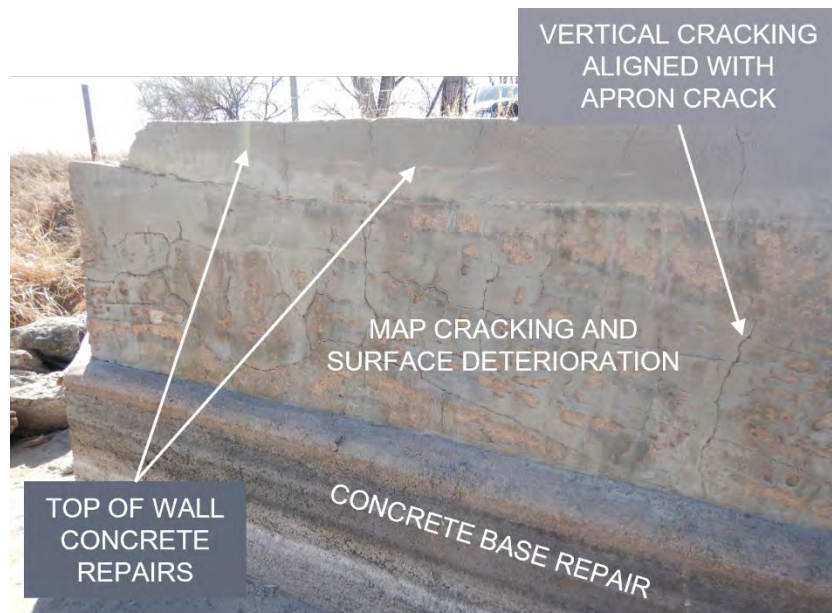
Figure 18. Looking Towards Canal Structure Outlet – Downstream End.

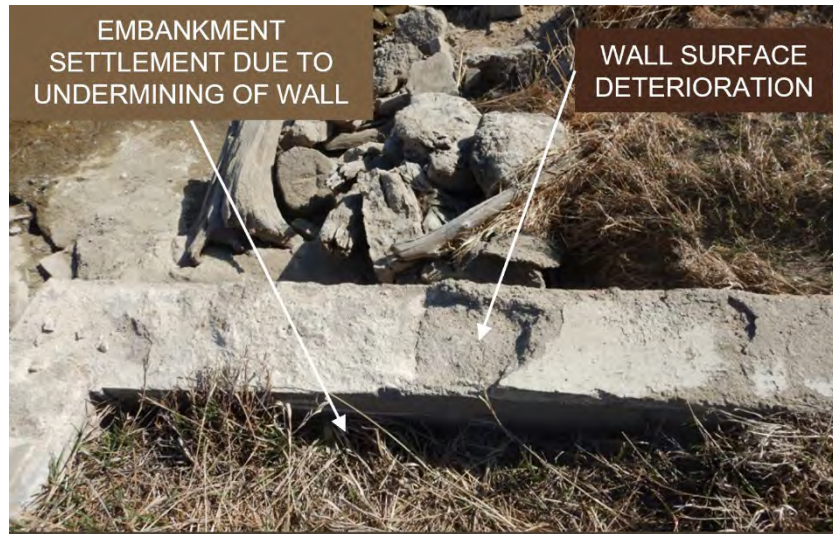
Figure 19. Western End Wall.

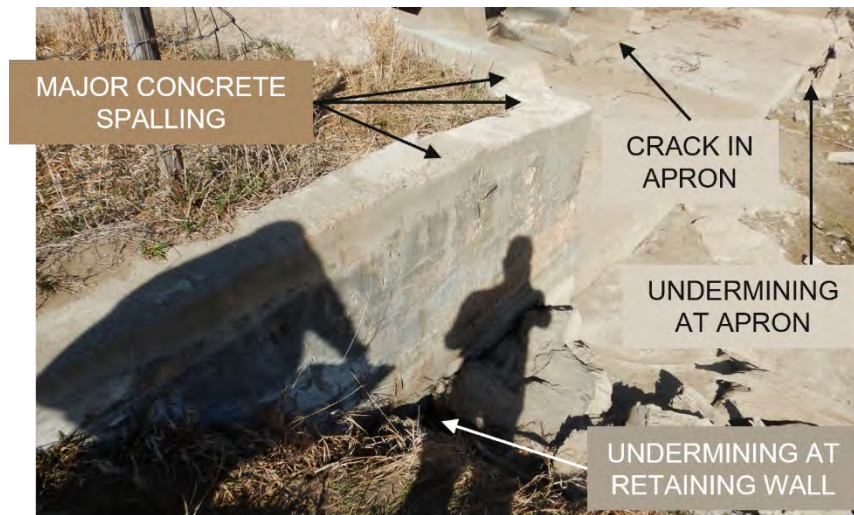
The western side wall consists of a U-shaped concrete wall that turns back at the upstream and downstream ends of the canal structure. The northern wall section parallels the river channel, while the southern section cuts back into the canal bank. The wall has map cracking present throughout and the top of the wall shows signs of deterioration and loss of concrete section. It appears this has been patched over time to try and restore the top of wall elevation (Figure 19). The base of the wall has a supplemental facing added to it. It is understood that this repair was completed to address deterioration of the base of the wall, likely resulting from abrasion erosion from the passing water. Undermining of the downstream end of the wall was observed and the ditch operator noted that water does pass through this embankment outside of the intended canal structure limits. No efforts to resolve this issue have been successful (Figures 20 and 21).

*Figure 20. Downstream Wall of Western Canal Wall.*

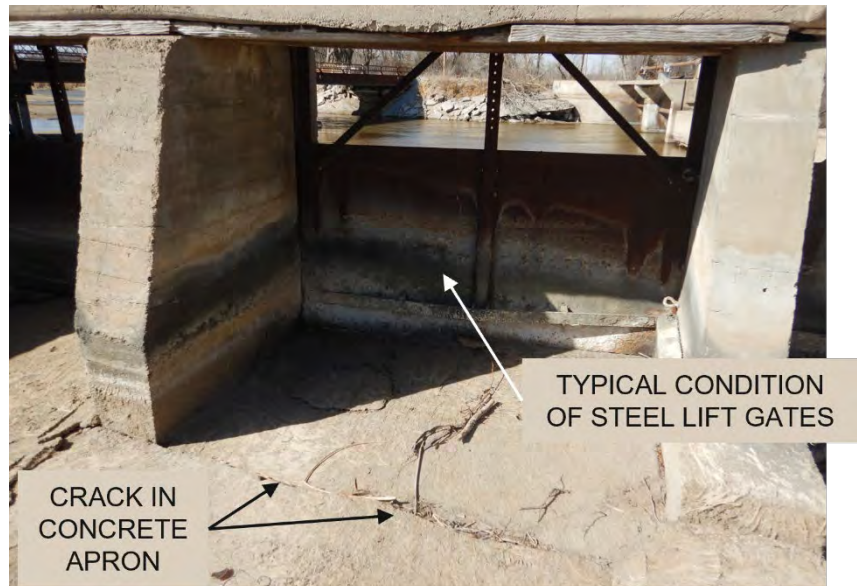
The canal structure concrete apron is in poor condition. It is split into two pieces by a large crack that extends through the width of the structure directly beyond the limits of the interior walls. Movement of the apron has occurred as is evident by the uneven surface (Figures 24 and 25). It appears the downstream apron section may have heaved some over time based on the observed conditions. The end of the concrete apron is fully exposed along with remnant sections of timber piling that was installed as a cut off wall (Figure 26). This piling has deteriorated significantly and is no longer functioning as intended. Much of the apron end has been undermined with large voids observed below. A large scour hole has developed in the canal directly downstream of the canal structure.

The canal structure gates consist of flat steel plates that slide within notches in the concrete walls. Each gate can be raised or lowered by a handyman jack. The steel plates are rusted with some section loss but no full depth holes were noted (Figure 24). In their closed position, some light was visible around the edges indicating a lack of water tightness.

Figure 24. Crack in Canal Gate Structure Slab – Downstream end.
