# NORTH BRANCH FOREST RIVER DAM NO.1 (BYLIN DAM)

## Appendix D-3 Alternatives Evaluation Report

February 29, 2024

Walsh County Water Resource District

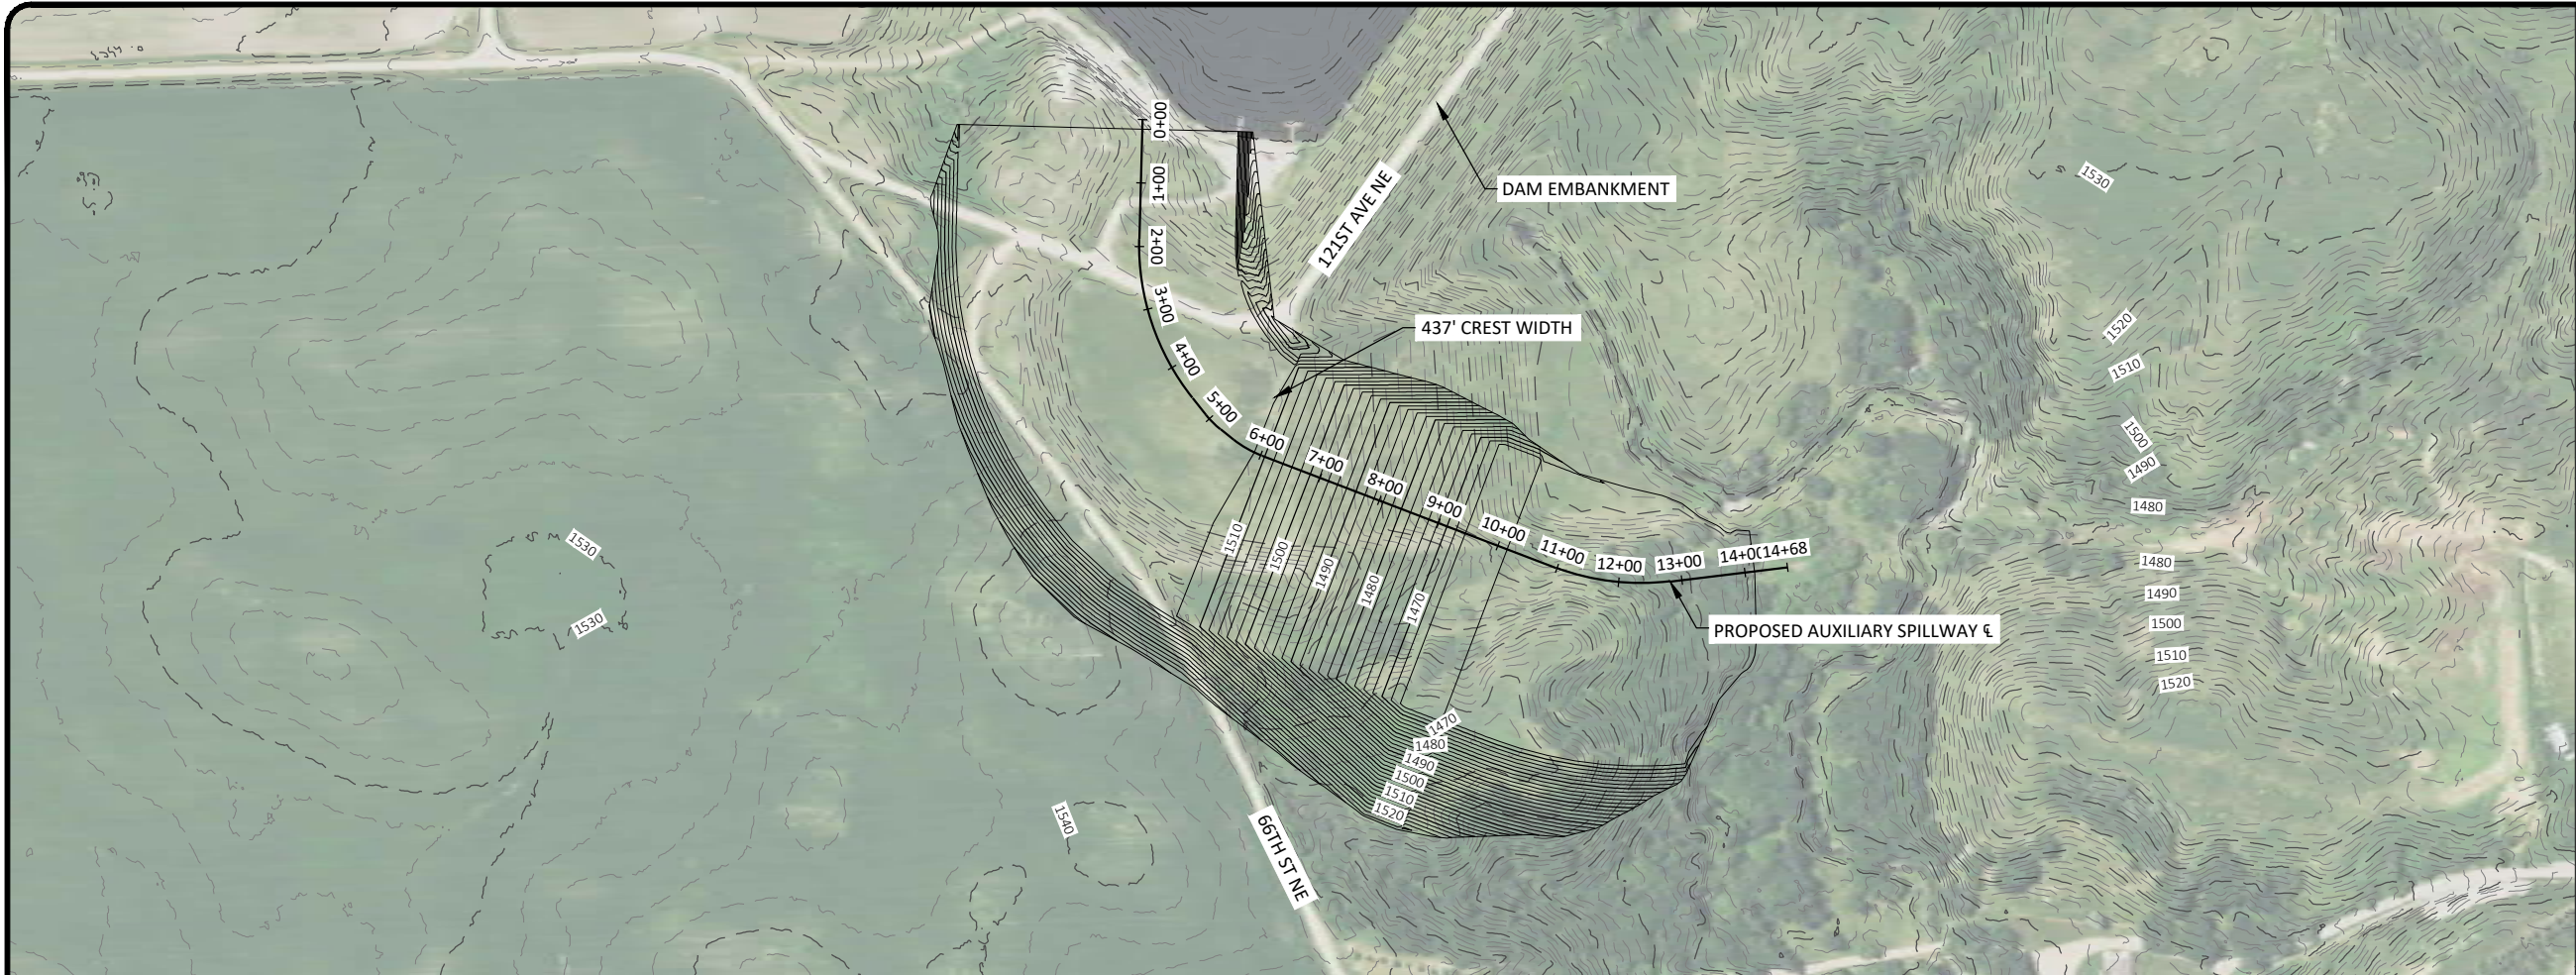
**FIGURE D-3-8**  
**Bylin Dam**  
**Option 9**

Ogee Weir 437-feet  
located near existing  
spillway

Dam not Raised

Feasibility Level Cost:  
\$ 14,157,000

This alternative includes an ogee hydraulic control section with an ACB lined auxiliary spillway. The control section and spillway are 437 feet wide located south of the embankment. The principal spillway would need to be modified to pass the principal spillway hydrograph because an ACB lined spillway is not classified as a structural spillway. The riser structure and conduit would be replaced using an open cut method. The dam would not need to be raised to meet freeboard hydrograph capacity requirements. A conceptual drawing of the alternative is shown on **Figure D-3-8**. This alternative was eliminated due to the unreasonably high cost and the challenges associated with realigning the road east of the dam.
