Subject: EM-34 Survey at the Gervais Farm near North Enosburg, Vermont **Date:** 7 August 1991

Purpose:
To conduct additional studies of the holding capacity of the animal waste storage facility at the Gervais Farm using electromagnetic induction (EM) methods.

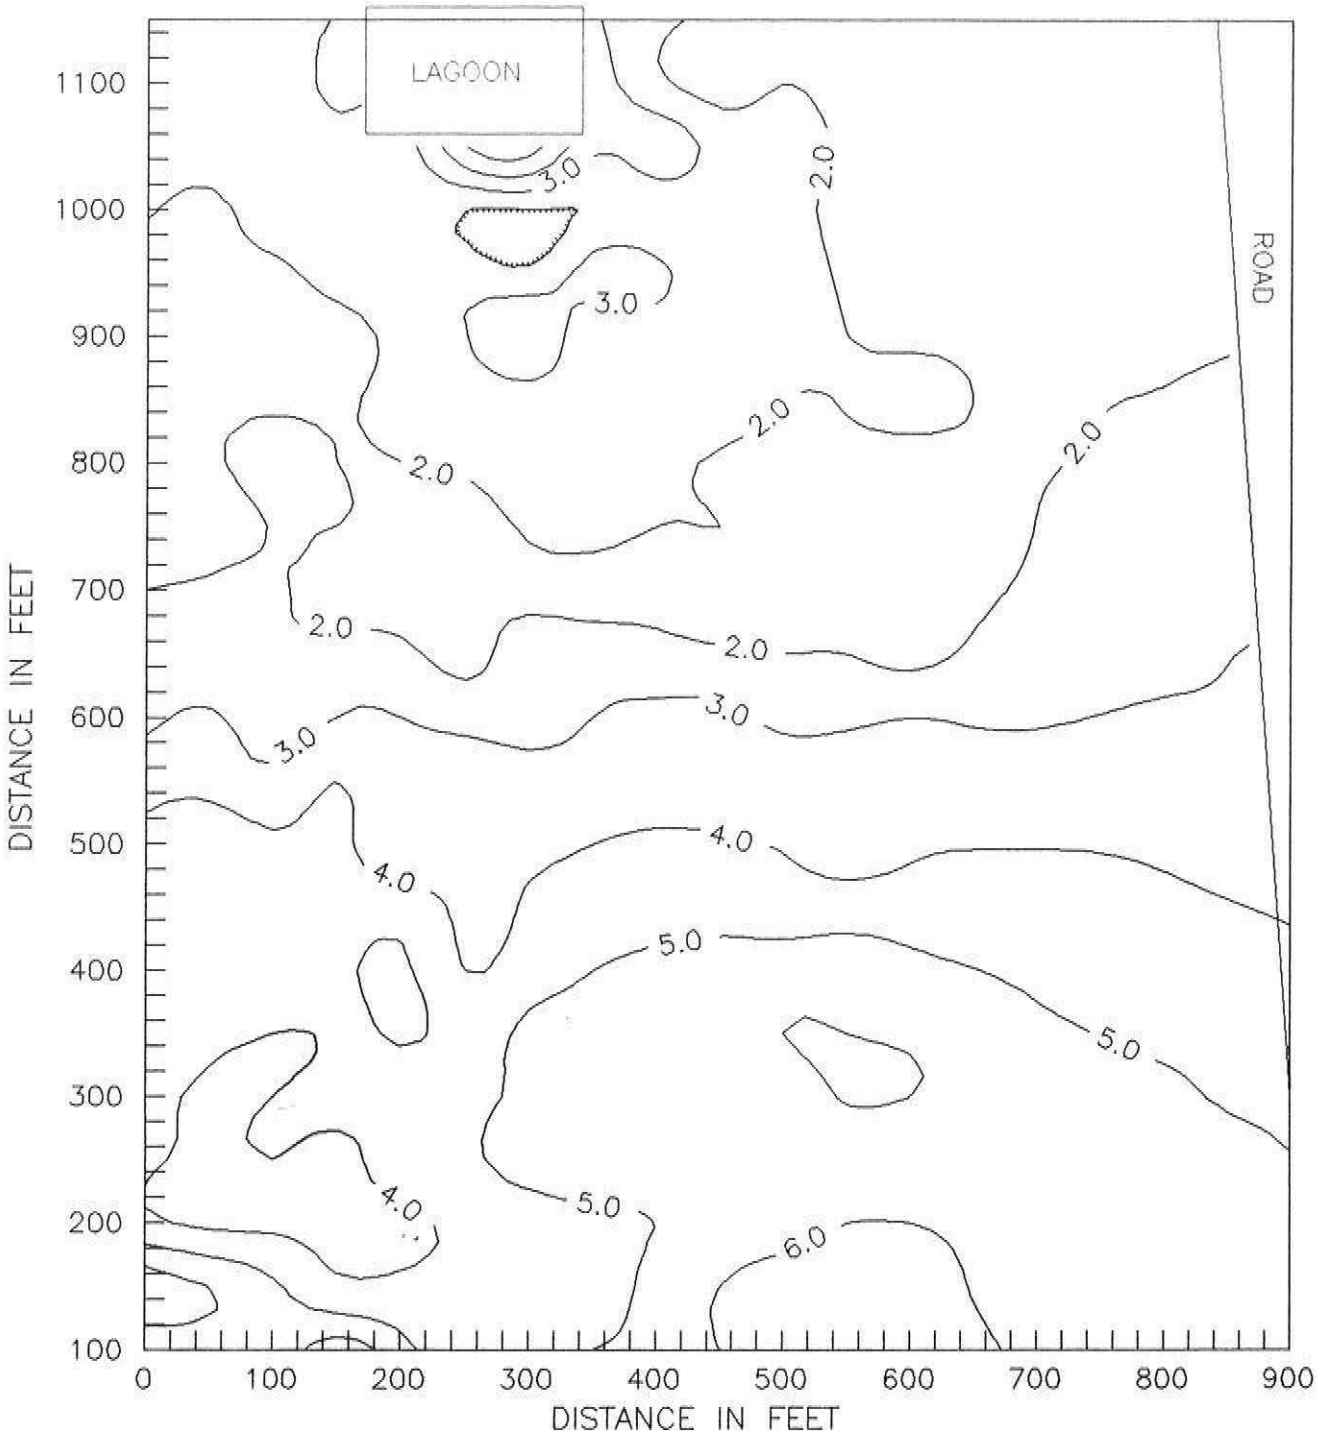
EM34(H) SURVEY AT THE GERVAIS FARM

The enclosed contour plot of the study area summarizes the apparent conductivity of the upper 15 meters of the earthen materials. The contour interval is 1.0 mS/m. Generally, apparent conductivity values increase with decreasing elevation (towards the north). As noted in the report of 7 December 1990, this pattern reflects the transition from coarse-loamy tills to moderately-fine and fine textured glaciolacustrine sediments. In addition, this pattern is believed to reflect, in part, a general deepening of soils over bedrock. Drainageways and seep areas having saturated soil conditions had slightly higher apparent conductivities than drier convex surfaces.

A pattern of higher apparent conductivities adjacent to the lagoon suggest possible seepage. With the exception of the northeast corner, a zone of relatively high (>3 mS/m) apparent conductivity values surrounds the lagoon. While relatively high, 3 mS/m is an exceedingly low value of apparent conductivity. These elevated values are believed to reflect the higher clay content and deeper depths to bedrock within the embankment materials, and the possible seepage of contaminants from the lagoon. As measured over a depth of

about 15 meters with the EM34-3 meter, the maximum extent of this area away from the lagoon is about 80 feet. Compared with measurements taken earlier with the EM31 meter (scanning depth of 5.5 meters) the zone of higher apparent conductivities which surrounds the lagoon becomes more restricted with increasing depth scanned. No evidence of extensive seepage from the lagoon is evident within the upper 15 meters.

In the enclosed contour plot, an isolated, bow-tie shaped zone of apparent conductivity values greater than 3 mS/m is apparent immediately downslope from the lagoon. This anomaly is located about a livestock watering tank. Because dairy cattle congregate here, this area receives a heavy dosage of animal wastes which will increase the apparent conductivity of the soils.
