# Nanticoke Creek Site 3 – Plan- Environmental Document

Second Agency Meeting  
December 12, 2024

Town of Lisle Office  
9234 NYS Route 79  
Lisle, NY 13797

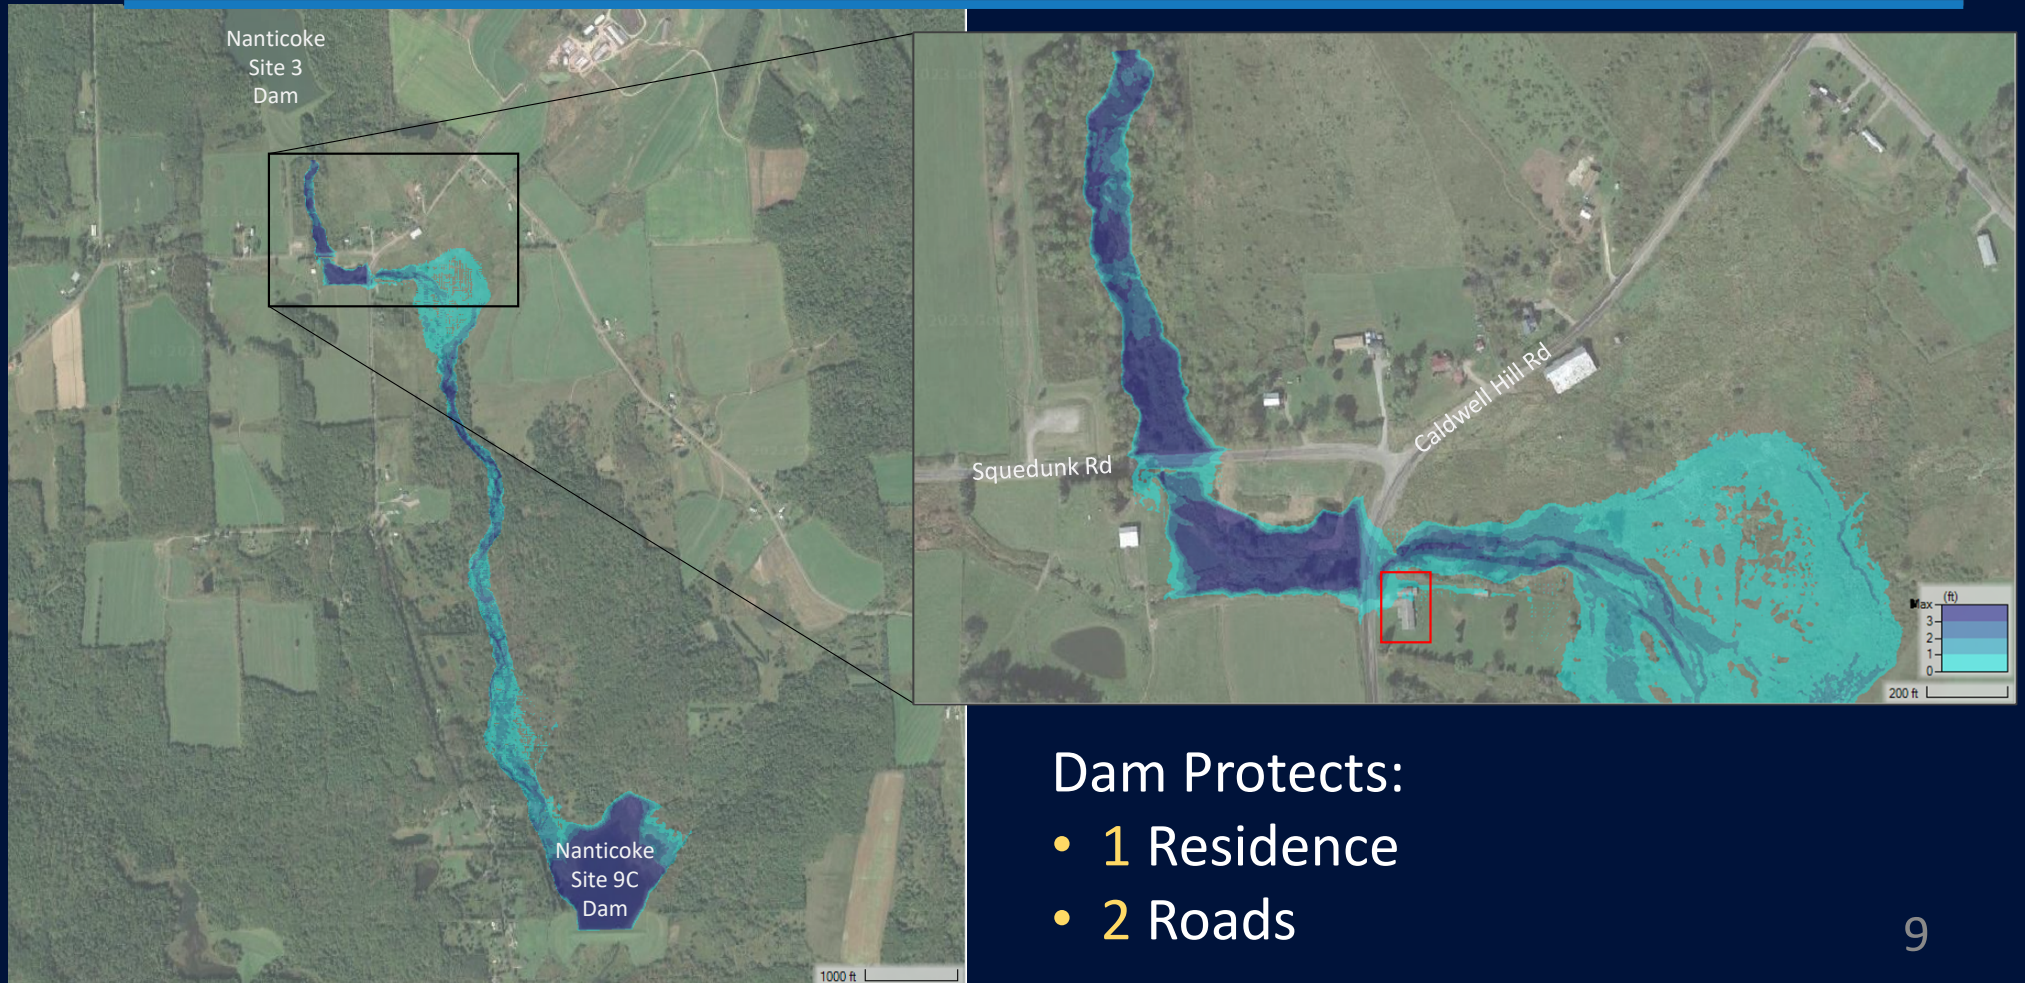
# Benefits – No Dam 100-Year Flood

Dam Protects:

- 1 Residence
- 2 Roads

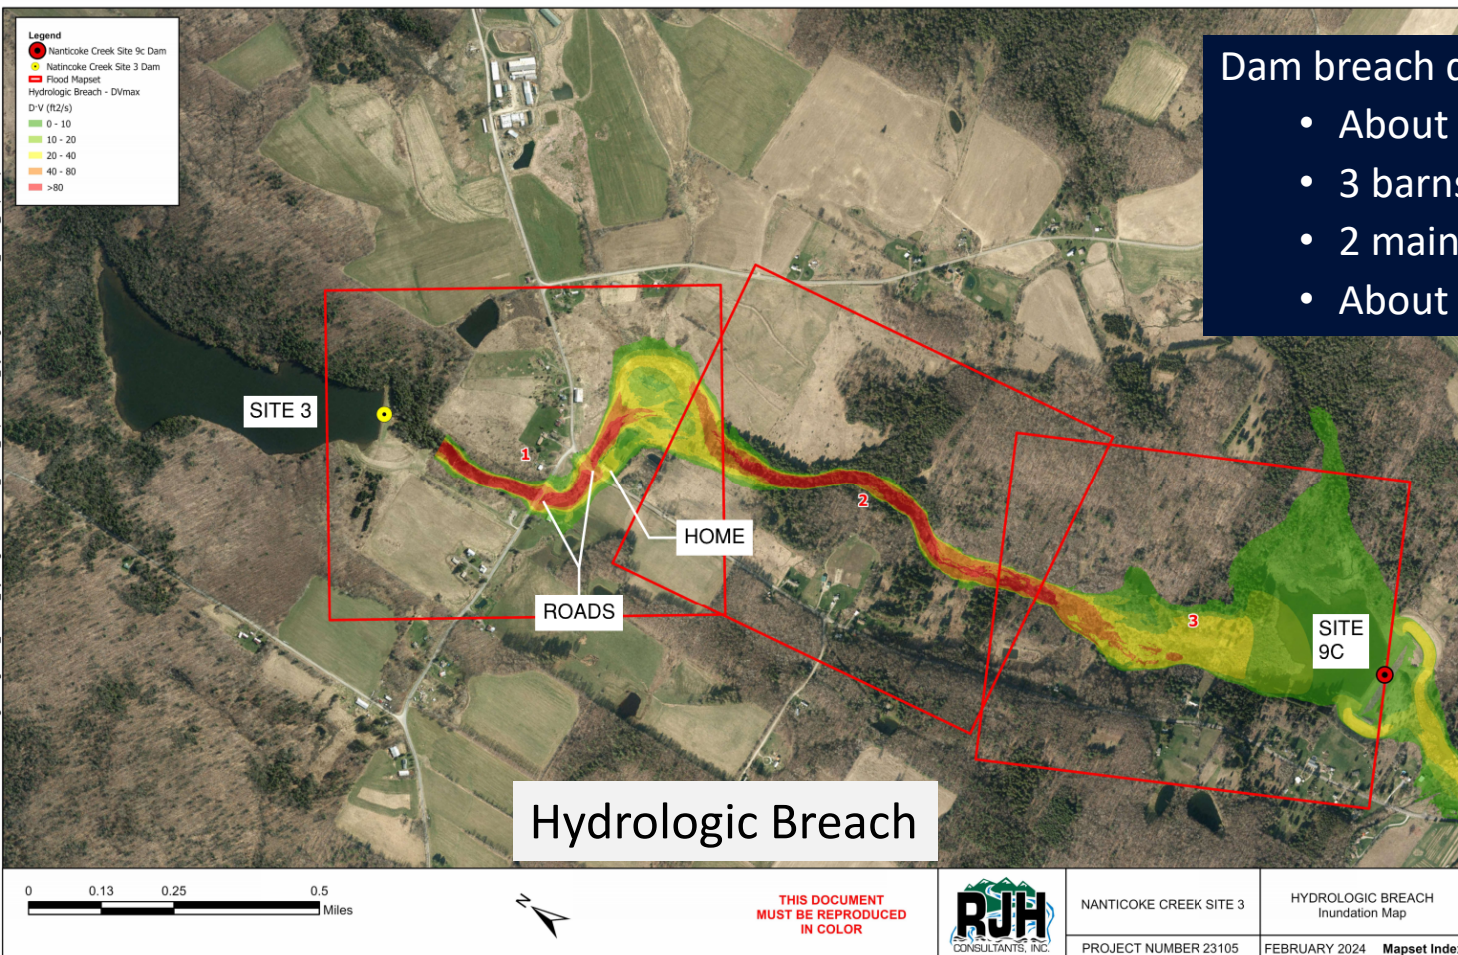
# Dam Breach Inundation

Dam breach during FBH would impact:

- About 1 home and 7 people
- 3 barns/sheds/garages
- 2 main local roads and minor highways
- About 1 life lost

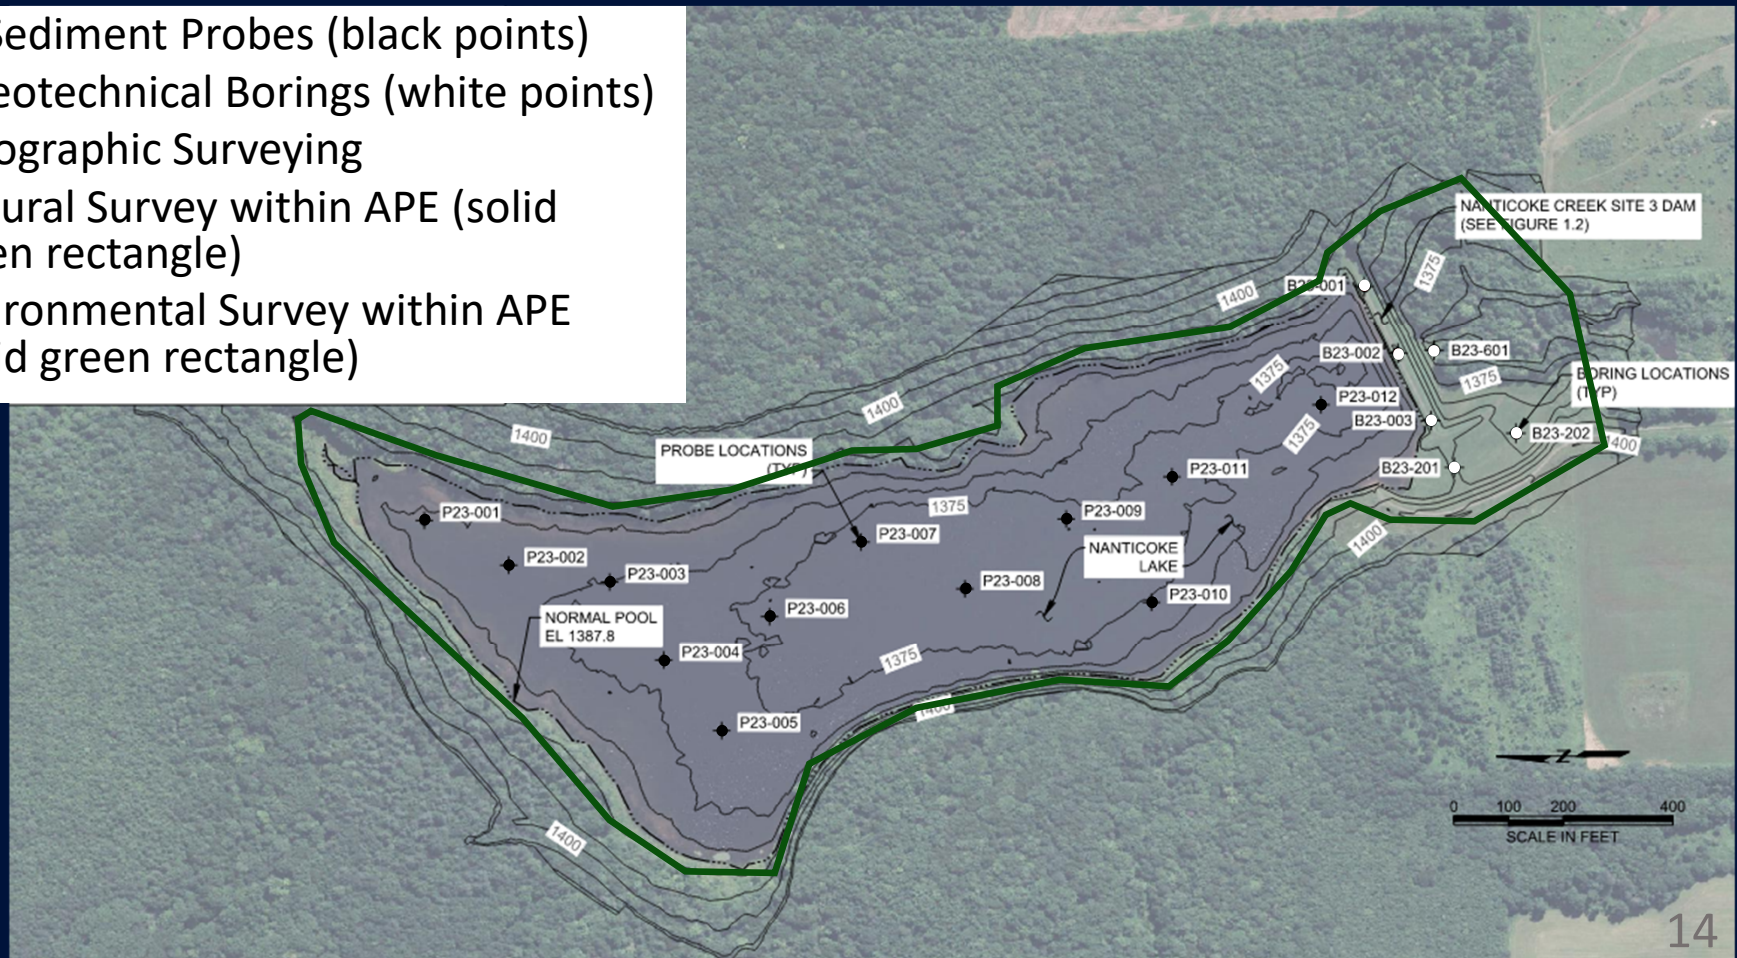
# Summary of Data Collection

- 12 Sediment Probes (black points)
- 6 Geotechnical Borings (white points)
- Topographic Surveying
- Cultural Survey within APE (solid green rectangle)
- Environmental Survey within APE (solid green rectangle)

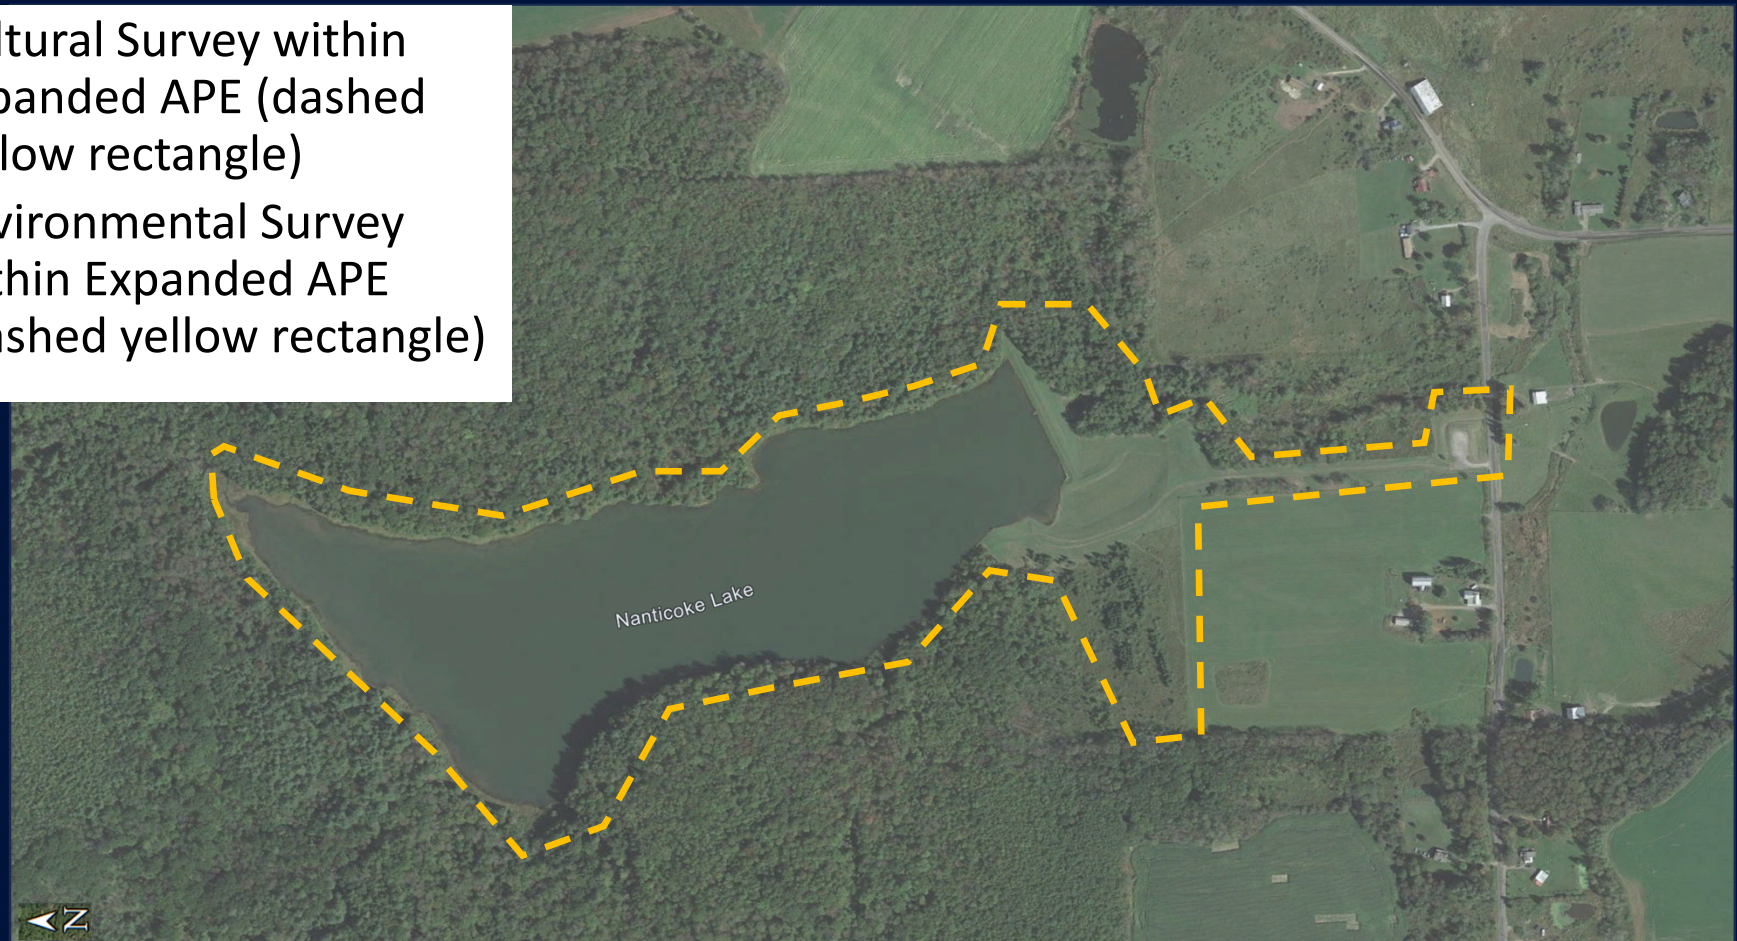
# Summary of Final Data Collection

- Cultural Survey within Expanded APE (dashed yellow rectangle)
- Environmental Survey within Expanded APE (dashed yellow rectangle)

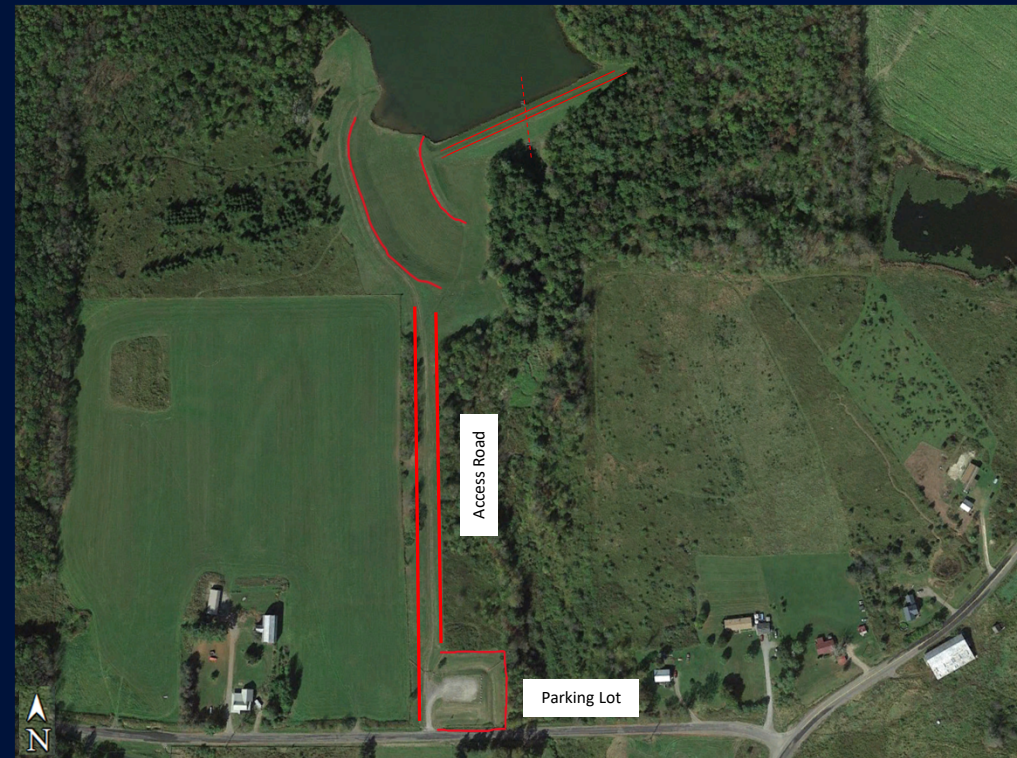
# Dam Components and Access

## Earthfill Embankment

- Height: 31.5 feet
- Crest Width: 14 feet
- Crest Length: 618 feet

## Principal Spillway

- Rectangular Riser
- 30-inch Outlet Pipe

## Auxiliary Spillway

- Base Width: 125 feet

## Site Access

- From parking area and entrance gate 0.25-miles south of site

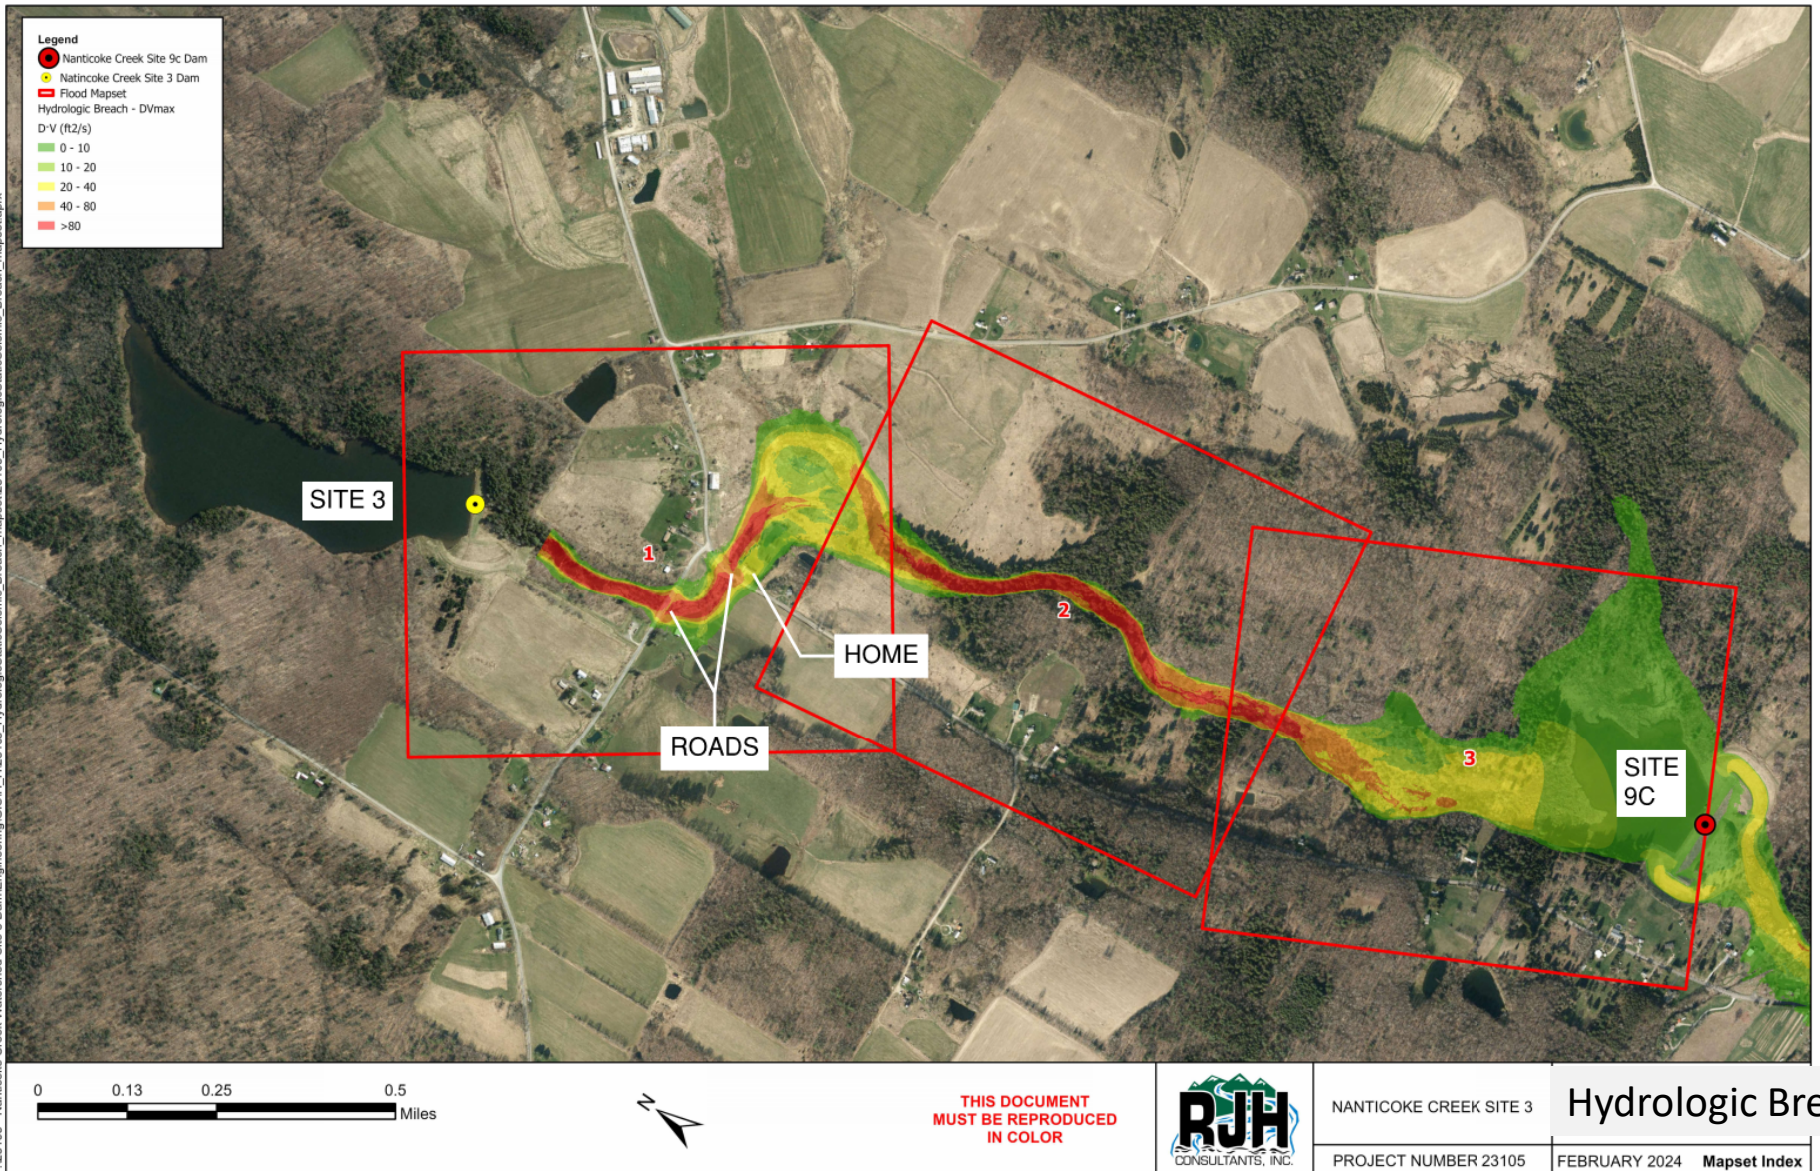
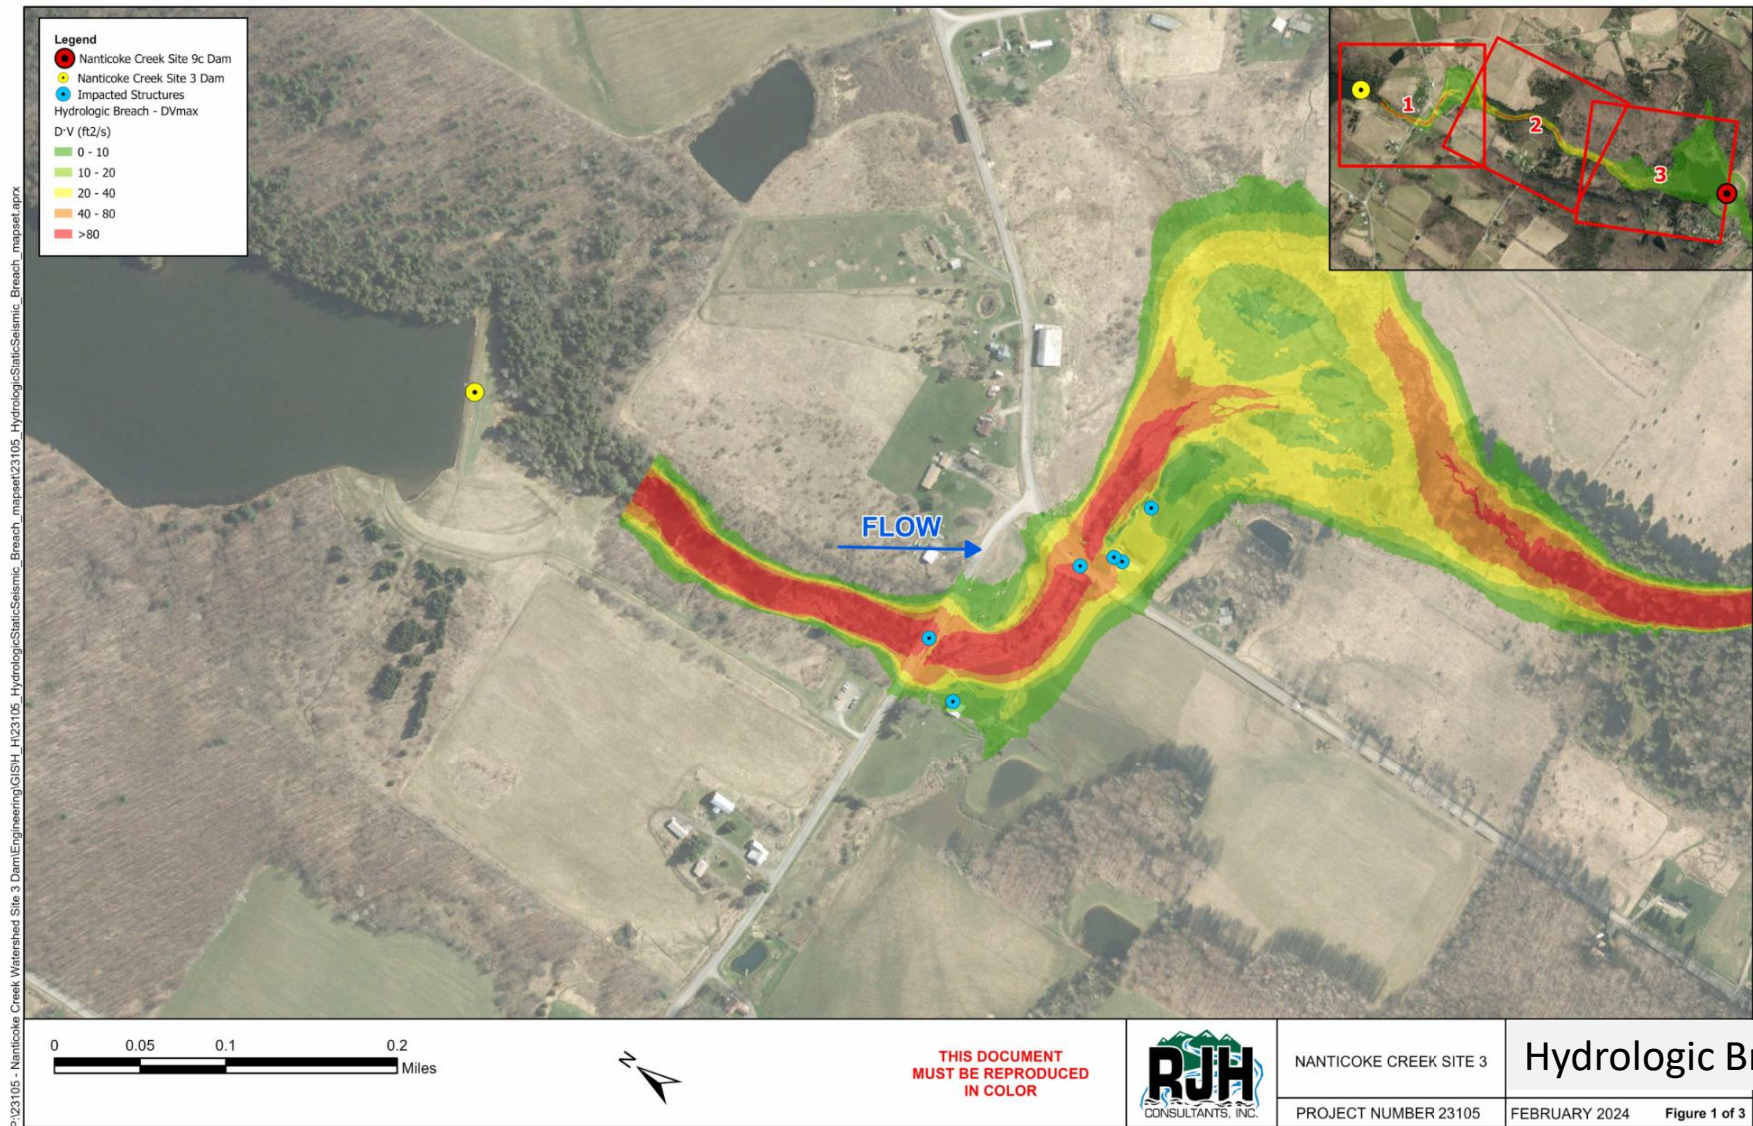
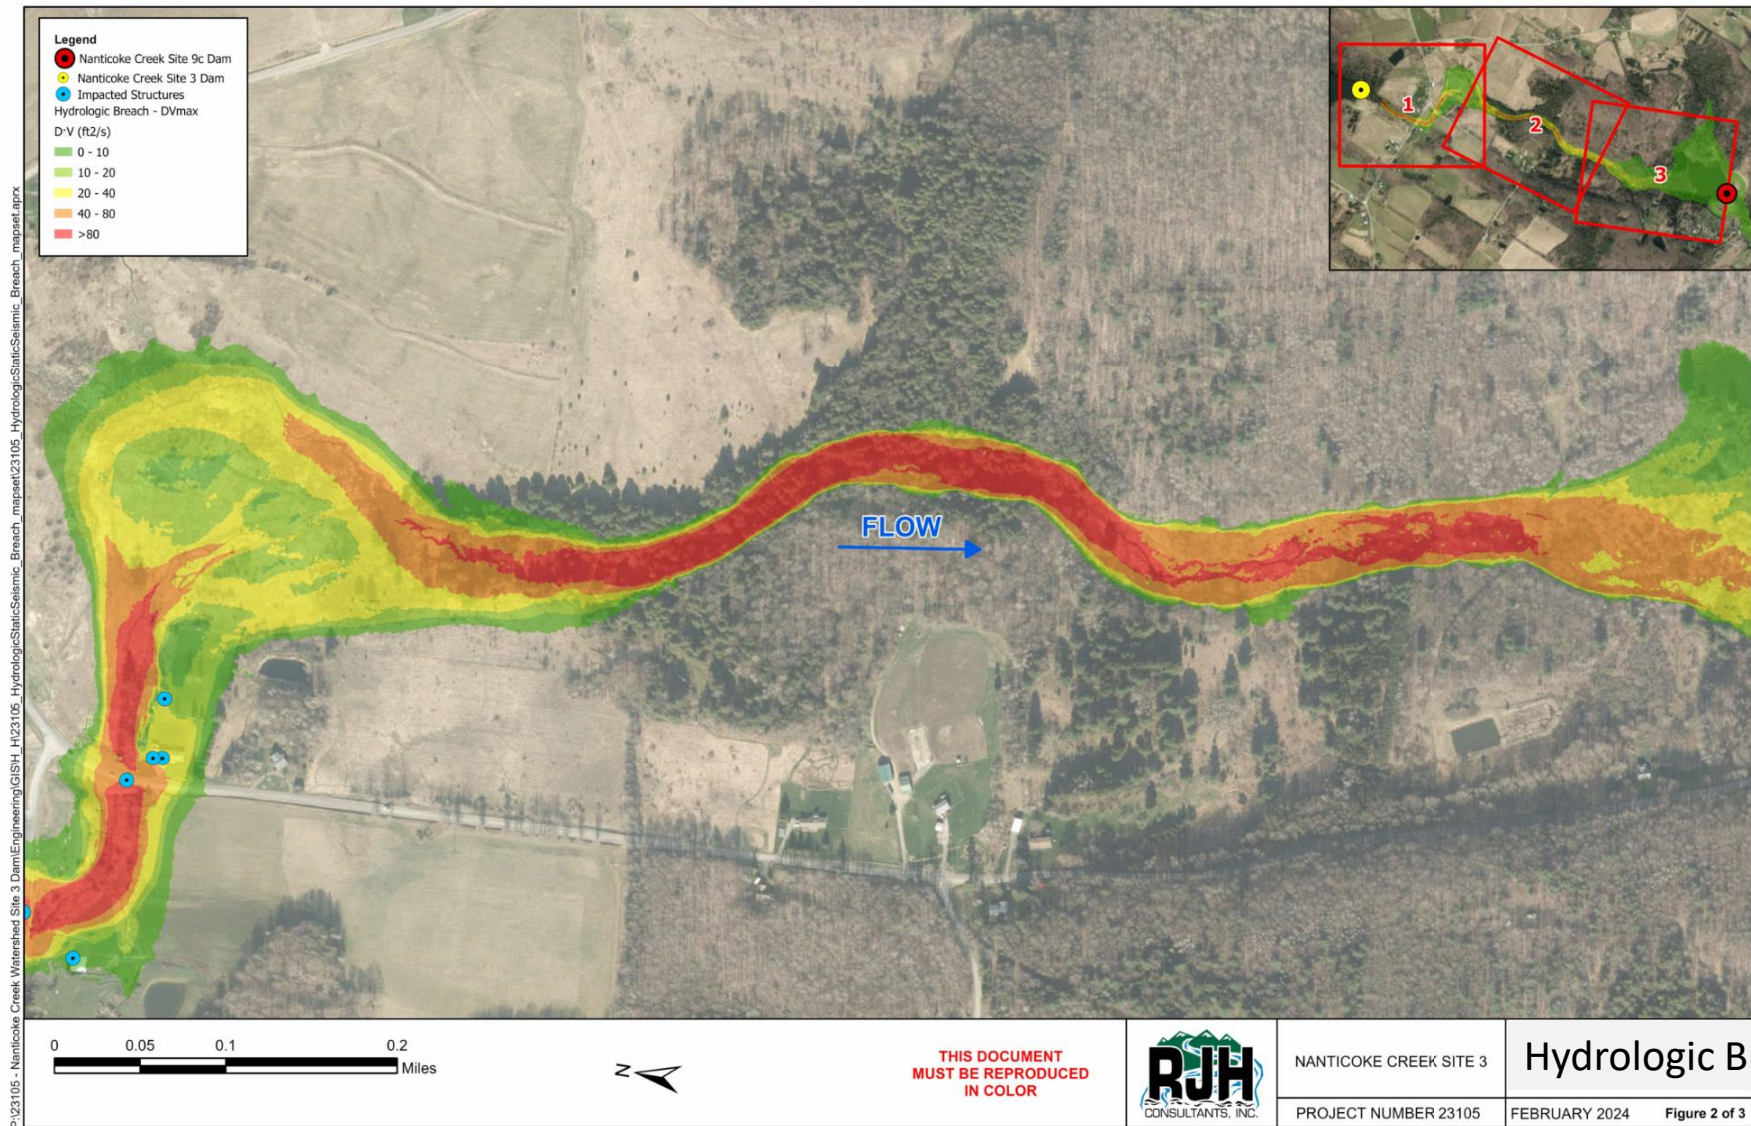
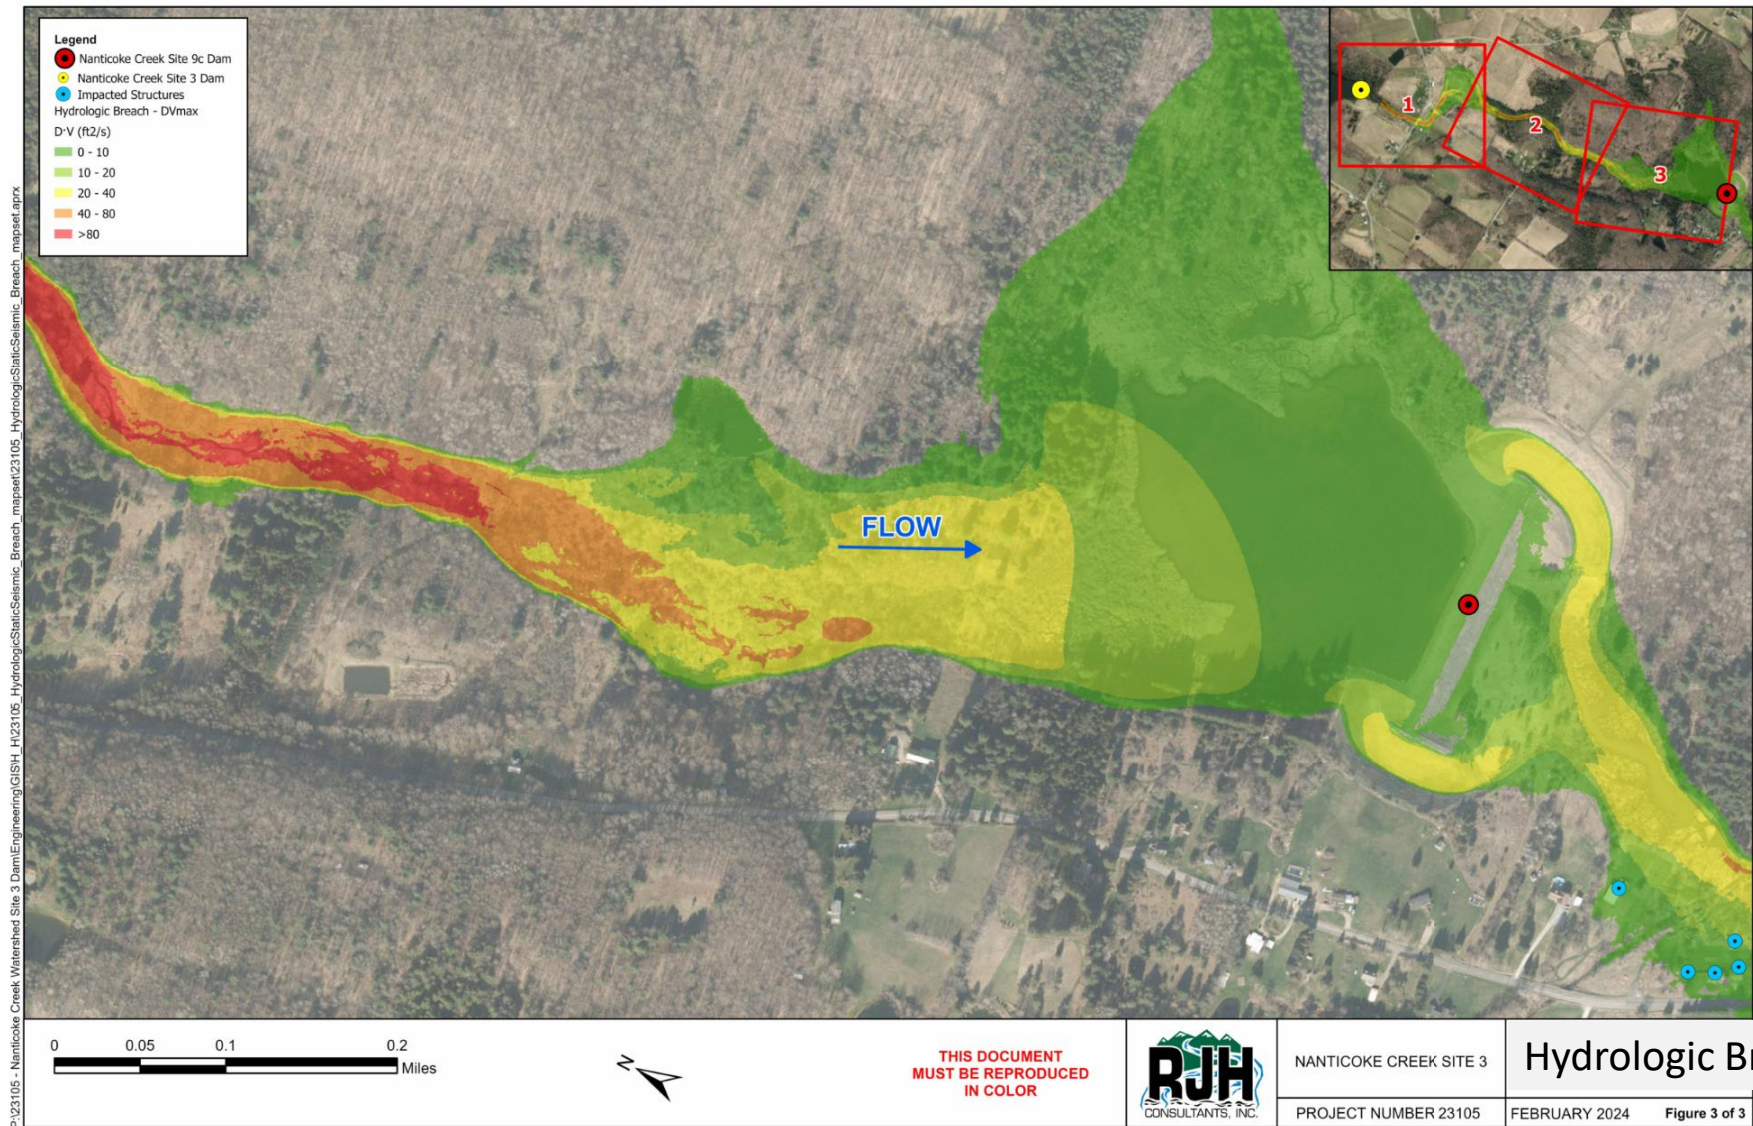
# Alternative 1 (No Action/FWOP)

- Downstream consequences will depend on hydraulic load at time of failure

Hydrologic Breach	Static Breach	Seismic Breach
Load		Peak of FBH	ASW Crest	Normal Pool
Peak Discharge (cfs)		19,900	500	400
Inundated Structures	Barns/Sheds/Garages	3	2	2
	Homes	1	1	1
	Main Local Roads and Minor State Highways	2	2	2
Population at risk (PAR)		7	7	4
Estimated lives lost (LL)		0.6	0.06	0.03
Results in Failure of Site 9c Dam:		Yes	No	No

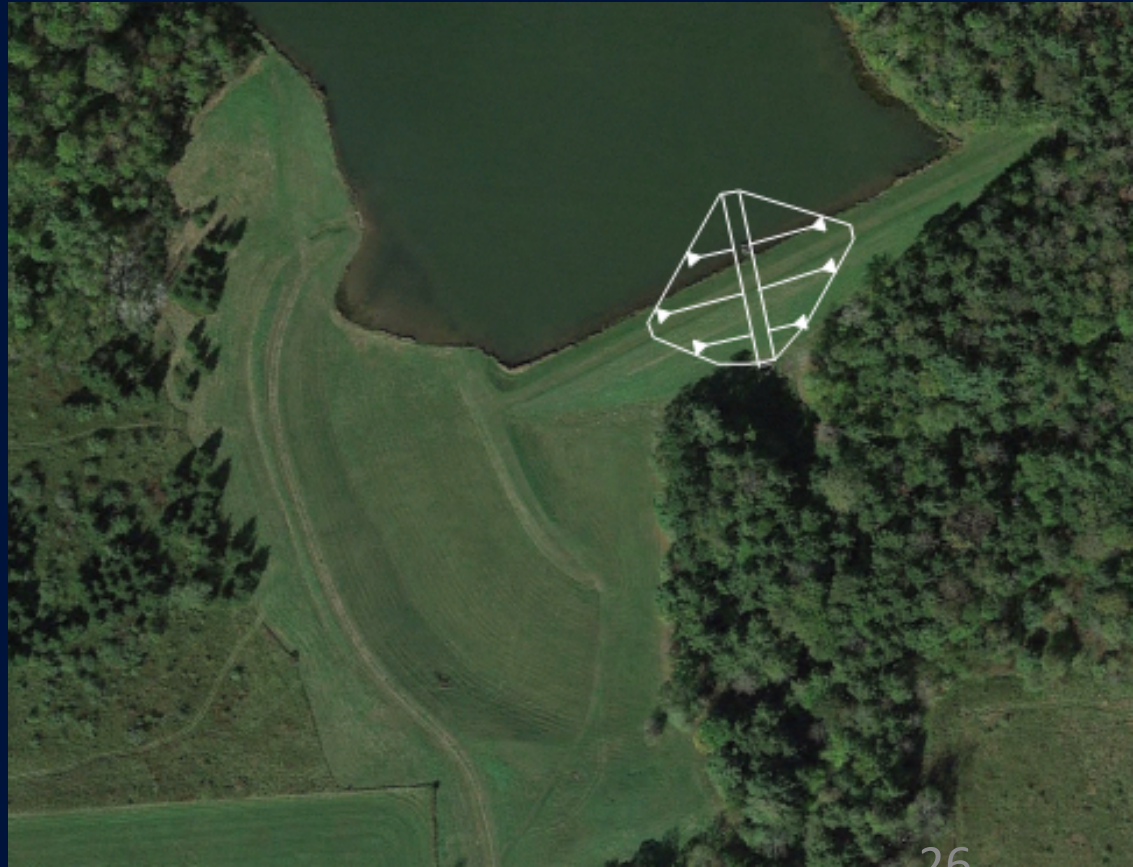
## Alternative 2 (Decommissioning)

- Breach existing dam and stockpile material onsite
- Demolish principal spillway structures and dispose of off-site
- Reclaim and revegetate reservoir bottom to stabilize sediment
- Purchase downstream properties and demolish structures in the inundation area

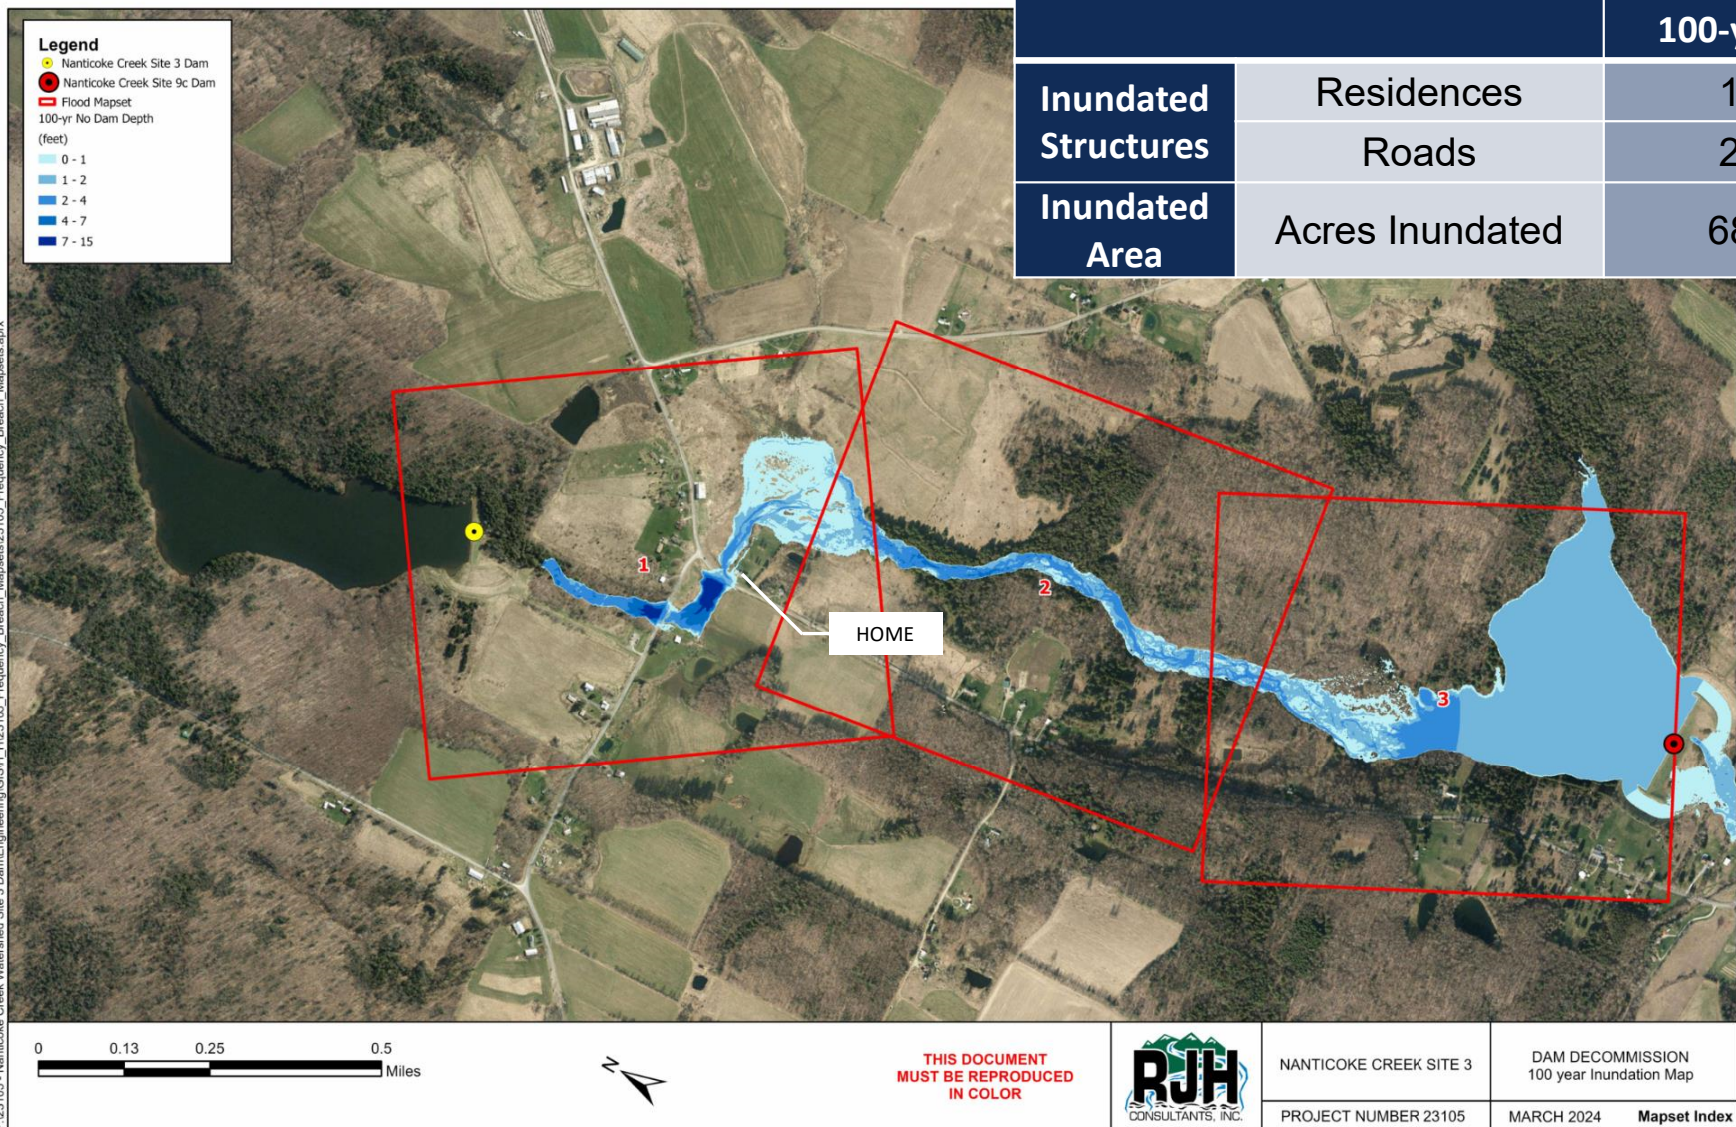
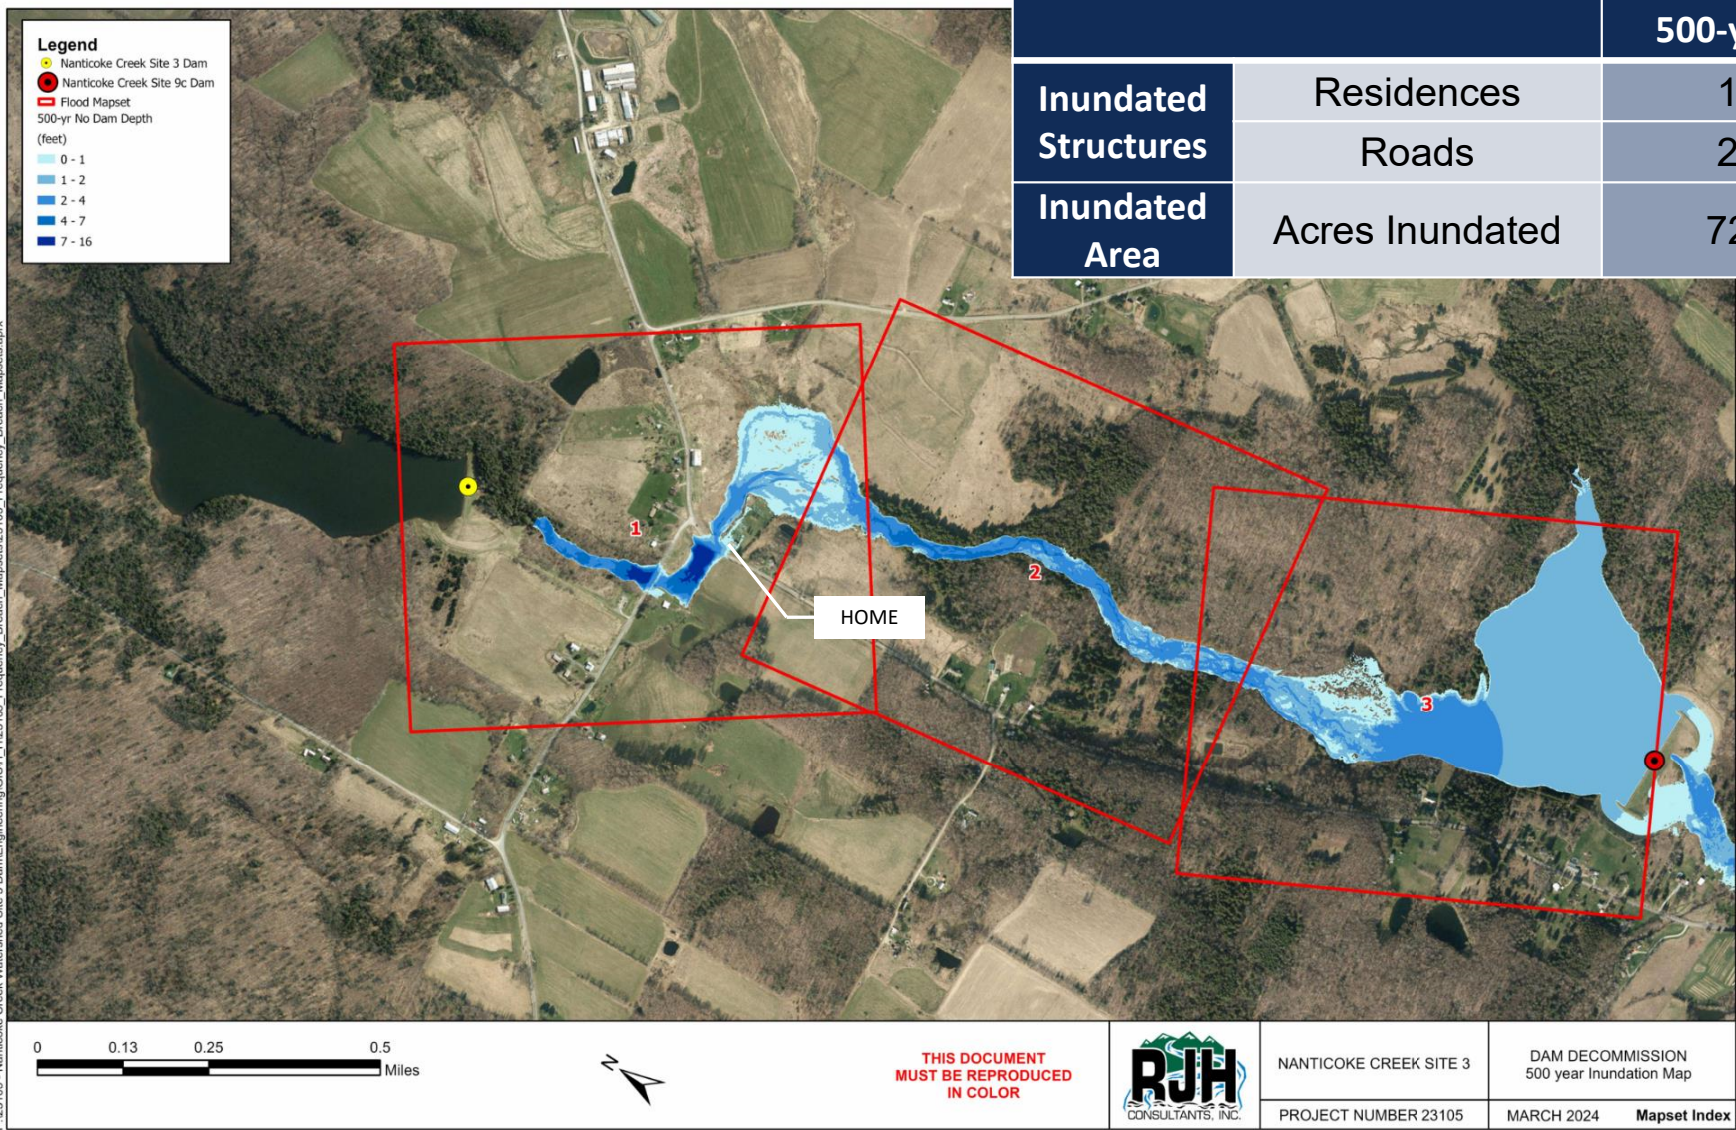
500-year
Inundated Structures	Residences	1
	Roads	2
Inundated Area	Acres Inundated	72

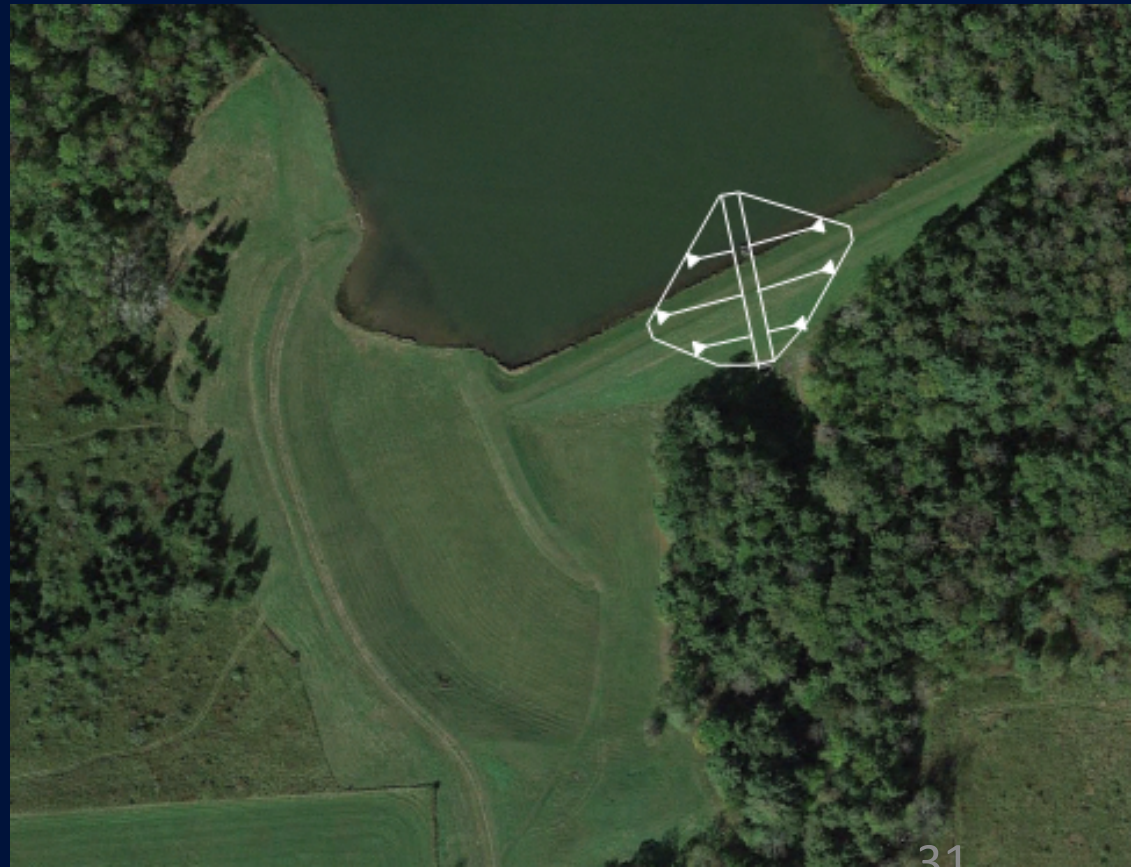
## Alternative 3 (Nonstructural)

- Breach existing dam and stockpile material onsite
- Demolish principal spillway structures and dispose of off-site
- Reclaim and revegetate reservoir bottom to stabilize sediment
- Construct downstream facilities to manage flooding
- Purchase vacant lands in the inundation area

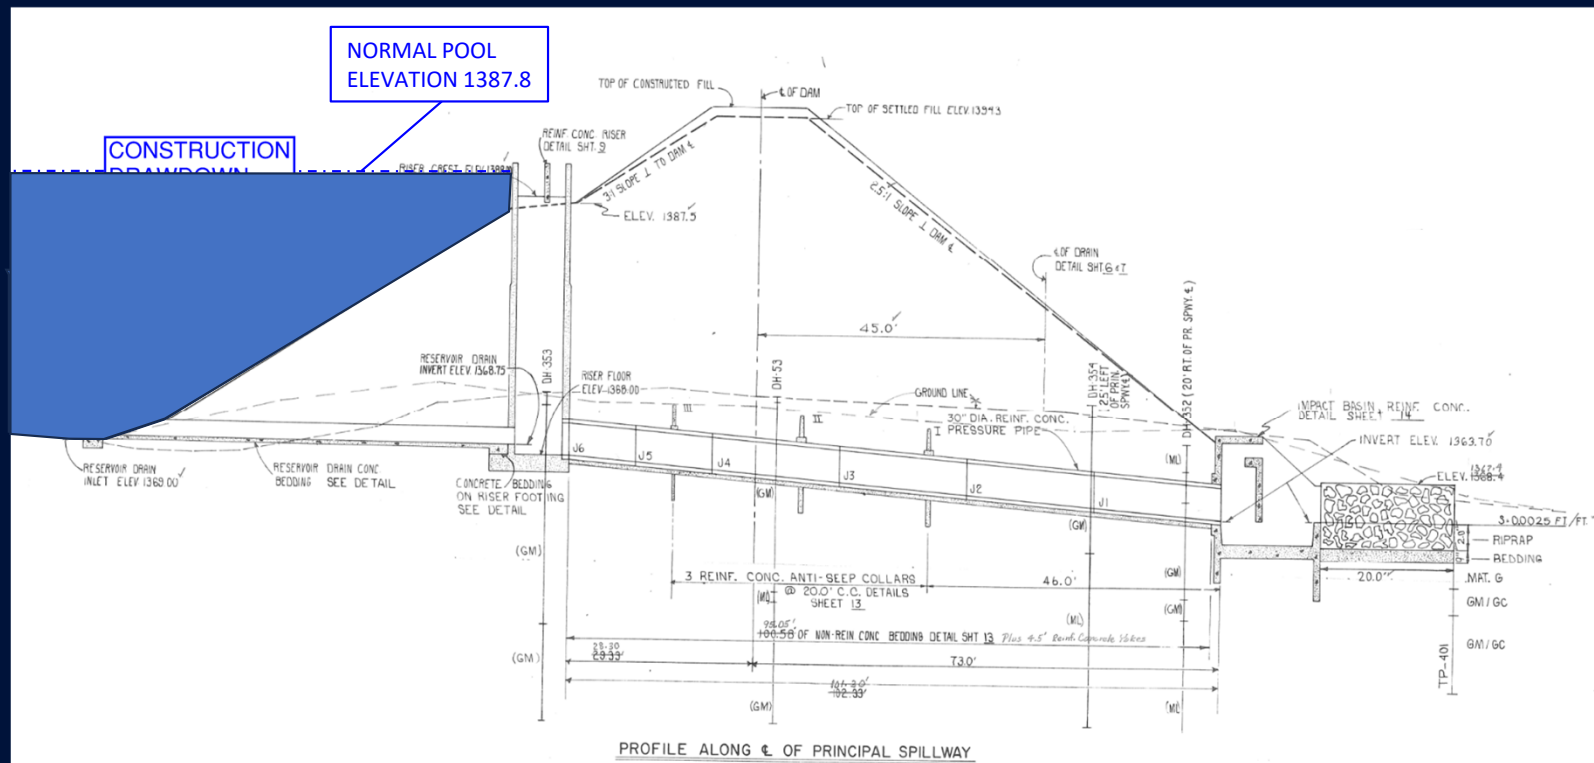
# Alternative 4 (Structural Rehabilitation):

- Lower reservoir for construction season, route inflow, and dewater construction areas
