# Nanticoke Creek Site 3 – Plan- Environmental Document

Second Agency Meeting  
December 12, 2024

Town of Lisle Office  
9234 NYS Route 79  
Lisle, NY 13797

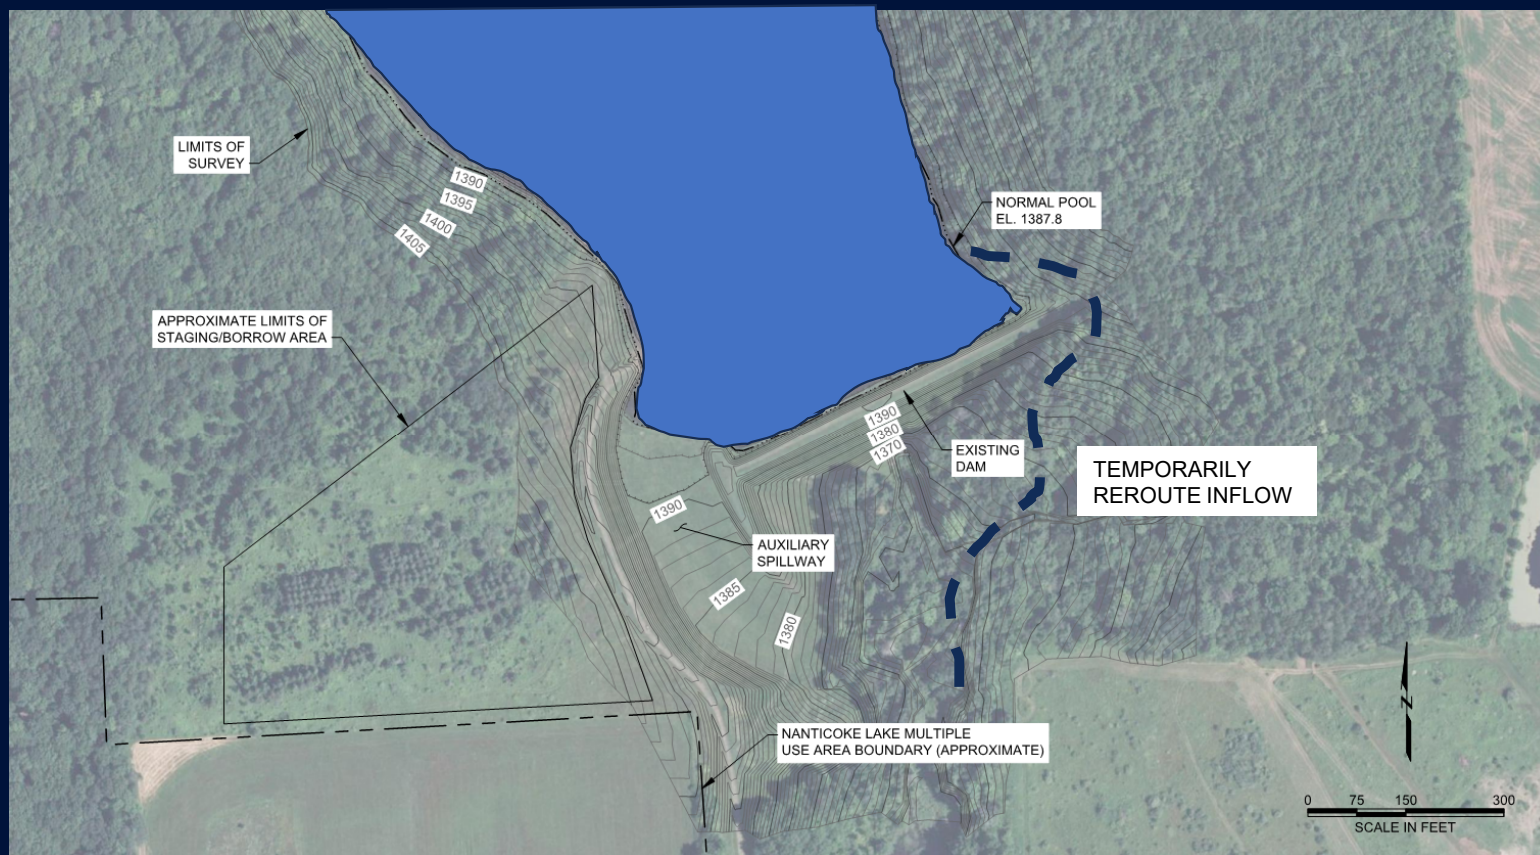
## Alternative 4 (Structural Rehabilitation):

- Lower reservoir for construction season, route inflow, and dewater construction areas

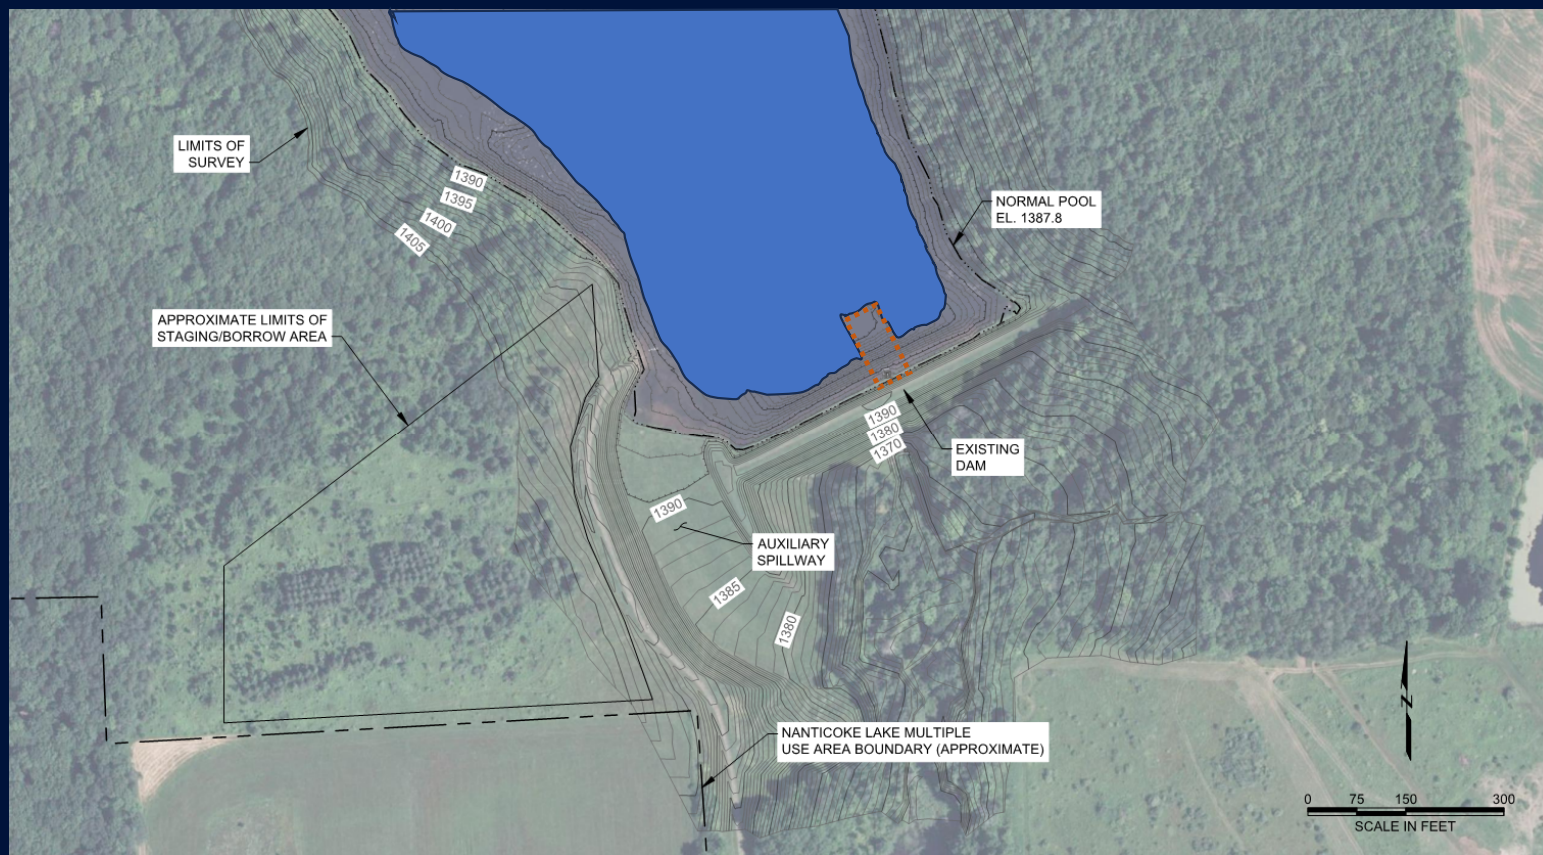
## Alternative 4 (Structural Rehabilitation):

- Construct a cofferdam around the low-level inlet

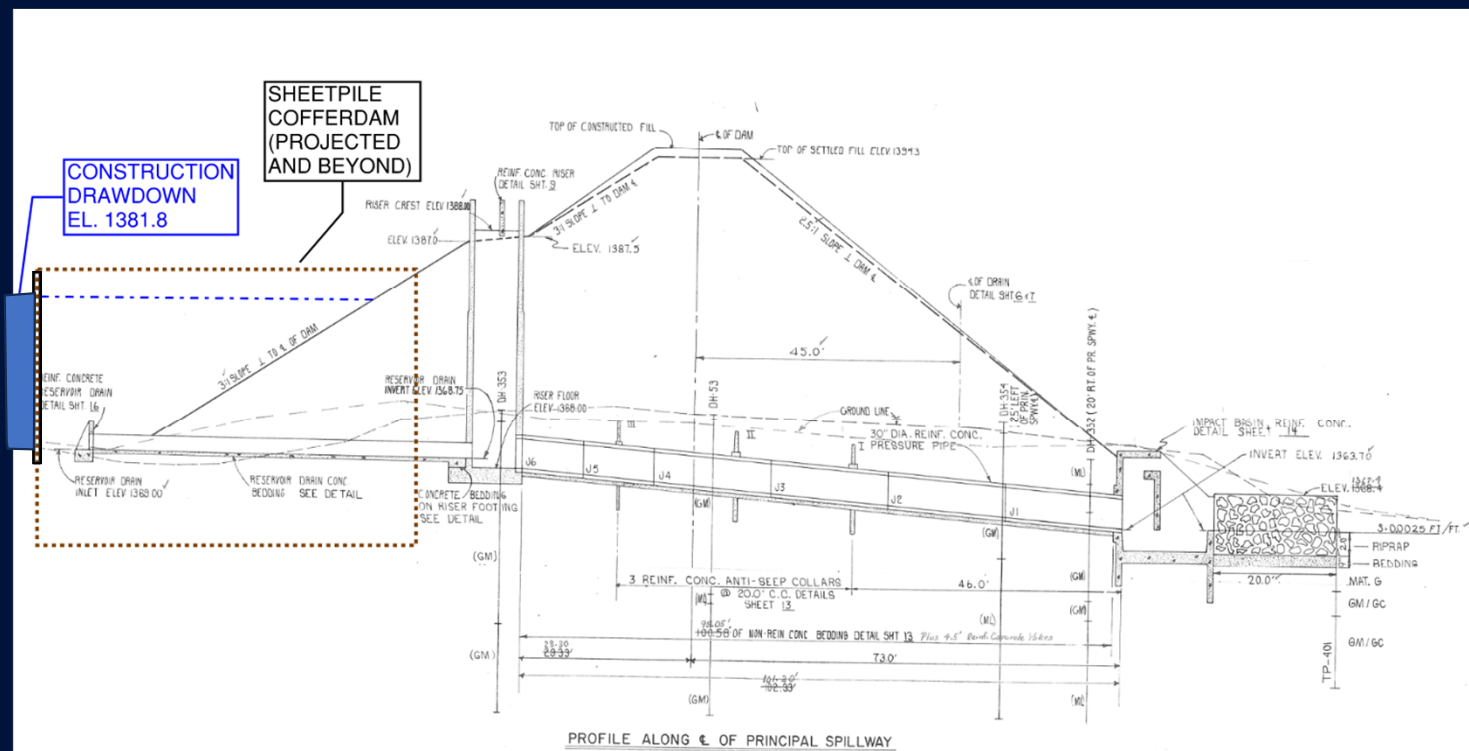
## Alternative 4 (Structural Rehabilitation):

- Construct a cofferdam around the low-level inlet

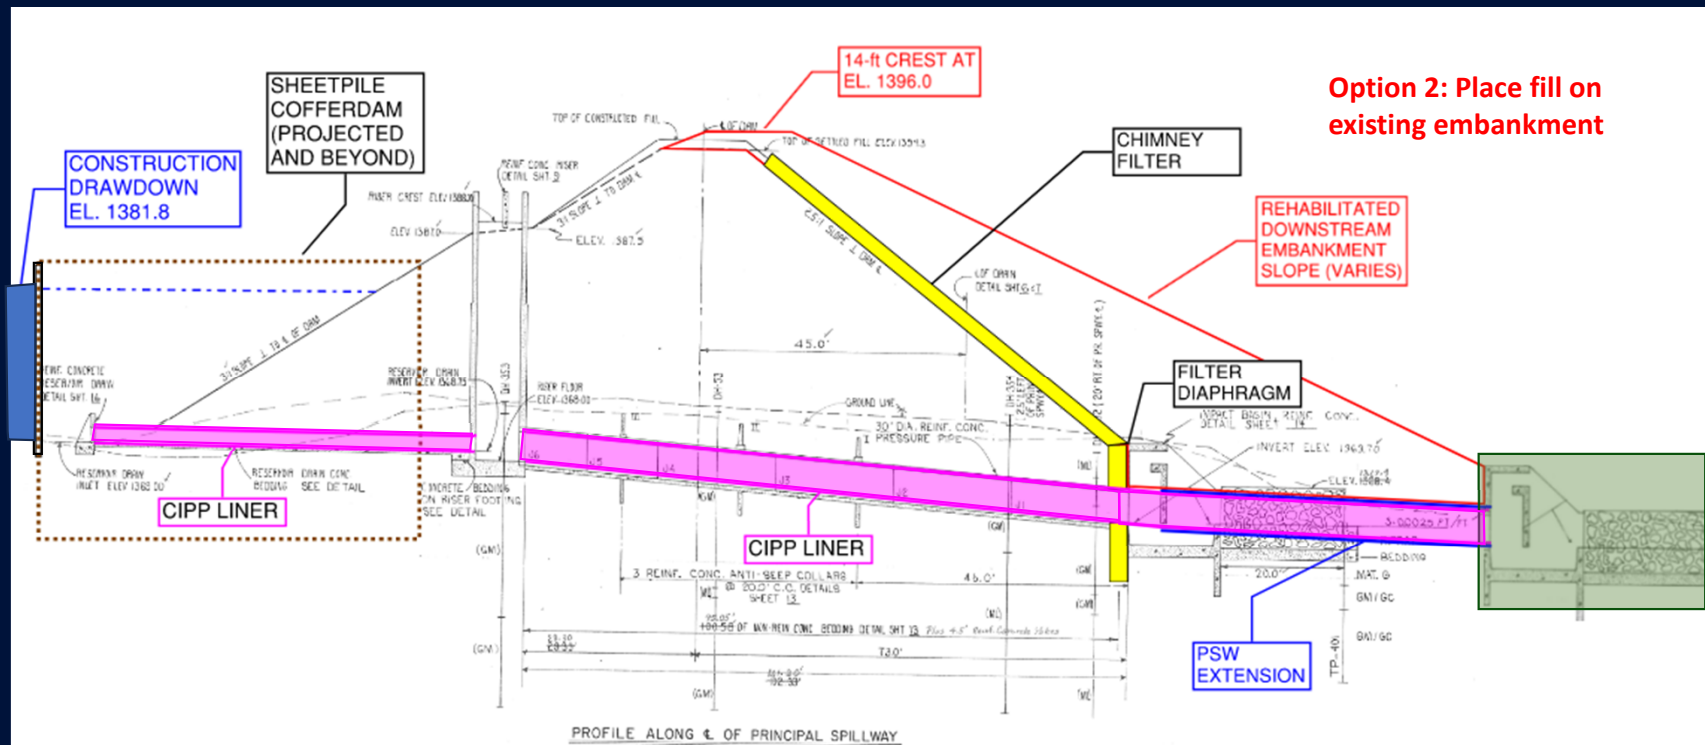
# Alternative 4 (Structural Rehabilitation):

- Demolish impact basin and dispose of offsite
- Construct filter diaphragm, blanket drain, and chimney filter
- Construct downstream embankment raise, raise and broaden auxiliary spillway berm, install instrumentation
- Extend principal spillway conduit, install 12-foot-wide impact basin, CIPP liner in low-level drain and principal spillway conduit

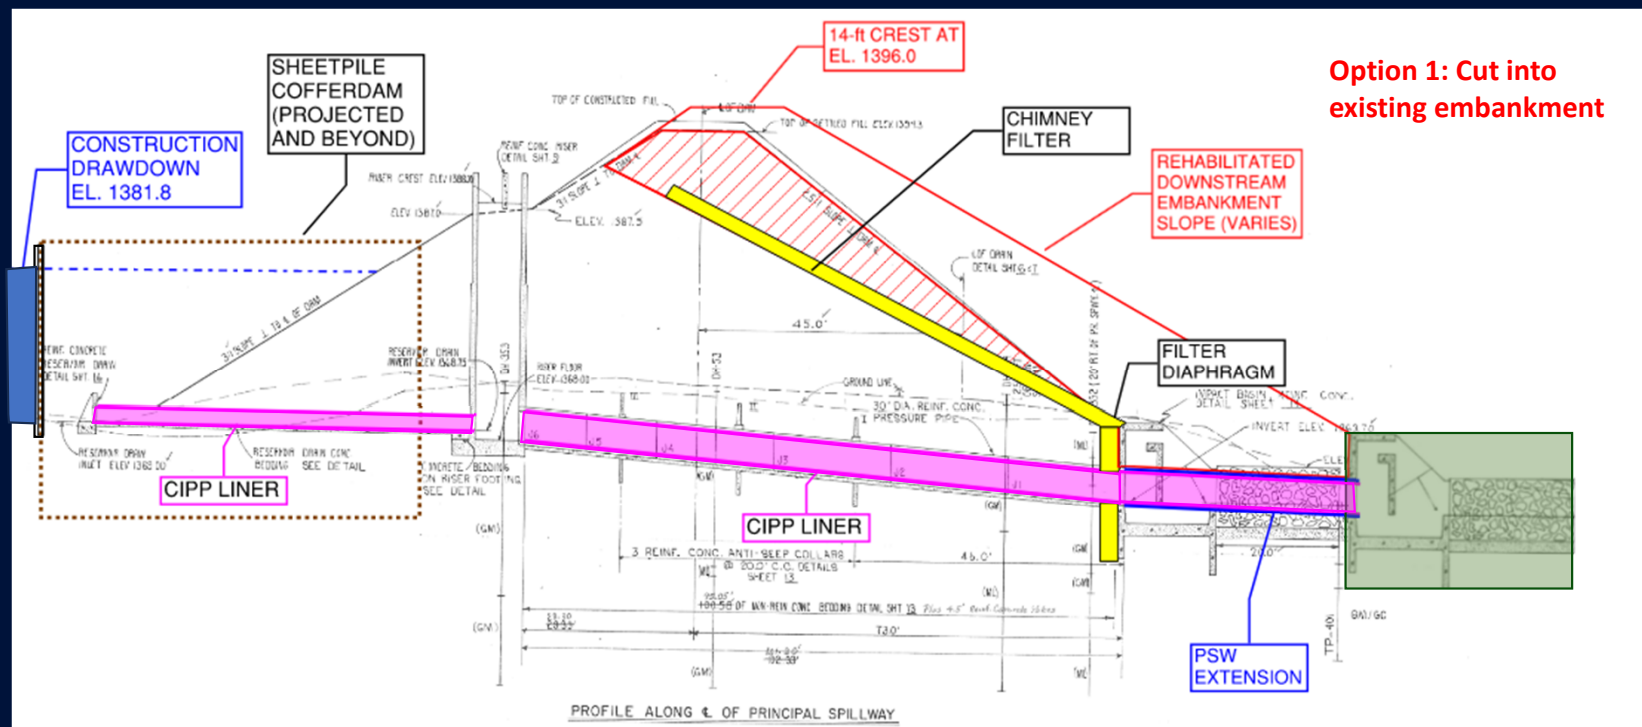
# Alternative 4 (Structural Rehabilitation):

- Demolish impact basin and dispose of offsite
- Construct filter diaphragm, blanket drain, and chimney filter
- Construct downstream embankment raise, raise and broaden auxiliary spillway berm, install instrumentation
- Extend principal spillway conduit, install 12-foot-wide impact basin, CIPP liner in low-level drain and principal spillway conduit

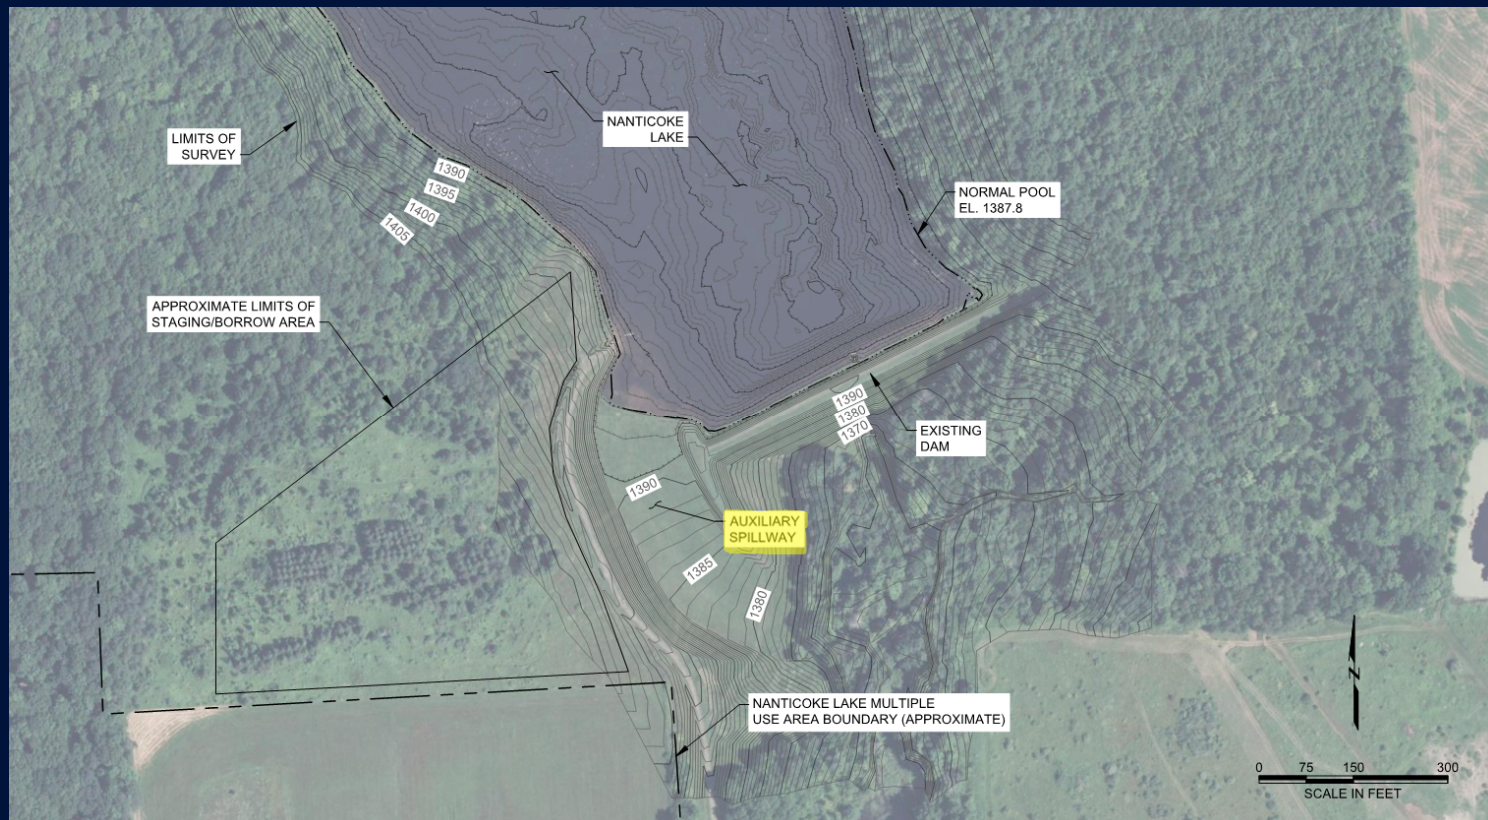
## Alternative 4 – Auxiliary Spillway Deficiencies

- Raise and Broaden the Auxiliary Spillway Berm

- The Auxiliary Spillway must be raised 0.1 foot to not be engaged by the PSH
- Spillway berm does not meet minimum crest width criteria in some areas
- ✔ • *Raise control section and broaden berm – addresses PSH deficiency, addresses crest width criteria*
