Subject: Archaeology -- Geophysical Assistance --

Date: 14 October 1998

To assist the Tippecanoe County Historical Association assess the site of Fort Quiatenon.

EM SURVEY
FORT QUIATENON
EM38 METER

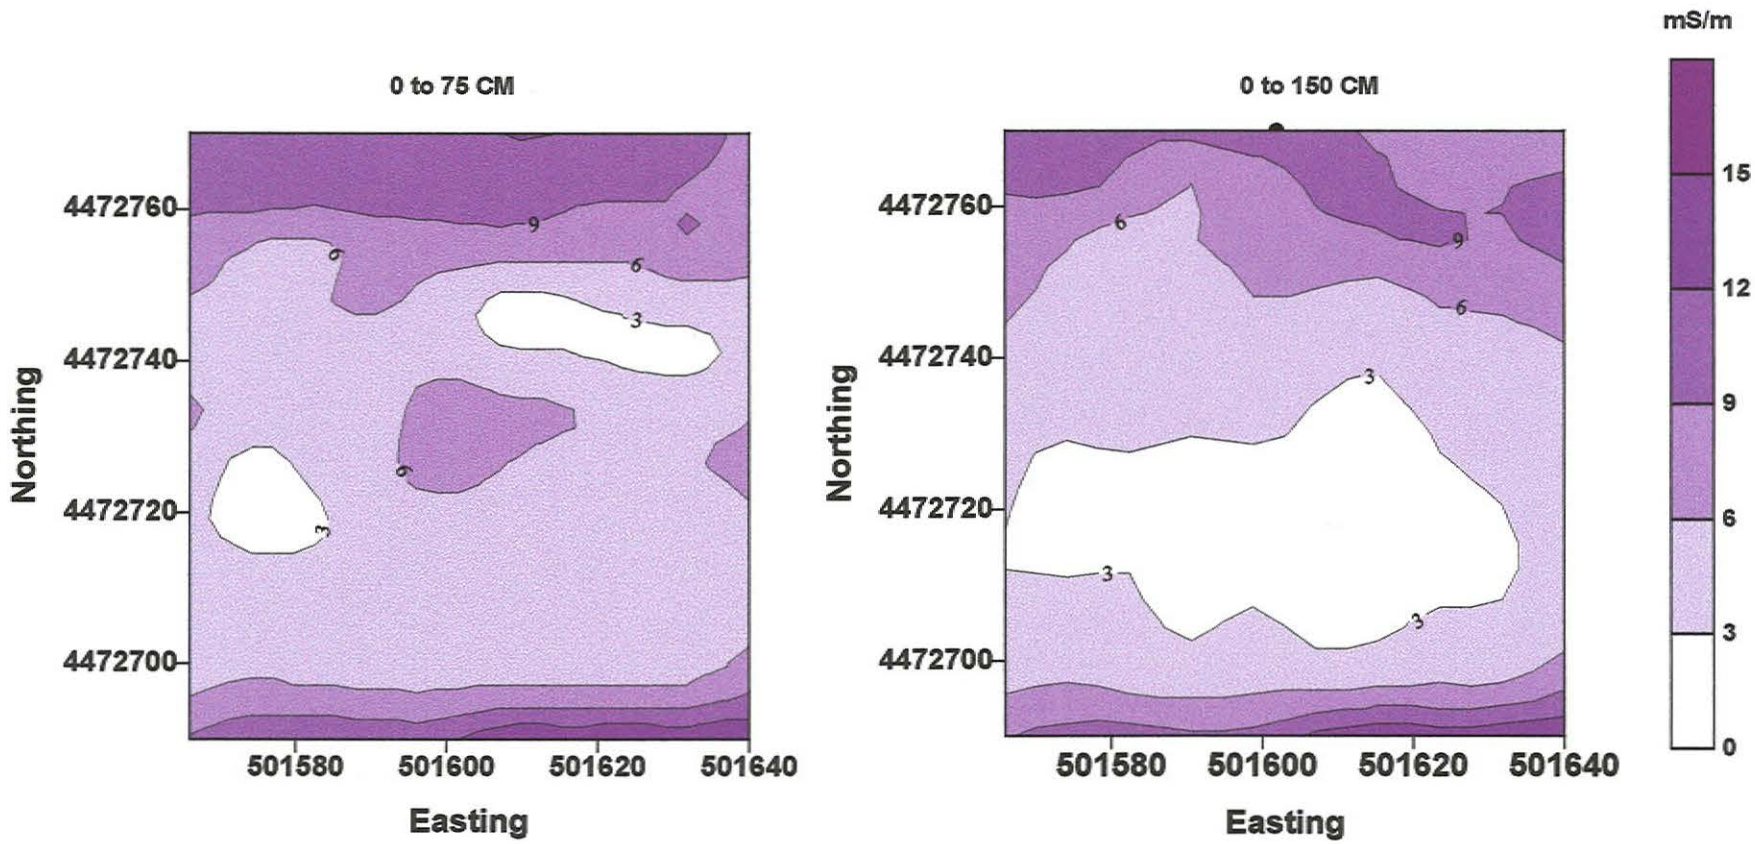
Figure 1 contains two-dimensional plots of data collected with the EM38 meter in the horizontal (left-hand plot) and vertical (right-hand plot) dipole orientations. In Figure 1, the left-hand plot represents the spatial distribution of apparent conductivity within the upper 30 inches of the soil profile. The right-hand plot represents the spatial distribution of apparent conductivity within the upper 60 inches of the soil profile. In each plot, the isoline interval is 3 mS/m.

Values of apparent conductivity were low within the site. Apparent conductivity averaged 7.34 mS/m and 6.23 mS/m in the horizontal and vertical dipole orientations, respectively. In general, apparent conductivity is comparatively high along the north and south border while it is low in the central portion of the site. This spatial pattern conforms to the topography and reflects changes in soil types and properties. The central portion of the site, is a slightly higher-lying, convex surface that is

In the plots shown in Figure 1, spatial patterns principally reflect gradual changes in soil types and properties. Surprisingly, no anomalously high or low (negative value) measurements were recorded. Such anomalous values could indicate the presence of a buried metallic, cultural feature. Considering the relative coarse grid interval used, it is probable that, if present, many of these cultural features would be overlooked. However, with 120 observation, it seems strange that, if present, no buried metallic artifact was detected.

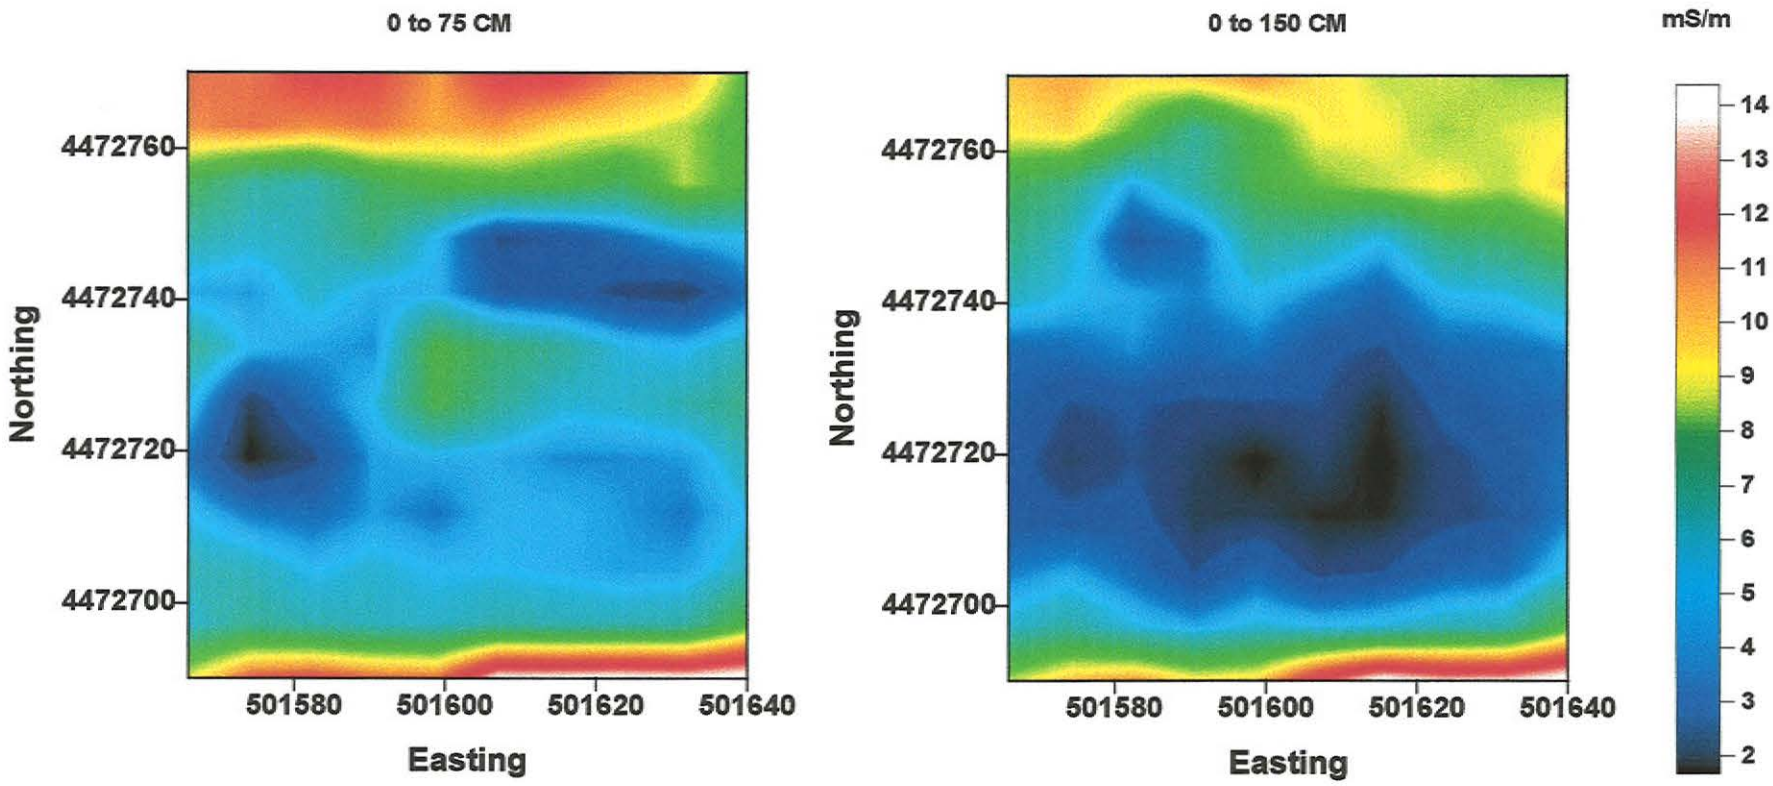
Figure 2 contains two-dimensional image maps of data collected with the EM38 meter in the horizontal (left-hand plot) and vertical (right-hand plot) dipole orientations. In Figure 2, the left-hand plot represents the spatial distribution of apparent conductivity within the upper 30 inches of the soil profile. The right-hand plot represents the spatial distribution of apparent conductivity within the upper 60 inches of the soil profile. In each plot, colors are associated with percentage values that have been aggregated to produce a smooth color gradation across each map. The percentage values are in relation to the minimum and maximum values shown in Table 1.

In the central portion of the left-hand plot, spatial patterns appear to be rectangular (therefore artificial) and could represent the outline of Fort Quiatenon. Three inter-connected structure can be visualized or fantasized. These patterns could represent debris from an occupational event scattered in the surface layers. In the central portion of the right-hand plot, a rectangular (therefore artificial) pattern of very low (less than 3 mS/m) could represent a more deeply buried cultural feature.

2. Although the EM38 meter was acting fitfully, recorded spatial patterns (see Figure 2) appear to reflect cultural features.

3. With the concurrence of the State Conservationist, I would like to complete a GPR survey of the site on my next scheduled visit to the wet-soil monitoring project in Jasper County, Indiana.
