## Appendix E.7 Cultural Resources Report (Redacted)

# INTENSIVE CULTURAL RESOURCE SURVEY OF THE EAST CLEAR CREEK WATERSHED ENVIRONMENTAL ASSESSMENT PROJECT ALTERNATIVES KEITH AND LINCOLN COUNTIES, NEBRASKA

By  
Jason D. Weston, MA, RPA No. 15092

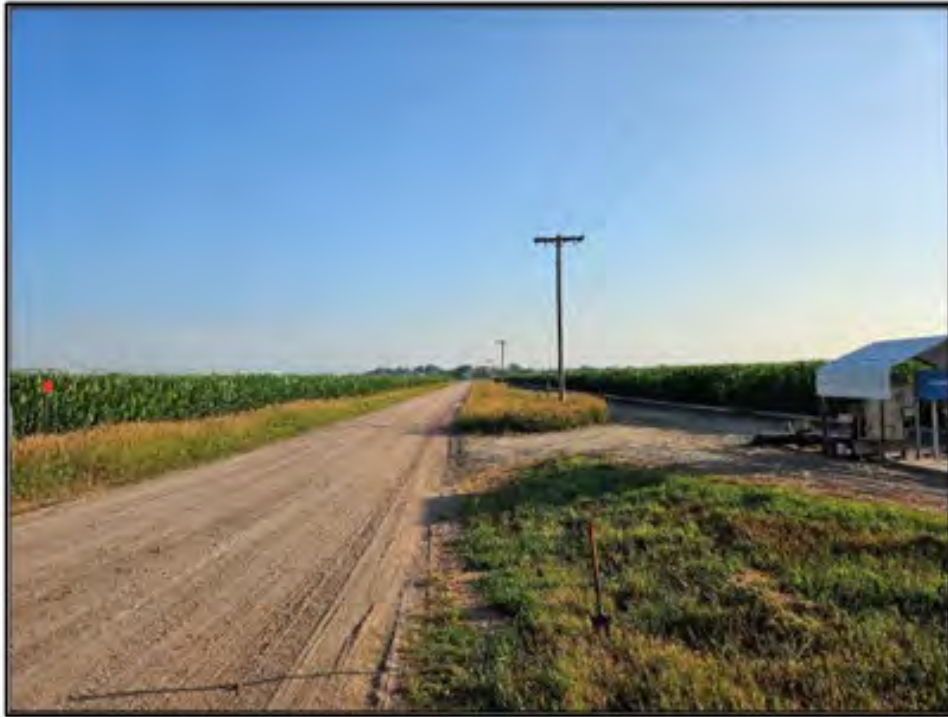
Figure 8. Example of gravel roads, pipe irrigation systems, and engine-powered water pumps. View to the north. Photograph taken on July 19, 2025.

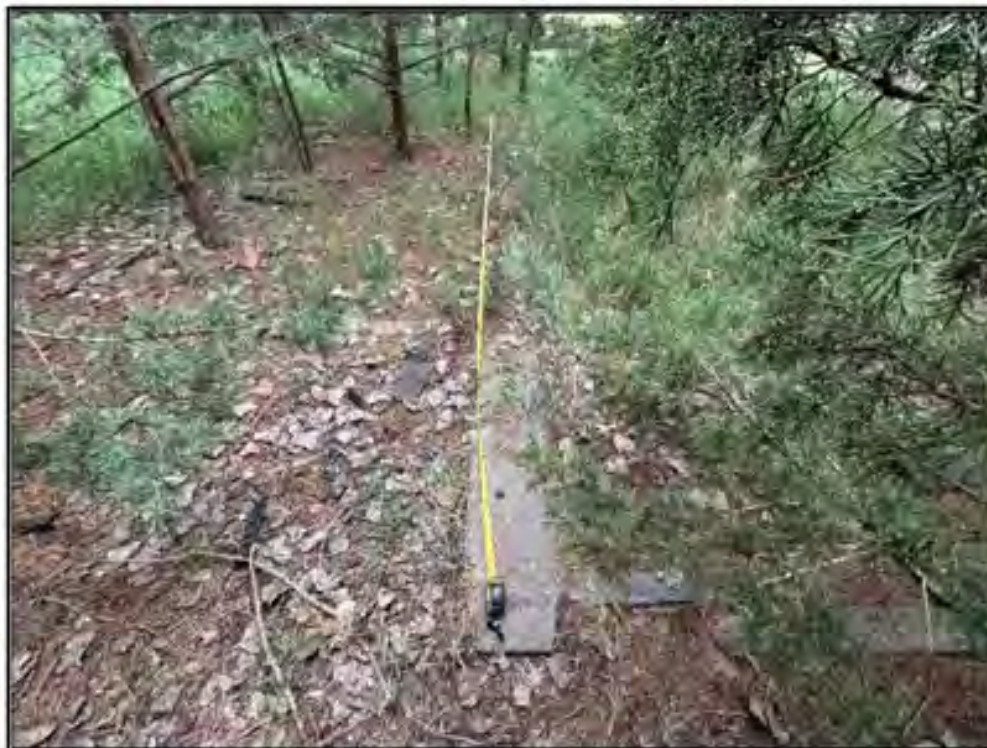
Figure 17. Site 25LN148. Feature 1 house foundation. View to the south from the northeast corner. Tape measure extended to 100 inches (8 ft 4 inches) for scale. Photograph taken by Derrick Maurer on July 16, 2025.

Site 25LN148 includes one concrete foundation (Feature 1), one fallow access road (Feature 2), a subsurface trash deposit (Feature 3), and a partially buried deposit of concrete rubble (Feature 4). Feature 1 is a concrete foundation that is overgrown with cedar trees (Figure 17). The foundation is flush with the ground surface and measures 47 ft 10 inches wide from east to west, and 78 ft 9 inches long from north to south. Shovel Test 6 (ST6) was excavated within the foundation. This shovel test revealed that the foundation extends 15 inches into the ground. No footer was poured to support the foundation, and no basement was present. Artifacts within the shovel test included 33 wire nails, 17 fragments of mortared brick, and 5 shards of clear plate glass (see Table 6). A water pipe riser was present within the foundation perimeter suggesting Feature 1 was a residence.

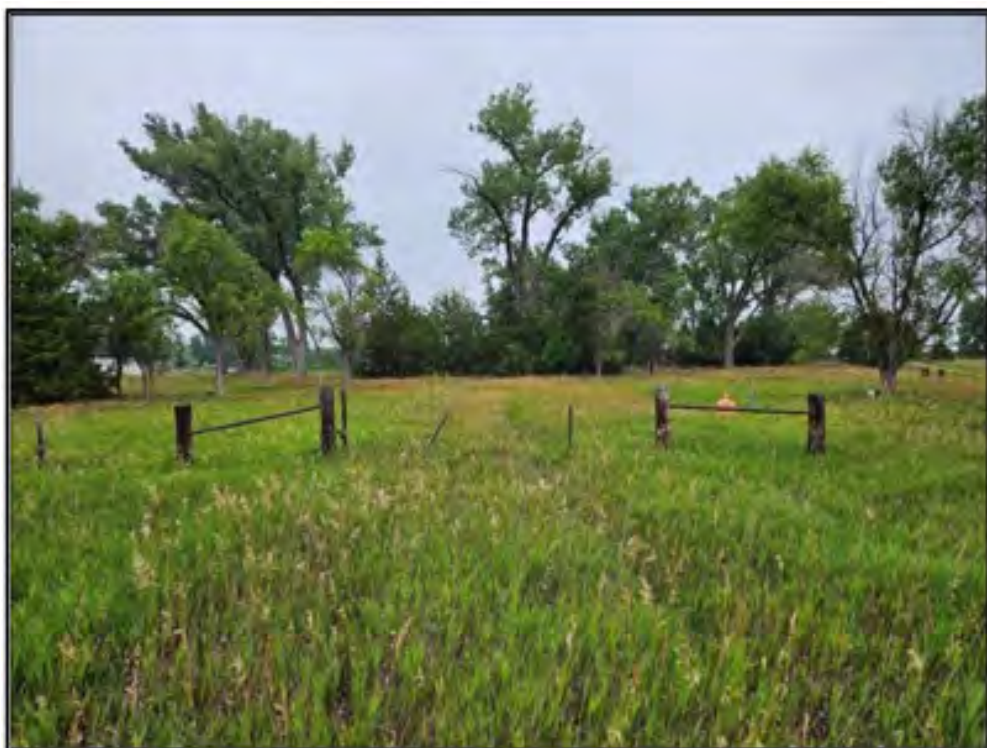
Figure 18. Site 25LN148. Feature 2 fallow raised access road/driveway. View to the east. Photograph taken by Jason Weston on July 16, 2025.

Feature 2 is a fallow access road that was built up approximately 3 ft above the ground surface (Figure 18). This engineered road trends east–west and enters the site from the west side. It is paralleled by a shallow ditch on each side. The road measures 15 ft wide and is within the site boundary for approximately 100 ft.

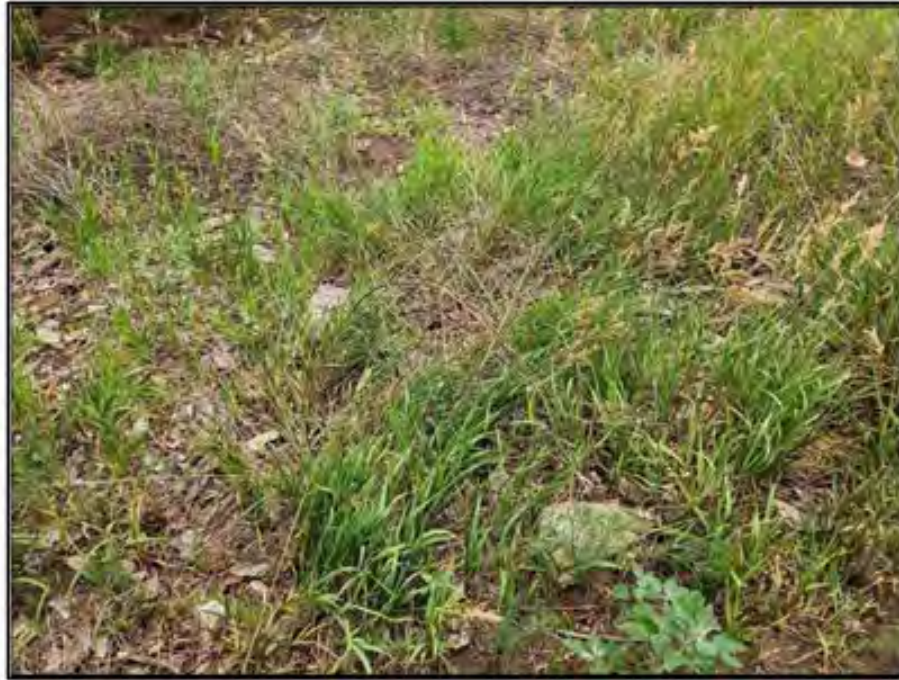
Figure 21. Site 25LN148. Feature 4 partially buried, disarticulated concrete rubble pile. Photograph taken by Jason Weston on July 16, 2025.

Feature 4 is a partially buried, disarticulated pile of concrete foundation fragments (Figure 21). This concrete rubble pile deposit measures approximately 20-x-20 ft.

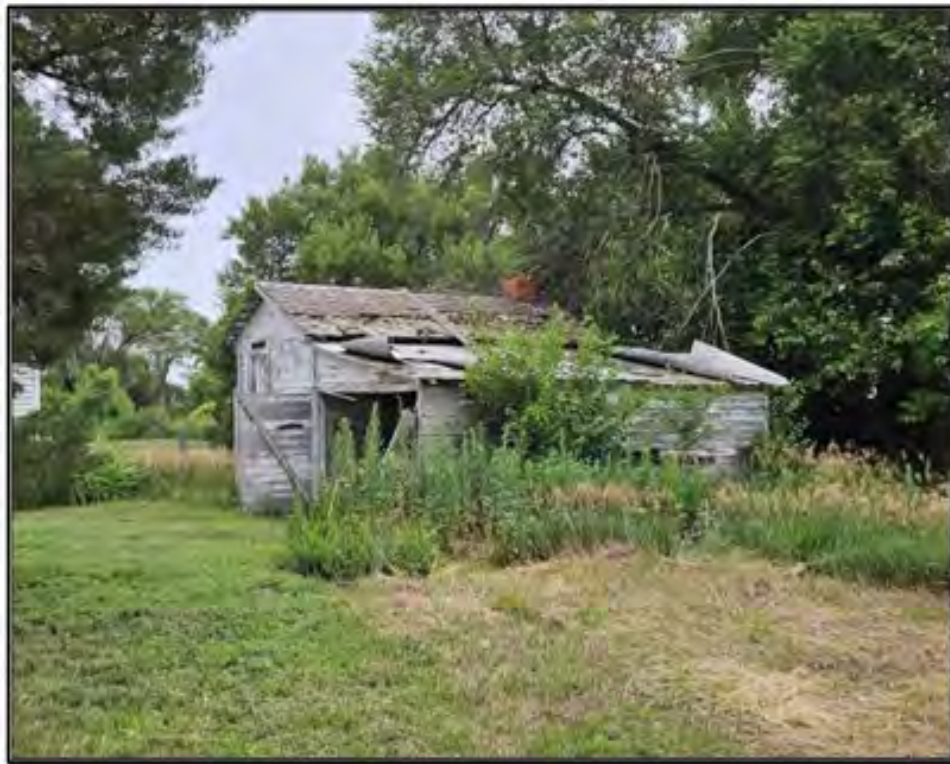
Figure 27. LN00-260. Feature 3 summer kitchen and lean-to addition, facing southwest toward the north and east elevations. Photograph taken on July 18, 2025.

Feature 3 is a summer kitchen that has a lean-to addition on the north side (Figure 27). This feature is west of the house. The primary summer kitchen structure is a single-story, end gabled building measuring 22 ft long and 12 ft wide. The lean-to addition extends the width another 10 ft. This structure is framed with nominal lumber fastened together with wire nails. It retains the original clapboard siding and wood shingle roof. The door is on the west end of the building and a chimney extends from the roof at the east end. The clapboard sided lean-to built on the north side of the summer kitchen has a shed roof covered in corrugated steel. A large hinged door opens on the west side. Feature 3 is in poor condition with flaking white paint, torn and decayed roofing, and decaying walls.

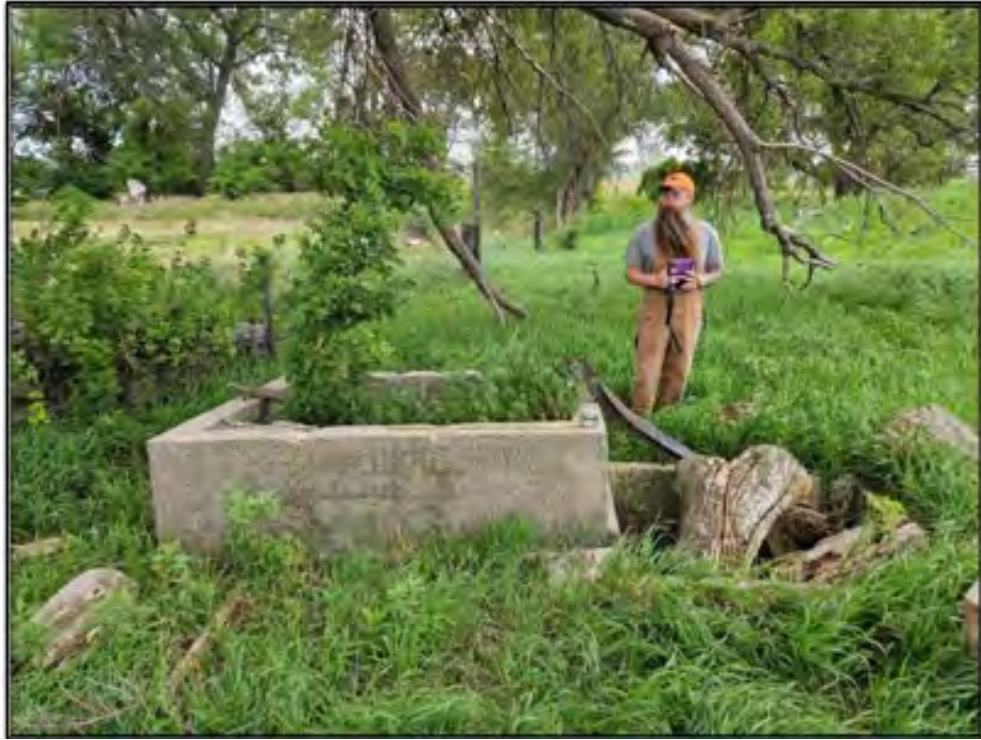
Figure 28. Site LN00-260. Feature 4 concrete water tank and pump house foundation overview looking west with crew member for scale. Photograph taken on July 18, 2025.

Feature 4 is a concrete livestock water tank with a concrete pump house foundation on the north side (Figure 28 and Figure 29). It is located in the pasture on the north side of the fence. The concrete water tank measures 7 ft long and 5 ft 3.5 inches wide. The tank is 2 ft high and the sides are 5 inches thick. A rotten milled lumber board was bolted across the top of the tank along the centerline and has hinges mounted on it indicating the tank had a wood cover. The concrete pump house foundation attached to the north side of the tank measures 5 ft long and 4 ft wide. It rises 6 inches above the ground surface and extends below ground approximately 3 ft. Anchor bolts indicate a structure was once fixed to the foundation.

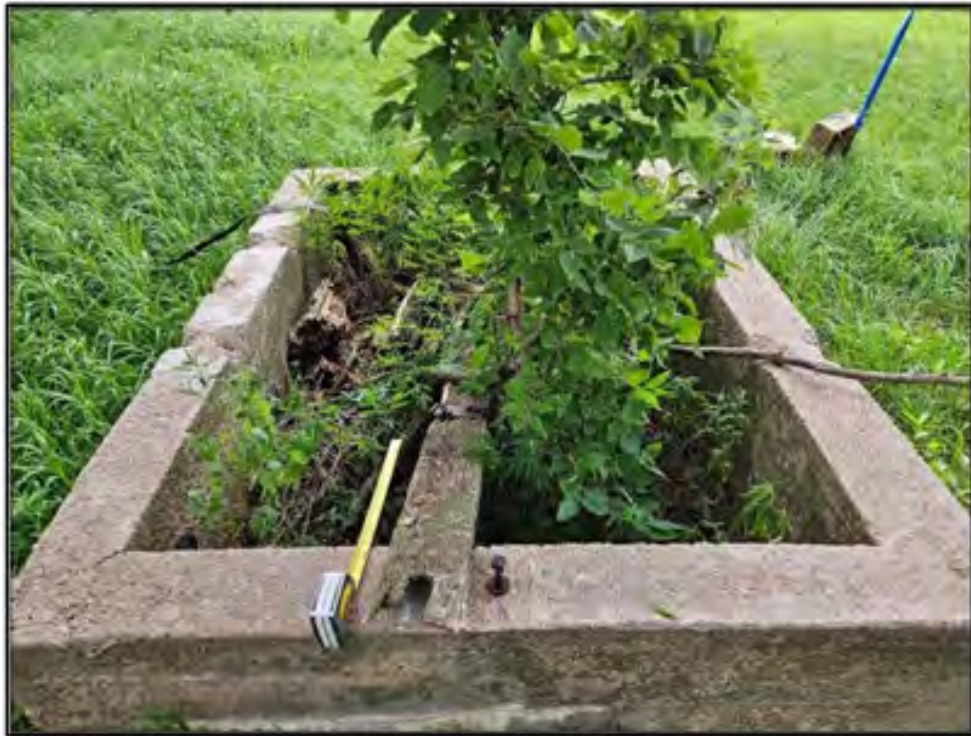
Figure 29. Site LN00-260. Feature 4 concrete water tank detail view looking north. Tape measure extended to 15 inches for scale. Photograph taken on July 18, 2025.

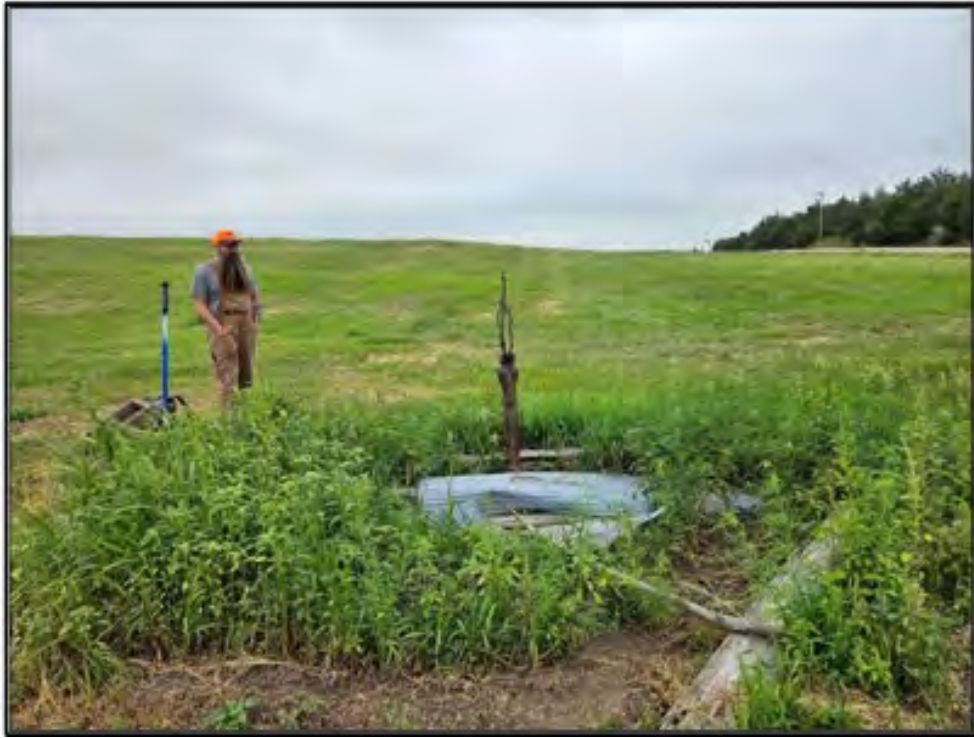
Figure 30. Site LN00-260. Feature 5 water well and pump overview looking east with crew member for scale. Photograph taken on July 18, 2025.

Feature 5 is an old water well enclosed by a poured concrete foundation measuring 4-x-4 ft (Figure 31). This well is located east of Feature 2 and the pasture fence. Wood debris is visible in the well at a depth of approximately 6 ft. The top of the well is covered with corrugated steel roofing. The pump extending out from the well was wind powered. The windmill super structure is missing. The cast iron pump was made by Trahern Pump Company in Rockford Illinois. The Trahern Pump company was founded in 1857 and made water pumps under that name until 1906 when the George D Roper Corporation bought Trahern (Roper Pump Company 2025).

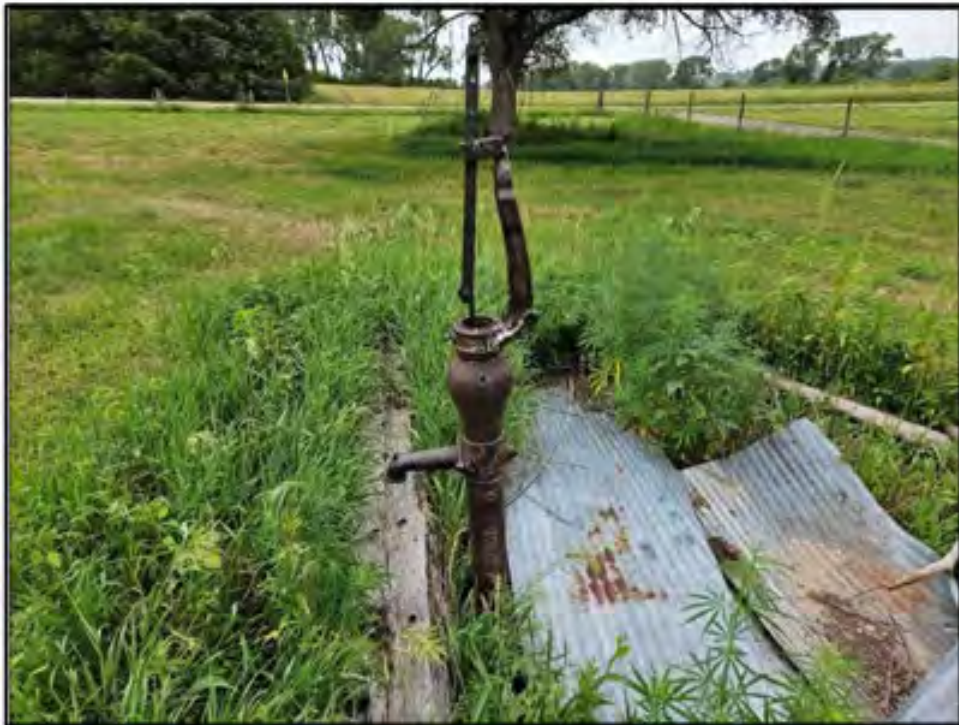
Figure 31. Site LN00-260. Feature 5, overview of the water pump looking south. Photograph taken on July 18, 2025.

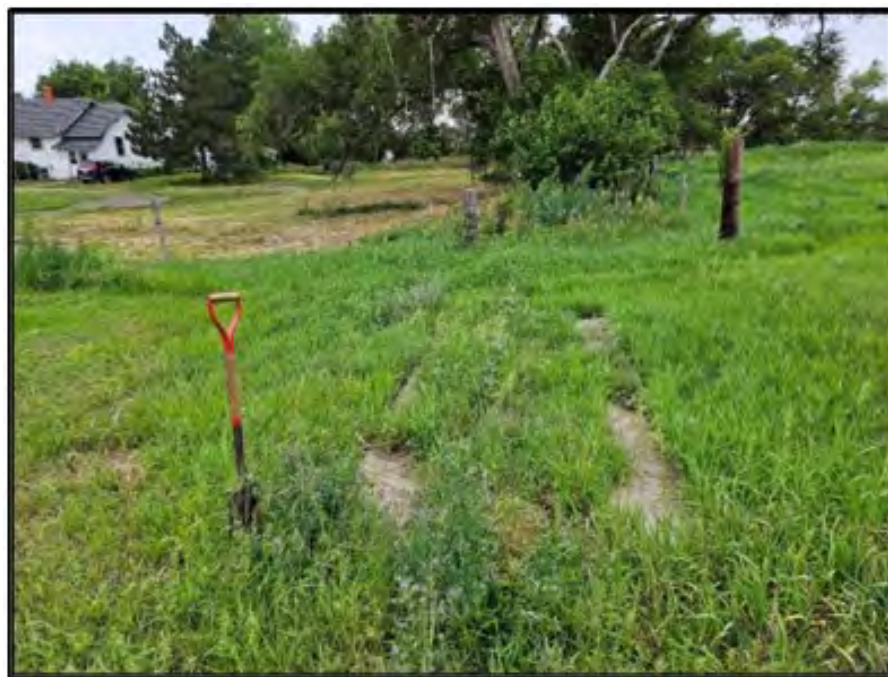
Figure 32. Site LN00-260. Feature 6 concrete foundation looking west. Shovel extending 3 ft above ground for scale. Photograph taken on July 18, 2025.

Feature 6 is a small concrete foundation measuring 12 ft 10 inches long and 5 ft 6 inches wide (Figure 32). It is located east of Feature 4 and north of Feature 5. No super structure anchors are visible, but there is a line of tar around the perimeter of the foundation. The function of this feature is unknown.

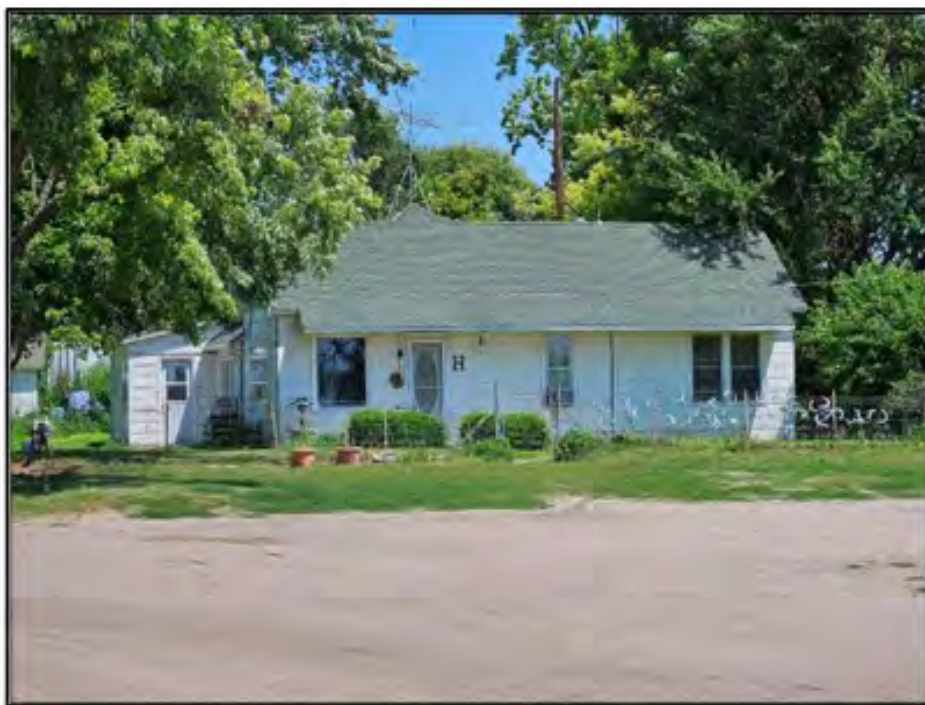
Figure 35. Site LN00-261. Feature 1 house looking north at the south elevation. Photograph taken on July 18, 2025.

Feature 1 is a story and a half house with no discernable architectural style (Figure 35). The house has been added on to multiple times with a side-gabled front and an enclosed porch on the west side. The house is located on the east side of the access road and measures 45 ft long and 42 ft wide. The roof is covered with modern asphalt shingles and a steel television antennae is mounted on the peak. The wood composite siding likely dates to the 1970s and 1980s, but the house appears to be older. The house has single-pane wood windows and aluminum replacement windows. It is painted white with a mint green color painted under the gable on the west end. The primary yard around the house is enclosed by a decorative wire fence with steel posts and a steel gate that are painted silver. This fence is similar to the yard fence at LN00-260 located less than 0.25 mi to the southeast. The fence at Site LN00-261 has been decorated with deer antlers.

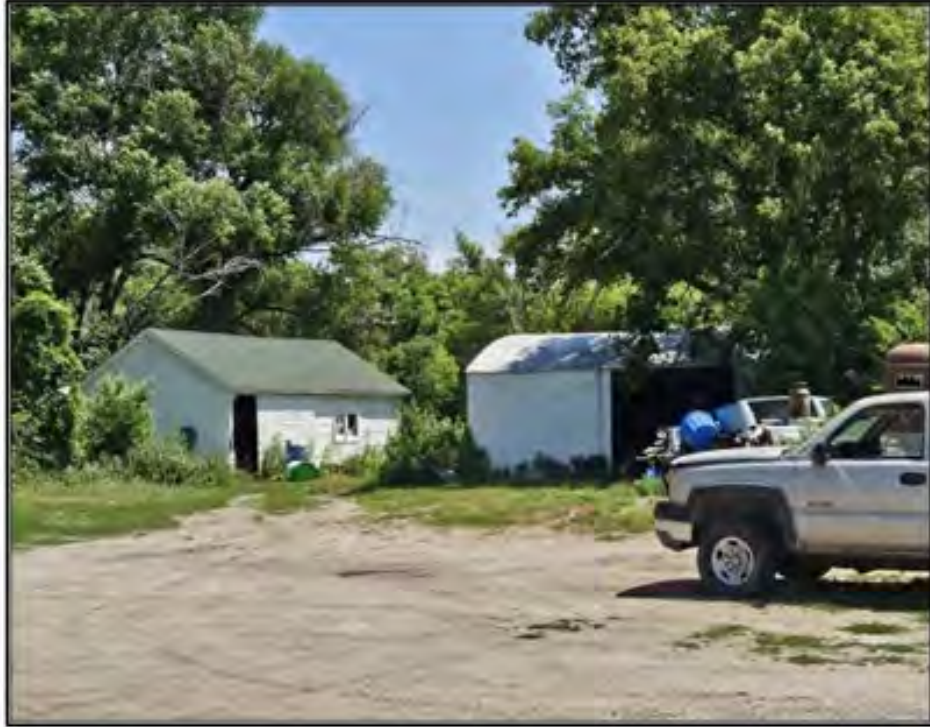
Figure 36. Site LN00-261. Feature 2 a small outbuilding (left side of image) and Feature 3 a storage shed (right side of image). View to the northeast. Photograph taken on July 18, 2025.

Feature 2 is a small single-story, side gabled building measuring 25 ft long and 12 ft wide (Figure 36). This feature is located east-southeast of the house. It is framed with nominal lumber fastened together with wire nails. Feature 2 has the original clapboard siding with a modern asphalt shingle roof. A sliding door and a broken window are in the south-facing wall. The building is painted white and has a power line running to it. It currently appears to be used for storage.

Feature 3 is a single-story, side gabled storage shed measuring 44 ft long and 20 ft wide (see Figure 36). This feature is located east-southeast of the house, to the south of Feature 2. There are sliding doors on the west side, and the roof is curved and covered in corrugated steel.

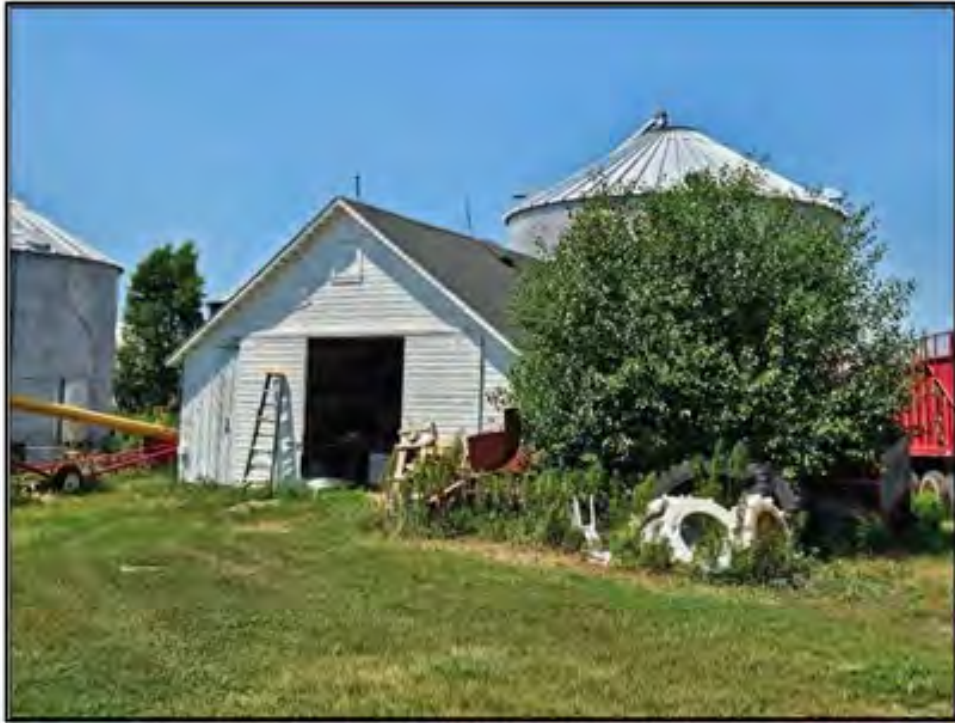
Figure 37. Site LN00-261. Feature 4 barn or enclosed corncrib looking southwest. Note modern steel grain bins (Feature 14 at right and Feature 16 at left). Photograph taken on July 18, 2025.

Feature 4 is a story and a half barn or enclosed corncrib measuring 32 ft long and 30 ft wide (Figure 37). This building is located southwest of the house. This structure is framed with nominal lumber fastened together with wire nails. There are two sliding wood doors on the east side with a small window centered above the doors. Part of the shed is clapboard sided, and the other part is board-and-batten sided. The roof is modern asphalt shingles. The building is painted white and has a power line running to it. It currently appears to be used for storage.

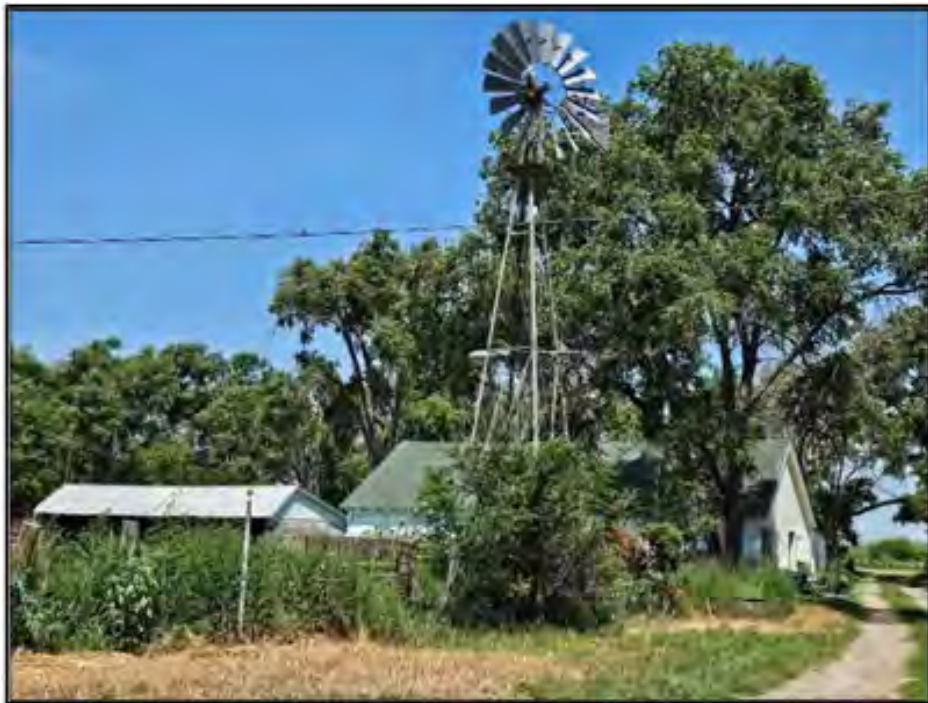
Figure 38. Site LN00-261. Overview of Feature 5, the Aermotor windmill circa 1915–1968. View to the northwest. Photograph taken on July 18, 2025.

Feature 5 is a steel legged windmill located across the access road from the house (Figure 38). The wind vane on the mill reads “The Aermotor Co. Chicago.” The windmill motor is a self-oiling type. Aermotor began making self-oiling mills in 1915 (Aermotor 2019). The manufacturer operated under the name “The Aermotor Company” until 1969 when it became a subsidiary of several other companies and briefly moved its manufacturing operations to Argentina. With the original company name branded on it, this mill was manufactured sometime between 1915 and 1968.

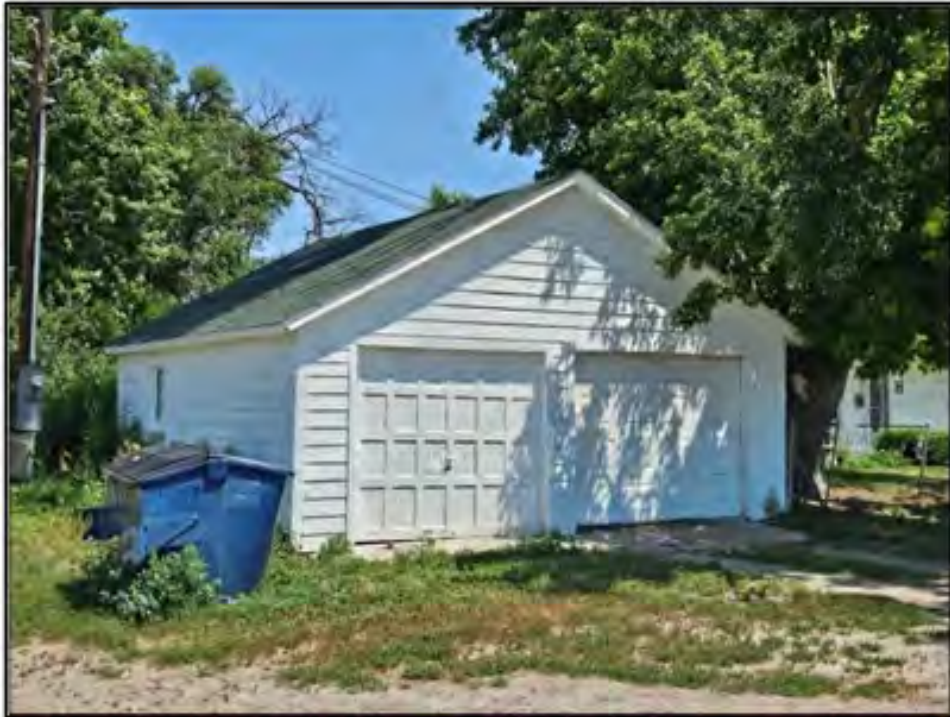
Figure 39. Site LN00-261. Feature 6 automobile garage looking northeast at the south and west elevations. Photograph taken on July 18, 2025.

Feature 6 is a single-story, two-car garage measuring 30 ft long and 22 ft wide (Figure 39). It was built immediately southwest of the house yard fence. It has the same late twentieth-century siding as the house with a modern asphalt shingle roof. There is one single pane wood window on the west side. The car doors are on the south side. One is an older door made from wood panels, and the other is a modern vinyl garage door. The garage is painted white.

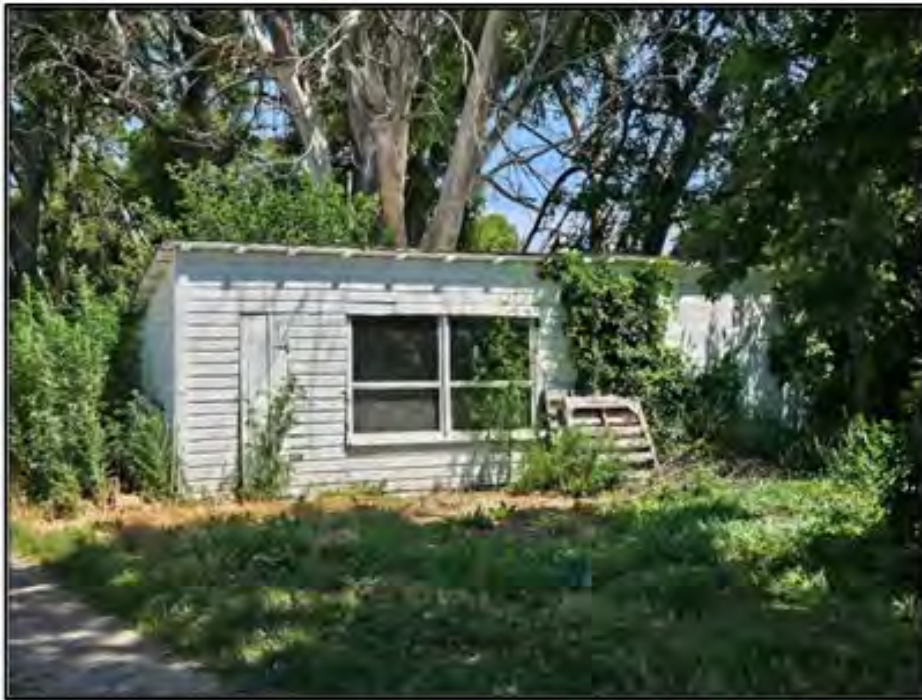
Figure 40. Site LN00-261. Feature 7 chicken house looking north at the south elevation. Photograph taken on July 18, 2025.

Feature 7 is a single-story chicken house measuring 30 ft long and 12 ft wide (Figure 40). It is located northwest of the house. This structure is framed with nominal lumber fastened together with wire nails. It is clapboarded sided with a corrugated steel shed roof. The roof rafters are visible under the eaves. Large windows are on the south side of the structure along with a narrow wood door. The building is painted white.

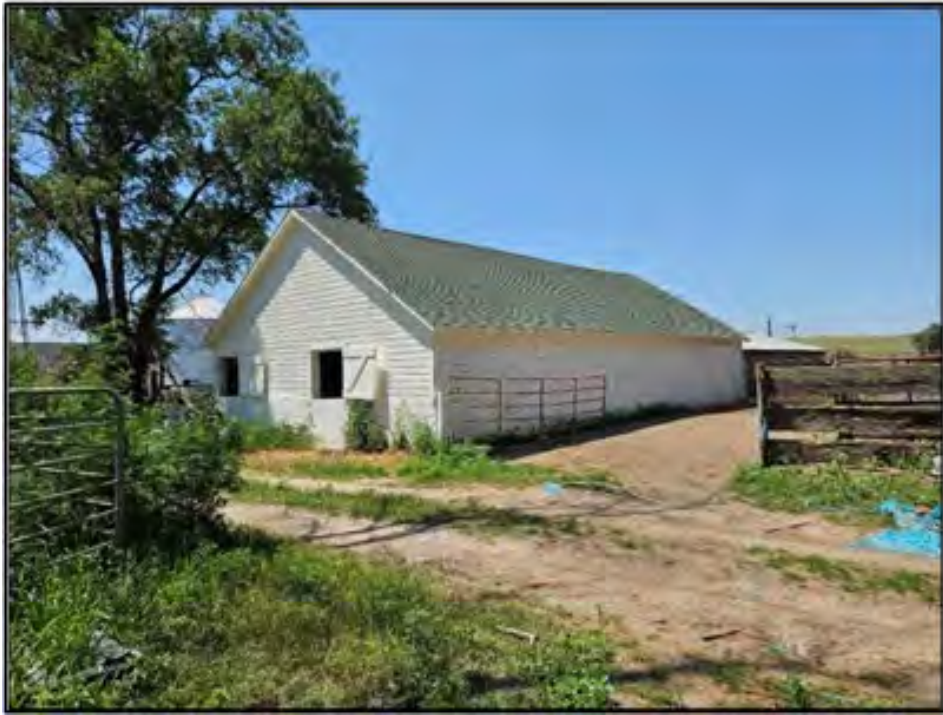
Figure 41. Site LN00-261. Feature 8 livestock barn looking southwest at the north and east elevations. Note Feature 9 to the right of the livestock barn. Photograph taken on July 18, 2025.

Feature 8 is a well-maintained livestock barn measuring 52 ft long and 28 ft wide (Figure 41). This building is located to the northwest of the house on the west side of the access road. This story and a half-end gabled barn is framed with nominal lumber fastened together with wire nails. It has the original clapboard siding with a modern asphalt shingle roof. There are two Dutch doors on the east side, and a sliding door in the northwest corner on the north side. The building rests on a concrete foundation that rises approximately 3 ft high. The roof rafters are visible under the eaves. The building is painted white and is in good condition.

Feature 9 is a modern cement block shed built immediately west of Feature 8. This building measures approximately 40 ft long and 22 ft wide. The structure is open on the south side and has an asymmetrical roof covered in corrugated steel (See Figure 41).

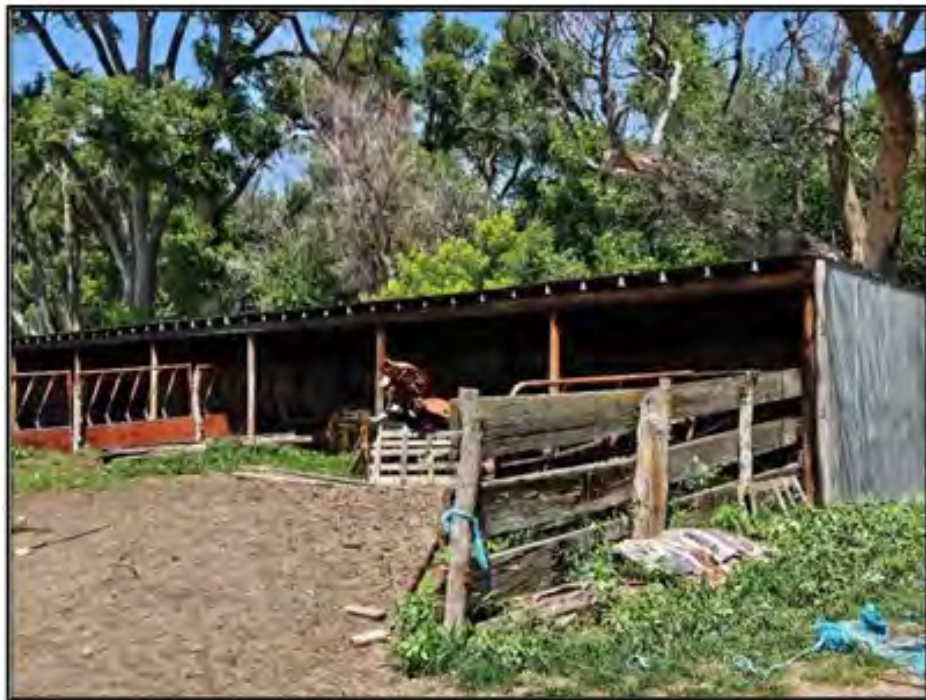
Figure 42. Site LN00-261. Feature 10 modern pole and frame livestock shed. View to the northwest. Photograph taken on July 18, 2025.

Feature 10 is a modern pole and frame livestock shed open on the south side. The shed measures 134 ft long and 17 ft wide and is located north of the Feature 8 barn. The walls and roof are enclosed with corrugated steel (Figure 42).

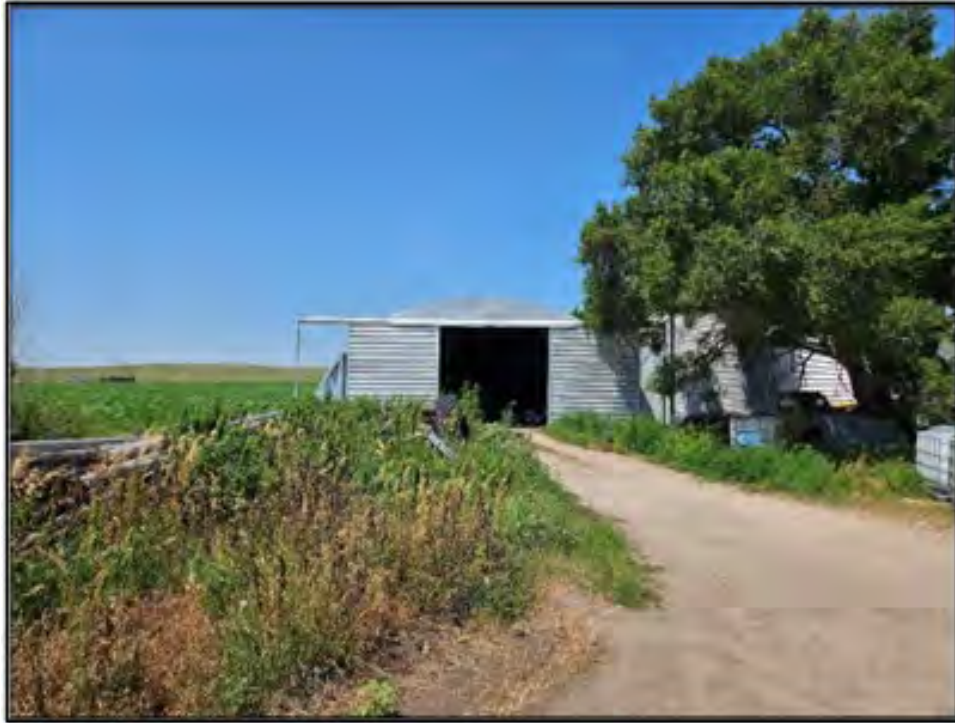
Figure 43. Site LN00-261. Feature 12, modern steel Quonset storage building looking west at the east elevation. Photograph taken on July 18, 2025.

Feature 12 is a modern steel Quonset storage building measuring 102 ft long and 45 ft wide. It rests on a concrete slab foundation and has two large sliding doors on the east end (Figure 43).

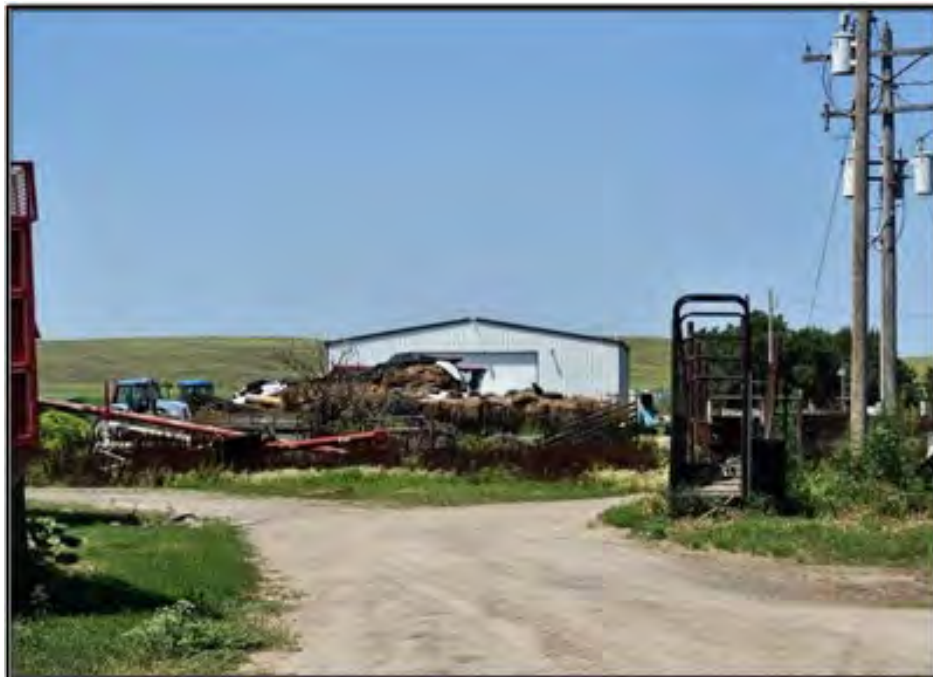
Figure 44. Site LN00-261. Feature 13, modern steel machine shed and storage building looking west at the east elevation. Photograph taken on July 18, 2025.

Feature 13 is a modern steel machine shed and storage building located west of the Feature 4 corncrib/barn structure. This modern white steel building has a large bay door on the east side and measures 62 ft long and 62 ft wide (see Figure 44).

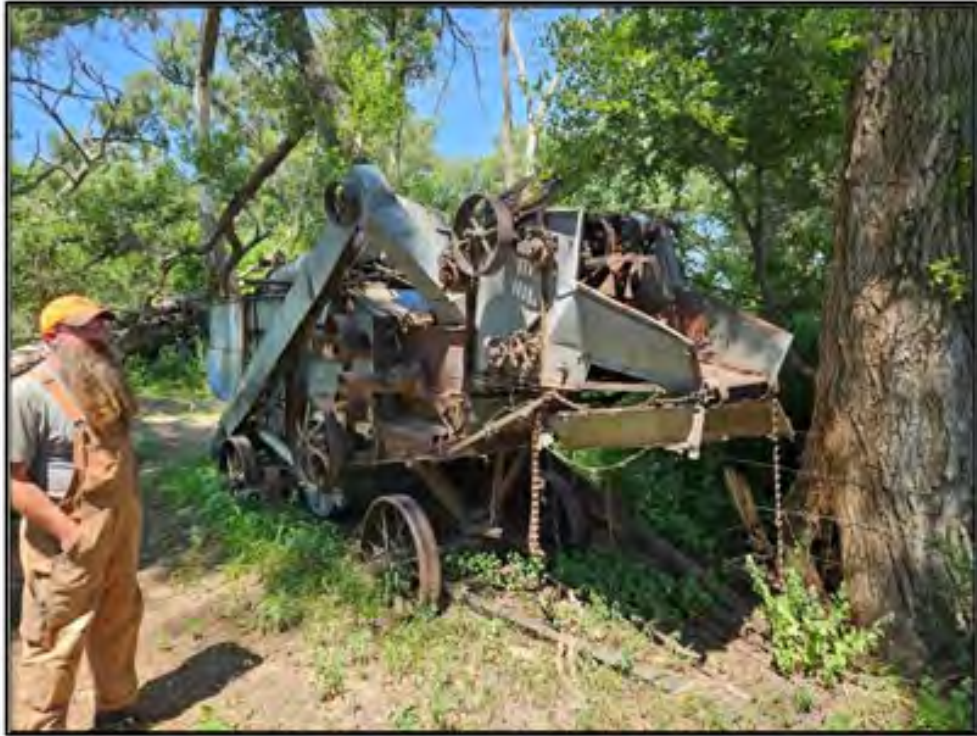
Figure 45. Site LN00-261. Overview of the Red River Special Line thresher circa 1915–1929 with crew member for scale. View to the northeast. Photograph taken on July 18, 2025.

The farm equipment in the trees in the northern portion of the site includes a variety of horse drawn farm implements. This location appears to be a fallow feed lot which extends east to Birdwood Creek near the diversion dam for the Birdwood Canal. An irrigation memorandum dating to 1942 noted that the landowner of this property (Mr. Welch) was planning on building a feedlot in this area (Kimmel 1942). This infers the fallow feed lot dates to sometime shortly after 1942. Field Specimen 1 (FS1) is a horse drawn thresher (Figure 45). The name plate on the thresher identifies it as a Red River Special Line model made by Nichols & Shepard Company. This all-steel model of thresher was produced beginning in 1915 for use with steam-powered engines, and later gasoline powered engines. Nichols & Shepard produced these threshers until they merged with the Oliver Farm Equipment Company in 1929 (Wendel 2022). FS2 is a horse-drawn hay rake with steel wheels and no identifiable maker's mark. FS3 is a horse-drawn sickle mower with the International Harvester Logo embossed on its parts (Figure 46). The International Harvester Company was founded in 1902 through a merger of McCormick and Deering (Hoover 2019). FS4 is a horse-drawn reaper-binder made by the John Deere Company (Figure 47). John Deere began making reaper-grain binders in 1910 (Percival 1955). Horse-drawn farm implements were manufactured and commonly used until tractor pulled equipment was developed in the 1920s and became commonly affordable in the 1930s and 1940s. FS5 and FS6 are early tractor-pulled plows. FS4 has the International Harvester Company logo cast into the iron and dates to sometime after the 1920s. FS7 is a horse-drawn wooden wagon truck with steel wheels. The wagon box is not present, and the truck is decayed and broken into pieces.

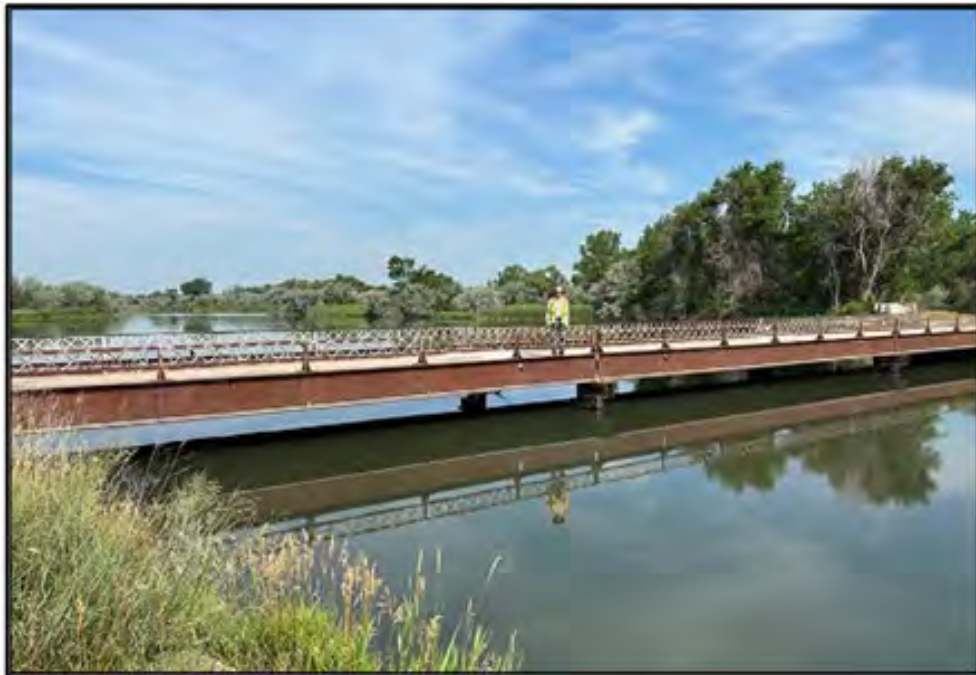
Figure 49. Site KH00-104. Overview of the bridge looking northwest with crew member for scale. Photograph taken on July 19, 2025.

This historic bridge is located within the floodplain of the North Platte River. This low bridge spans the river from north to south. Sediment is alluvial loam to silt loam. Sand Road, a county gravel road ends at the bridge. Vegetation is primarily grasses and mixed deciduous trees with 40 percent bare ground in the vicinity of the bridge. Existing disturbances include continued use, erosion, structural decay, and maintenance. This site measures approximately 52-x-9 m, covering 468 sq m of privately owned land (Figure 1d; Figure 48 and Figure 49) .

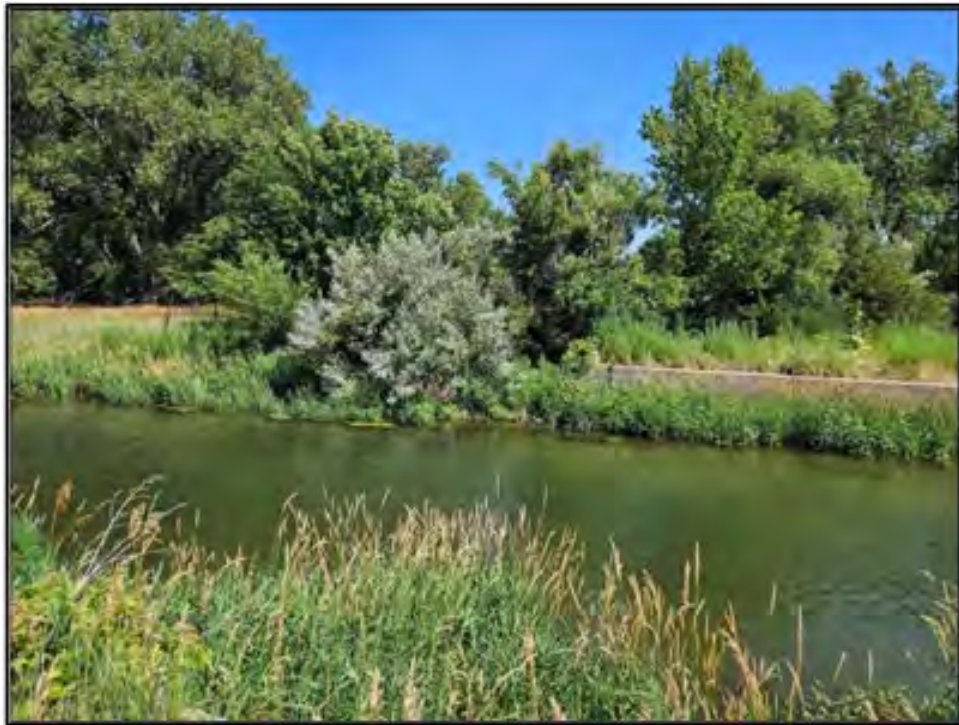
Figure 52. Keith Lincoln Canal: Feature 1 the overgrown return gate. View to the north.. Photograph taken on July 15, 2025.

Feature 1 is a side channel or return gate that is partially plugged with sediment and vegetation (Figure 52). The gate structure is not visible, or is no longer present. The gate empties water into a north flowing side channel and is flanked by concrete wing walls. The western wing wall is curved and measures 18.5 ft long, 6 inches thick, and is at least 3 ft high. The eastern wing wall is straight and measures approximately 44 ft long and 6 inches thick, rising 3 ft above the canal waterline.

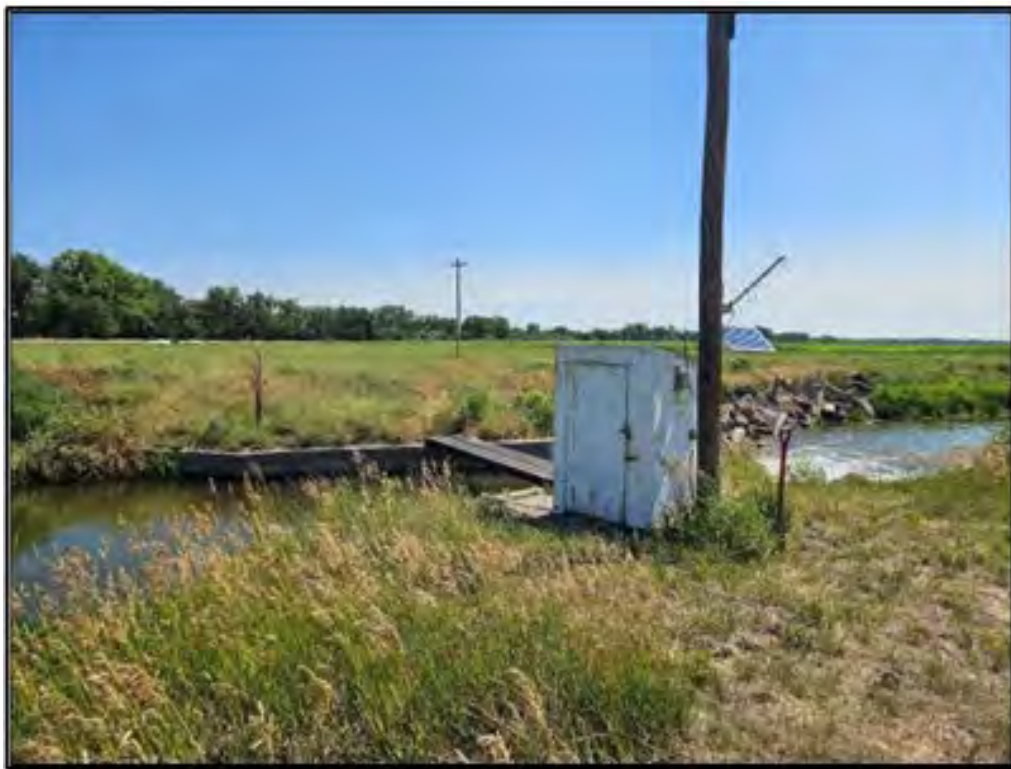
Figure 53. Keith Lincoln Canal: Feature 2, gaging station. View to the north. Photograph taken on July 15, 2025.

Feature 2 is a gaging station consisting of a small steel shed, concrete abutment walls, and a concrete drop structure crossed by a milled lumber plank access platform (Figure 53). The shed measures approximately 5.5 ft tall, 4 ft long and 3 ft wide. The gaging instrumentation is locked behind the sheet steel door. A radio control transmitter/receiver is mounted on the side of the shed and is connected to an antennae and solar panel. The shed is painted white. Renovations to the canal were conducted in the 1960s and mid-1970s, and this structure is consistent with a mid- to late twentieth-century date.

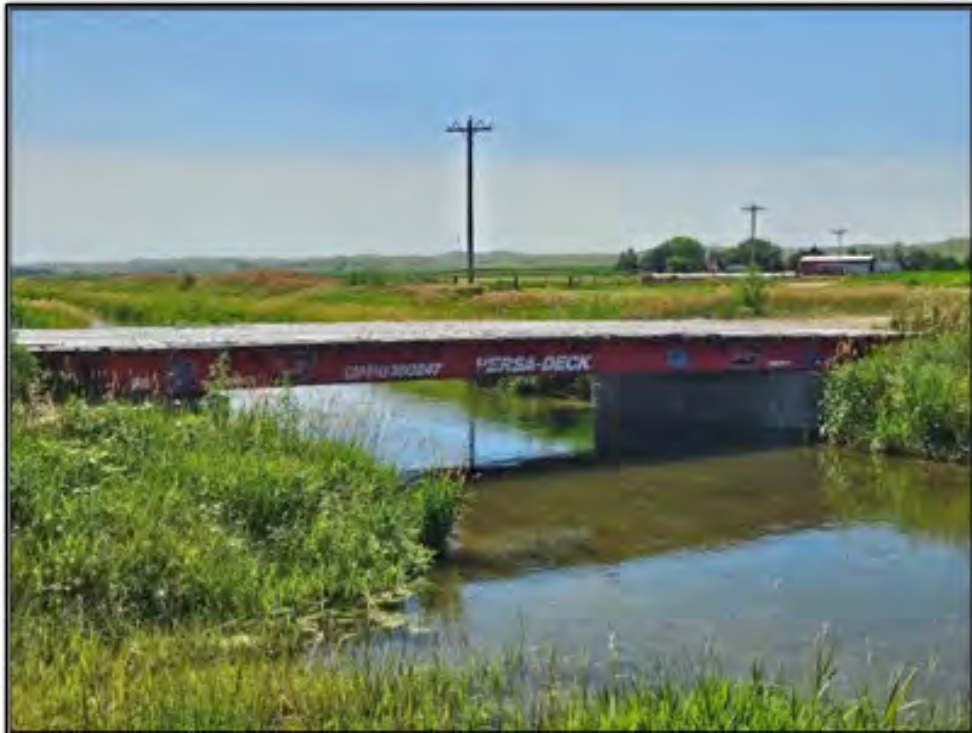
Figure 54. Keith Lincoln Canal: Feature 3, modern vehicle bridge. View to the southeast. Photograph taken on July 15, 2025.

Feature 3 is a vehicle bridge built across the canal (Figure 54). The bridge is based on steel-I beam stringers and is a “Versa-Deck” bridge base made by the Burlington Northern Railroad. This steel deck has been covered with thick milled lumber planks overlaid with steel sheeting. It is a single span bridge that rests on concrete abutments and measures 45 ft long and 20 ft wide. This structure is likely less than 50 years old.

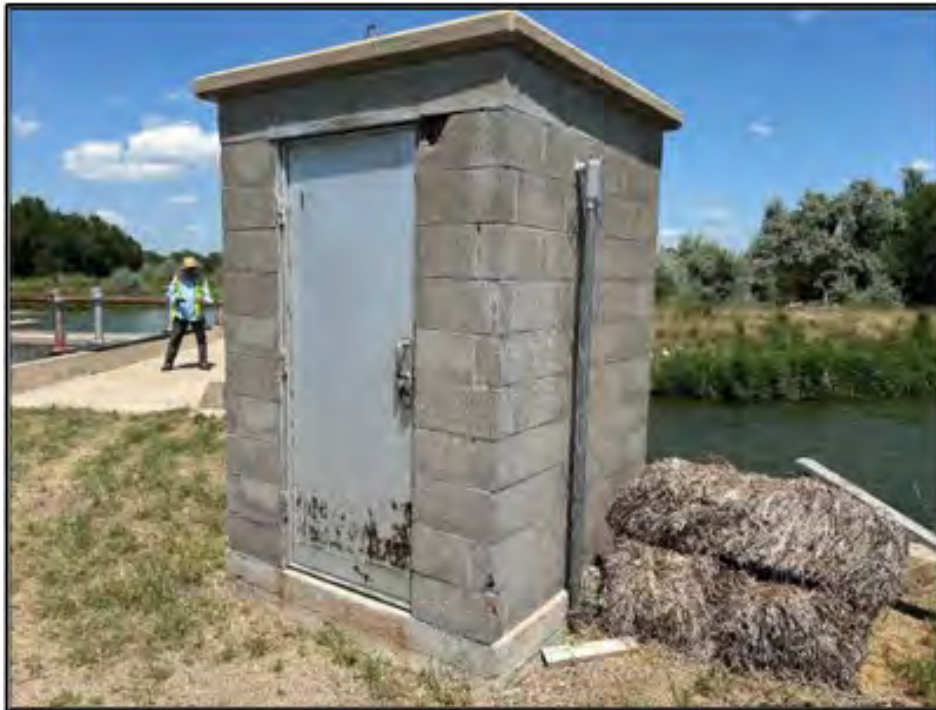
Figure 55. Keith Lincoln Canal: Feature 4, the diversion dam control shed. View to the north. Photograph taken on July 15, 2025.

Feature 4 is the control shed for the diversion dam water control gates (Figure 55). This control shed is made of concrete blocks built on a concrete slab foundation with a concrete slab roof. Power is supplied by a buried electric cable. The locked steel door is on the west side of the small structure. The door is painted gray and there are traces of sliver paint on the concrete block walls. Renovations to the canal were conducted in the 1960s and mid-1970s, and this structure is consistent with a mid- to late twentieth-century date.
