## Appendix E.7 Cultural Resources Report (Redacted)

# INTENSIVE CULTURAL RESOURCE SURVEY OF THE EAST CLEAR CREEK WATERSHED ENVIRONMENTAL ASSESSMENT PROJECT ALTERNATIVES KEITH AND LINCOLN COUNTIES, NEBRASKA

By  
Jason D. Weston, MA, RPA No. 15092

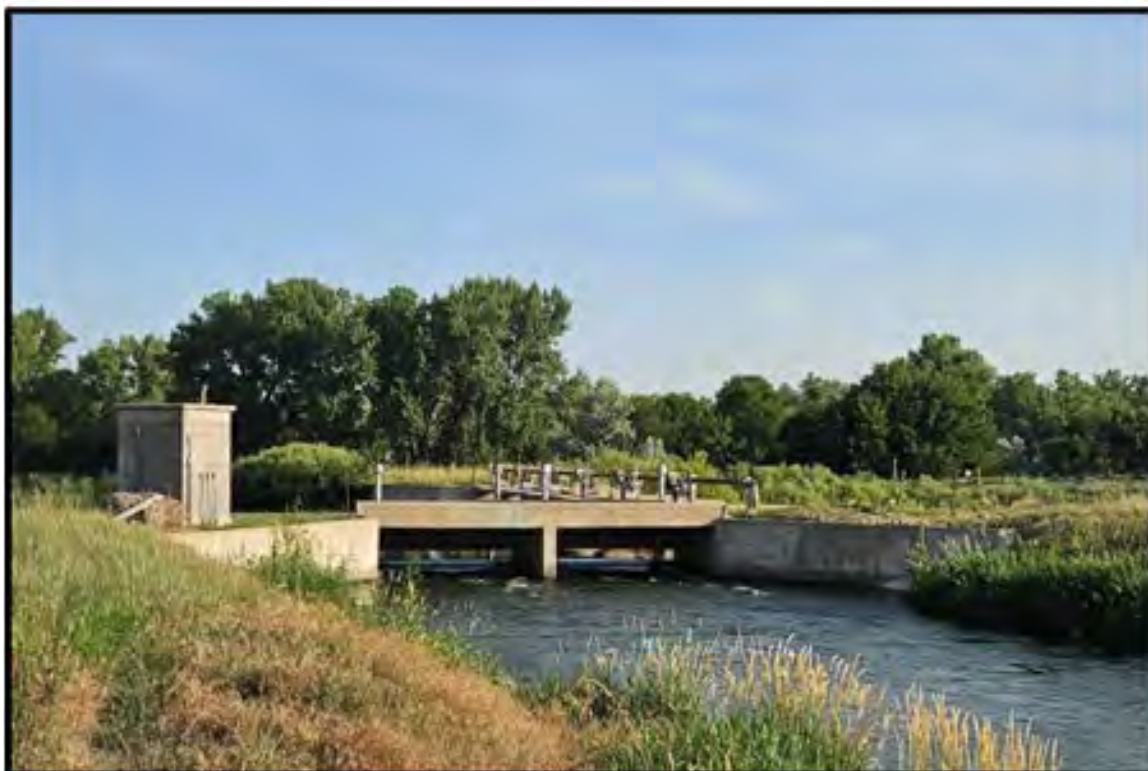
Figure 56. Keith Lincoln Canal: Feature 5, headgate. View to the north. Photograph taken on July 15, 2025.

Feature 5 is the headgate which was rebuilt in the mid-1970s (Irrigation Leader 2025) (Figure 56). It is located on the south bank of the North Platte River immediately upstream of the diversion dam. The headgate is a concrete structure with a 27 ft long and 8 ft wide access platform spanning two water control gates. The concrete sidewall on the river side of the headgate measures 35 ft long. The downstream sidewalls are each approximately 24 ft long. The apron is estimated to be 10 ft wide. The gates are opened and closed by hand-operated equipment. The current headgate is not original to the canal. A report on the headgate in 1912 described the original headgate as a wooden structure, and that plans were being made to replace it with a concrete structure (State Board of Irrigation, Highways, and Drainage 1912). The current headgate is the third version of this structure. The engineer’s certificate for the current headgate was filed in 1974 and indicates that the current headgate is located 1,668.8 ft east of the original location (State of Nebraska Department of Water Resources 1974). The length of canal between the original intake and current headgate location was abandoned (Figure 57).

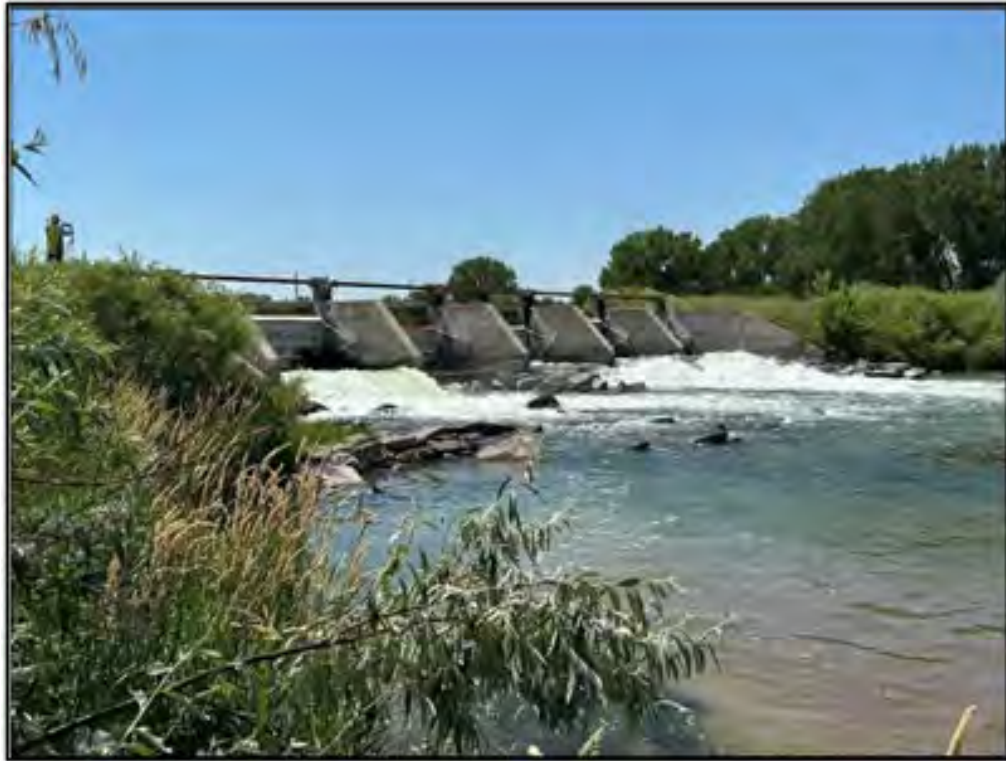
Figure 58. Keith Lincoln Canal: Feature 6, diversion dam overview. View to the southwest. Photograph taken on July 15, 2025.

Feature 6 is the diversion dam. It measures approximately 130 ft long and 24 ft wide, including the downstream apron (Figure 58 and Figure 59). The dam has a 4 ft wide concrete access platform with no railings spanning its entire length from riverbank to riverbank. This dam has six cells separated by intermediate concrete support piers. Each cell houses one curved (radial) steel water gate. The gates are partially automated by retrofitted motors that power a wire winch system. Concrete riprap has been placed downstream of the dam to address erosion issues along the sidewalls. The water control gates and motors date to the 1960s or 1970. As with the headgate, the current diversion dam is downstream from the original dam and would have been relocated around 1974 when the original intake of the canal was abandoned.

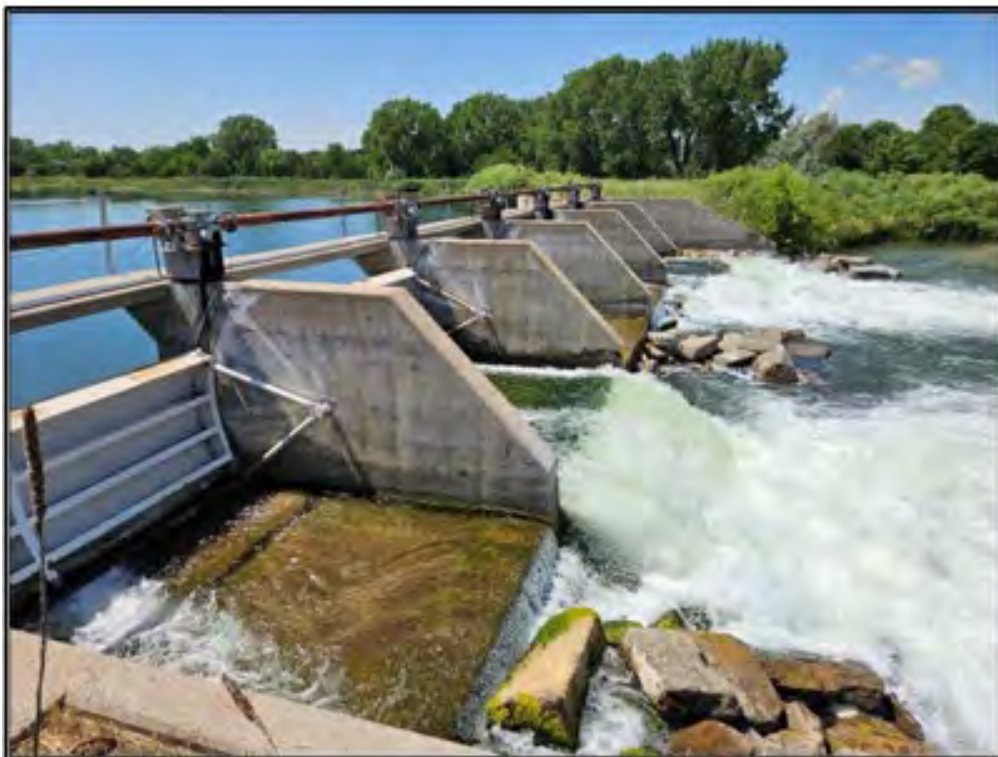
Figure 59. Keith Lincoln Canal: Feature 6, diversion dam radial water gates and access platform with crew member for scale. View to the northwest. Photograph taken on July 15, 2025.

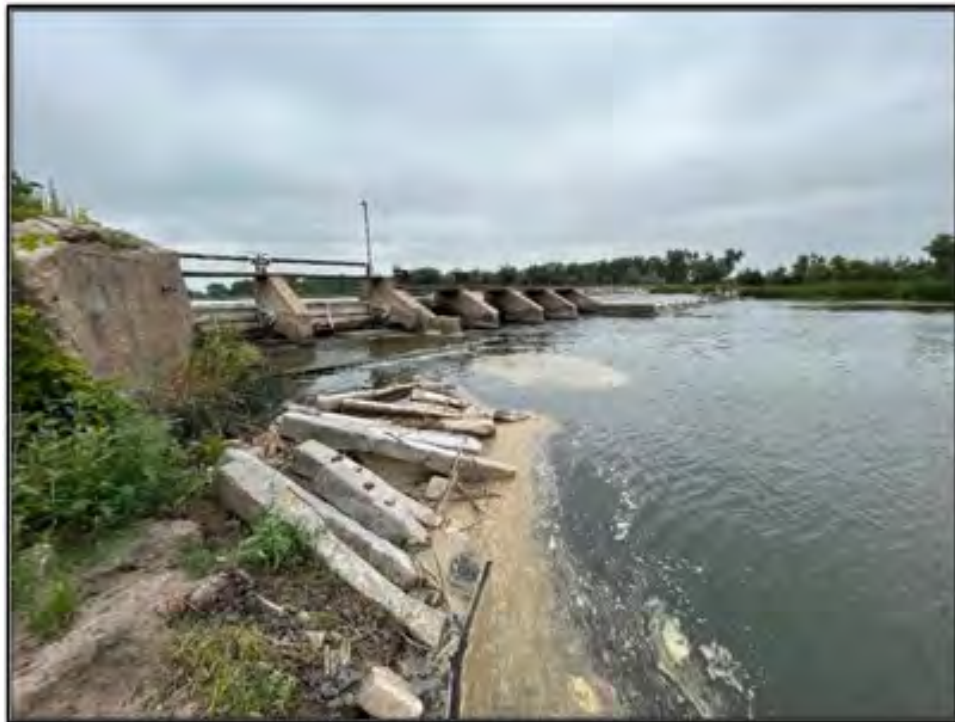
Figure 62. North Platte (Platte Valley) Canal: Feature 2 diversion dam overview, looking west. Photograph taken on July 16, 2025.

1914. Concrete riprap has been placed downstream of the dam slipway to address erosion issues. The dam has cracked and spalled concrete that is patched in places, but is still leaking. The sidewalls, retaining walls, and apron exhibit damage.

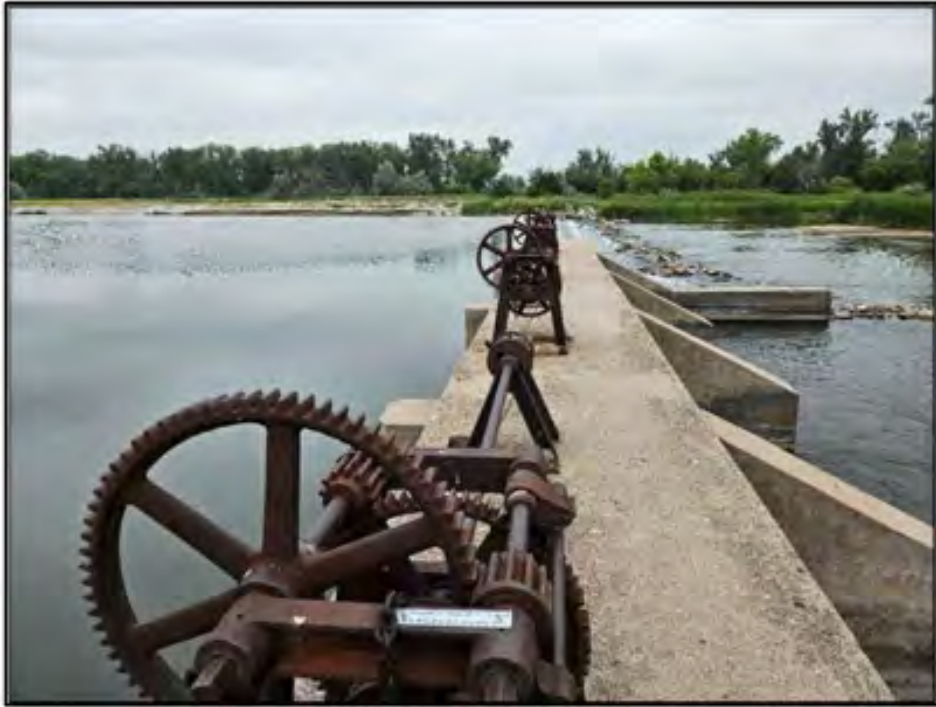
Figure 63. North Platte (Platte Valley) Canal: Feature 2 diversion dam, looking north along the top of the access platform with the hand operated gate equipment mounted on the platform. Photograph taken on July 16, 2025.

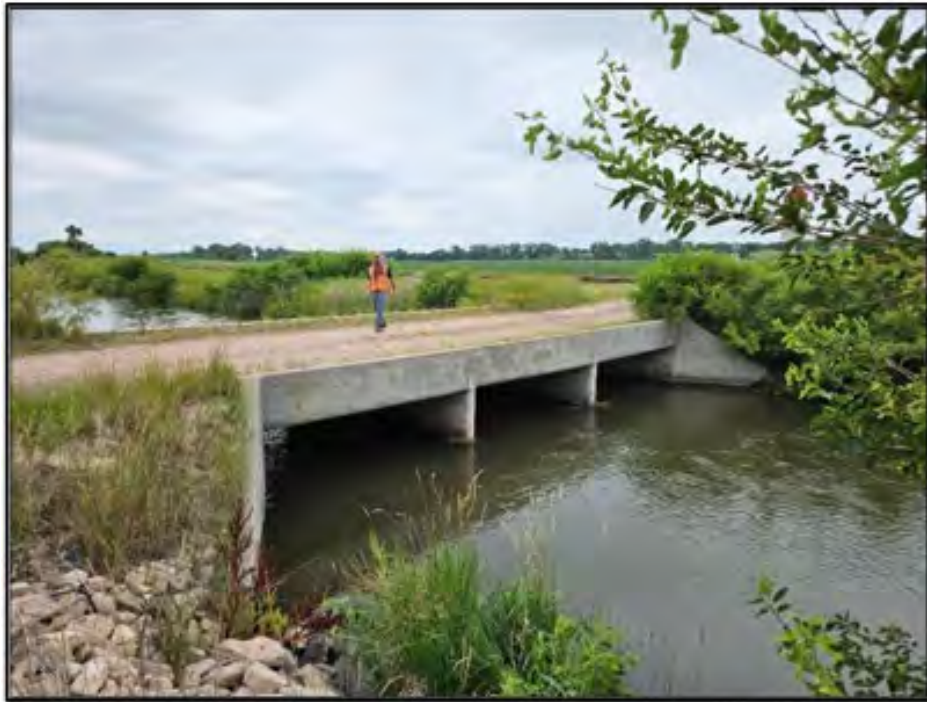
Figure 64. North Platte (Platte Valley) Canal: Feature 3 concrete vehicle bridge built in 1991 with crew member for scale. View to the east. Photograph taken on July 16, 2025.

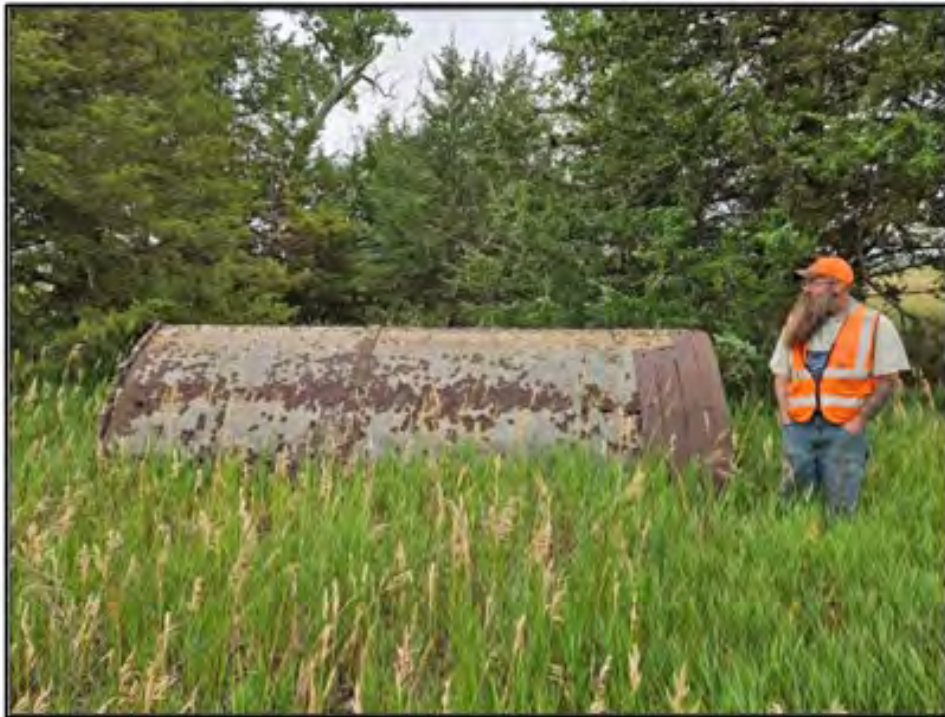
Figure 66. North Platte (Platte Valley) Canal: FS2, discarded radial gate with crew member for scale. View to the south. Photograph taken on July 16, 2025.

West of Feature 1 is a modern office trailer (FS1) mounded on a wheeled steel beam chassis. It measures 20 ft long, 8 ft wide, and likely dates to the 1980s or later (Figure 65). FS2 located 134.5 ft (41 m) south of the trailer, is a discarded curved steel water gate (Figure 66). The gate is severely pitted and damaged by rust. It was patched with steel straps to prolong its use before finally being removed from the dam and replaced. The original components of the gate are riveted together rather than welded indicating it likely pre-dates World War II.

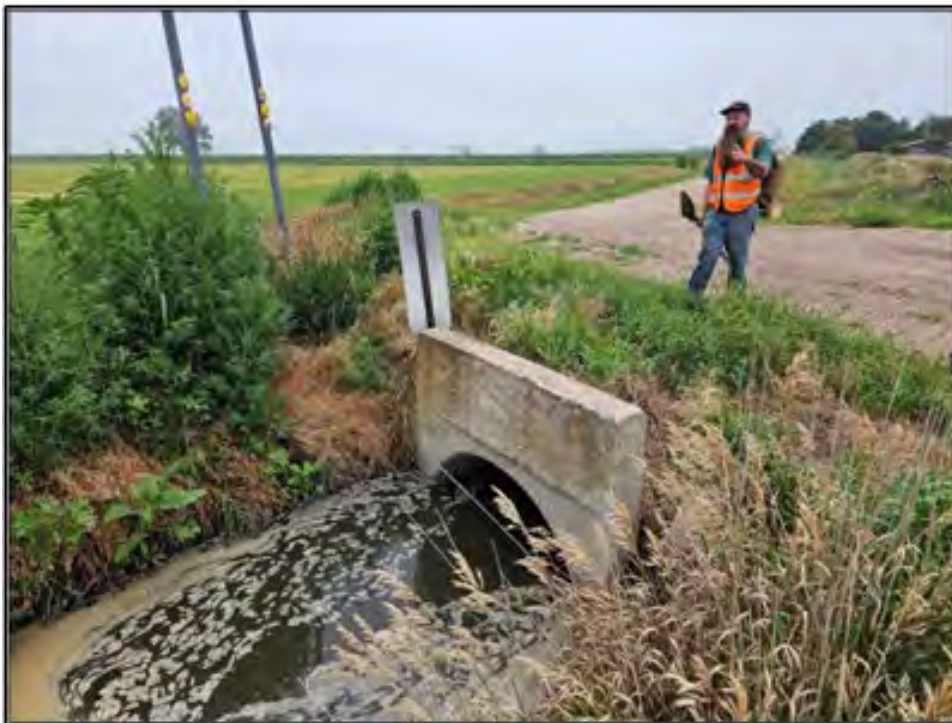
Figure 68. North Platte (Platte Valley) Canal: Feature 4 concrete culvert passing under the county road. Crew member for scale. View to the south-southeast. Photograph taken on July 21, 2025.

Segment 2 is situated within the access road corridor of the Cody-Dillon inventory parcel. In this area the canal is located within the floodplain of the North Platte River. Sediment is alluvial loam and silt loam. Vegetation is hayfield and corn fields, affording 20 percent bare ground in the hay fields and 60 percent bare ground between the corn rows. Existing impacts are erosion, agricultural fields (plowing), and county road maintenance. The second recorded segment measures 6,326 ft (1,928 m) long and 5.0 ft (1.5 m) wide, covering 2,892 sq m of private lands (Figure 1e; Figure 67 and Figure 68).

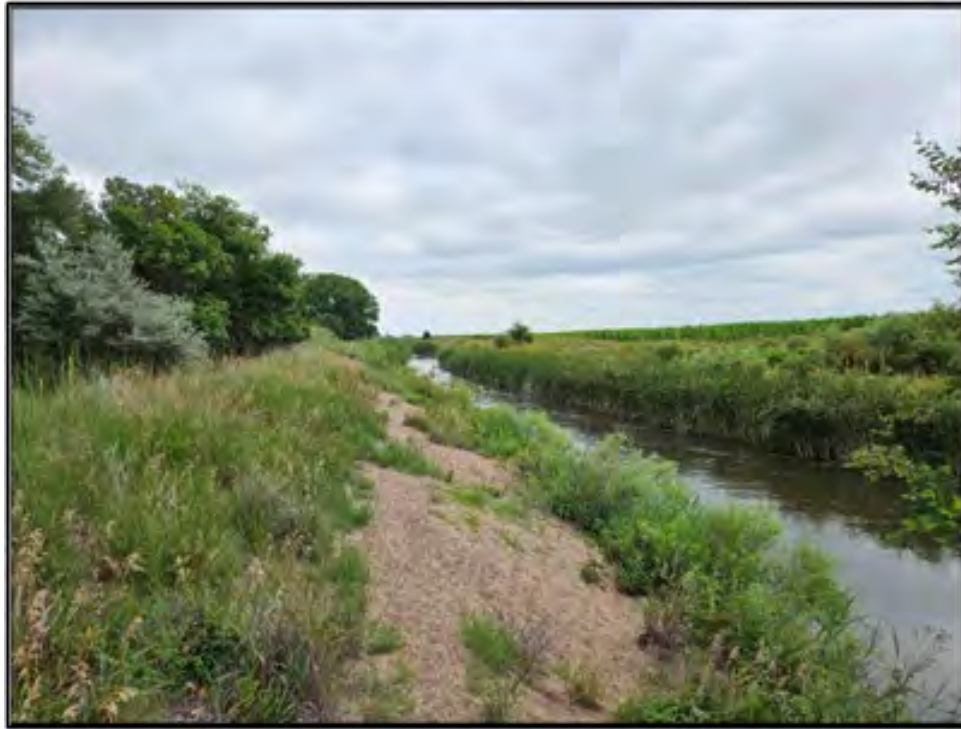
Figure 69. Paxton Hershey Canal: channel overview, Segment 1. Note sediment berm on the left descending bank. View to the northwest. Photograph taken on July 16, 2025.

Segment 1 is located within the floodplain of the North Platte River. Sediment is alluvium varying from loam to sandy loam, and sand. Vegetation is primarily grasses and riparian woodlands with wetlands adjacent to portions of the canal. Surface visibility averages 20 percent. Existing disturbances include erosion, structural decay, and canal infrastructure maintenance. This first recorded segment measures 7,057 ft (2,151 m) long and 35 ft (10 m) wide, covering 21,510 sq m of private lands (Figure 1b; Figure 69).

This recorded segment of the historic North Platte Canal consists of the canal channel and seven features including the diversion dam (Feature 1), the headgate (Feature 2), one return gate (Feature 3), one channel gate with vehicle bridge (Feature 4), one gaging station with an associated fall structure (Feature 5), one culvert crossing (Feature 6), and a sediment stockpile and concrete debris (Feature 7). The canal is an excavated earthen channel that is 45 ft wide, immediately downstream of the headgate (Feature 2) and the culvert road crossing (Feature 6). The channel narrows to 35 ft wide along most of the recorded segment. The canal is flanked on the north side by a sandy earthen berm measuring 10 ft high and 15 ft wide at the base. The south side of the canal channel is excavated into the natural ground surface with berms notable in places. Concrete fragments and old automobiles are occasionally used as riprap along the banks to prevent erosion.

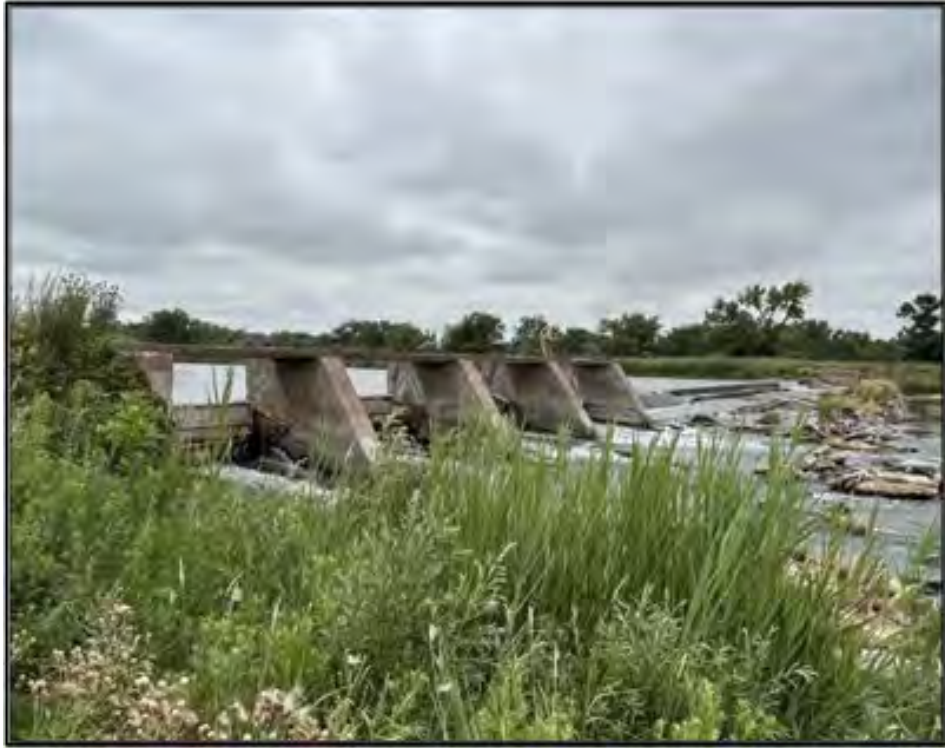
Figure 70. Paxton Hershey Canal: Feature 1, diversion dam overview looking southwest. Photograph taken on July 17, 2025.

Feature 1 is the diversion dam (Figure 70 and Figure 71). It measures approximately 285 ft long and 30 ft wide, including the downstream apron width. The dam includes water control gates on the right descending bank and a spillway on the left descending bank. The dam gate structure measures approximately 70 ft long, and the spillway is 215 ft long. The dam has a 5 ft wide concrete access platform spanning the water control gates. This dam houses four radial steel water gates that are controlled by hand operated equipment. Concrete riprap has been placed downstream of the dam spillway to address erosion issues, and the apron has been patched in places. The spillway actively leaks water when the gates are closed. The dam has cracked, spalled, and worn concrete with rusting water control equipment and gates. Overall, the feature is in poor structural condition.

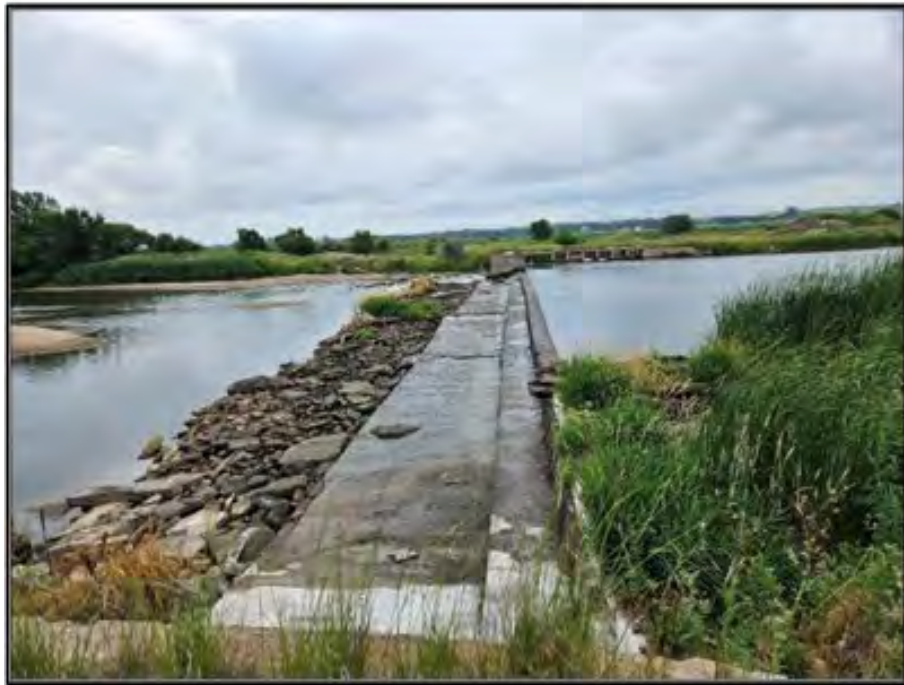
Figure 71. Paxton Hershey Canal: Feature 1, diversion dam overview looking southeast at the spillway apron and weir exposed while the water gates are open. Photograph taken on July 17, 2025.

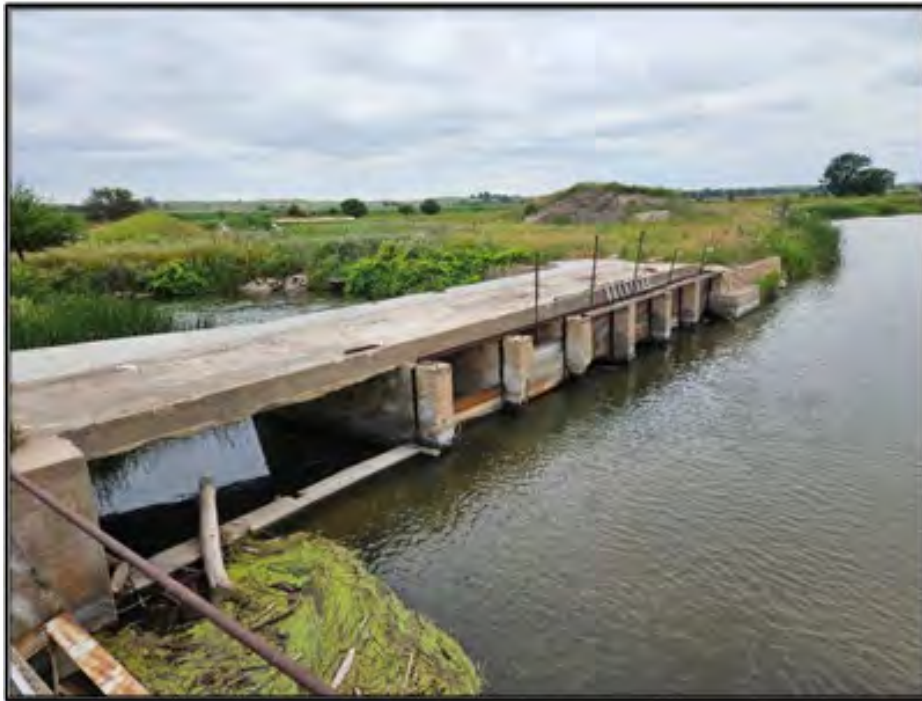
Figure 72. Paxton Hershey Canal: Feature 2 headgate, looking southeast. Photograph taken on July 17, 2025.

Feature 2 is the canal headgate (Figure 72). It is located on the right descending bank of the North Platte River immediate upstream of the diversion dam. The headgate is a concrete structure with a 60 ft long and 12.5 ft wide access platform spanning seven steel water control gates which are raised and lowered with a handyman jack. The access platform has been repaired on the south side as evidenced by a new concrete surface. The headgate has cracked concrete and worn, rusting water control equipment and gates. The concrete sidewalls and retaining walls have been inscribed with the date of 1981, indicating renovation work has been conducted on this feature in the late twentieth century. Despite this, the structure is in overall poor condition.

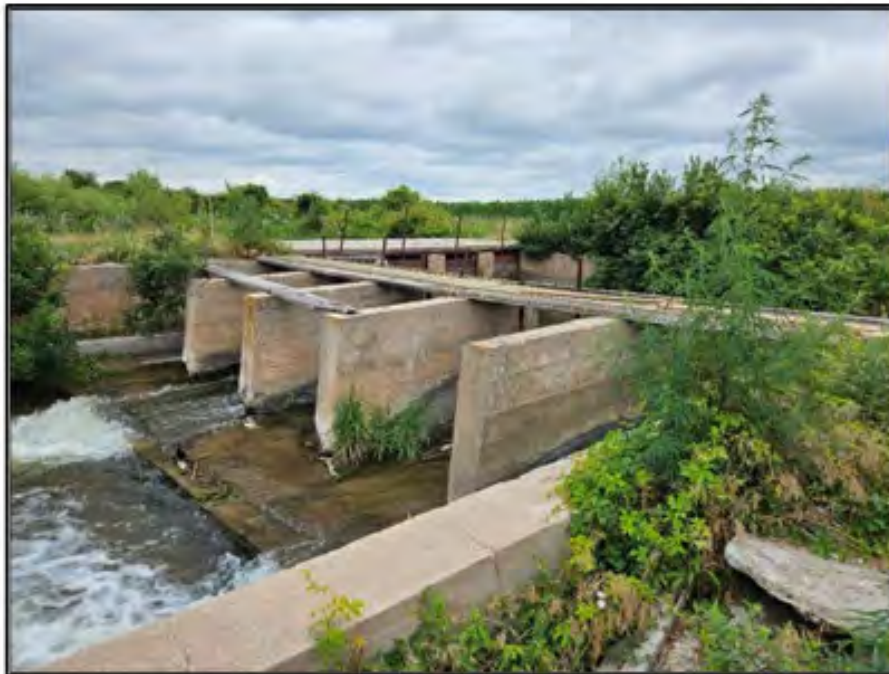
Figure 73. Paxton Hershey Canal: Feature 3 return channel gate, looking east. Photograph taken on July 17, 2025.

Feature 3 is a return channel gate (Figure 73) on the left descending bank located immediately upstream from a mid-channel gate and vehicle bridge (Feature 4). This return gate is composed of two concrete wing walls measuring 30 ft wide which bracket the 36 ft wide side gate. This gate is separated by four concrete intermediate piers that are spanned by a decomposing wood plank access platform. Two new pressure treated planks have been added to allow foot traffic across the gate.

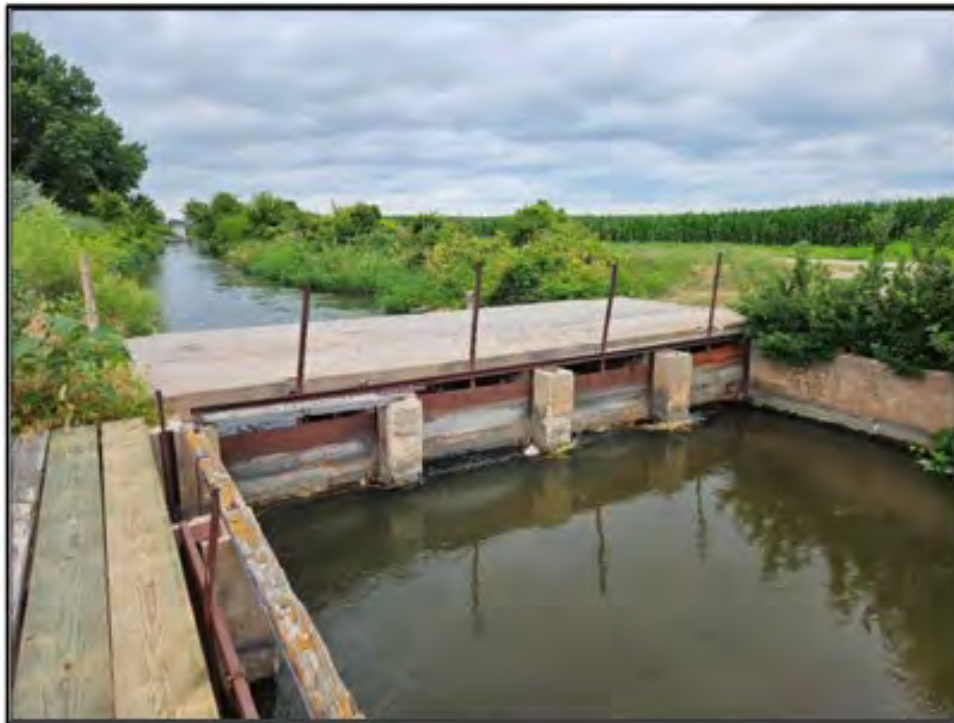
Figure 74. Paxton Hershey Canal: Feature 4, mid-channel gate capped by a concrete vehicle bridge deck. View to the east-northeast. Photograph taken on July 17, 2025.

Feature 4, located immediately downstream from Feature 3, is a mid-channel gate that spans the canal channel (Figure 74). This gate is capped by a concrete vehicle bridge deck. Feature 4 measures 30 ft long and 12 ft wide. The upstream concrete abutment walls measure 30 ft long, and the downstream walls measure 16 ft long. The deck of the bridge is concrete that is supported by four concrete piers.

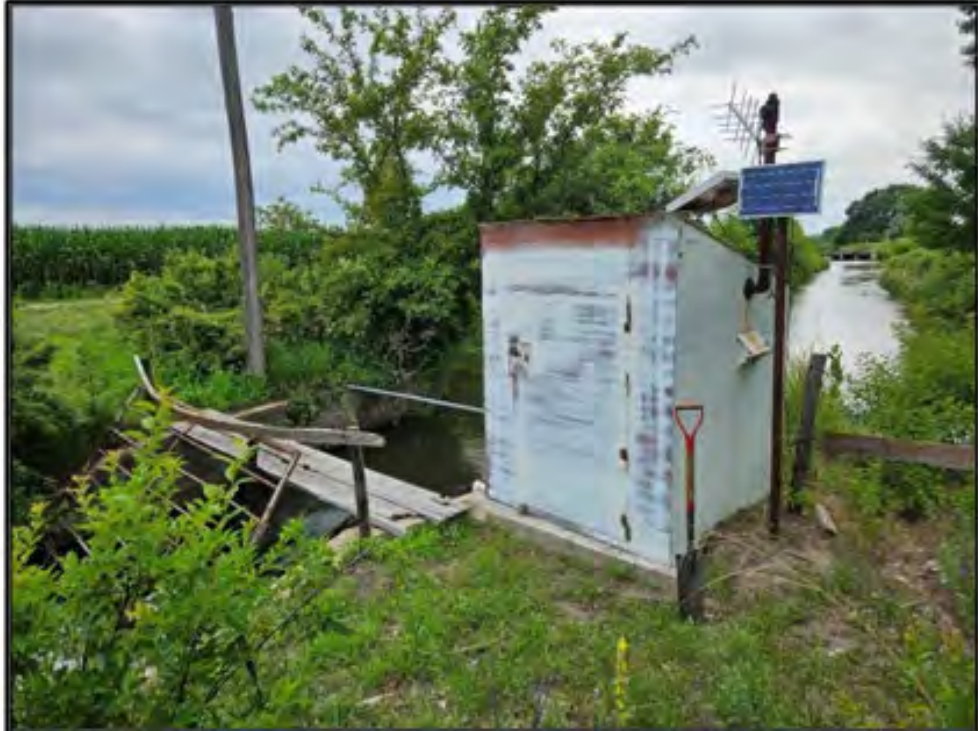
Figure 75. Paxton Hershey Canal: Feature 5 gaging station and fall structure. View to the southwest. Shovel extending 3 ft above ground for scale. Photograph taken on July 17, 2025.

Feature 5 is a gaging station with an associated fall structure. The gaging station is composed of a small steel shed, and a fall structure made with concrete sidewalls. The fall structure is crossed by a milled lumber plank access platform (Figure 75). The shed measures approximately 7 ft tall, 5 ft long, and 5 ft wide and rests on a concrete slab foundation. The gaging instrumentation is locked behind the sheet steel door. A radio control transmitter/receiver is mounted on the side of the shed and is connected to an antennae and solar panel. The shed is painted white. Renovations to the canal were conducted in the 1960s (Glenn Bowers, Twin Platte Natural Resource Division, personal communication on July 15, 2025) and in the early 1980s. This structure is consistent with a mid- to late twentieth-century date. The collapsed remains of an old wood gaging station structure are located 3 ft to the west of the current structure. It was made of milled lumber clad in corrugated sheet steel (Figure 76). The concrete fall structure measures 15 ft wide, and the sidewalls are approximately 27 ft long. The access platform consists of two severely rotten milled lumber planks with equally rotten wood railings supported by rusted steel posts. A tube steel gate has been wired in place across the opening of the fall structure.

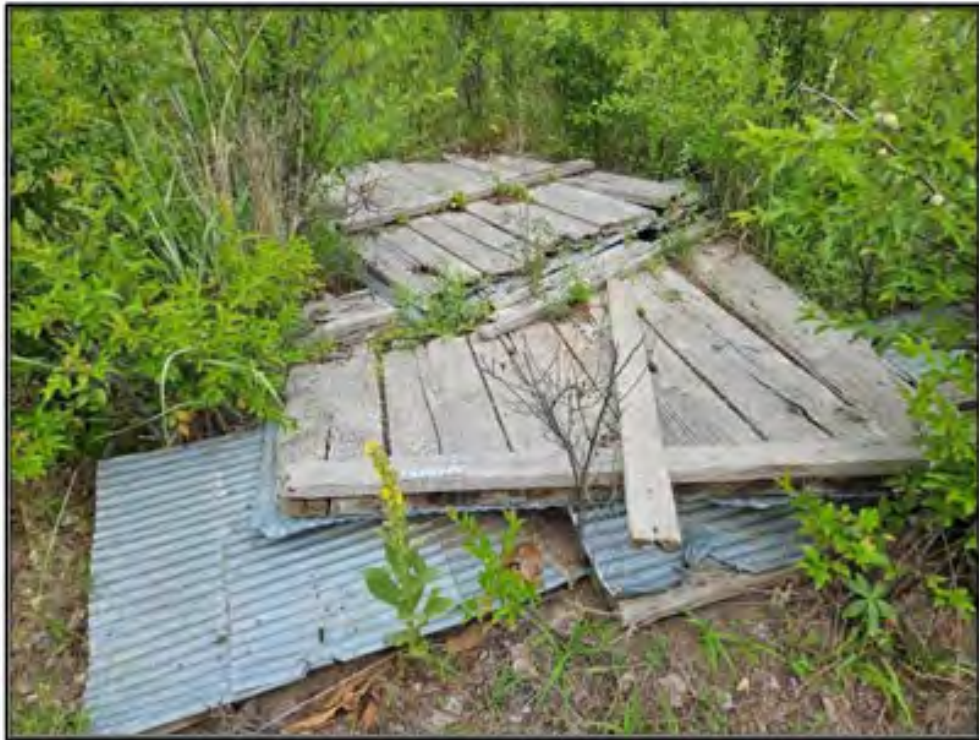
Figure 76. Paxton Hershey Canal: Collapsed remains of old gaging station at Feature 5. View to the east. Photograph taken on July 17, 2025.

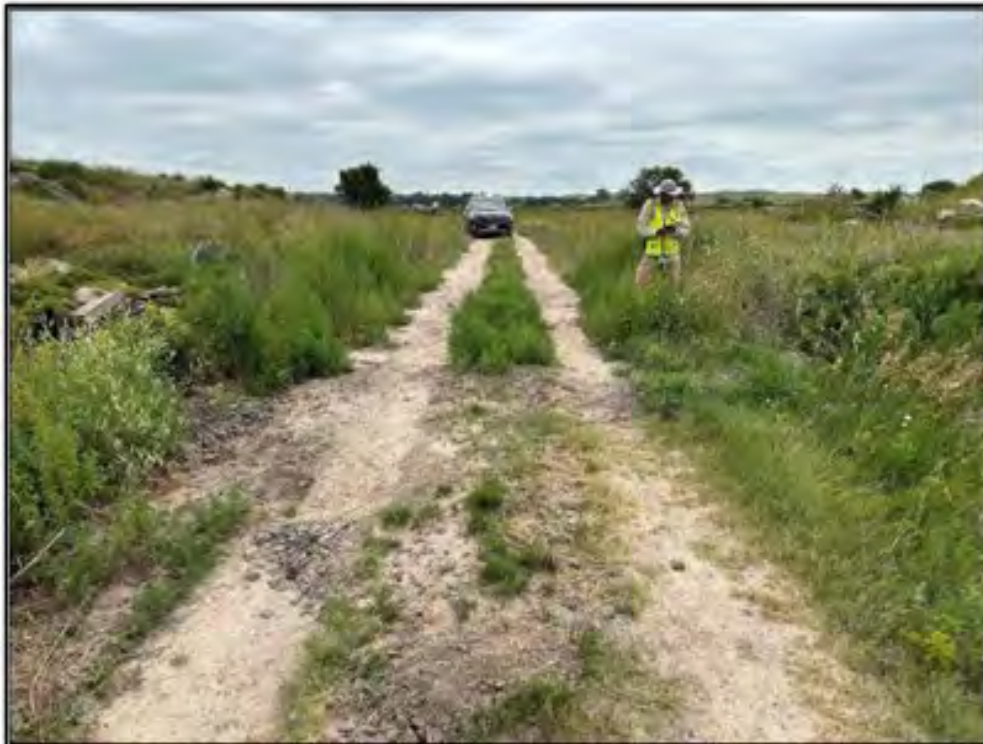
Figure 77. Paxton Hershey Canal: Feature 6 the culvert and sediment road crossing. View to the southeast with crew member for scale. Photograph taken on July 17, 2025.

Feature 6 is a culvert and sediment road crossing of the canal channel located 100 ft downstream from the headgate (Feature 2). The crossing measures 34 ft long and 16 ft wide. The culverts are made from 0.25-inch-thick steel tanks that have the ends cut off. The tanks are riveted at the seams and are 4 to 5 ft in diameter (Figure 77 and Figure 78). The original function of these tanks is unknown, but considering the robust construction they may have been boilers. Similar culverts have been used for a crossing at the Cody-Dillon Canal.

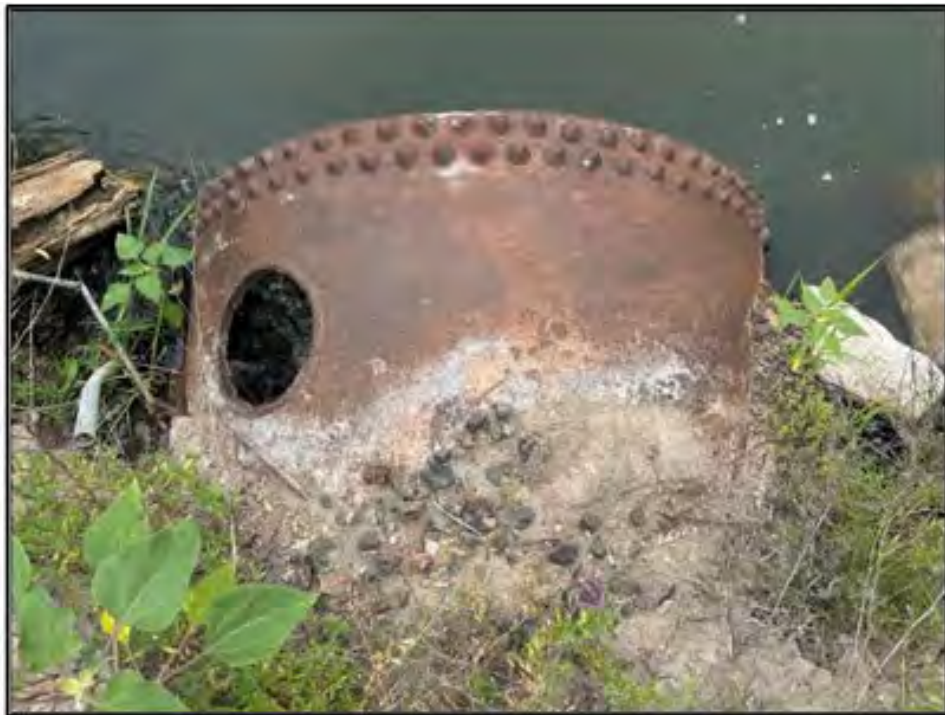
Figure 78. Paxton Hershey Canal: Example of the riveted steel tanks repurposed as culverts at Feature 6 the culvert and sediment road crossing. View to the east. Photograph taken on July 17, 2025.

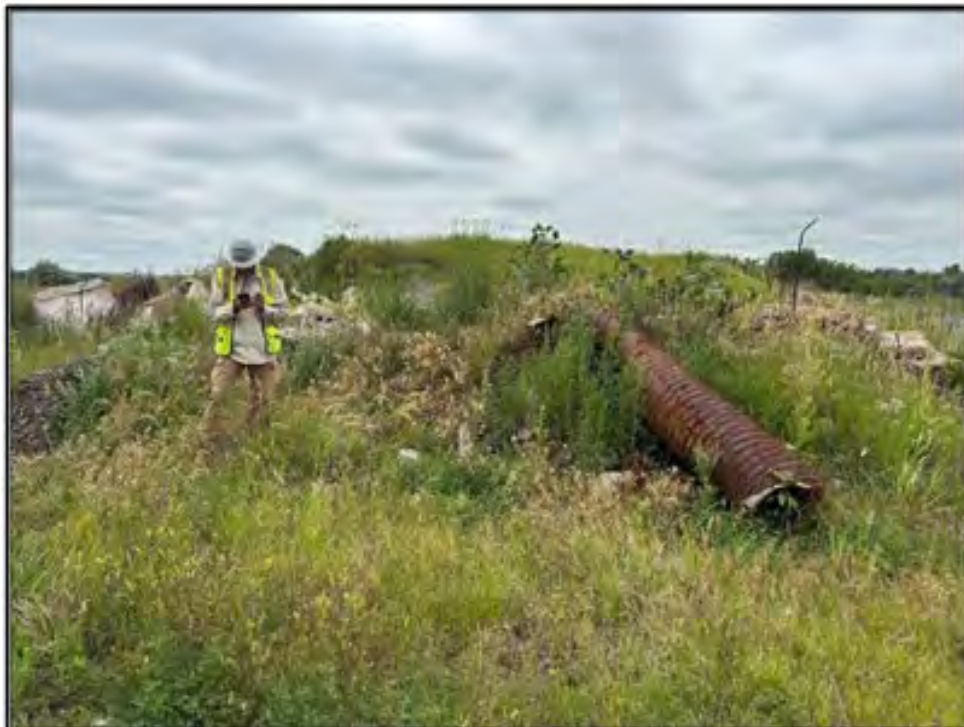
Figure 79. Paxton Hershey Canal: Feature 7 the stockpile of sediment, concrete fragments and gravel. View to the southwest. Photograph taken on July 17, 2025.

Feature 7 is a large stockpile of sediment, concrete fragments, old steel culverts, and gravel brought in for use as fill dirt for dealing with ongoing erosion issues. This pile measures 50 ft long and 40 ft wide, and is piled to a height of 15 ft (Figure 79).

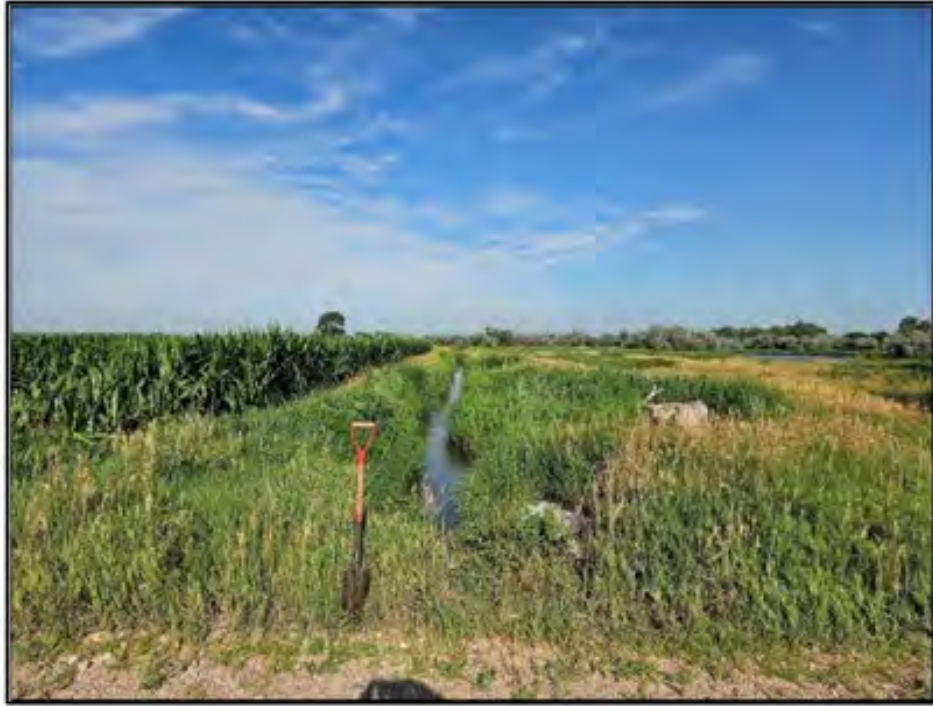
Figure 80. Paxton Hershey Canal: channel overview, Segment 2. Looking west from the modern steel culvert (Feature 8). Photograph taken on July 19, 2025.

Segment 2 is situated within the Suburban survey area. This segment of the canal is identified as Ditch No. 3 of the Paxton Hershey Canal. It passes along the base of the first terrace on the right descending bank of the North Platte River. Sediment is alluvial loam to sandy loam, and silt loam. Vegetation is primarily grasses and wetlands, with cornfields planted to the south. Surface visibility averages 10 percent. Existing disturbances include erosion and canal infrastructure maintenance. This second recorded segment of this historic canal measures 6,058 ft (1,846 m) long and 5.0 ft (1.5 m) wide, covering 2,769 sq m of private lands (Figure 1d; Figure 80).

Feature 8 is a steel culvert road crossing measuring 13 ft long and 16 ft wide. The culvert is shiny corrugated steel and is modern in age (see Figure 80).

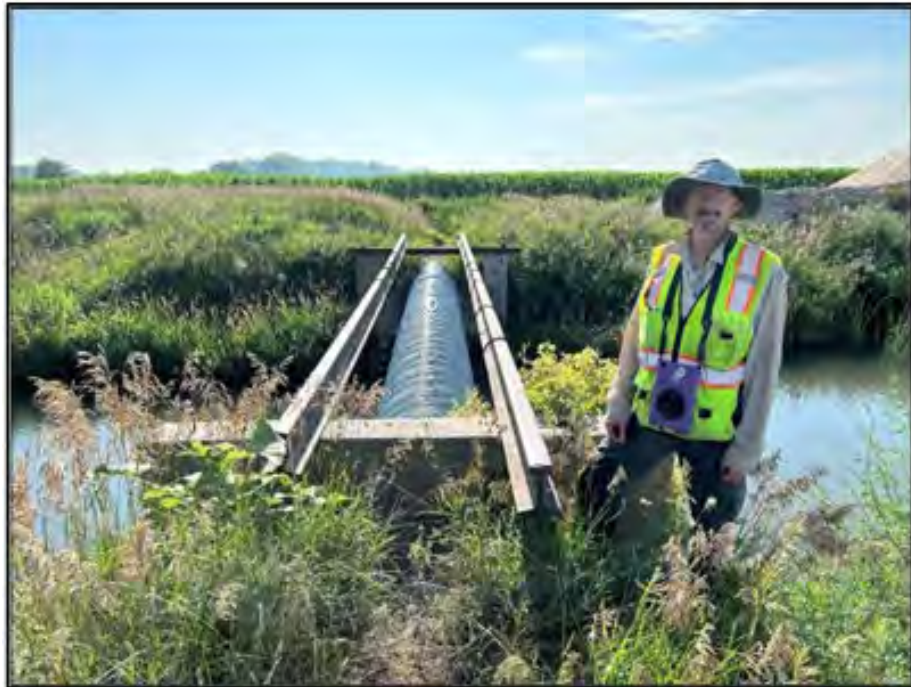
Figure 81. Paxton Hershey Canal: Feature 9, the corrugated steel flume allowing the Paxton Hershey Canal to pass over the Suburban canal. Crew member for scale. Photograph taken on July 19, 2025.

Feature 9 is a corrugated steel culvert flume anchored by a concrete retaining wall and abutments on each side (Figure 81). This flume is supported by two steel railroad rails and steel cables and is used to carry water from the Paxton Hershey Canal over the Suburban Canal. The flume measures 65 ft long and 4 ft wide. The concrete retaining wall on the west side is stamped with the date of 1982, and on the east side the date is 1989.

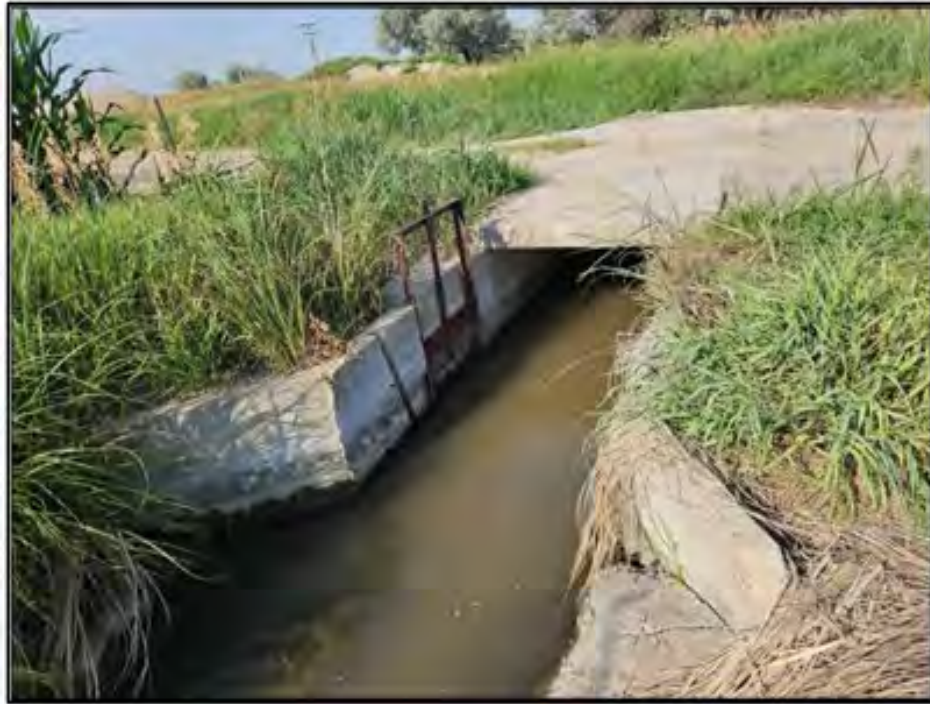
Figure 82. Paxton Hershey Canal: Feature 10, concrete box culvert. View to the west. Photograph taken on July 19, 2025.

Feature 10 is a rectangular concrete box culvert measuring 15 ft long and 4 ft wide (Figure 82). This culvert is a crossing point for an agricultural field access road.

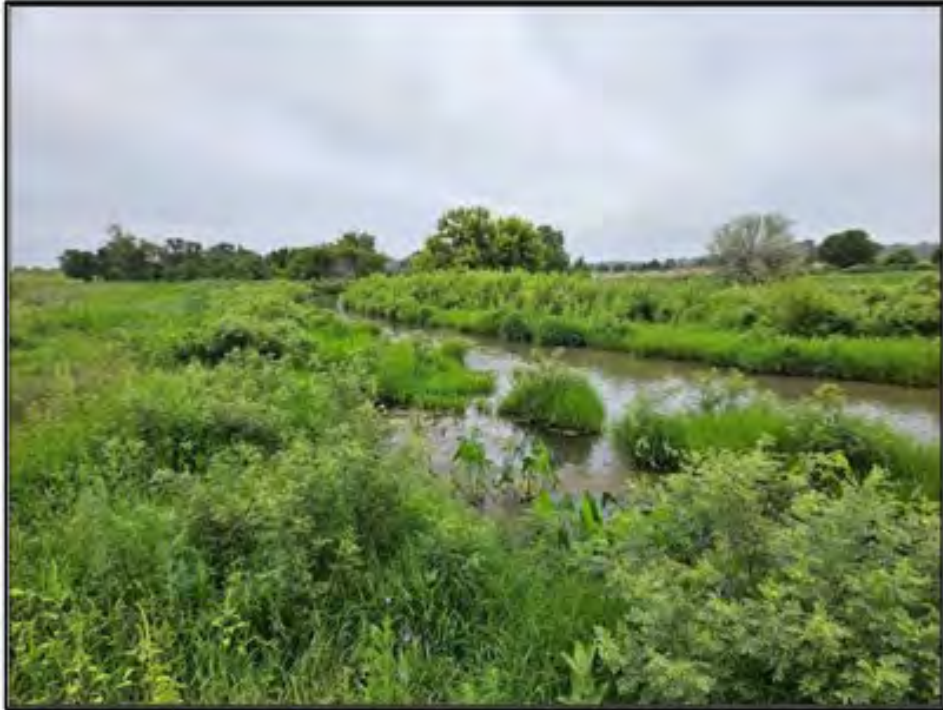
Figure 83. Birdwood Canal: channel overview looking south. Photograph taken on July 18, 2025.

pasture, hayfields, and riparian woodlands with wetlands adjacent to portions of the canal. Surface visibility averages 10 percent. Existing disturbances include erosion, and structural decay of the canal infrastructure. The recorded segment measures 4,170 ft (1,271 m) long and 12 ft (4 m) wide, covering 5,084 sq m of private lands (Figure 1c; Figure 83).

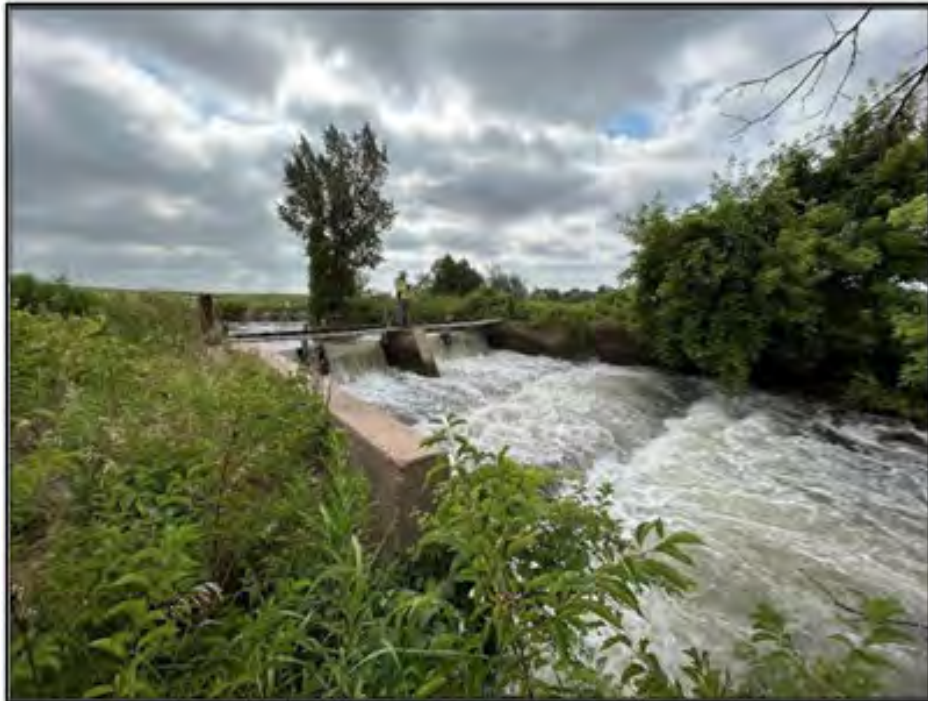
Figure 84. Birdwood Canal: Feature 1, diversion dam with crew member for scale. View to the southeast. Photograph taken on July 18, 2025.

Feature 1 is the diversion dam. It measures approximately 32 ft long and 16 ft wide, including the downstream apron width (Figure 84). The dam includes an intermediate concrete pier dividing the dam into two cells housing the wood plank gates. The sidewalls support a wood plank access platform with steel cable railings. The sidewalls measure 80 ft long including the wing walls. A steel railroad rail spans the dam on the upstream side and supports the access platform and the 4-x-4-inch nominal dimension posts which are used to support wood plank gates that are held in place with water pressure. The historic gate structures and formal mechanisms to raise and lower the gates are no longer present. This structure is in very poor condition.

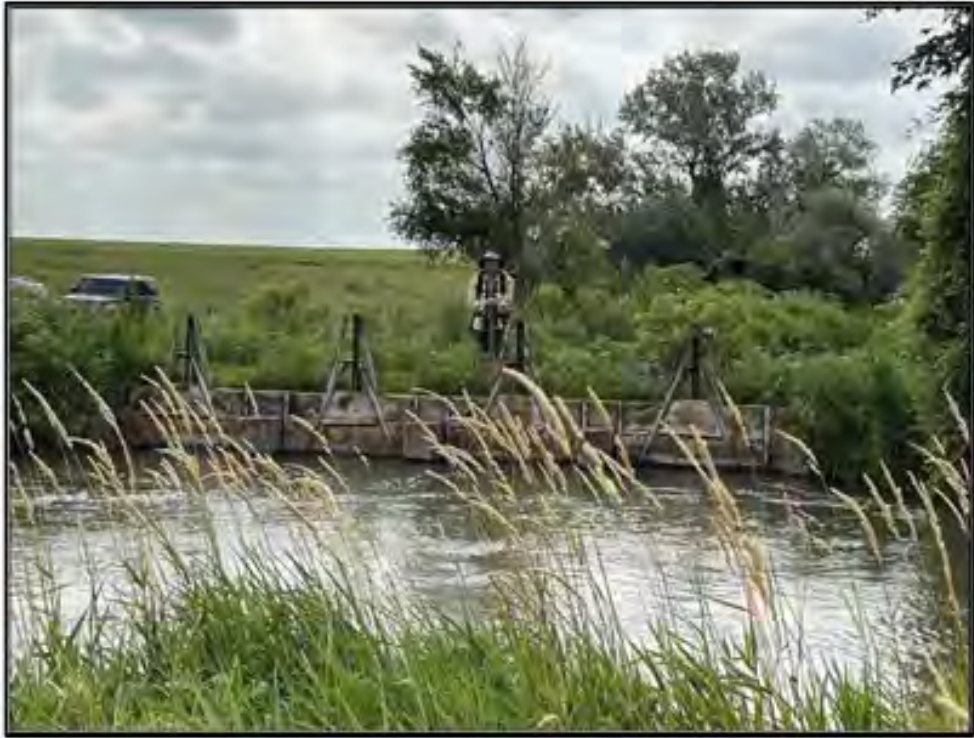
Figure 85. Birdwood Canal: Feature 2, headgate with crew member for scale. View to the south. Photograph taken on July 18, 2025.

Feature 2 is the canal headgate located on the left descending bank of Birdwood Creek immediately upstream of the diversion dam (Figure 85). The headgate structure is composed of four large corrugated steel culverts with a concrete abutment wall on the upstream side measuring approximately 70 ft long. The culverts measure 4.5 ft in diameter and are approximately 12 ft long. The top of the headgate is covered with soil, overlaid by a two-track access road. In several locations the culverts under the road are collapsing and the structure is failing. The upstream concrete abutment wall houses four steel water control gates. The gates are raised and lowered by hand operated screw mechanisms.

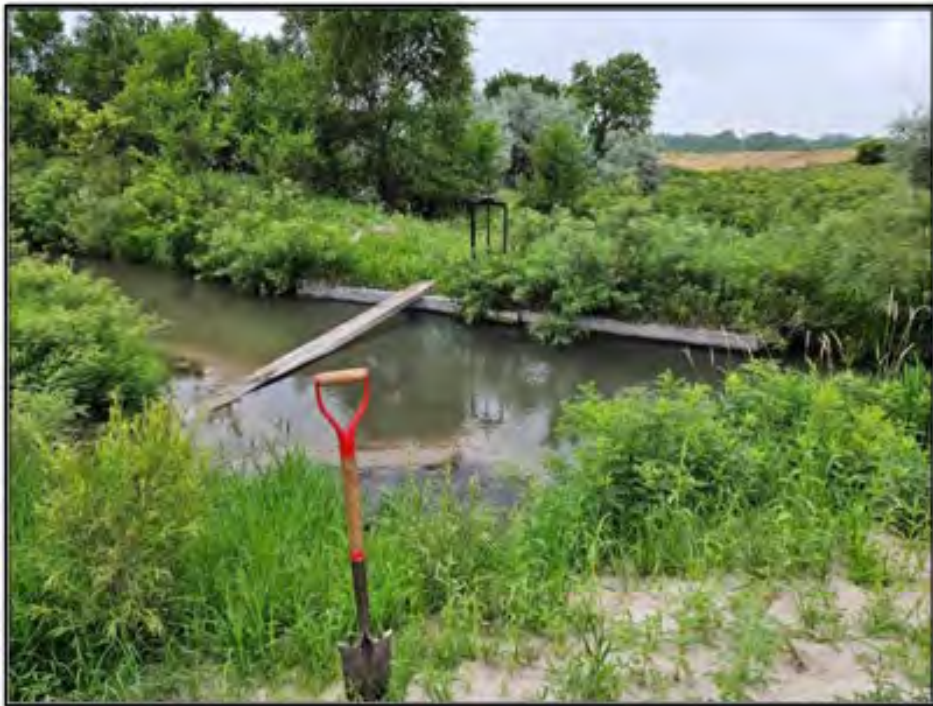
Figure 86. Birdwood Canal: Feature 3, disused rating flume. View to the southwest. Shovel extending 3 ft above ground for scale. Photograph taken on July 18, 2025.

Feature 3 is located approximately 690 ft downstream from the headgate (Figure 86). This feature was initially interpreted as a side channel gate to let overflow back into Birdwood Creek. However, plans for the installation of a rating flume were filed in 1942 and illustrate the structure at a similar location, approximately 700 ft downstream of the headgate (Kimmel 1942). This rating flume consists of a gate set into a concrete wall. The wood gate is mounted on a steel frame and operated by a wheel screw crank. The concrete retaining wall is approximately 15 ft long. The wood gate is rotten and overgrown with vegetation. This rating flume does not appear to have been utilized in a considerable amount of time.
