## Appendix E.7 Cultural Resources Report (Redacted)

# INTENSIVE CULTURAL RESOURCE SURVEY OF THE EAST CLEAR CREEK WATERSHED ENVIRONMENTAL ASSESSMENT PROJECT ALTERNATIVES KEITH AND LINCOLN COUNTIES, NEBRASKA

By  
Jason D. Weston, MA, RPA No. 15092

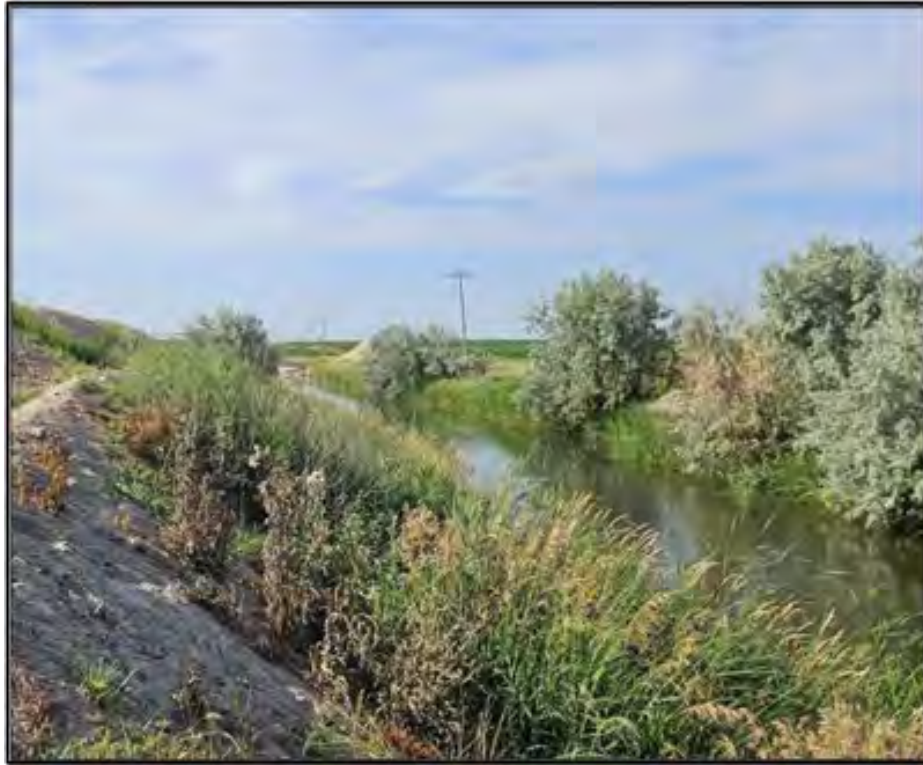
Figure 87. Suburban Canal: channel overview looking south. Photograph taken on July 19, 2025.

This historic linear resource is located within the floodplain of the North Platte River. Sediment is alluvial loam to sandy loam. Vegetation is primarily grasses and cornfields with 60 percent bare ground between the rows of corn. Existing disturbances include erosion and structural decay of the canal infrastructure. This recorded segment measures 4,416 ft (1,346 m) long and 20 ft (6 m) wide, covering approximately 8,076 sq m of private lands (Figure 1d; Figure 87).

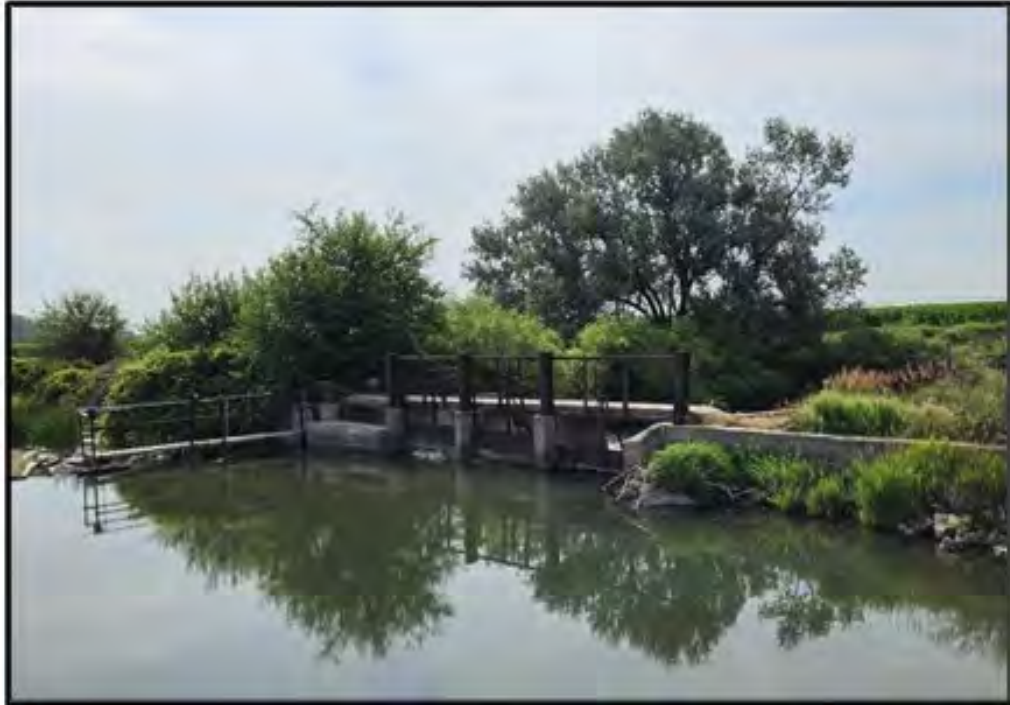
Figure 88. Suburban Canal: Feature 1, headgate. View to the southeast. Photograph taken on July 19, 2025.

Feature 1 is the headgate measuring 36 ft long and 16 ft wide, including the downstream apron (Figure 88 and Figure 89). It has 24 ft long sidewalls with 10 ft wing walls, and the river side retaining walls measure 24 and 26 ft long with 6 and 8 ft long wing walls. The characteristics match the 1919 plans by McNamara (1919a). Changes since the 1919 plans include a concrete wall closing off one cell on the east end leaving operational three of the steel gates rather than four. The headgate has been spanned by a 3 ft wide concrete access platform which was not illustrated in the 1919 plans. This platform has the tracks of a *Felis catus* (domestic cat) made when the concrete was wet. This concrete platform was poured on top of wood planks. These planks are beginning to rot and undermine the integrity of the concrete platform. The three steel gates are mounted on a steel I beam frame and are opened and closed with a handyman jack. These gates were also not illustrated on the 1919 plans and were likely installed in the 1960s along with the radial water gates in the diversion dam (Feature 2) (Glenn Bowers, Twin Platte Natural Resource Division, personal communication on July 15, 2025). Erosion under the headgate is causing sediment subsidence behind the riverside retaining walls and the structure is cracked in multiple places.

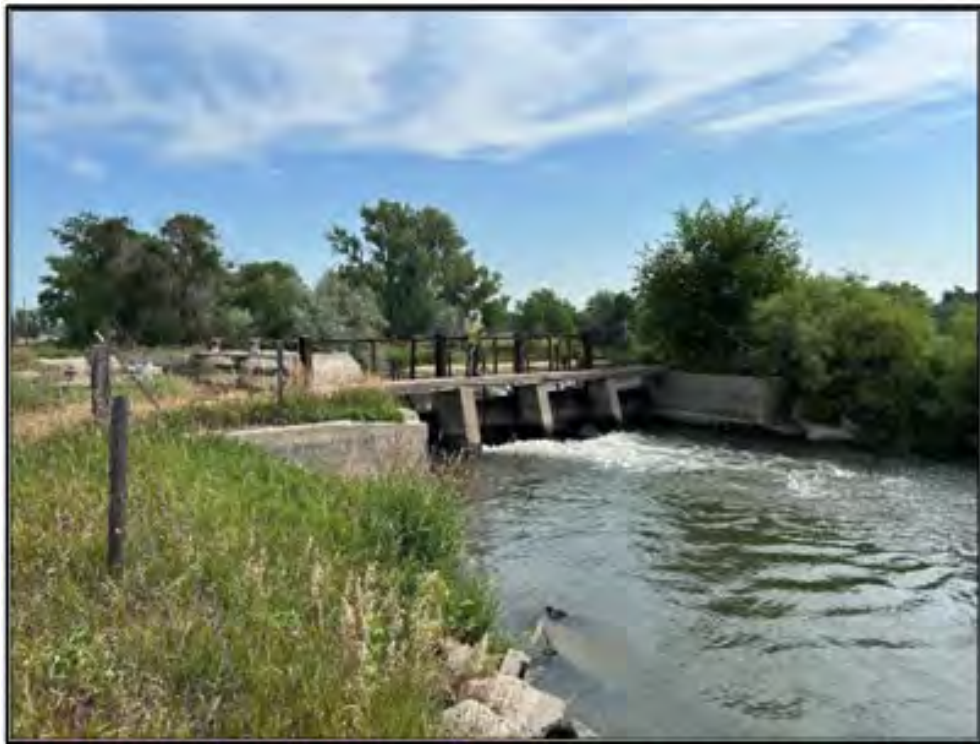
Figure 89. Suburban Canal: Feature 1, headgate with crew member for scale. View to the north. Photograph taken on July 19, 2025.

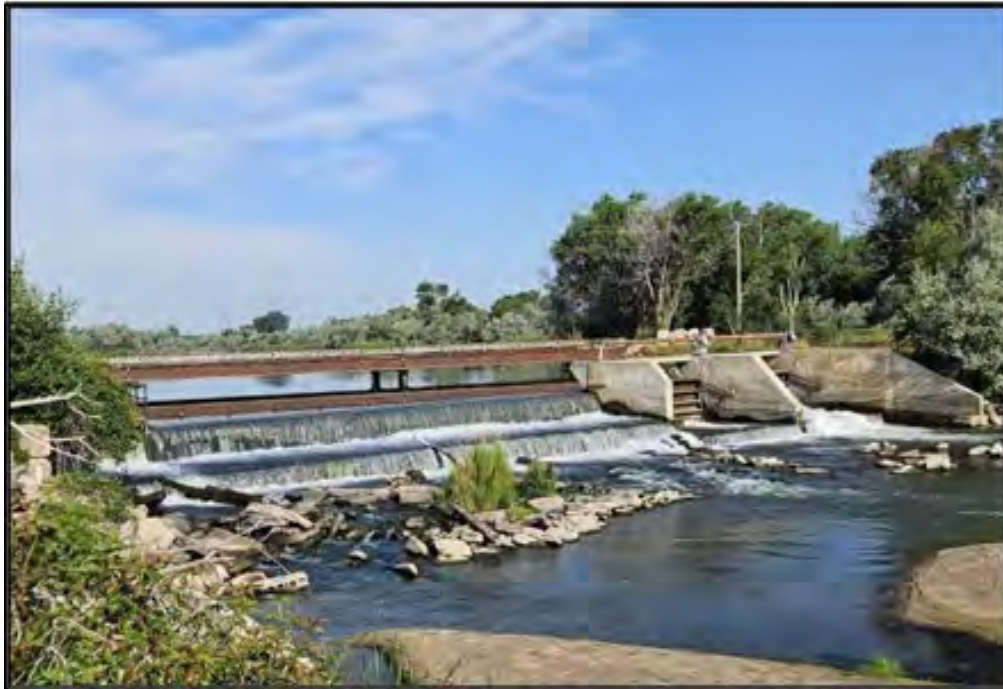
Figure 90. Suburban Canal: Feature 2, diversion dam. View to the west. Photograph taken on July 19, 2025.

Feature 2 is the diversion dam which measures approximately 130 ft long and 25 ft wide, including the downstream apron width (Figure 90). This is considerably shorter than the 450 ft long planned piling dam illustrated by McNamara (1919a). The dam includes water control gates on the left descending bank, a spillway in the center, and two smaller water control gates on the right descending

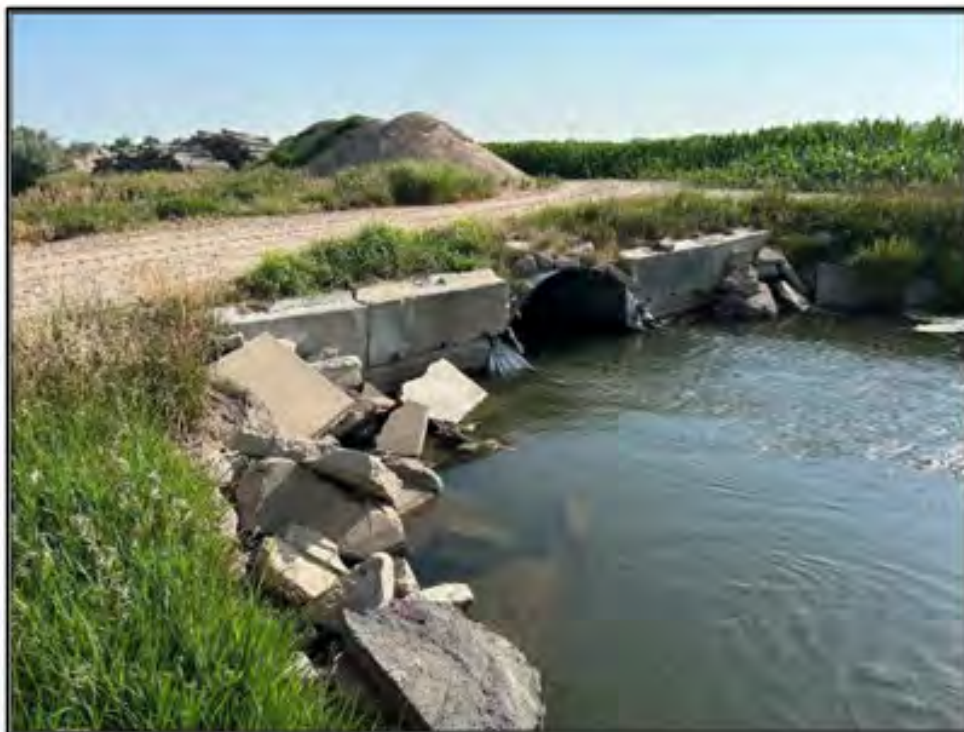
Figure 91. Suburban Canal: Feature 3, culvert and concrete retaining wall access road crossing. View to the northeast. Photograph taken on July 19, 2025.

Feature 3 is an access road crossing over the canal made from 10 ft long concrete retaining walls, a 5 ft diameter steel culvert, plastic sheeting, and concrete riprap covered in soil and gravel (Figure 91). This crossing measures 42 ft long and 23 ft wide and is modern in age.

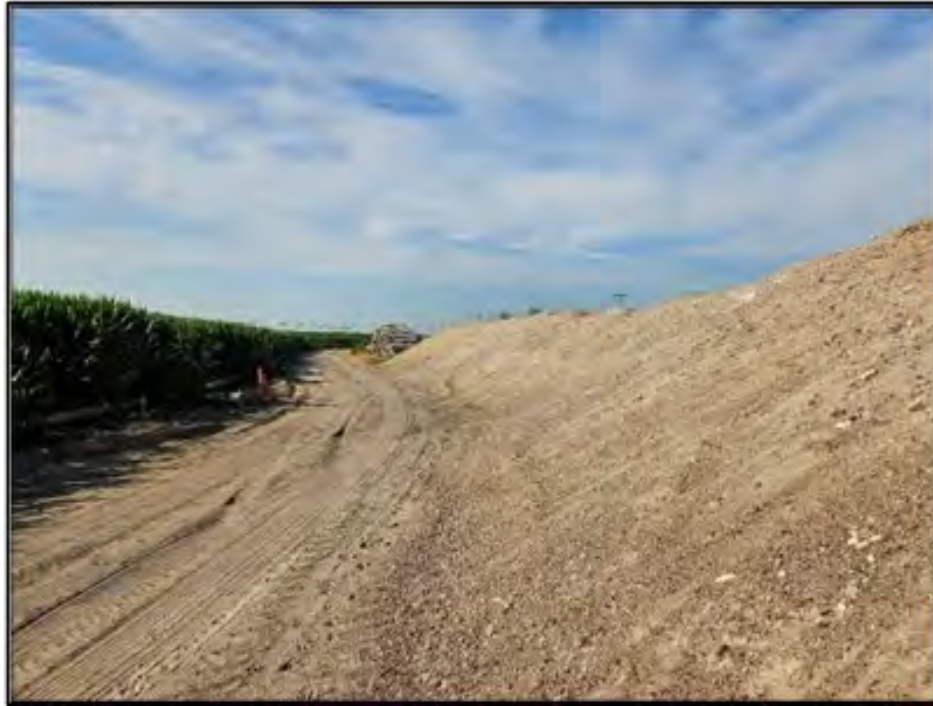
Figure 92. Suburban Canal: Feature 4, sediment and railroad tie stockpile for erosion control. View to the south. Photograph taken on July 19, 2025.

Feature 4 is a large stockpile of sediment and modern concrete railroad ties in an area measuring 330 ft long and 30 ft wide on the east side of the canal (Figure 92).

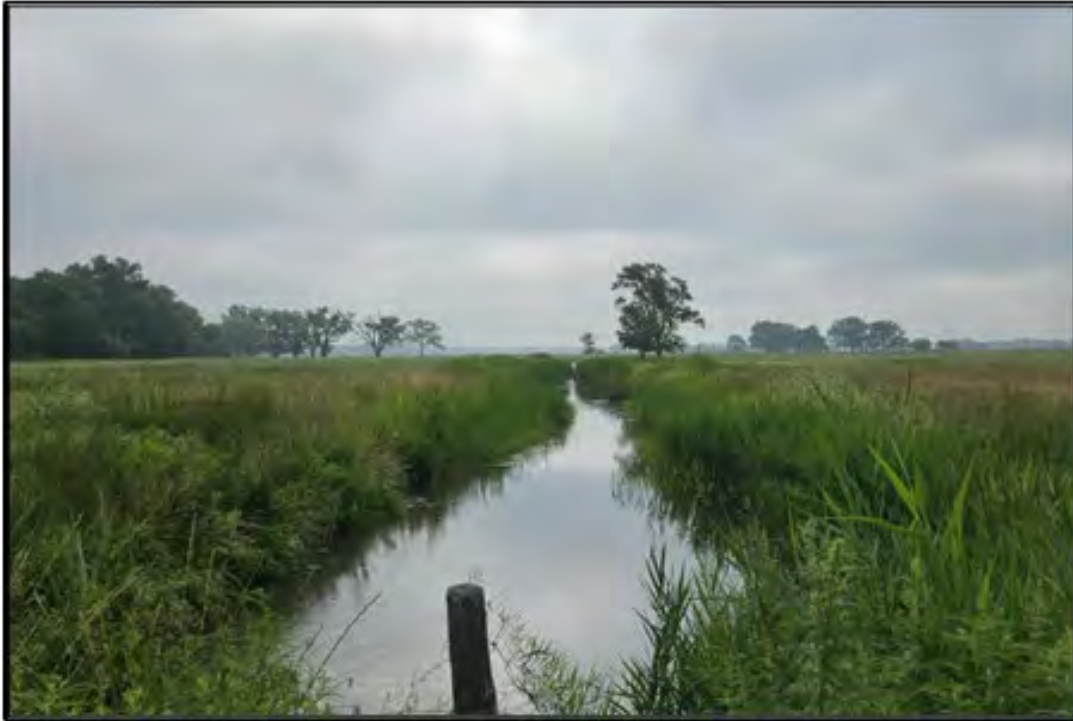
Figure 93. Cody Dillon Canal: channel overview looking east from a culvert road crossing of the canal (Feature 2). Photograph taken on July 21, 2025.

This historic linear resource is located on the first terrace above the right descending bank of the North Platte River. Sediment is alluvium varying from loam to silt loam, sandy loam, and sand. Vegetation is primarily grasses, scattered trees, and small wetland areas adjacent to portions of the canal. Surface visibility averages 10 percent. Existing disturbances include erosion and structural decay. The recorded segment of this historic canal measures 5,910 ft (1,801 m) long and averages 20 ft (6 m) wide, covering 10,806 sq m of private lands (Figure 1e; Figure 93).

channel with low banks. The channel is beginning to meander due to erosion. Wetland vegetation is intruding into the channel. Between the effects of bank erosion, siltation and vegetation growth, the channel width varies from 12 to 27 ft.

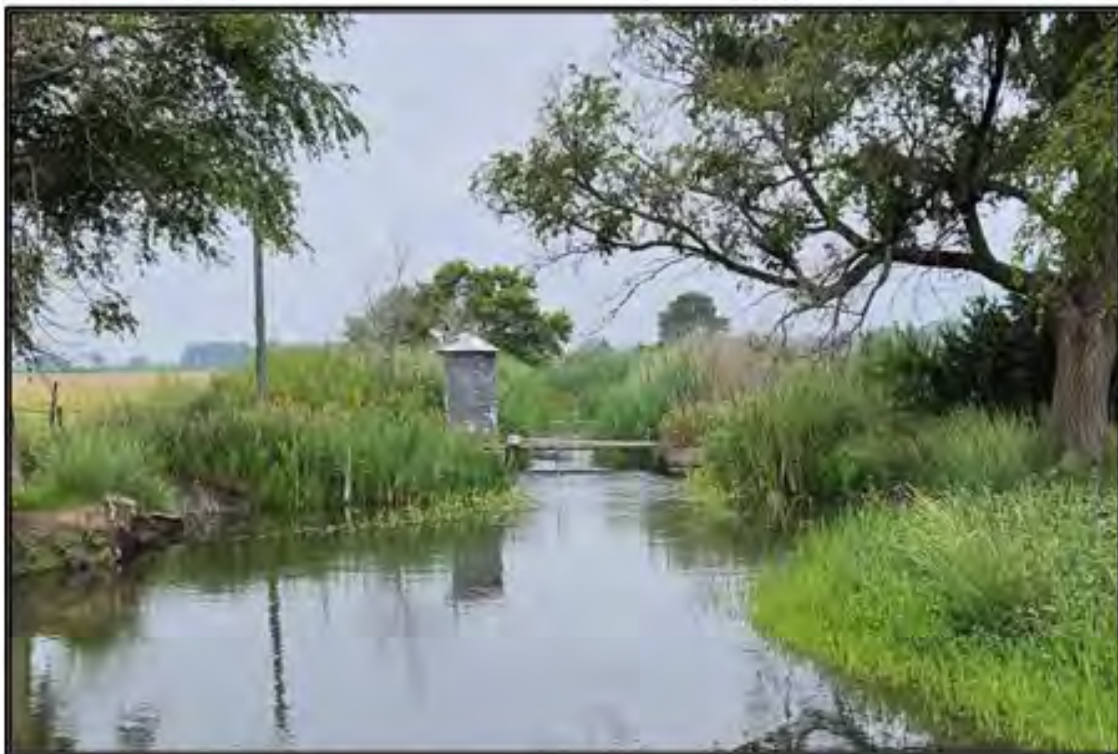
Figure 94. Cody Dillon Canal: Feature 1, gaging station. View to the west. Photograph taken on July 21, 2025.

Feature 1 is a gaging station built from a 4 ft diameter corrugated steel culvert that has been placed vertically on a slab concrete foundation (Figure 94). The shed measures approximately 6 ft tall with a conical roof made of sheet steel. The gaging instrumentation is locked behind the sheet steel door. The door is mounted into a steel frame welded into the site of the culvert shed structure. A radio control transmitter/receiver is mounted on the side of the shed. Concrete sidewalls are located north of the gaging station along the canal channel and are spanned by a milled lumber plank access platform.

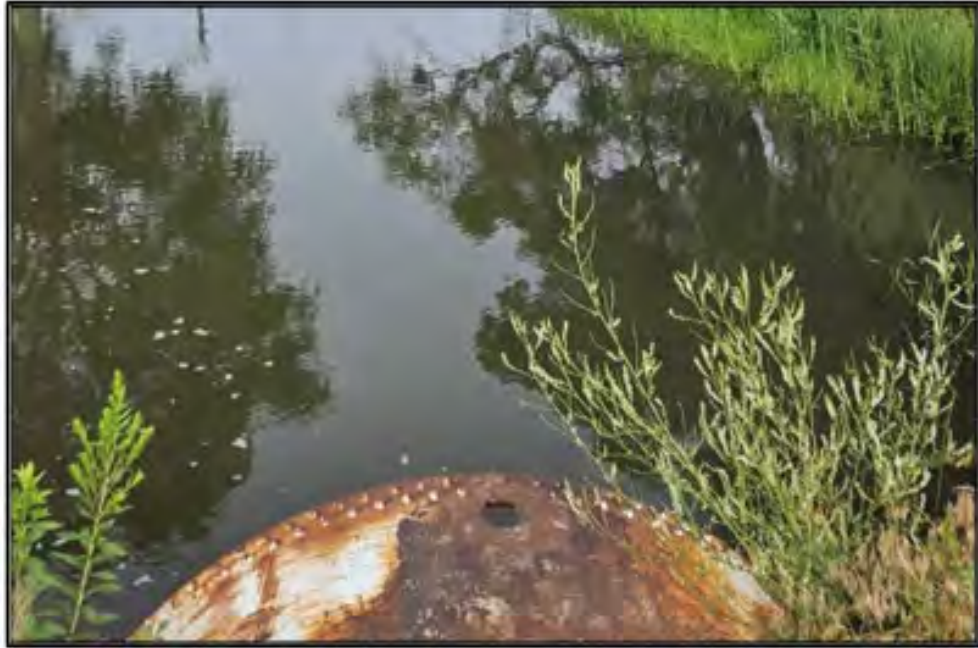
Figure 95. Cody Dillon Canal: Example of the riveted steel tank repurposed as a culvert at Feature 2 the culvert and sediment road crossing. View to the west. Photograph taken on July 21, 2025.

Feature 2 is a culvert and sediment road crossing of the canal channel located 120 ft downstream from the gaging station (Figure 95). The crossing measures 34 ft long and 30 ft wide. The culverts are made from 0.25-inch-thick steel tanks that have the ends cut off. The rusted tanks were painted white. They are riveted at the seams and are 4 ft in diameter. The original function of these tanks is unknown, but considering the robust construction they may have been boilers. Similar culverts have been used for a crossing at the Paxton Hershey Canal.

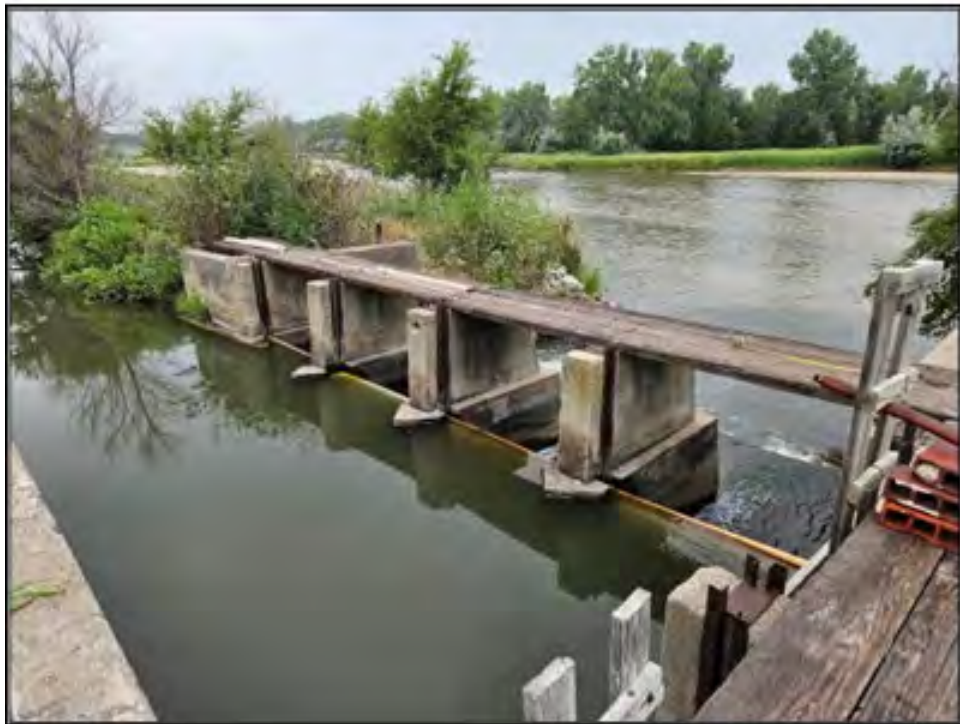
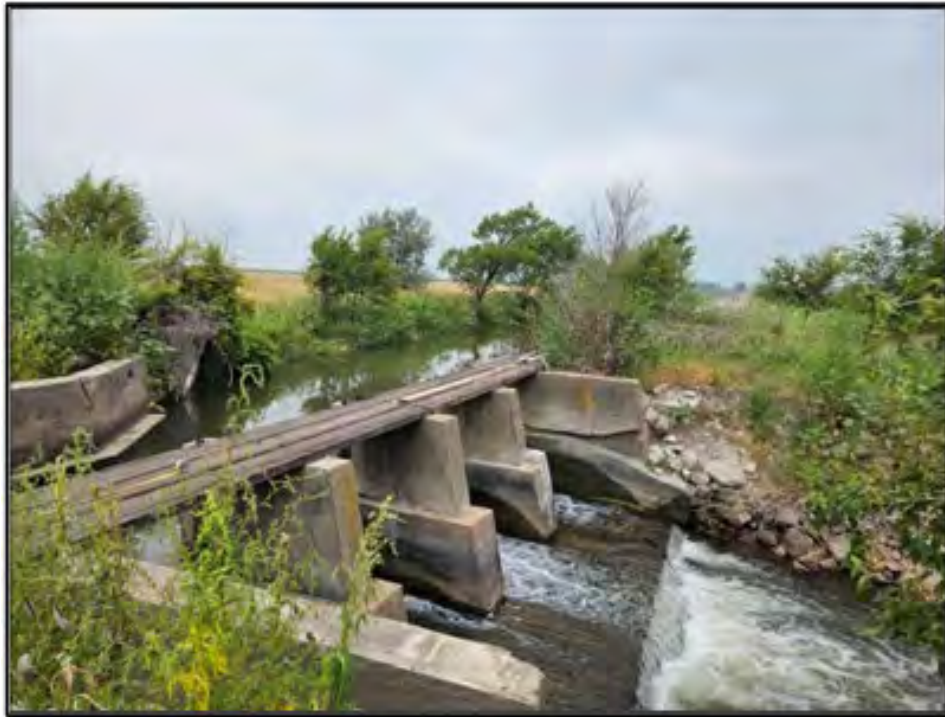
Figure 96. Cody Dillon Canal: Feature 3 return gate, looking northwest towards the North Platte River. Photograph taken on July 21, 2025.

Figure 97. Cody Dillon Canal: Feature 3 return gate, looking southwest towards the canal channel. Photograph taken on July 21, 2025.

Features 3 and 4 are immediately next to each other. Feature 3 is a return gate that regulates the amount of water available to the headgate (Feature 4). This return gate is located on the left descending bank (north side) of the canal and empties water into the North Platte River (Figure 96 and Figure 97). The return gate is a concrete structure measuring 30 ft long and 10–12 ft wide sidewalls and 8 ft long upstream wing walls. The downstream apron measures approximately 12 ft wide. The structure is divided into four cells which house one gate each. The gates are wood planks slid into steel rails. Plastic sheeting has been placed on the upstream side of the wood gates so water pressure will hold it in place and stop leaks. At the time of recording the plastic was torn in several places and the gates were leaking badly. To address concrete cracks, spalls, and structural weaknesses, the sidewalls and the intermediate concrete piers between the gates have been reinforced by additional concrete at the base. These reinforcements are old enough to be worn and cracking.

The return gate is spanned by a decayed wood plank access platform. The concrete structure is in overall poor physical condition.

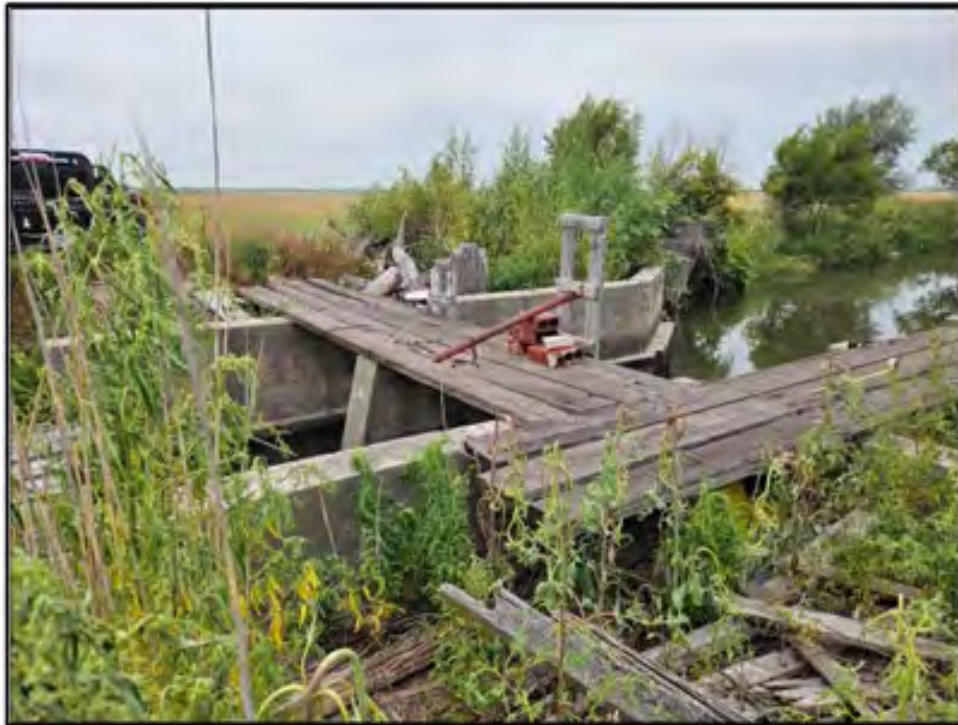
Figure 98. Cody Dillon Canal: Feature 4 headgate. View to the south. Photograph taken on July 21, 2025.

Feature 4 is the headgate (Figure 98). It is a concrete structure measuring 12 ft wide with 24 ft long sidewalls. The upstream wing wall measures 8 ft long. The gate has two cells separated by one intermediate pier. Each cell houses one wood plank gate. The wood gates are set into steel rails and are raised and lowered by a simple lever utilizing a steel pipe and clay bricks.

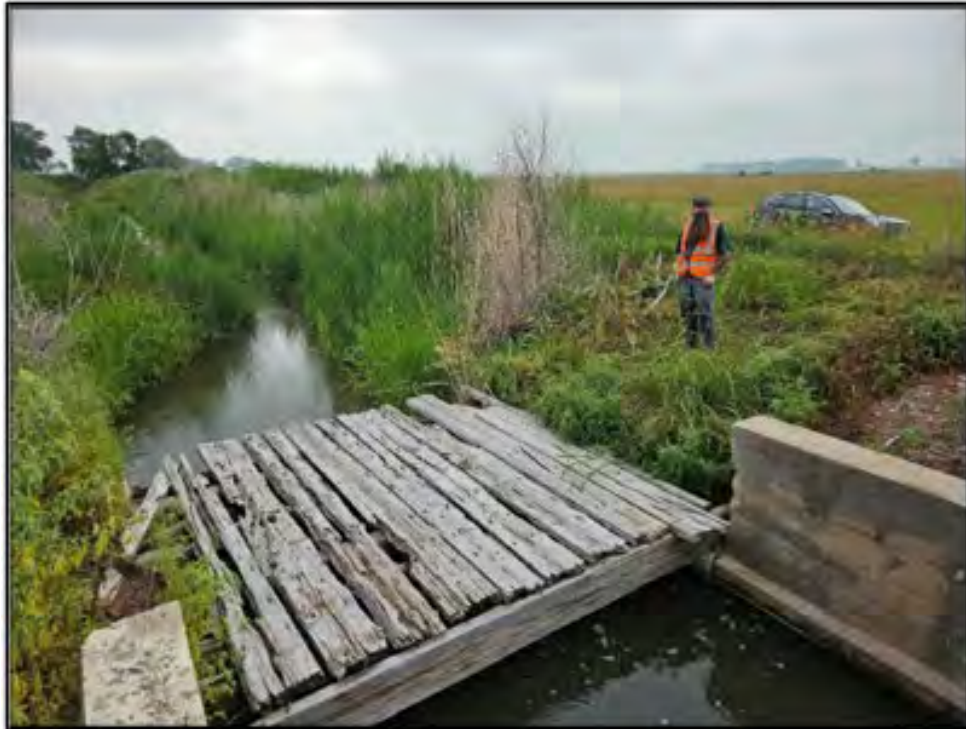
Figure 99. Cody Dillon Canal: Feature 5, decayed wood vehicle bridge. View to the east from the access platform of the headgate (Feature 4). Photograph taken on July 21, 2025.

Feature 5 is a severely decayed and structurally weak milled plank vehicle bridge that measures 12 ft long and 10 ft 5 inches wide (Figure 99). The planks are fastened to eight wood stringers with wire spikes and nails. The structure sits on concrete abutments that are immediately downstream of the headgate abutment walls.

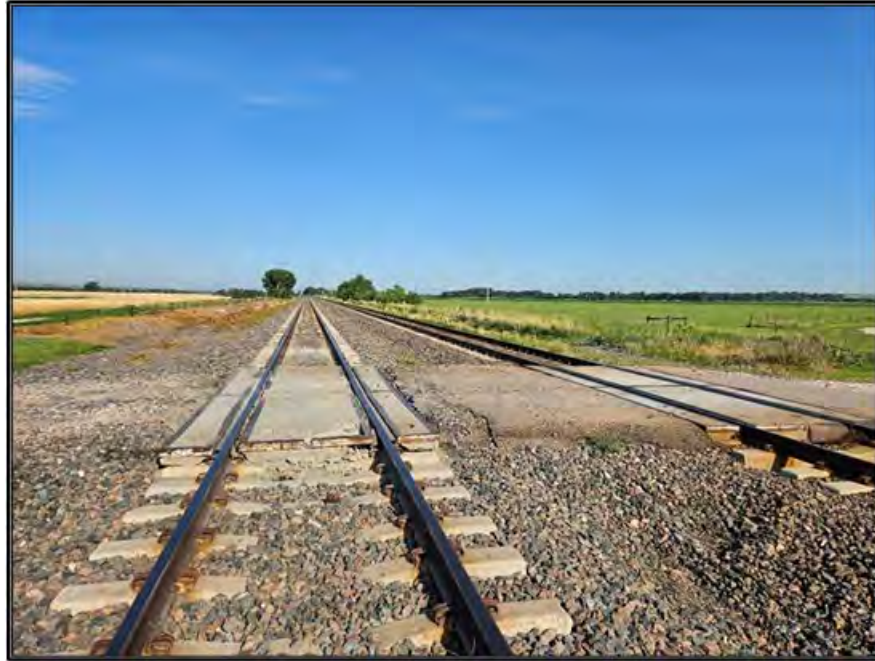
Figure 100. O&RV / Union Pacific Railroad: Segment 1 overview at the north end of the Keith Lincoln access road corridor survey area. View to the west. Photograph taken on July 15, 2025.

This segment of the historic O&RV / Union Pacific Railroad consists of a double set of modern steel railroad tracks supported by modern concrete railroad ties with gravel ballast. The road crossing is a concrete flush crossing. No historic elements were observed within the inventory area.

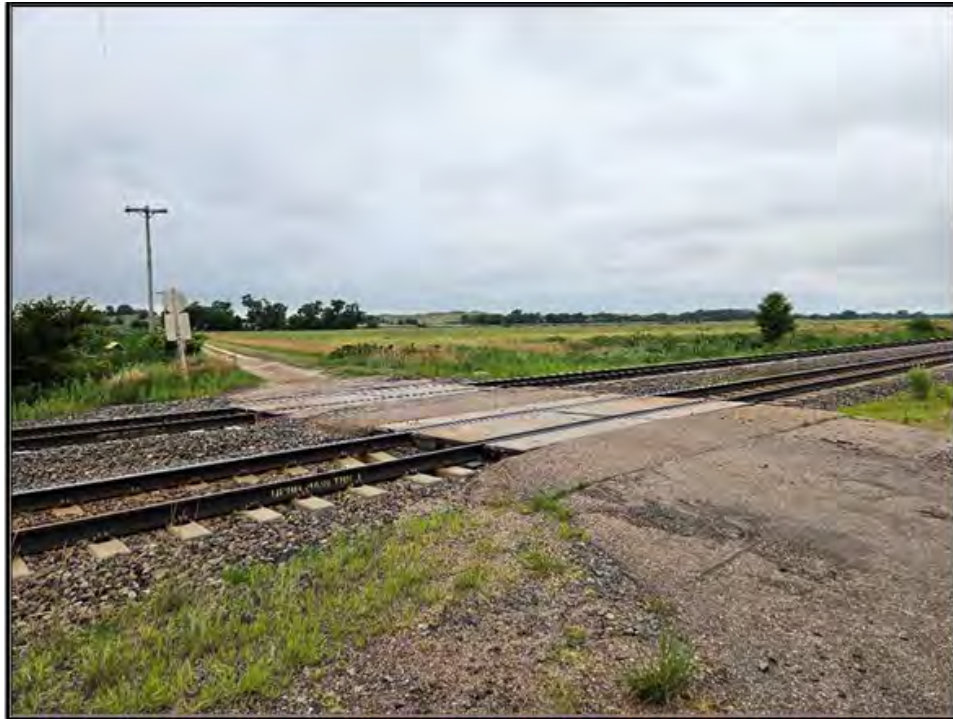
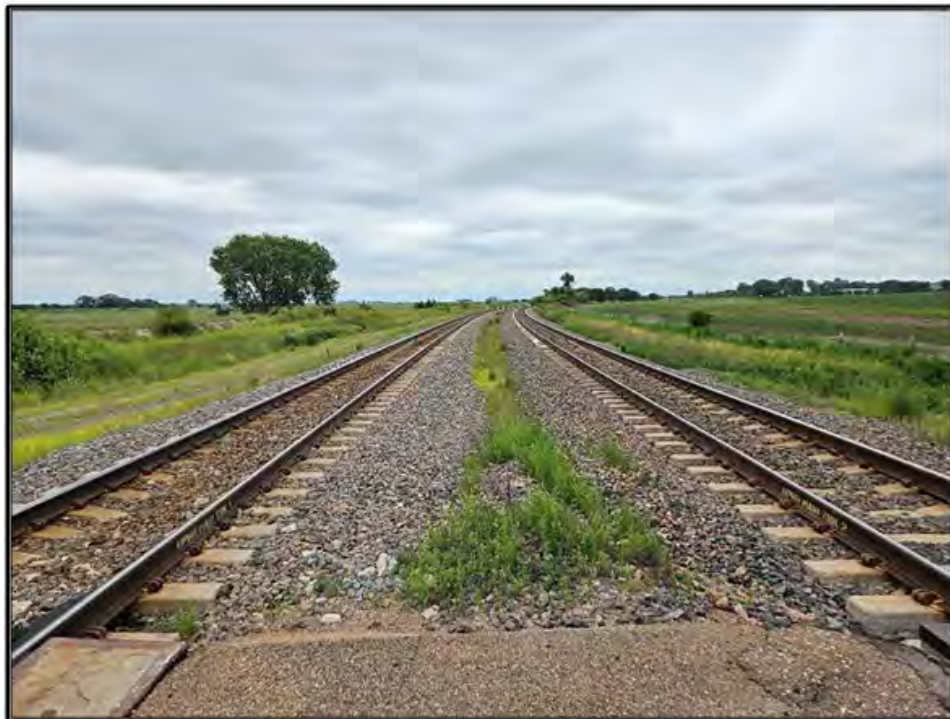
Figure 101. O&RV / Union Pacific Railroad: Segment 2, overview at the south end of the North Platte / Platte Valley access road corridor. View to the southwest. Photograph taken on July 16, 2025.

Figure 102. O&RV / Union Pacific Railroad: Segment 2, overview at the south end of the Paxton Hershey access road corridor. View to the southwest. Photograph taken on July 16, 2025.

This segment of the historic O&RV / Union Pacific Railroad consists of a double set of modern steel railroad tracks supported by modern concrete railroad ties with gravel ballast. The road crossings in the North Platte and Hershey Paxton survey parcels are both concrete flush crossings with asphalt approaches. No historic elements were observed within the inventory area.
