Progress Report on the Use of Piligrass (*Heteropogon contortus*) Hay Bales for the Island of Kaho`olawe's Highly Erodible Sites

Glenn Sakamoto, September 2008

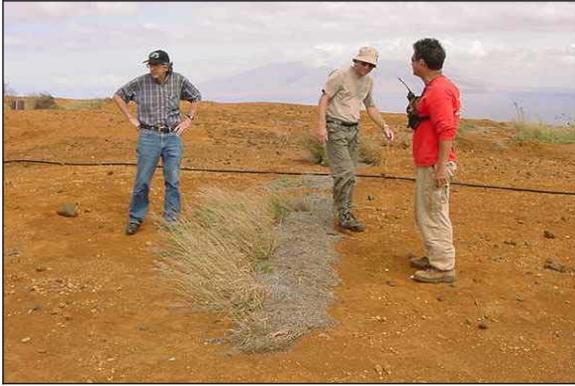
Robert Joy, USDA NRCS; Paul Scales USDA NRCS; and Paul Higashino, KIRC April 2005 look at pilgrass flakes installed in 2004. Photo taken October 2005

Mulching by separating flakes or sections from bales and placing them on the hardpan areas is working. At one site visited, it was observed that by placing these flakes across the slope on gently sloping areas (less than 2 percent) enabled wind blown sediment and soil runoff to accumulate within and up slope of these flakes. This accumulation of soil provided a suitable environment for seeds within the piligrass bales to germinate and grow along these flakes. These flakes were approximately 2-3 inches thick and laid side by side in a single row. According to Paul Higashino, Natural Resource Specialist for KIRC, the sheets were installed in February 2005. During a site visit in October of 2005 of the same area, the piligrass was approximately 14 inches tall and soil deposition by wind and runoff was very noticeable. The growing piligrass formed a vegetative barrier along the edges of these flakes and trapped sediment. Though the treatment area visited was small (less than 10 feet long), the effects were positive and effective in controlling erosion. In August of 2008, a site visit to the same area showed piligrass, natal redtop, (*Rhynchelytrum repens*) and `Uhaloa, (*Waltheria indica*) growing within and along these piligrass sheets. The overall vigor of these plants was good, considering it was in the middle of summer and not irrigated. The use of this method also enabled the KIRC staff to maximize the use of the bales. Mr. Higashino estimates that for each bale used in this method, one could cover approximately 15 to 20 linear feet of mulch. In contrast, using entire bales that have not been separated would require 24 bales.

It was interesting to note that the flakes did not blow away with the wind. This was either due to the placement of the flakes in a slight depression or direction of the prevailing trade winds. Placing these flakes along the contour of a slope, staking the flakes to the ground in the hardpan areas, would be most beneficial. Mulching as a conservation method is simple and requires minimal amount of resources.

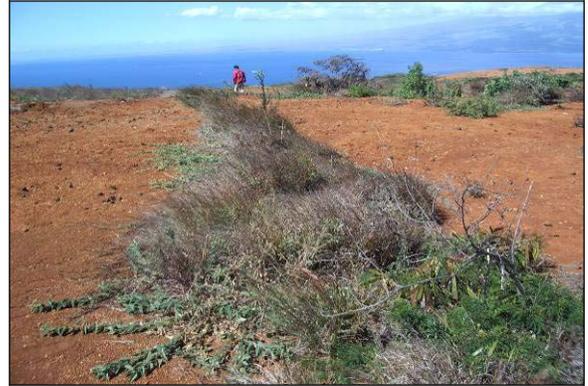
Established Piligrass mulch flakes installed 2004. Note pilgrass and *Walthria indica*, *Ualoa* growing along mulch line. August 2008

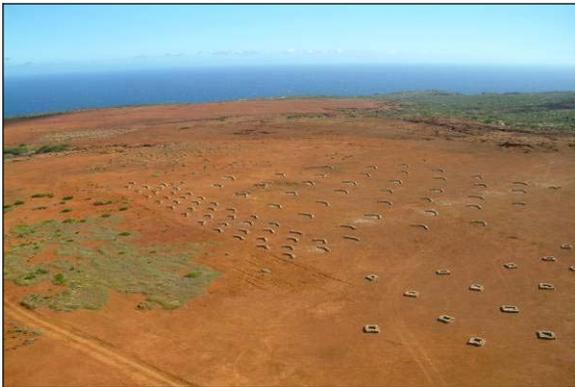
Piligrass hay bales at LZ-3, Kahoolawe "C" and Box configurations. Photo by Paul Higashino, KIRC, May 2006

In one area of LZ-3, adjacent to and directly downwind of Rene Silva's native planting site, the "C" hay bale method was placed in rows perpendicular to the prevailing trade winds. Each succeeding row was slightly off set from the previous row and formed a staggered formation. A total of four rows approximately 250 feet long were installed. The spacing between and within the rows are approximately 12 to 15 feet. Further downwind of these crescent structures, larger "C" bales were situated, using more than 6 bales per crescent and spaced farther apart. Seven rows of this configuration were installed. These structures collect a considerable amount of windblown sediment. On some of these structures, soil deposition by wind erosion reached the top of the bales (15") within a one year period. Plants such as Pili, `Aweoweo, and `A`ali`i were growing in good condition and mainly growing along the edges of the piligrass bales and sediment deposits. The plant height of the piligrass ranged from between a few inches to over 22 inches in height. `A`ali`i plant heights ranged from several inches to heights of 32 inches. These plants grew from seed under natural rainfall conditions and were either naturally windblown into these "C" structures or manually distributed by KIRC staff. The original "C" structures (2003) remain intact, though the baling twine and hay were brittle. The decomposition of the bales has been slow and thus, should withstand the elements, as long as the bales are not trampled or stepped on.

Just north and adjacent to the "C" structures, are the box or kipuka configurations. These boxes were also initially installed in August of 2003. The use of the piligrass box configuration was gradually increased, as piligrass became readily available at the PMC. These boxes were installed in rows approximately 15 to 20 feet apart. The number of rows was estimated to be between 10 to 15 rows and 250 or more feet in length. Seed of Pili, `A`ali`i, `Aweoweo and Kawelu were sprinkled in these boxes prior to the rainy season. If recycled potting mix was available from other planting projects, they were deposited in these boxes. According to Paul Higashino, after the 2003 rainy season, native plant seeds germinated and grew. `Aweoweo, Pili and `A`ali`i fared the best and survived the first dry summer of 2004. The Kawelu seedlings, however, did not fair as well. During a site visit in October of 2005, `Aweoweo plants were the dominant species within these boxes. Their height was approximately 20 to 30 inches and in good vigor. Piligrass and `A`ali`i were noted within and along the boxes, their numbers were few, and plant heights were between a few inches to a foot tall. During another visit in August of 2008, `Aweoweo continued to be the dominant species within the boxes, but in fair vigor. `A`ali`i and piligrass were noted in the original boxes and growing in fair to good vigor, 12 to 24 inches in height.

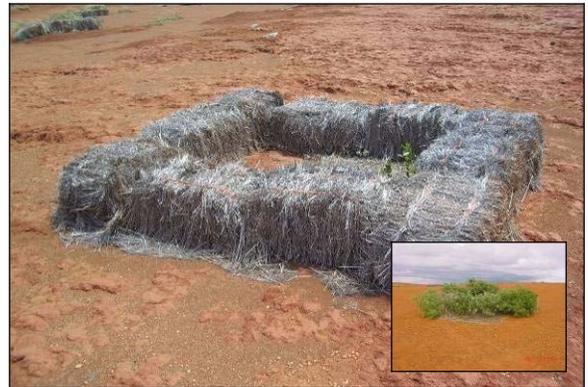
Piligrass hay bales in box configuration installed in 2004 at Moiwī bypass road on Kahoolawe. Photo inset of *Aweoweo* growing in box October 2005, LZ-3

The "kipuka's" or boxes have proven to be one of the successful methods to establish native plants on the Kahoolawe hardpan. It traps windblown soil deposition and provides the needed environment for plants to grow. Wind protection and moisture retention is one of the positive attributes of this design. The concept is simple, with no materials other than bales and seed. No wooden staking or mechanical intervention was involved to secure the bales or to establish the plants. This concept is extremely important due to the hazards of unexploded military ordinances.

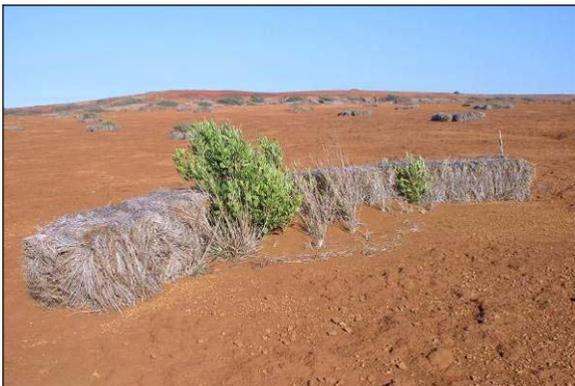
Piligrass hay bales "C" configuration August 2008, LZ-3 Kahoolawe

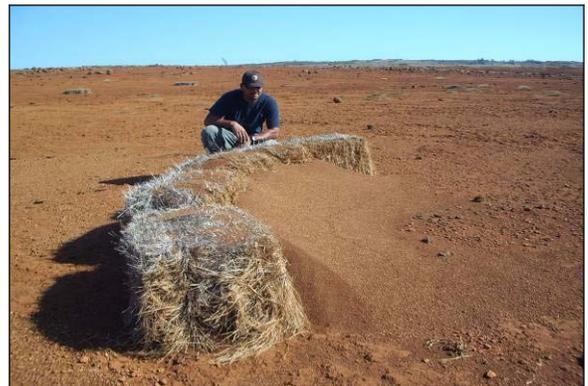
LZ-3, David Duvauchelle next to "C" configuration installed April 2007. Photo taken August 2008, 16 months later

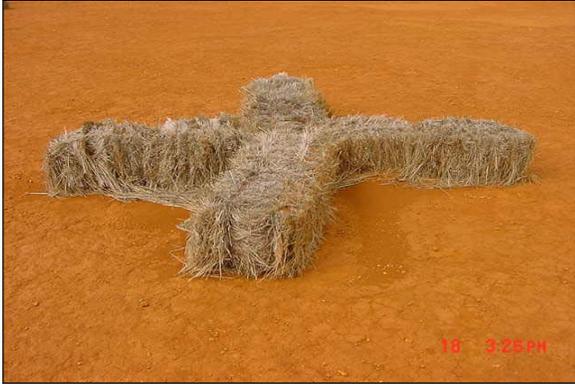
X configuration using 8 piligrass bales LZ-3 2005

Other configurations, such as the "C" and "X" have proven to work well utilizing the piligrass hay bales. The "C" or crescent shape configuration works as such: six piligrass bales are lined up to form a crescent shape, with the opening facing the prevailing trade winds. These configurations range in length of between 10 to 12 feet. This allows windblown sediment deposition and seeds to be captured in the cup of the crescent shape structure. And the "X" configuration works with the concept of the bales forming an "X" shape, the center of the "X" forming a square hole. This method utilizes four to eight bales per "X", and is designed to trap windblown soil deposition and seed from the any direction. Depending on the availability of bales, four bales created a 6' x 6' "X". An eight bale "X" configuration created a 10.5' x 10.5' "X". The center of the "X" with its square (18" by 18") hole acted as a planter box where seeds could be planted.

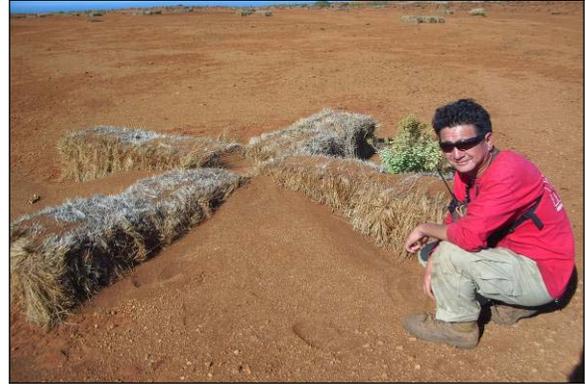
Paul Higashino, KIRC at one of the 'X' structures at LZ-3 August 2008. The "X" was installed in April 2007 Note wind blown soil deposits

The use and placement of these configurations is by far the most eye catching, as one approaches LZ-3 (West of Kanapou) and the Moiwi area on Kahoolawe. From a distance, whether you approach by air or vehicle the "X" and "C" boxes look out of place in the barren, windy and desolate hardpan of Kahoolawe. As one gets closer, you begin to realize that these configurations are sustaining plant life. The first of these configurations was installed in August of 2003 at LZ-3 and with each succeeding year, more of them were installed and expanded to include the Moiwi bypass road area. It is clearly evident that each of the different shapes did have an impact in collecting sediment and or promoting plant life. In an area that is totally dependent on natural rainfall, it was impressive to note at many native plants such as `Aweoweo, *Chenopodium oahuense*; `A`ali`i, *Dodonaea viscosa*; Piligrass, *Heteropogon contortus*; and Kawelu, *Eragrostis variabilis* are growing within these structures. Whether native seeds were intentionally seeded by KIRC employees or naturally windblown into these structures, it does indicate a positive step toward the vegetation recovery of the island.

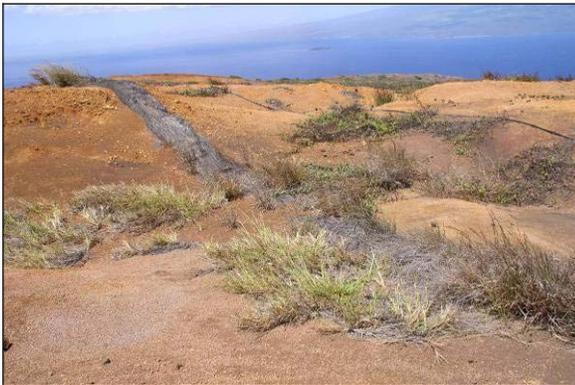
Piligrass wrapped in geotextile fabric were named the bundle or berm method. Native Kamanomano and Piligrass growing along bundles, August 2008

Another method utilized to trap sediment, is the construction of berms. Due to the nature in which the piligrass is compressed during the baling process, the bales can be peeled apart into various sized "flakes" or sections. The KIRC staff has taken advantage of this characteristic and fabricated "bundles" with piligrass flakes encased in commercially manufactured erosion control matting (geotextiles) in an attempt to conserve materials. Geo-textile matting is comprised either of straw, coconut fibers or polypropylene yarn, which are encased within polypropylene netting. Bundles are constructed by placing piligrass sheets or flakes within the geotextile matting and rolling it like a "burrito". These bundles are placed cross-slope on highly erodible sites and fastened in place with short wooden stakes.

Piligrass berms, as described earlier, essentially works in the same manner as mentioned above. The use of these berms has proven to be somewhat successful in areas, where the land is sloping less than 5 percent. Along the north to northeast rim of Lua Makika, berms such as these were installed as early as August of 2002. These small berms are successful in controlling low flow sheet and rill erosion. Although the original berms have not been revisited, newer berms have since been installed on the northeast rim and southeast rim of Lua Makika. Berms on slightly sloping land provided enough sediment deposit for KIRC employees to plant grasses and shrubs such as *Cenchrus agrimonioides*, Kamanomano and *Achyranthes splendens* respectively. During a site visit in August of 2008, three year old berms were still intact and providing erosion control to surrounding areas. The coconut fibers within the polypropylene netting have decomposed somewhat, but piligrass straws still remain. The use of this method, though expensive and time consuming, may prove to be a good candidate for areas such as the LZ-3 hardpan area. The use of piligrass is effectively and efficiently used with minimum waste. By placing these berms on contours and are spaced appropriately, sedimentation deposit and erosion may be minimized.

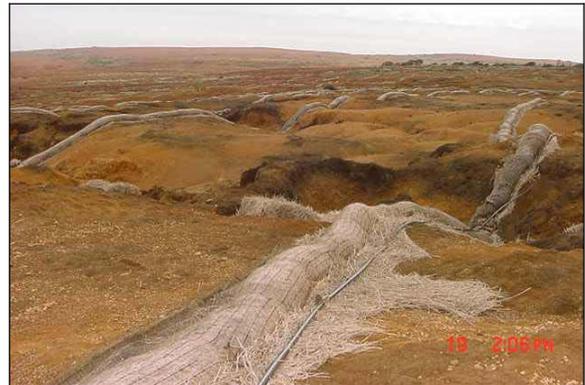
Piligrass bundles installed in 2005 on southeast rim of Lua Makika, Kahoolawe

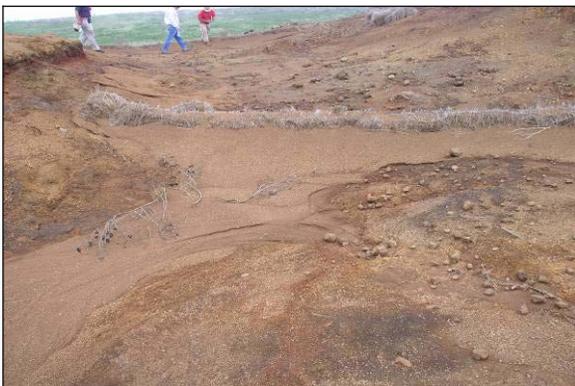
Piligrass bales used to trap sediment runoff in washouts and small gullies at the summit of Lua Makika, 2005

This method of using piligrass for sediment trapping, was initially installed in the summer of 2002 along the outer rim of the Lua Makika summit. Pili bales were used to trap and slow down the movement of soil in depressions and gently sloping (less than 5% slope) washouts. Piligrass bales were simply laid length wise, end to end to create a wall of piligrass. By installing the bales perpendicular to the direction of the flow of water, sedimentation of soil after a storm was immediate. The concept has been somewhat successful and its use is being increased with in specific areas of Kahoolawe. The sedimentation that has occurred upslope of these bales has made it an excellent medium to plant native grasses and shrubs. The original bales that were installed in 2002 are currently in place, as of the August 2008 site visit. These bales, though old and crumbly are still doing the job it was intended to. The disadvantage of this method, in the long term (7 to 8 years) would be the maintenance of these sediment traps. As stated earlier, hay bales should be used as a temporary structure to aid in a series of steps towards a permanent erosion control system. It was noted that though the bales worked well in trapping soil, eventually, the sediment traps filled up with soil, and water overtopped these bales. This overtopping of water during storms on the down slope of the bales began to undermine and erode beneath the bale. The proper construction of these sediment traps is crucial. The USDA NRCS does provide information on the construction of "checkdams" that is quite similar to the ones being used on Kahoolawe.

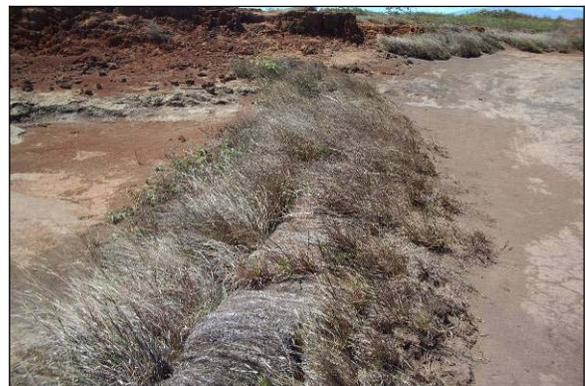
Piligrass bales installed in 2002 continue to trap sediment. Note piligrass growth both up slope and down slope of bales. August 2008

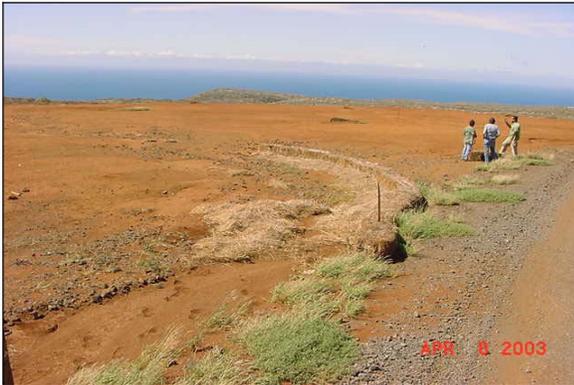
Piligrass bales used to divert water away from road shoulders before causing further damage down stream. Structure was installed in early 2003. Photo taken in April 2003

Piligrass bales have been used, but to a lesser degree, in channeling water away from the main access road from Honokanai`a Bay to Lua Makika Crater (approximately 11 miles long). During heavy storms, water runoff along the access roads can severely damage road shoulders. Piligrass hay bales were installed to divert surface runoff before it caused further damage down stream along road shoulders. One noted hay bale diversion was installed in 2003 near the Moiwī bypass road area and is still intact

today. It has weathered through several major storms and continues to function for the purpose intended. It is uncertain if staking the bales was ever done, as they did not appear to have moved in any way, by the force water flow. It was interesting to note that volunteer piligrass has grown along the edges of the bales and possibly aided in the bales stability during heavy water flow. Sedimentation was also noted being trapped along side and within the bales and being slowed by the piligrass vegetation. Although the accumulation of sedimentation, and vegetation is forming a natural water bar to re-direct water flow away from road shoulders, the use of hay bales for this practice should be used with caution and in conjunction with other conservation practices.

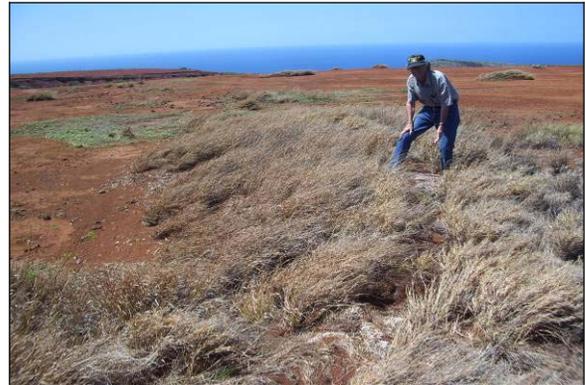
Bob Joy stands along the same structure taken in August of 2008. Piligrass bales are barely visible but continue provide the function as it was intended.
