# Another Conservation Success Story...

## Chattahoochee County, Georgia

### River of Mud Becomes a Stream of Traffic

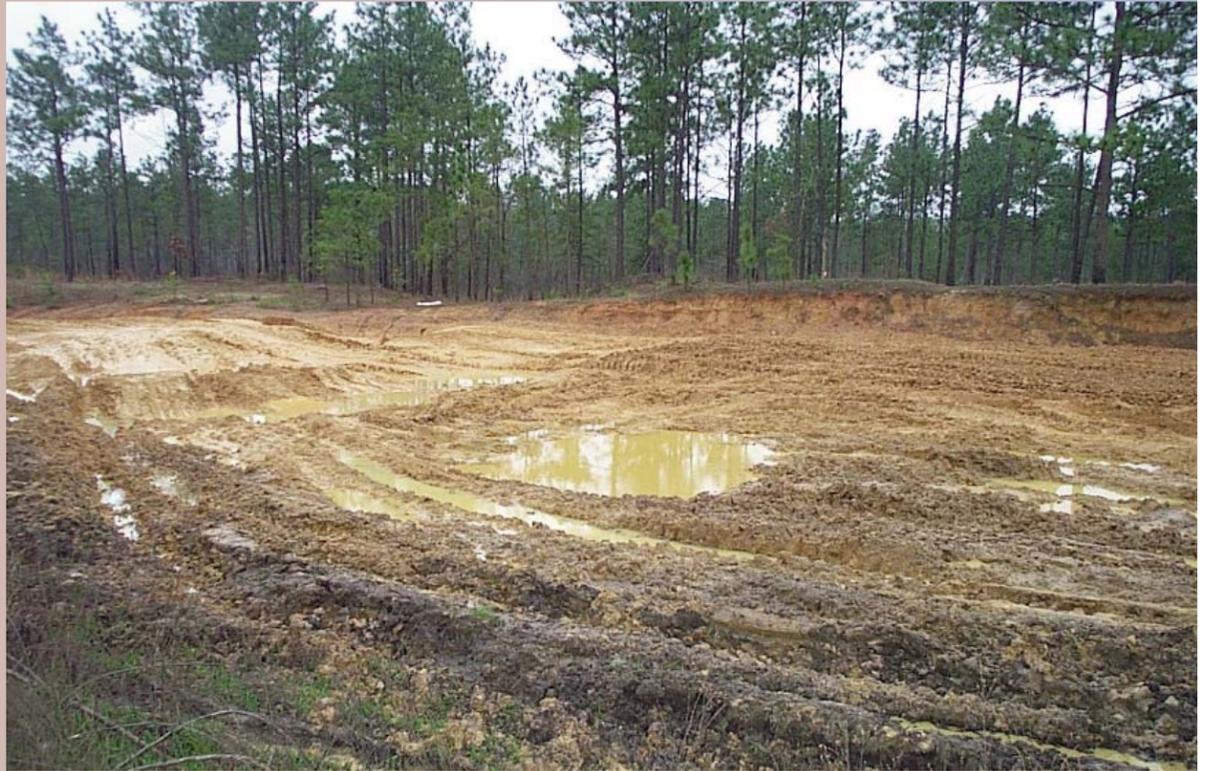
The tank trail in the A7 Training Compartment was a prime example of where an especially bad segment of the trail was located adjacent to Martin Range.

Even though it was a primary travel route out to the mechanized training areas, over time the severity of the damage and concerns for safety forced all traffic to be detoured to a longer secondary route. Routine maintenance per-

Before - March 6, 2003

The NRCS was asked to assist in permanently correcting the damage and stabilizing the site to provide all-weather access for mechanized vehicles. After a thorough investigation of the site, a plan was developed by NRCS and the representatives of the Army to remedy the problem.

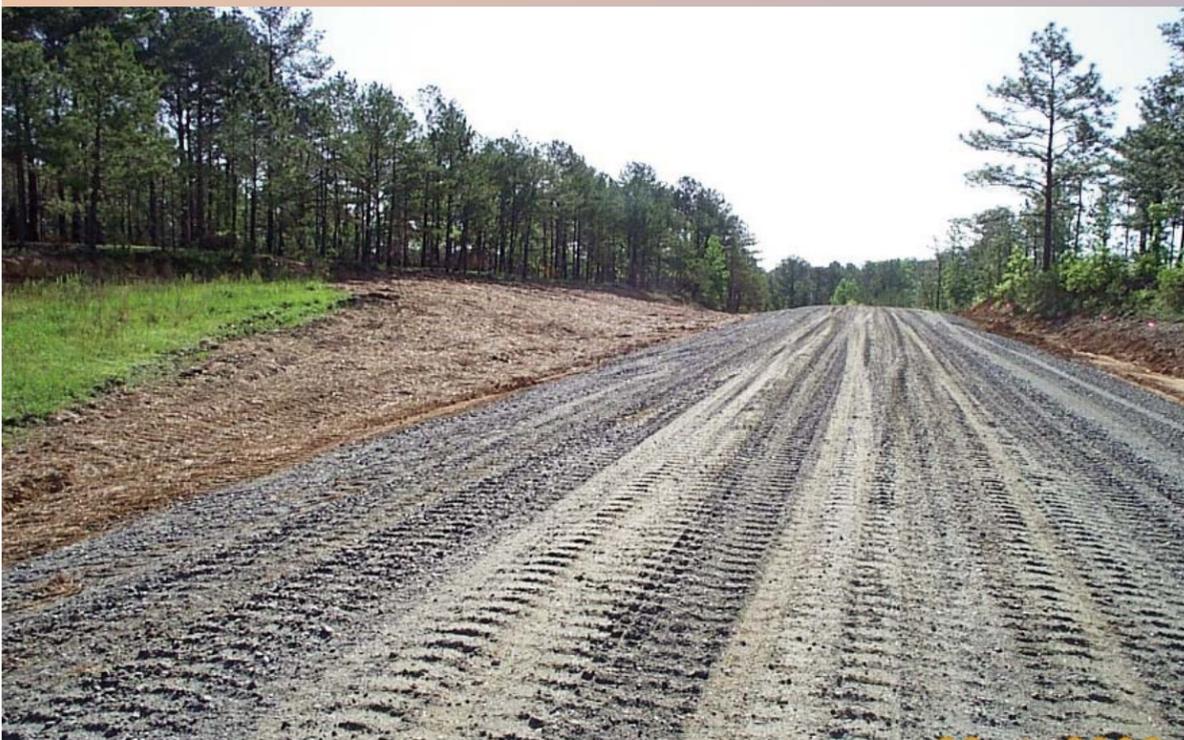
By extending NRCS's traditional concept of heavy use protection to accommodate the foot print of a 60 ton tank, the A7 tank trail is back in use and is holding up well in all types of weather.

After - April 22, 2003

To stabilize the site, it was first necessary to remove approximately 2 feet of unconsolidated mud and soil.

Once the sub-grade preparation was complete, a 12 inch layer of No.3 coarse aggregate stone was put down on a geotextile fabric to form a foundation.

The coarse aggregate stone also provided drainage relief for wet weather seepage. This stone was then covered with 9 inches of finely graded aggregate base material, crowned, and compacted to provide a smooth durable two lane driving surface.

The ditches, shoulders and road banks were reshaped to provide for stable surface drainage and all disturbed areas were vegetated.
