United States Department of Agriculture  
Natural Resources Conservation Service

## Animal Enhancement Activity –ANM18- Retrofit Watering Facility for Wildlife Escape

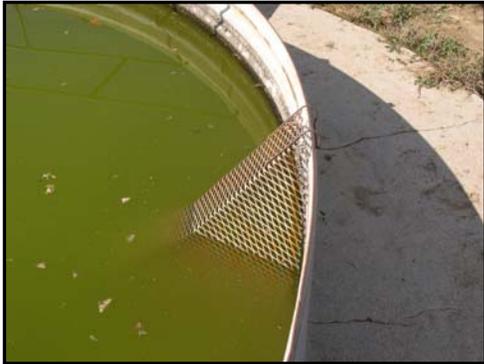
Retrofit existing watering facilities (troughs, tanks, etc.) to allow for the escape of wildlife that become trapped while trying to drink.

- Extend into the water and meet the inside wall of the trough
- Reach to the bottom of the trough
- Be firmly secured to the trough rim and to the bottom of the trough so as not to be displaced by livestock
- Be built of grippable, long-lasting materials, such as painted or coated metal grating, roughened fiberglass, concrete, rock and mortar, or high-strength plastic composites.
- Have a slope no steeper than 45 degrees
- Be located to cause minimal interference with livestock
- One structure for every 20 linear feet of trough edge.
