Rapid Watershed Assessment,
Keweenaw Bay Indian
Community

Western Upper Peninsula Planning &
Development Regional Commission
10/1/2008

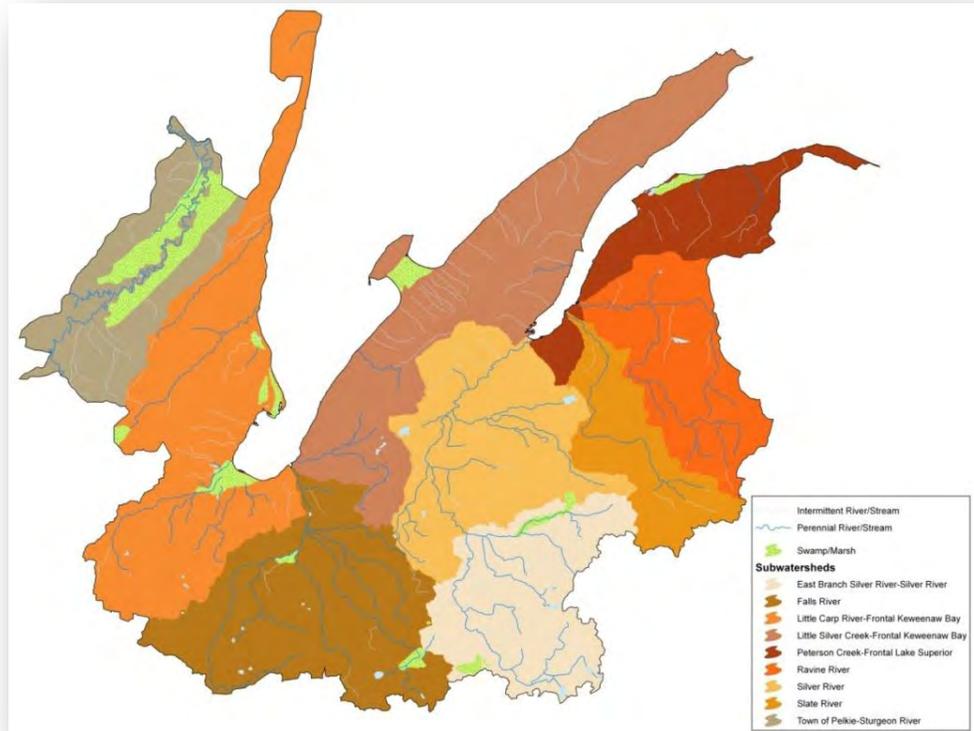
Map 3: Sub Watersheds, Appendix 3

The scope of this project incorporates 9 sub-basins. Within the 9 sub watersheds there are 16 perennial rivers and numerous intermittent stream systems. There are 257 miles of perennial rivers and 117 miles of intermittent rivers/streams. In addition, there are a

total of 74 miles of coastline of Lake Superior. All but one water system drains into either Keweenaw or Huron Bay of Lake Superior. The Sturgeon River sub-watershed flows into Portage Lake, which is a tributary of Lake Superior. The other main rivers consist of the Silver, Slate, Falls and Ravine River that flow into Lake Superior.

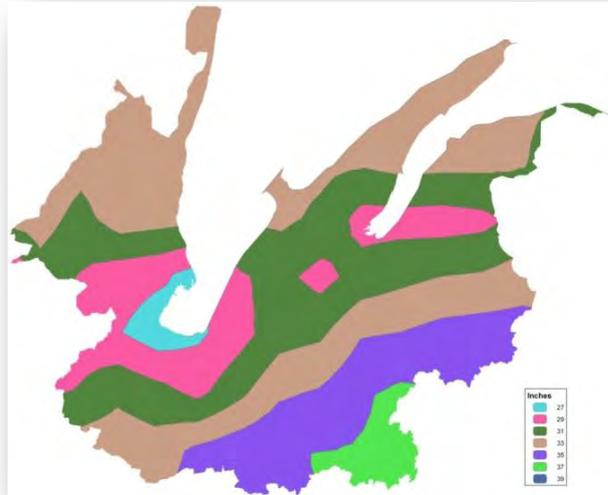
Map 4: Precipitation, Appendix 4

KBIC Rapid Watershed Assessment project area has an average annual precipitation of 32 inches (see Map 4).

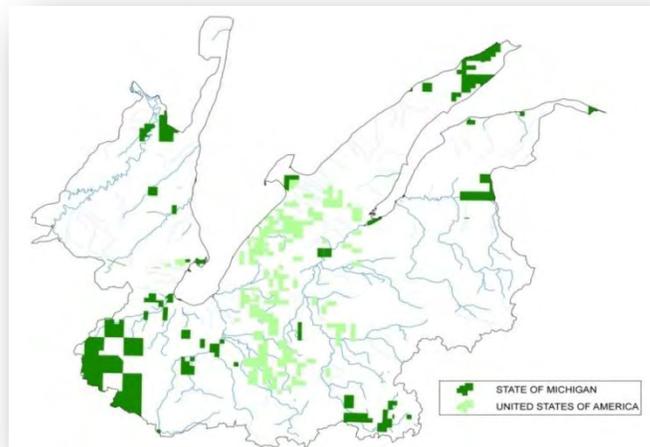
Map 5: Public Land, Appendix 5

The total watershed has nearly 40 square miles of public lands, which accounts for only 13% of the total watershed area. These public lands are either State or Federal and are dispersed throughout the watershed area. The land cover of this publicly owned land is primarily forest land of a mix of northern deciduous and coniferous trees.

Table 2: Public Lands		
Ownership	Acres in Watershed	% in Watershed
State of Michigan	12,597	6.20%
U.S. Government	10,020	5%

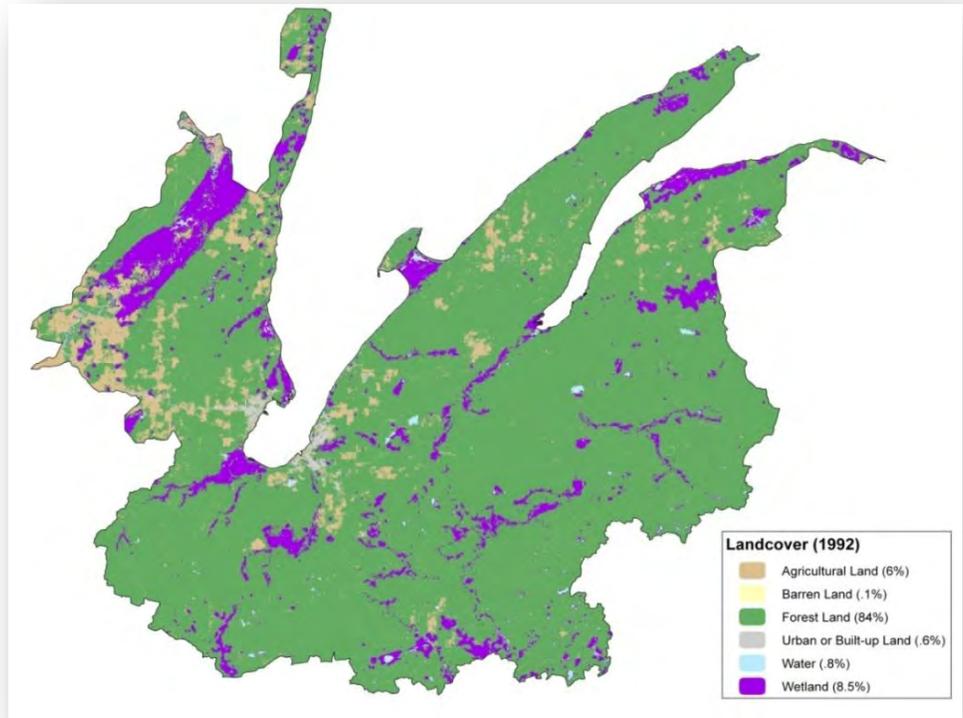
Map 6: Land Cover, Appendix 6

The terms land cover and land use tend to be interchangeable. However there are differences. Two land parcels may have similar land cover, but different land use. Land cover refers to the features that cover the land. For example, the land covered by trees, water, or by buildings. The land cover within the project area is primarily forest land accounting for 84% of the coverage, followed by wetland at 8.5%. Land use refers to how land is used by humans. That is, economic use to which land is placed. For an example, forest land used for recreational purposes or commercial forestry or even residential.

Table 3: Land Cover Classification		
Land Cover	Acres in Watershed	% of Watershed
Agricultural	12,849	6.0%
Barren Land	15	0.1%
Forest Land	174,943	84.0%
Urban or Built up Land	1,240	0.6%
Water	1,722	0.8%
Wetland	18,059	8.5%

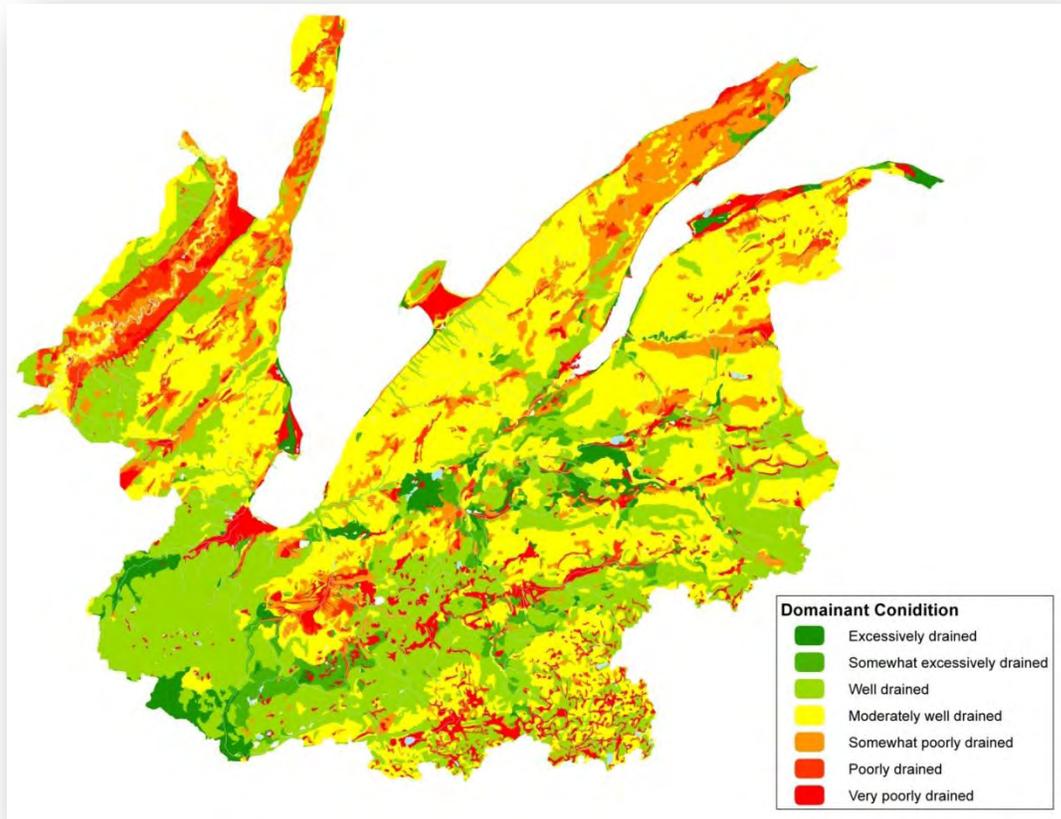
Map 7: Soil Drain Classification, Appendix 7

Drainage class refers to the frequency and duration of wet periods under conditions similar to those under which the soil formed. Alterations of the water regime by human activities, either through drainage or irrigation, are not a consideration unless they have significantly changed the morphology of the soil.

Seven classes of natural soil drainage shown in Map 7 “Soil Drain Classification” are recognized and are defined in the “Soil Survey Manual”.

Table 4: Soil Drain Classification			
Domainant Condition	Acres in Watershed	Sq Miles	% of Watershed
Excessively drained	7,231	11.2	3.5%
Somewhat excessively drained	8,165	12.7	4.0%
Well drained	63,912	99.8	31.1%
Moderately well drained	77,187	120.6	37.6%
Somewhat poorly drained	25,484	39.8	12.4%
Poorly drained	11,549	18	5.6%
Very poorly drained	11,809	18.4	5.8%

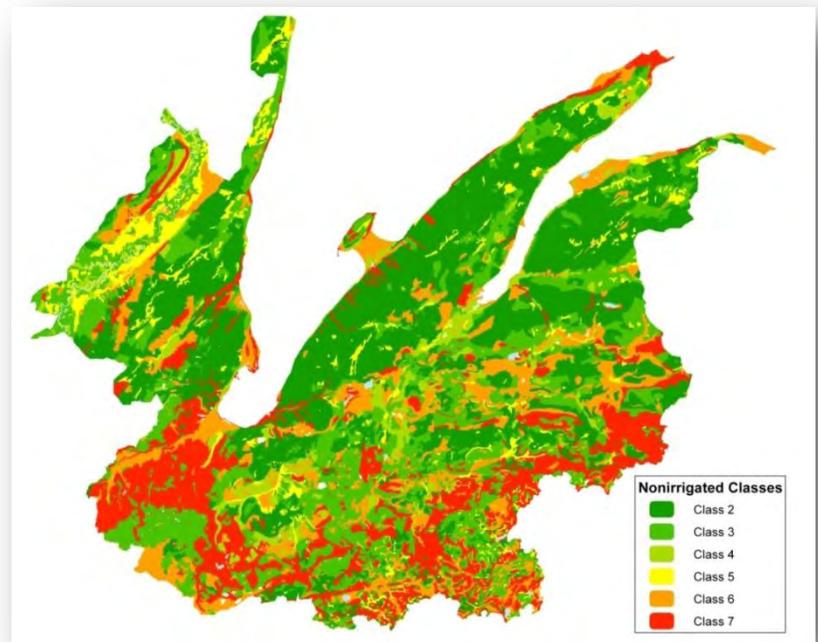
Map 8: Land Capability Class, Appendix 8

Land capability classification shows, in a general way, the suitability of soils for most kinds of field crops. Crops that require special management are excluded. The soils are grouped according to their limitations for field crops, the risk of damage if they are used for crops, and the way they respond to management. The criteria used in grouping the soils do not include major and generally expensive land forming that would change slope, depth, or other characteristics of the soils, nor do they include possible but unlikely major reclamation projects. Capability classification is not a substitute for interpretations designed to show suitability and limitations of groups of soils for rangeland, forestland, or engineering purposes.

Class codes 1,2,3,4,5,6,7, and 8 are used to represent both irrigated and non-irrigated land capability classes.

Table 5: Land Capability Class			
Nonirrigated Classes	Acres in Watershed	Sq Miles	% in Watershed
Class 2	69,986	109.35	34.0%
Class 3	51,390	80.29	25.0%
Class 4	10,530	16.45	5.0%
Class 5	11,097	17.33	5.0%
Class 6	28,131	43.95	14.0%
Class 7	34,204	53.44	17.0%

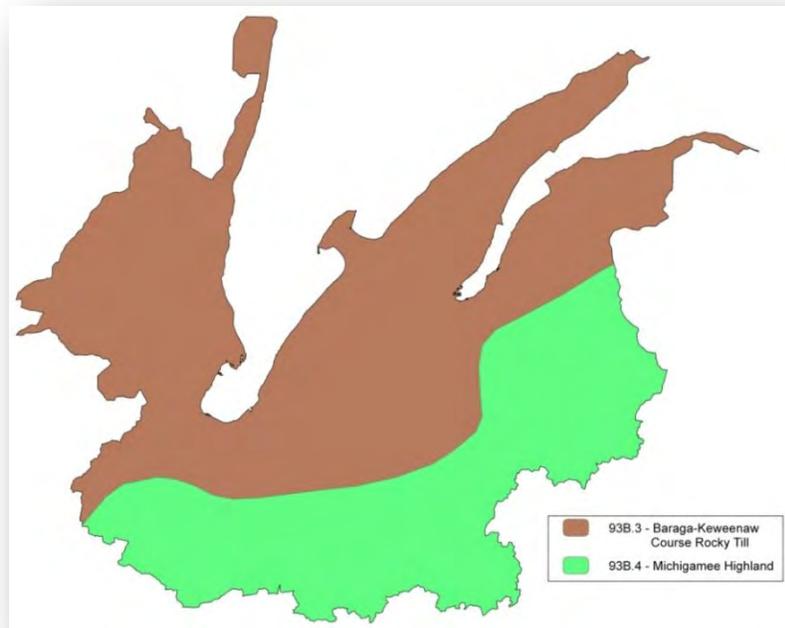
Map 9: Common Resource Areas, Appendix 9

The project area consists of two common resource areas, Baraga-Keweenaw Coarse Rocky Till and Michigamee Highland (see Map 9 “Common Resource Areas”).

Nearly level to steep ground moraine and ridges with areas of rock outcrops. Well drained to somewhat poorly drained loamy and sandy soils predominate. Mostly deciduous and coniferous forest. The major land use is woodland and recreation. Primary resource concerns are soil erosion, groundwater quality, surface water quality, forestland productivity, erosion during timber harvest and wildlife habitat.

Rock outcrop and nearly level to very steep, deep and moderately deep soils on bedrock controlled uplands. Well drained to somewhat poorly drained loamy soils predominate. Dominant land use is woodland. The primary resource concerns are soil erosion, groundwater quality, surface water quality and forestland productivity.

Table 6: Common Resource Areas				
Common Resource Area	Acres	in Watershed	Sq Miles	% in Watershed
Baraga-Keweenaw Coarse Rocky Till	133,904		196	64%
Michigamee Highland	75,177		117	36%

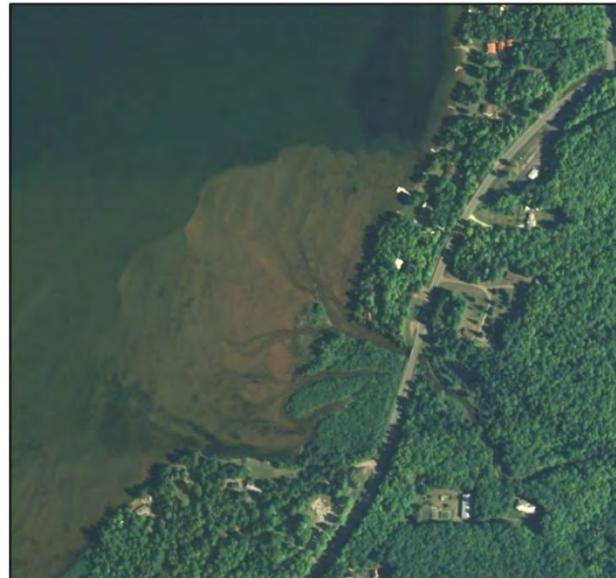
The picture to the right shows sedimentation deposit at the mouth of the Ravine River in Huron Bay.

Mouth of the Ravine River into Huron Bay

The main local resource concerns of this project area are fish passages on rivers and sedimentation being deposited at the mouths of rivers flowing into Lake Superior. Road crossings are known areas of sediment input if poorly constructed and drained. Sediment input into Keweenaw and Huron Bays can negatively impact spawning and other fishery habitat in the bays.

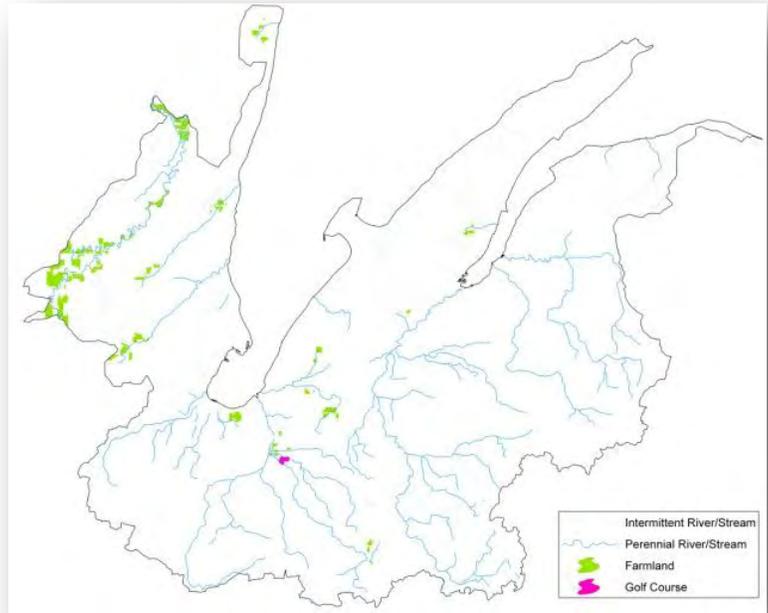
Map 10: Land Use, Appendix 10

Possible land uses of active farmland and golf courses may contribute to non-point source pollution, if adequate prevention measures are not implemented. Increasing the chemicals these land uses encounter places the natural resources of the watershed at higher risk of pollution because of their proximities to bodies of water. Farmland use may also introduce nutrients and bacteria into waters. These land uses are within 1,000 ft of a body of water and are indicated in Map 10.

Land Use	Acres
Active Farmland	2,202
Golf Courses	58

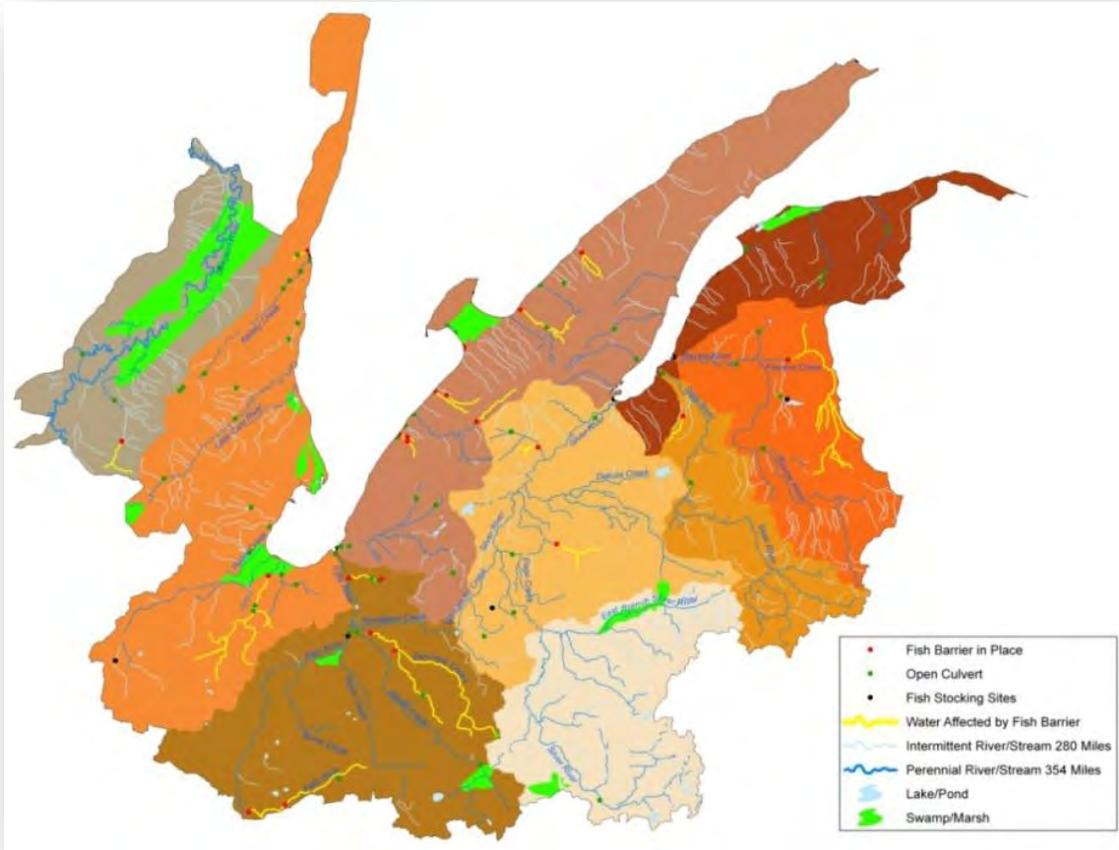
Map 11: Fish Barriers, Appendix 11

A survey was taken of 92 culverts and bridges within the project area. Of these 92 culverts and bridges inventoried, 25 of the culverts had a fish barrier. These fish barriers are affecting 32 miles of perennial rivers and 19 miles of intermittent streams (see Map 11 “Fish Barriers”).

Nearly all road crossings of rivers and streams are culverts and bridges that are intended for the purpose of vehicle access. However these crossings can lead to unintended blocking of migration of fish up or down streams. Fish movement within rivers and streams are vital for maintaining healthy populations.

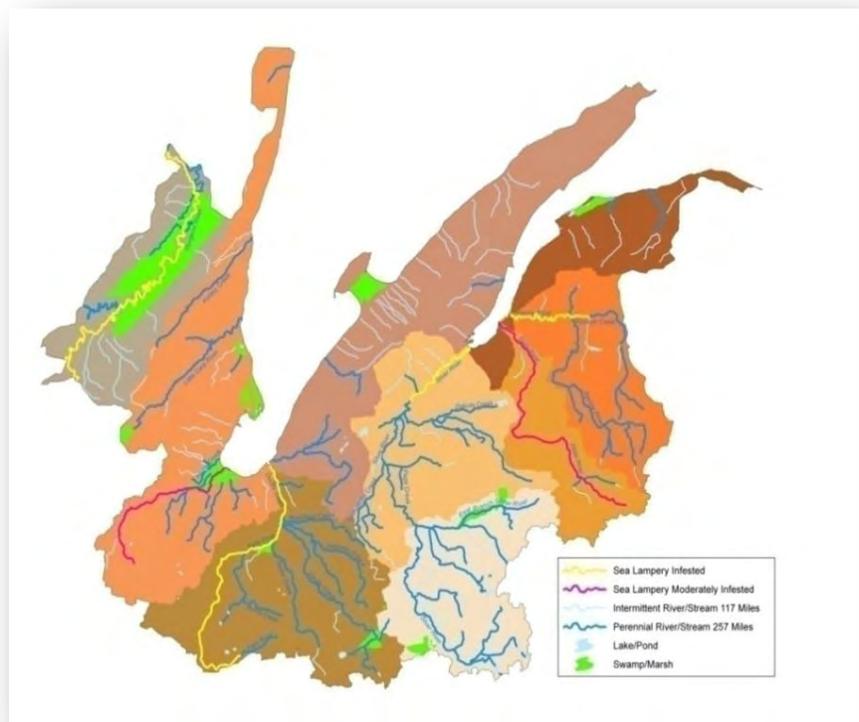
[Map 12: Sea Lamprey Infested Waters, Appendix 12](#)

The U.S. Fish and Wildlife Service (USFWS) Sea Lamprey Control program treats the following infested streams in the KBIC project area: the Ravine, Silver, Falls, and Sturgeon Rivers. The Slate and Six Mile Creek are two that are sometimes infested with sea lamprey and they survey these streams regularly and treat when necessary. There are a total of 72 miles of infested streams and 30 miles of moderately infested streams within the KBIC Rapid Watershed Assessment. These rivers are depicted on Map 12.

The Falls River is infested with larval sea lamprey from the mouth up to the waterfall at US-41. The bay is also infested offshore of the Falls River. The USFWS has estimated that approximately 22 acres of silt/sand habitat offshore of the Falls River is contaminated with larval lamprey.

The Ravine River has been treated for larval sea lamprey five times since 1998, and will be treated again in 2008. The main stream is often infested up to the junction of Fossom Creek. Fossom Creek is typically infested up to Roland Lake Road. There are also 12 acres infested offshore of the Ravine and this area will be treated in 2008.

The Silver River has been treated for larval sea lamprey nine times in the past 10 years and will be treated in 2008. None of the small tributaries are known to harbor larval lamprey. The lamprey are generally found up to the Silver Falls.

The Sturgeon River has been treated for larval sea lamprey four times in the past 10 years. Lamprey distribution on the river is usually up to the Prickett Dam and around the mouth of Clear Creek. This river is generally treated every four or five years if treatments are successful.
