**Animal Enhancement Activity – ANM18 – Retrofit watering facility for wildlife escape**

**ANM18 – OR      Retrofit watering facility for wildlife escape**

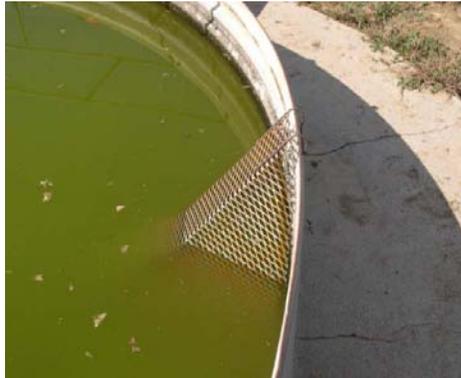
Retrofit existing watering facilities (troughs, tanks, etc.) to allow for the escape of wildlife that becomes trapped while trying to drink.

1. Extend into the water and meet the inside wall of the watering facility,
2. Reach to the bottom of the watering facility,
3. Be firmly secured to the rim of the watering facility so as not to be displaced by livestock
4. Be built of graspable, long-lasting materials, such as painted or coated metal grating, roughened fiberglass, concrete, rock and mortar, or high-strength plastic composites,
5. Have a slope no steeper than 45 degrees,
6. Be located to cause minimal interference with livestock drinking, and
7. One structure for every 30 linear feet of watering facility edge.
