## Emergency Watershed Protection Program

### **An EWP Success Story**

## Silver Lake Basin Marquette County, Michigan

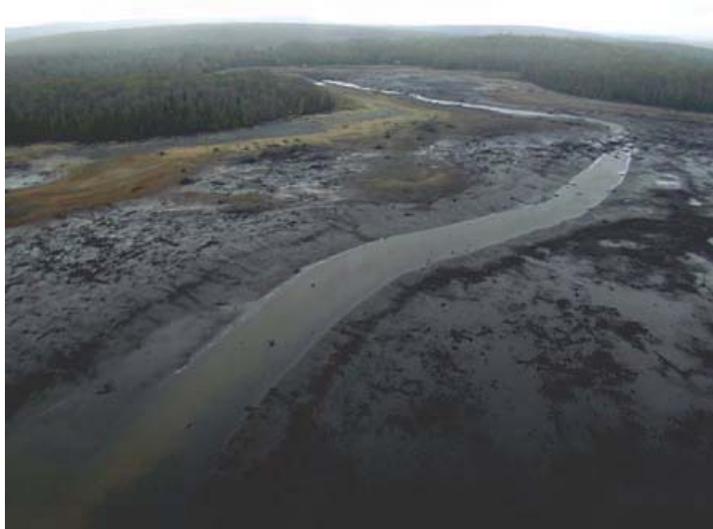
In rural Marquette County, an earthen dam on the Silver Lake Basin failed resulting in flooding of homes and businesses along the Dead River basin and in the city of Marquette.

Silver Lake Basin emptied after the dam failure.

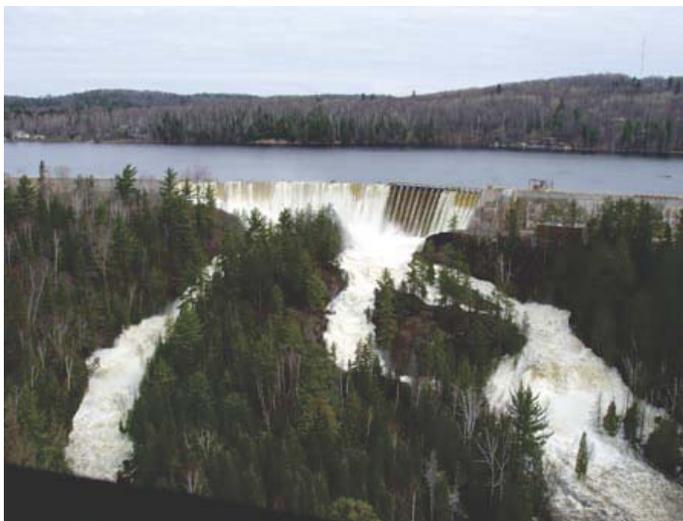
Downstream of the Silver Lake Basin, the Dead River Basin spillway overflowed during the flood.

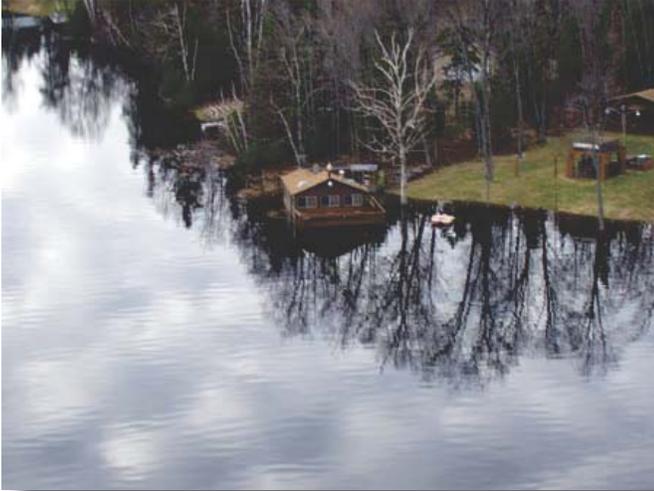
Flooded residence in the Dead River Watershed

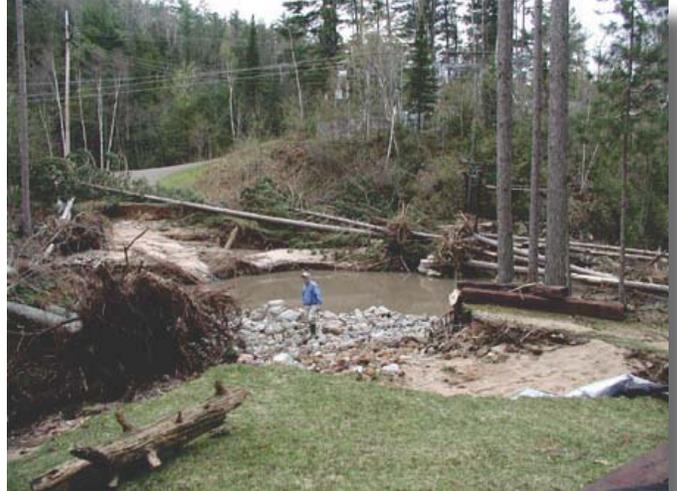
Road washout after the flood.

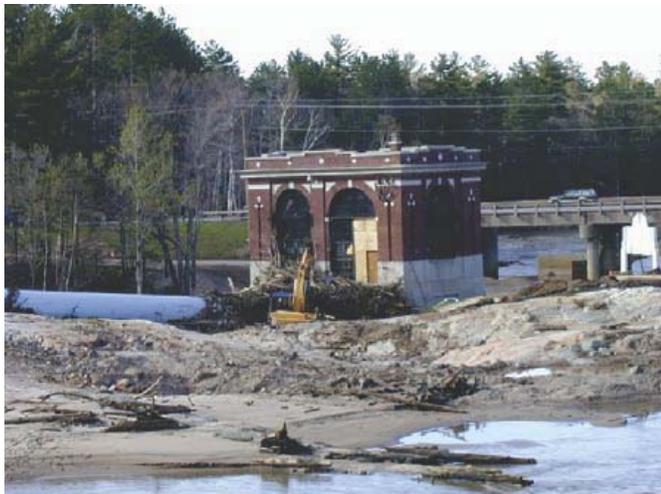
Debris removal at Tourist Park substation.

Debris was removed to reduce the risk of additional flooding of homes and businesses. Stream bank revetment measures were also installed to protect roads and public utilities.

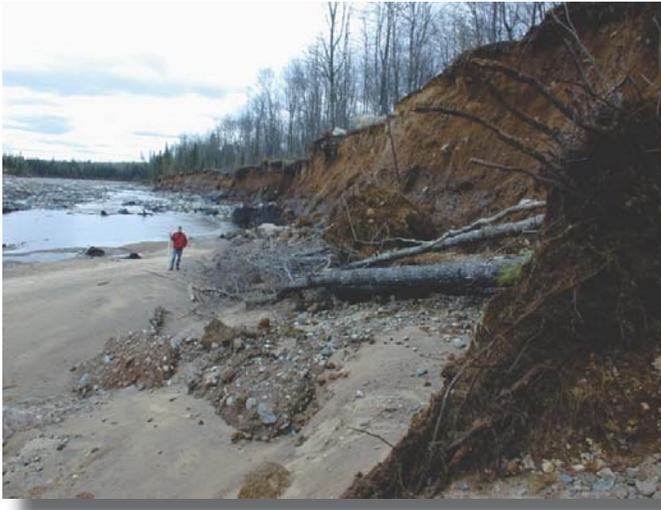
Before EWP recovery assistance:  
Severe streambank erosion downstream of the basin. (May 2003)

The restoration work involved stabilizing critically eroded areas so that project sponsors could repair washed out access roads to the hydroelectric power substations. Eroded areas were backfilled and seeded. Sediment was removed to alleviate the threat of additional damage to the power plant turbines.

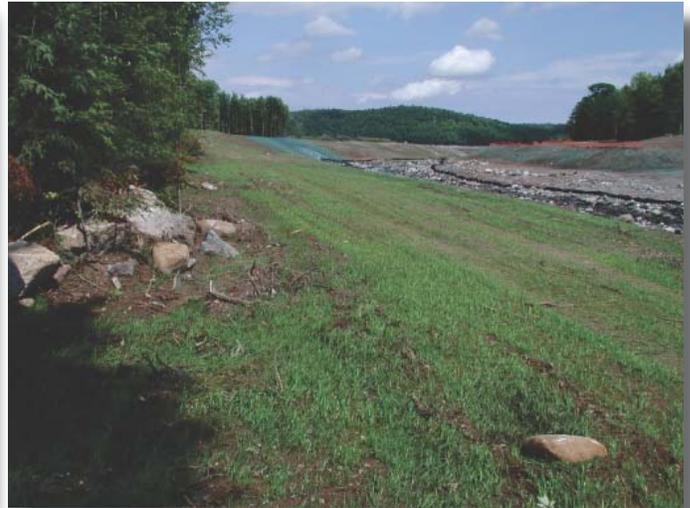
After EWP recovery assistance:  
Streambanks have been sloped and seeded. (July 2003)

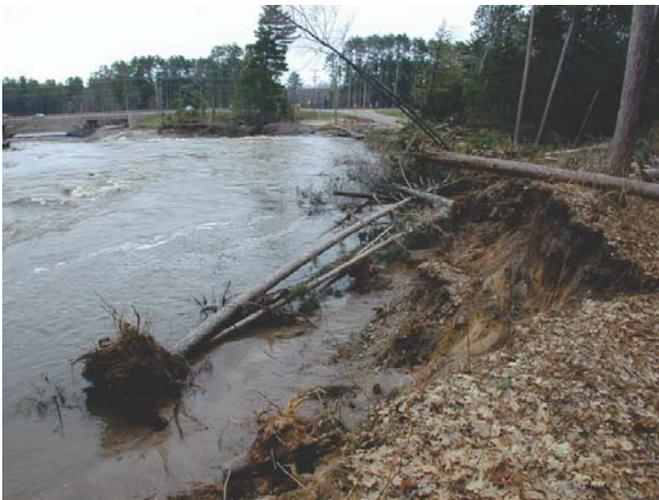
Before EWP recovery assistance:  
Tourist Park streambank erosion. (May 2003)

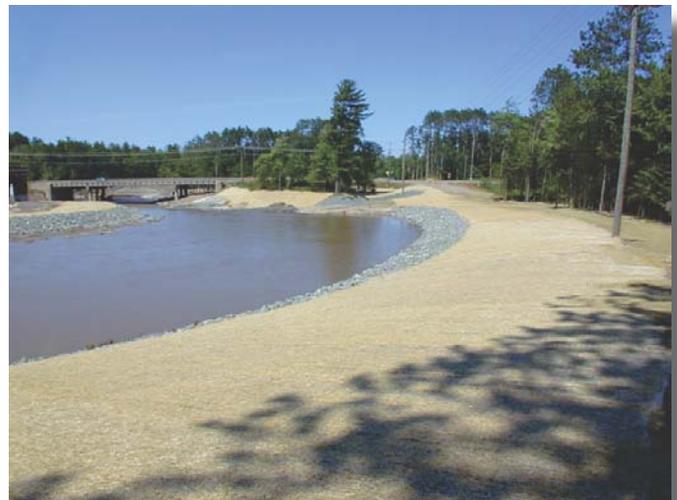
After EWP recovery assistance:  
Tourist Park stream banks were reshaped, seeded, and stabilized with rock rip-rap. (July 2003)

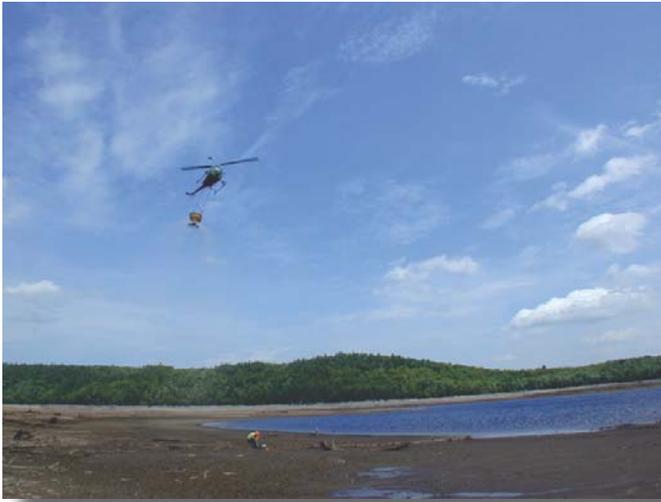
During EWP recovery assistance:  
Aerial seeding of Silver Lake Basin to prevent erosion. (June 2003)

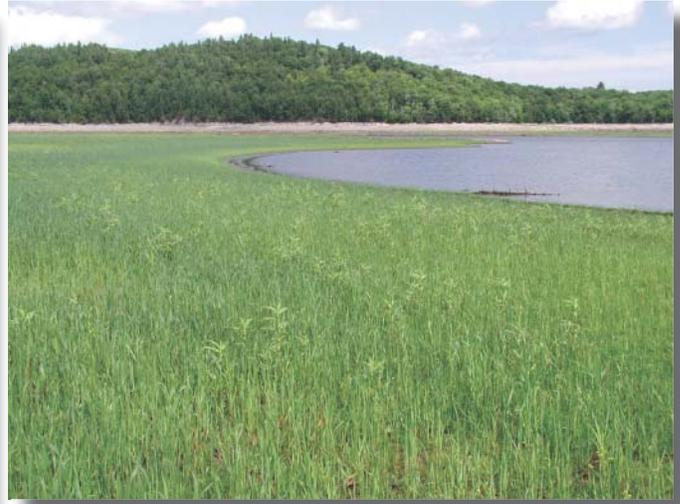
After EWP recovery assistance:  
One month after seeding of the basin. (July 2003)
