Naturally vegetated buffers work for wildlife and water quality

Summary of:

Agricultural Wildlife Conservation Center
Project # 68-7482-2-35

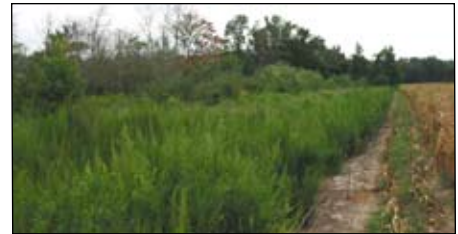
Multistage buffer with no planting (top); Shrub buffer (middle); Forest riparian buffer (bottom)

The vegetation composition at the multistage buffer incorporated characteristics of grassland, shrub, and woodland into a single streamside area. As a result, the area was occupied by a wide range of bird species ranging from grassland to shrub and woodland species.

Vegetation present at this site was volunteer. Restoration of the riparian habitat involved simply allowing native vegetation to recolonize the area. This suggests that vegetative plantings of species suitable for surviving in riparian conditions need not necessarily be planted for the area to act as a functional streamside zone. The large trees along the streambank, although sparse, effectively supported woodland species.
