Leon River, Texas

(An ARS Benchmark Research Watershed, one of 24 CEAP watershed projects.)

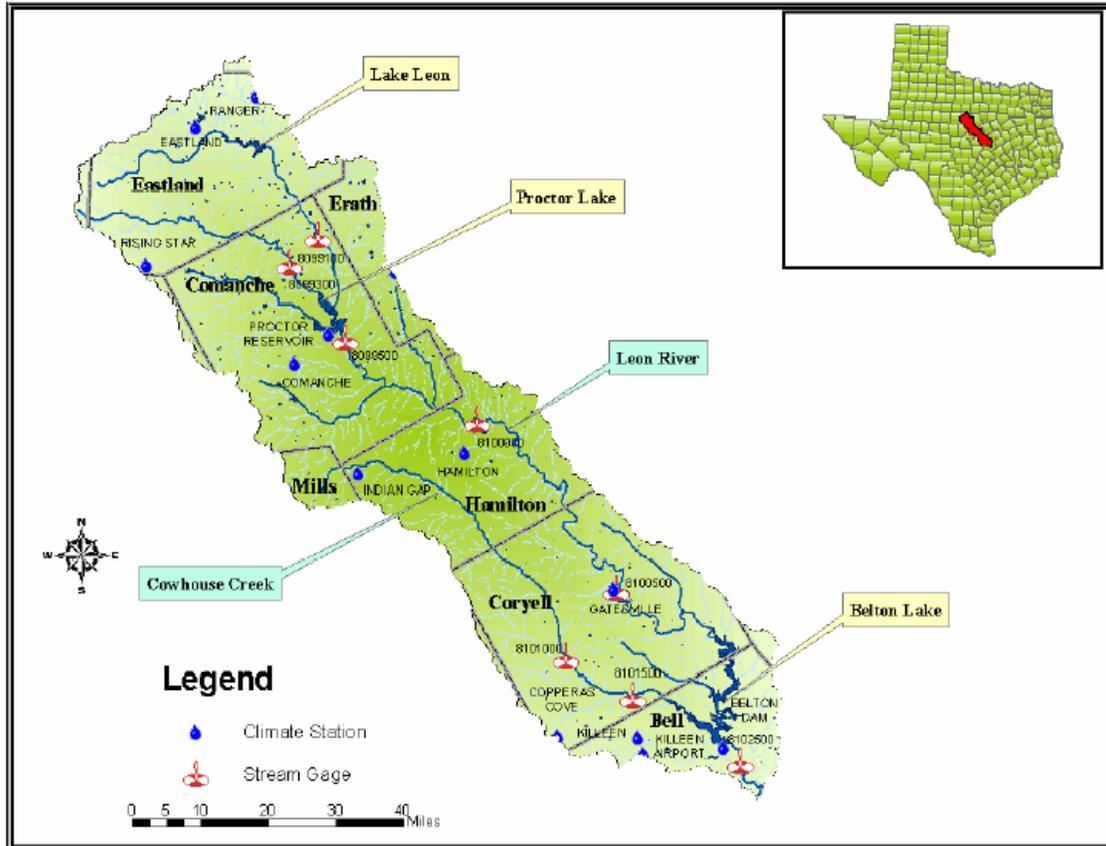
The upper Leon River Watershed location and existing stream gages. County names and major streams are identified.

The upper Leon River, above Lake Belton, consists of 735,600 ha, predominately in the Grand Prairie MLRA and West Cross Timbers (Fig. B8). The watershed area to be evaluated is 607,000 ha above Gatesville in Coryell County Texas. The area is well dissected with streams. Numerous small flood control dams (exact number unknown at this time) have been constructed in the watershed. Two reservoirs, Lake Leon and Lake Proctor, are located in the watershed. The watershed drains into Lake Belton, a large reservoir that provides domestic water for about one-half million people. Soils in the watershed are divided into two major groups. In the upper portion of the watershed, soils are generally lighter textured with loamy fine sands and sand soils occurring near the streams. In the lower portion of the watershed, soils are finer textured, with clays and clay loam soils occurring most often. About 68% of the land area is either in pasture or rangeland. Agricultural cropland makes up about 10% of the total watershed land area, although this amount is decreasing due to a decrease in peanut production in the area. Forestland makes up 17% of the land area. Mean annual rainfall decreases from east to west, but averages about 800mm per year near the center of the watershed. There are 55 concentrated animal feeding operations (CAFOs) in the watershed, mostly dairy operations or replacement heifers. There are about 66,000 dairy cattle in the watershed. Most of the dairy operations are in Erath County in the eastern portion of the watershed located on tributaries of Resley Creek.

The upper Leon River Watershed is a new area for ARS research, and few structures are in place. The U.S. Geological Survey (USGS) has a long history of monitoring flow in the Leon River with records dating back to 1925. Monitoring stations have been operated by the USGS in the watershed, resulting in a nest of sub-watersheds of 68,400, 124,000, and 489,700 ha. These records will be invaluable in developing and evaluating models of the hydrology of the watershed. Instruments for sampling stream flow and for measuring flow from smaller areas will be installed to determine how conservation practices associated with manure and nutrient management impact water and soil quality. A watershed model will be used to evaluate the watershed and potential management scenarios.
