WORK PLAN

FOR WATERSHED PROTECTION, FLOOD PREVENTION
AND AGRICULTURAL AND NON-AGRICULTURAL
WATER MANAGEMENT

PALUXY RIVER WATERSHED

ERATH, HOOD, AND SOMERVELL COUNTIES, TEXAS

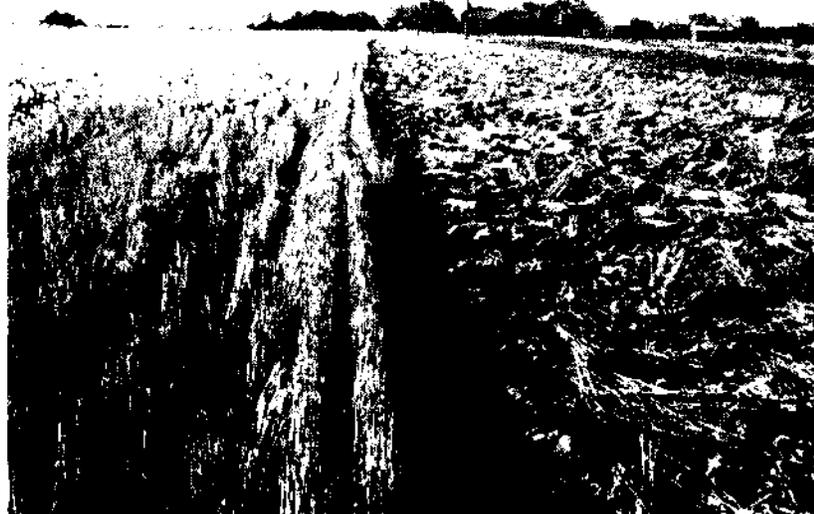
Properly managed crop residues improve soil structure and fertility and enable the soil to absorb rainfall at a more rapid rate.

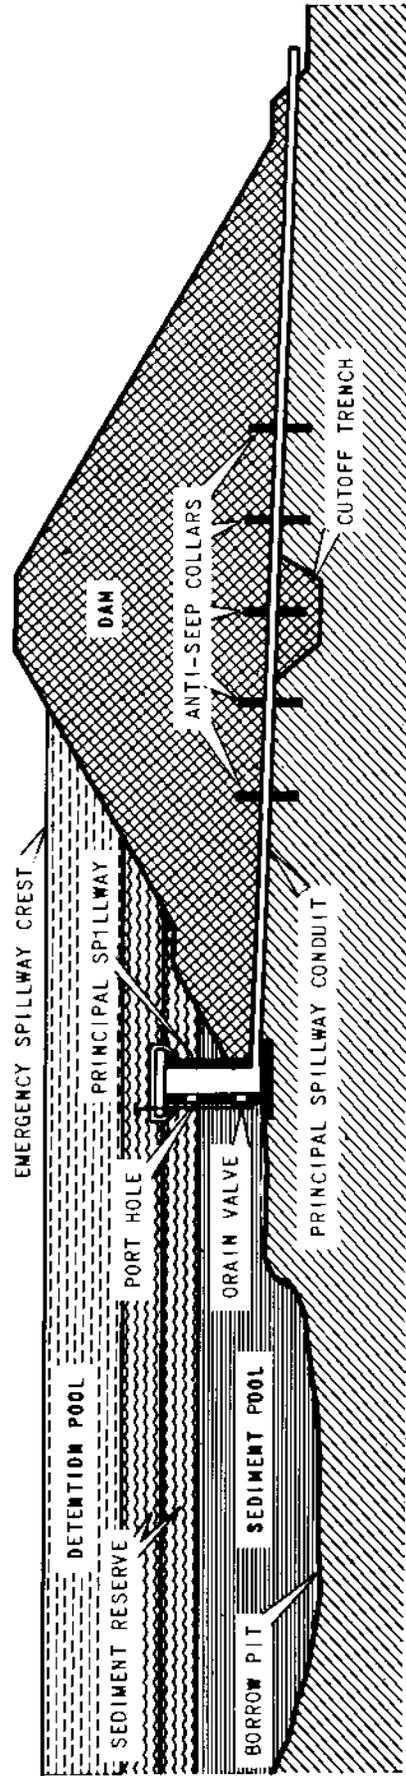
Figure 1

SECTION OF A TYPICAL FLOODWATER RETARDING STRUCTURE

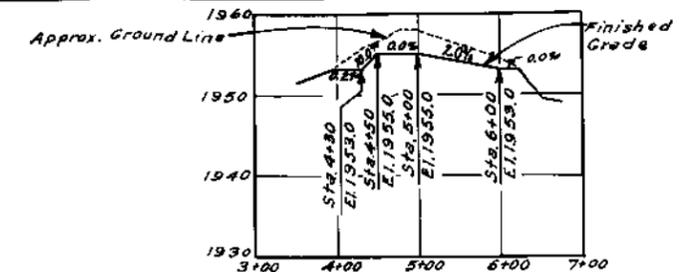
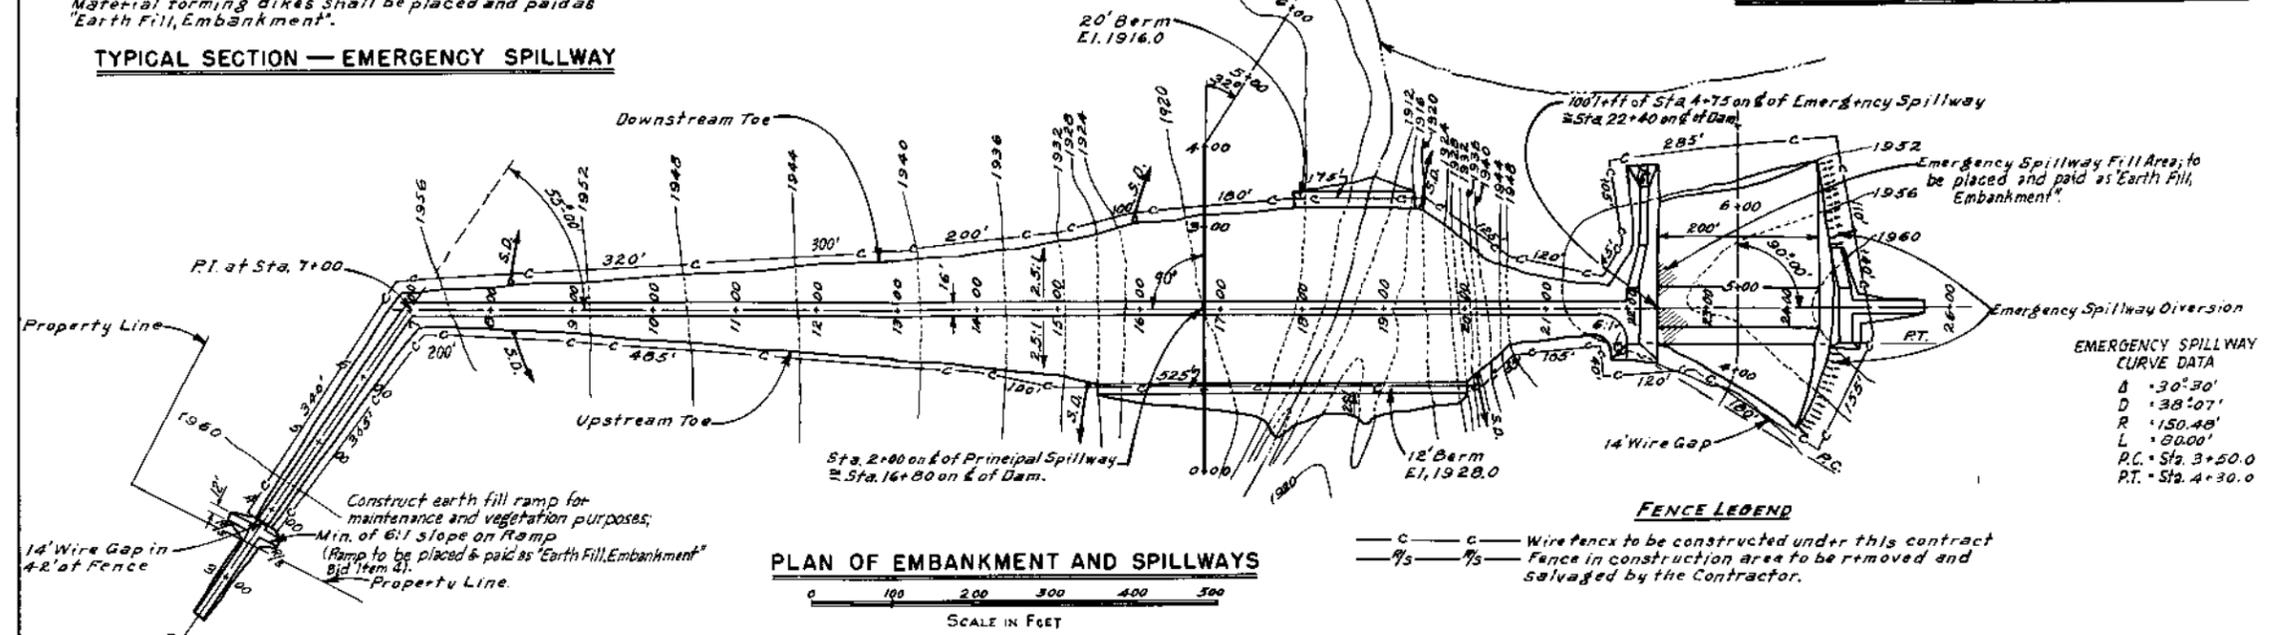
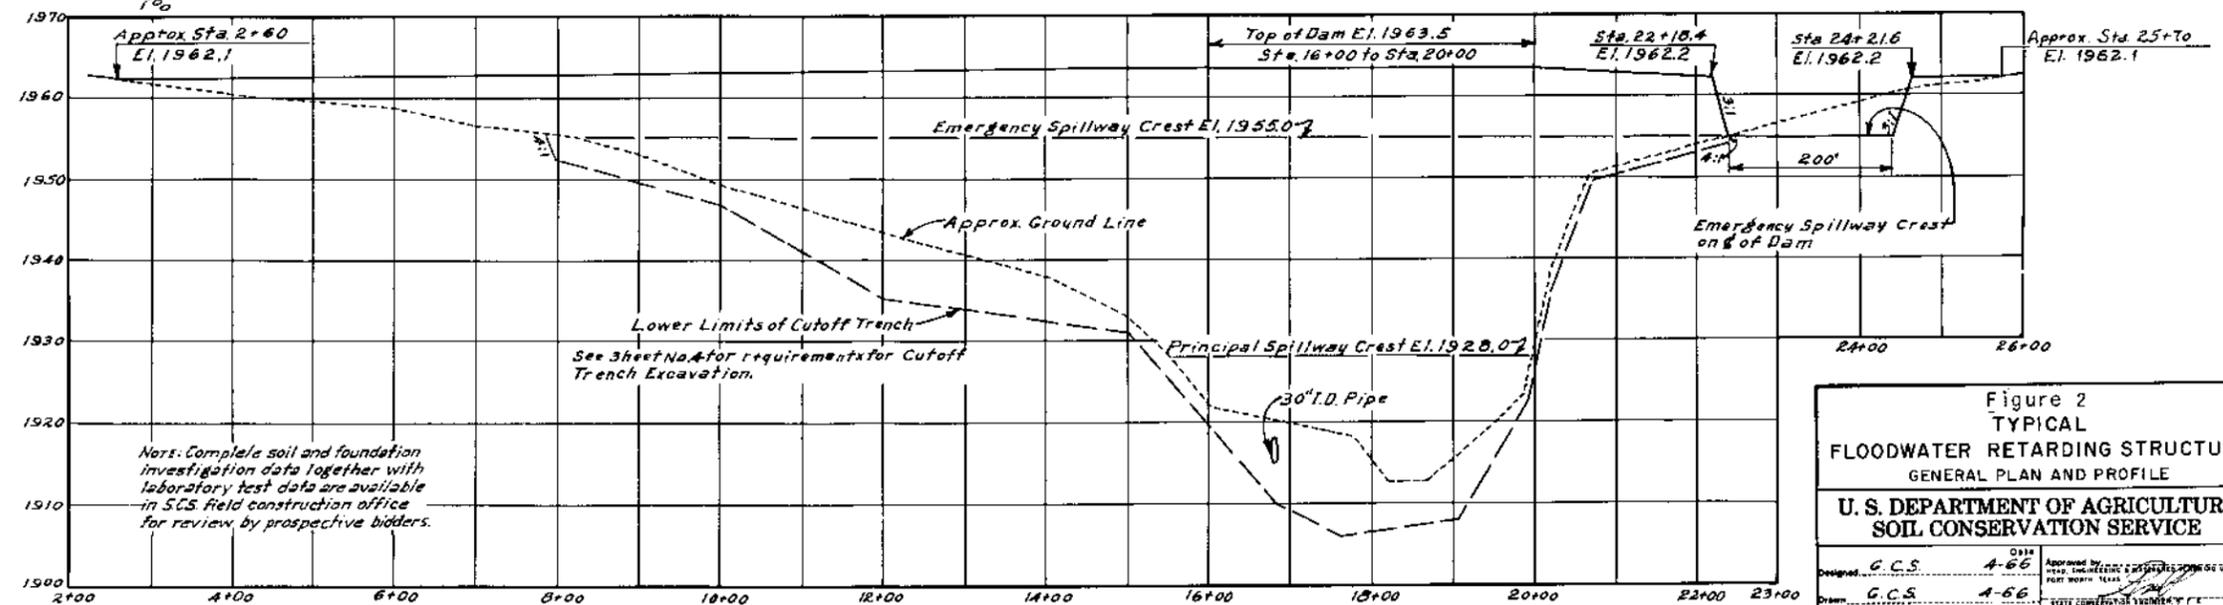
Figure 2
TYPICAL
FLOODWATER RETARDING STRUCTURE
GENERAL PLAN AND PROFILE
U. S. DEPARTMENT OF AGRICULTURE
SOIL CONSERVATION SERVICE

PROFILE ON C OF EMERGENCY SPILLWAY

PROFILE ON C OF DAM

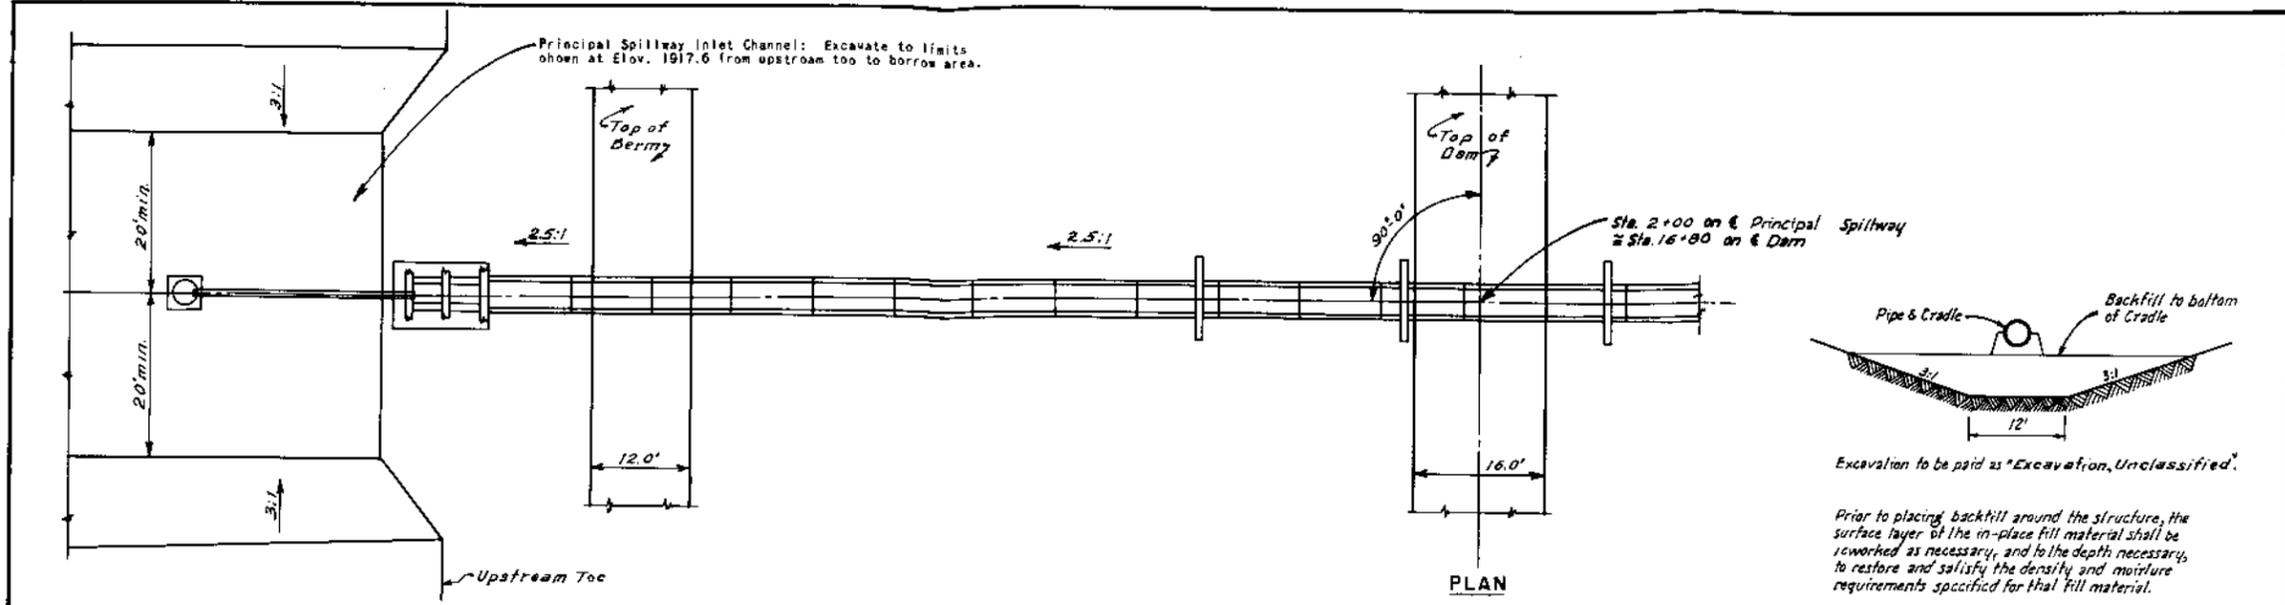
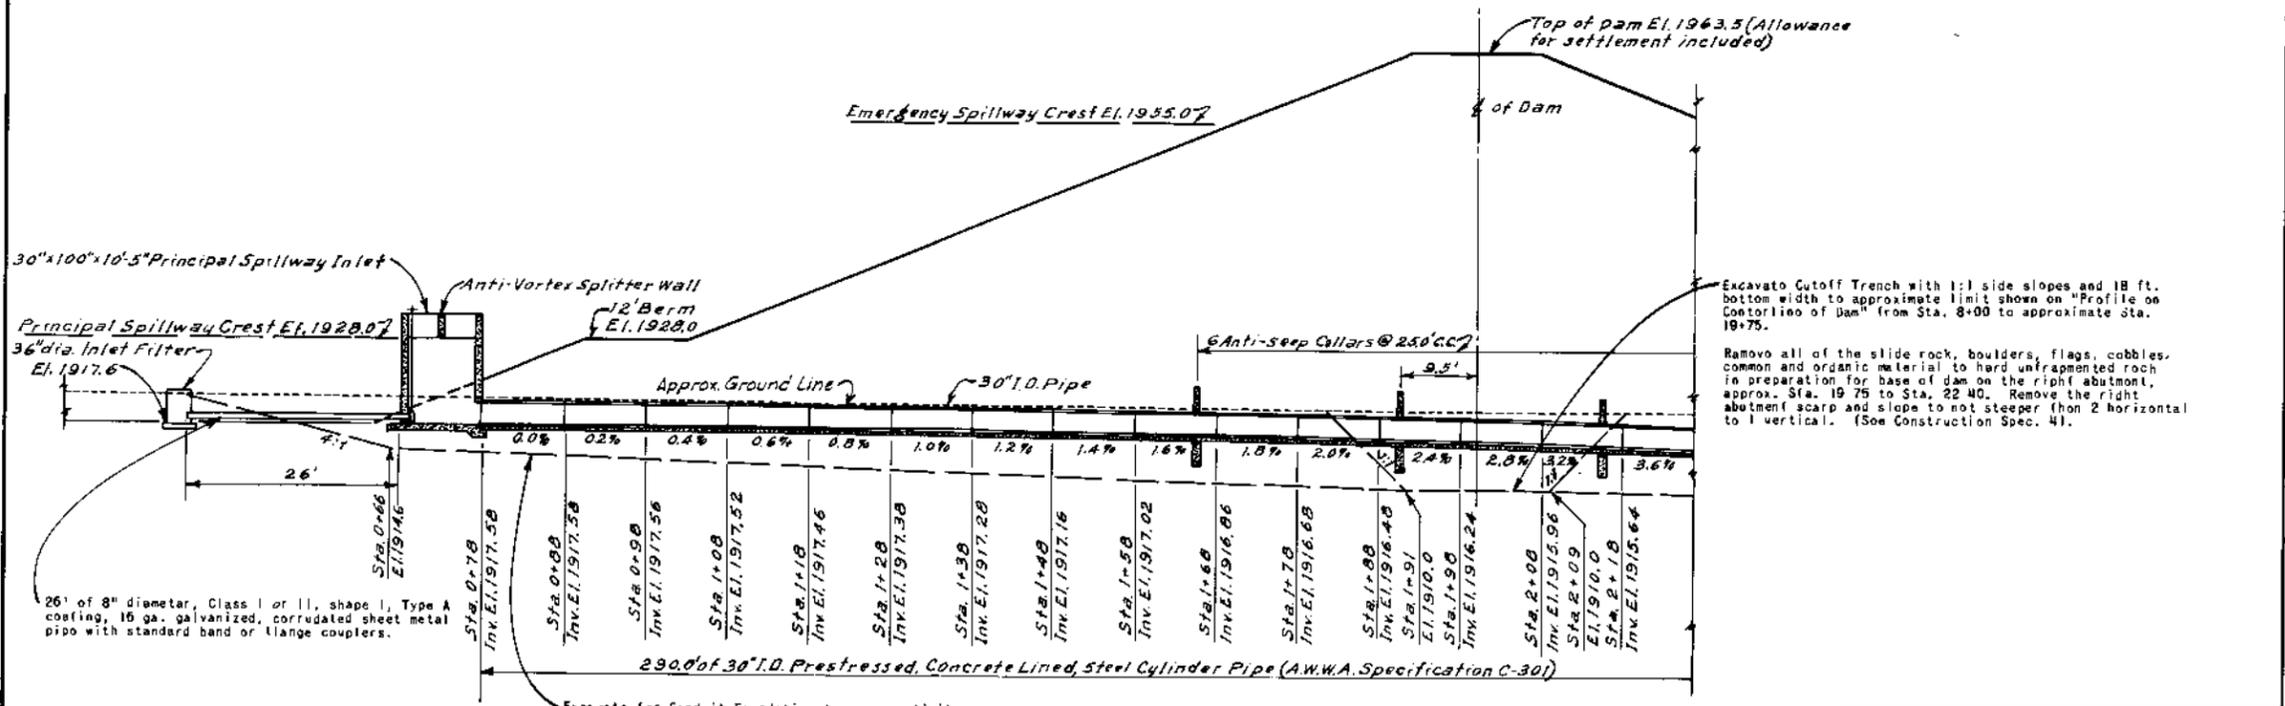
TYPICAL CONDUIT FOUNDATION EXCAVATION

SECTION
PRINCIPAL SPILLWAY

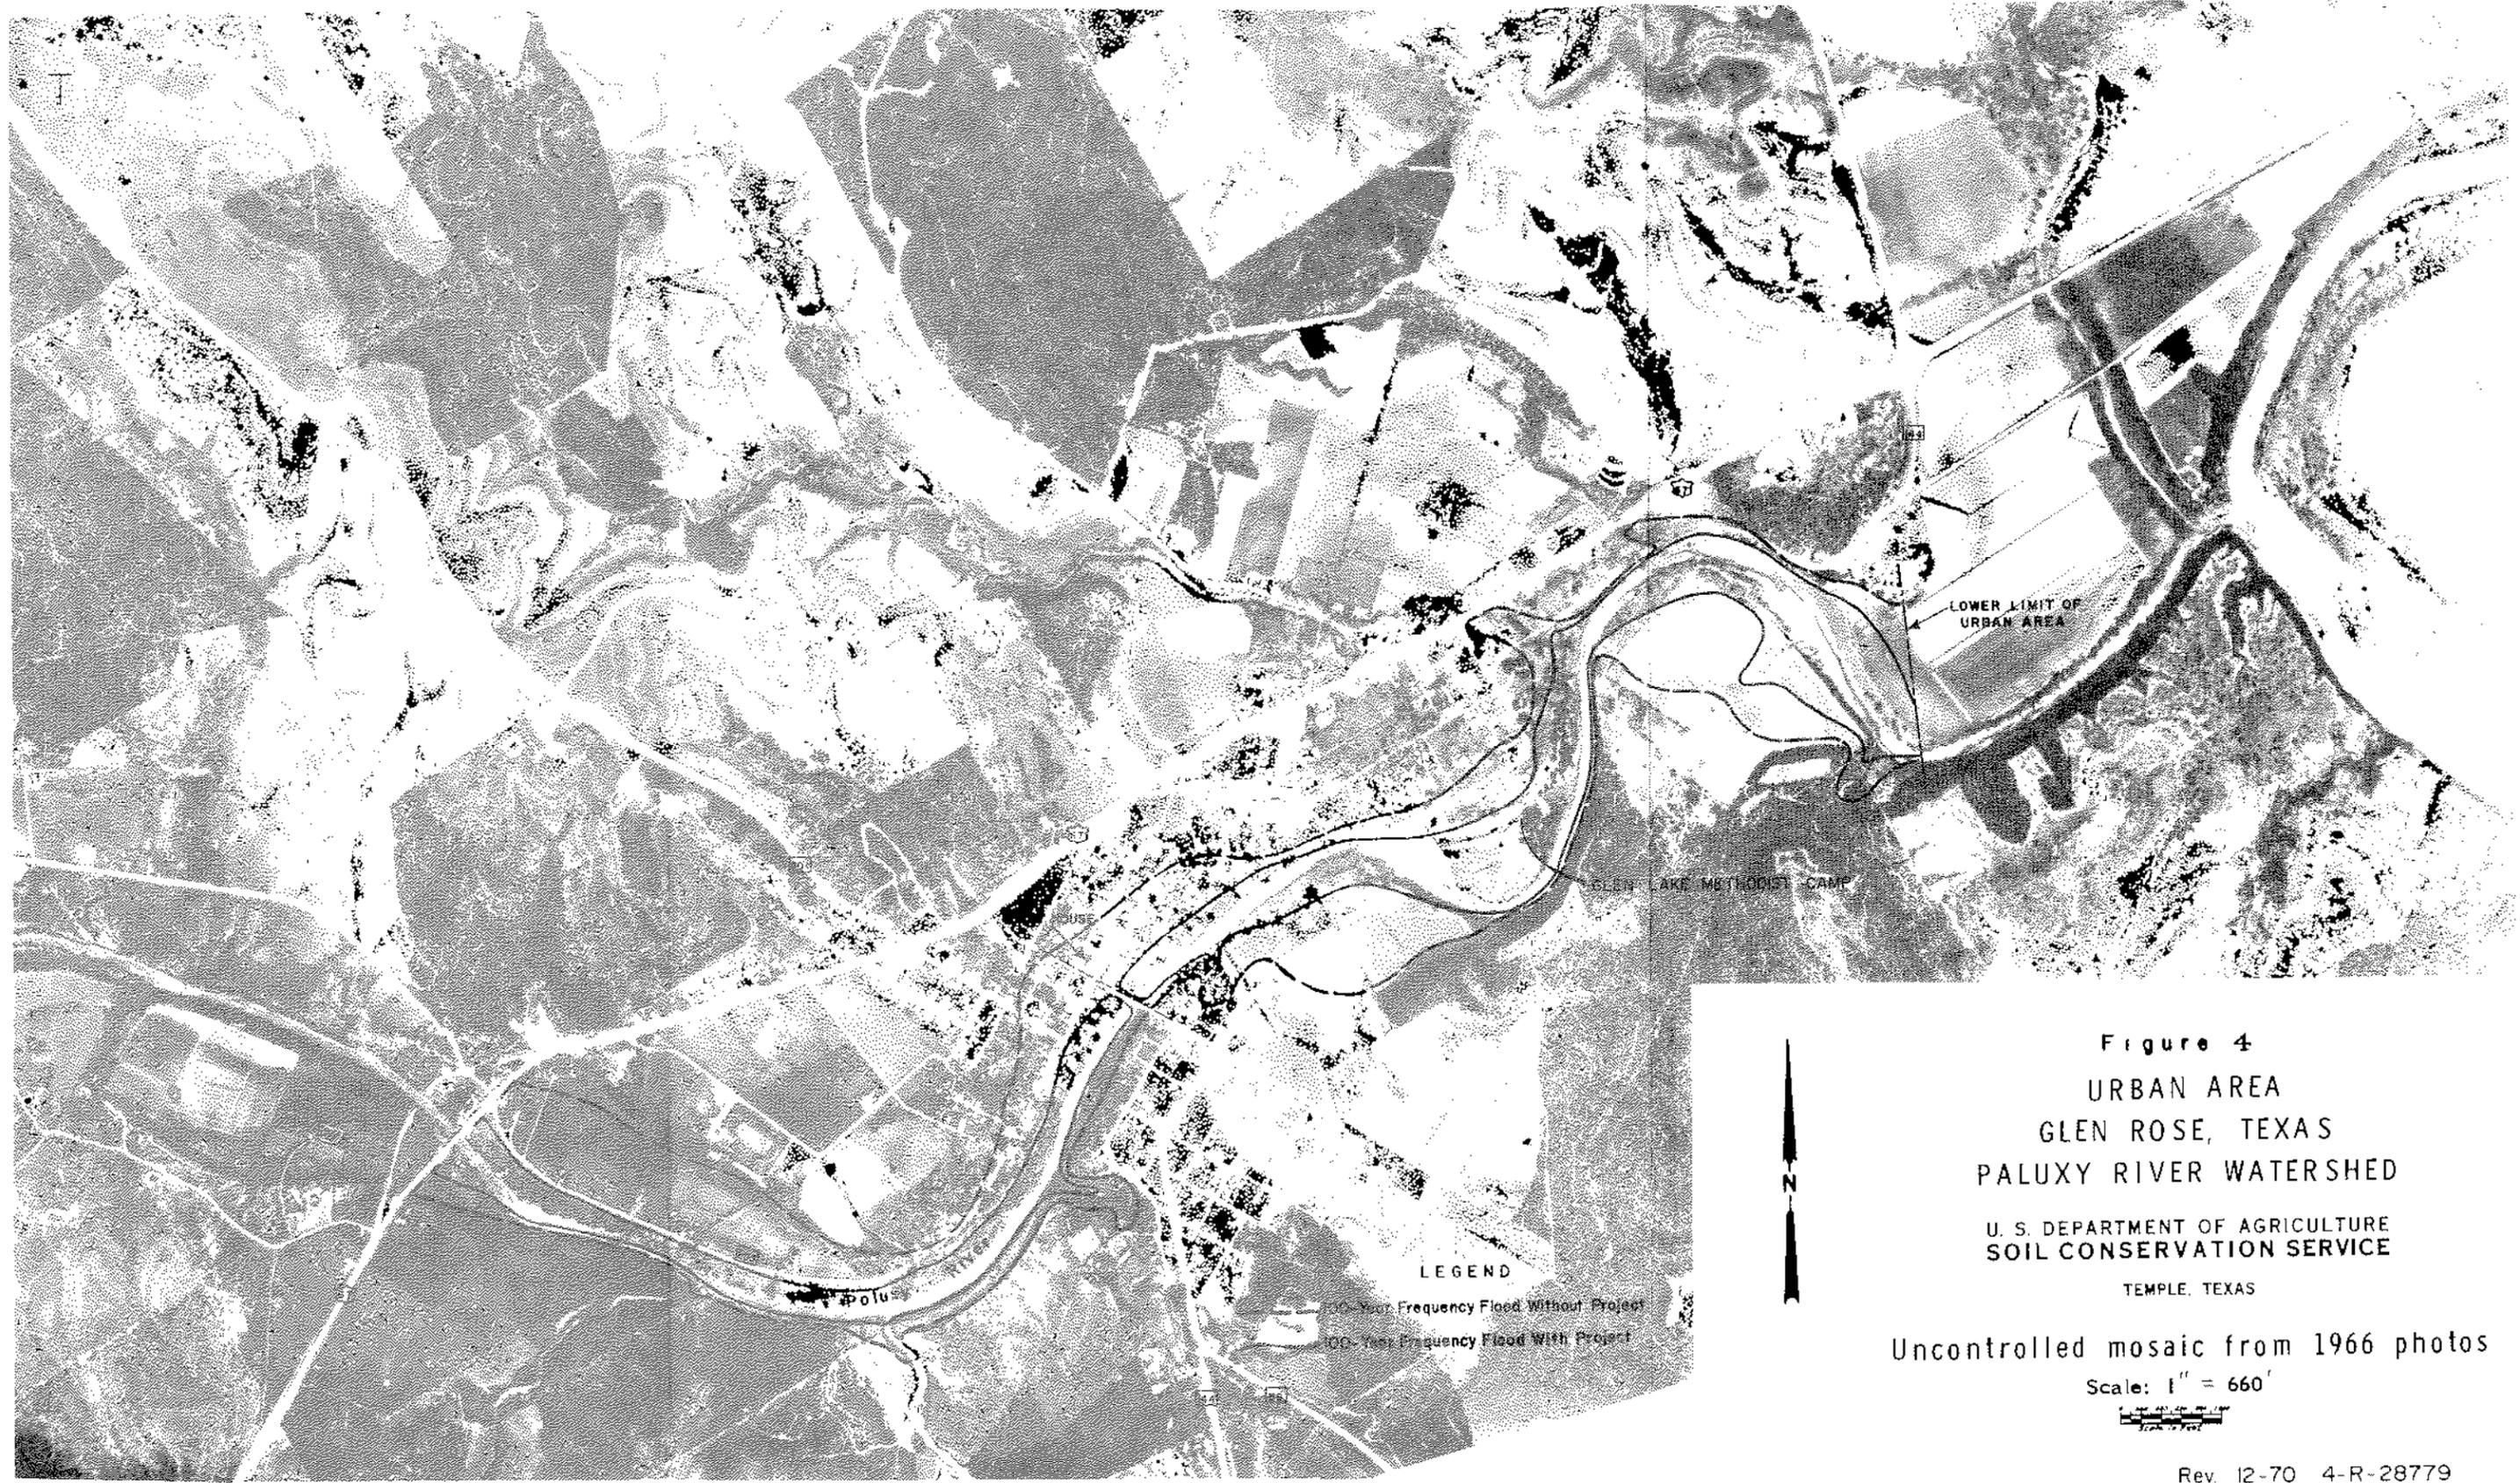
Figure 4
 URBAN AREA
 GLEN ROSE, TEXAS
 PALUXY RIVER WATERSHED
 U. S. DEPARTMENT OF AGRICULTURE
 SOIL CONSERVATION SERVICE
 TEMPLE, TEXAS

Uncontrolled mosaic from 1966 photos

Figure 3 shows the flood plain that is subject to flood damage. The urban area of the city of Glen Rose that will be damaged by the 100-year frequency flood is shown in figure 4.

Figure 4 shows the areal extent of flooding in the urban area of Glen Rose under both with and without project conditions. Figure 5 shows the depth of flooding at valley section 201 under the same conditions. This reduction of area flooded, depth, and velocities will reduce average annual damages by 96 percent.
