United States Department of Agriculture  
Soil Conservation Service

Subject: Electromagnetic Induction (EM)  
survey of Animal Waste Storage Ponds,  
Arizona; 17 to 21 August 1992

Date: 9 September 1992

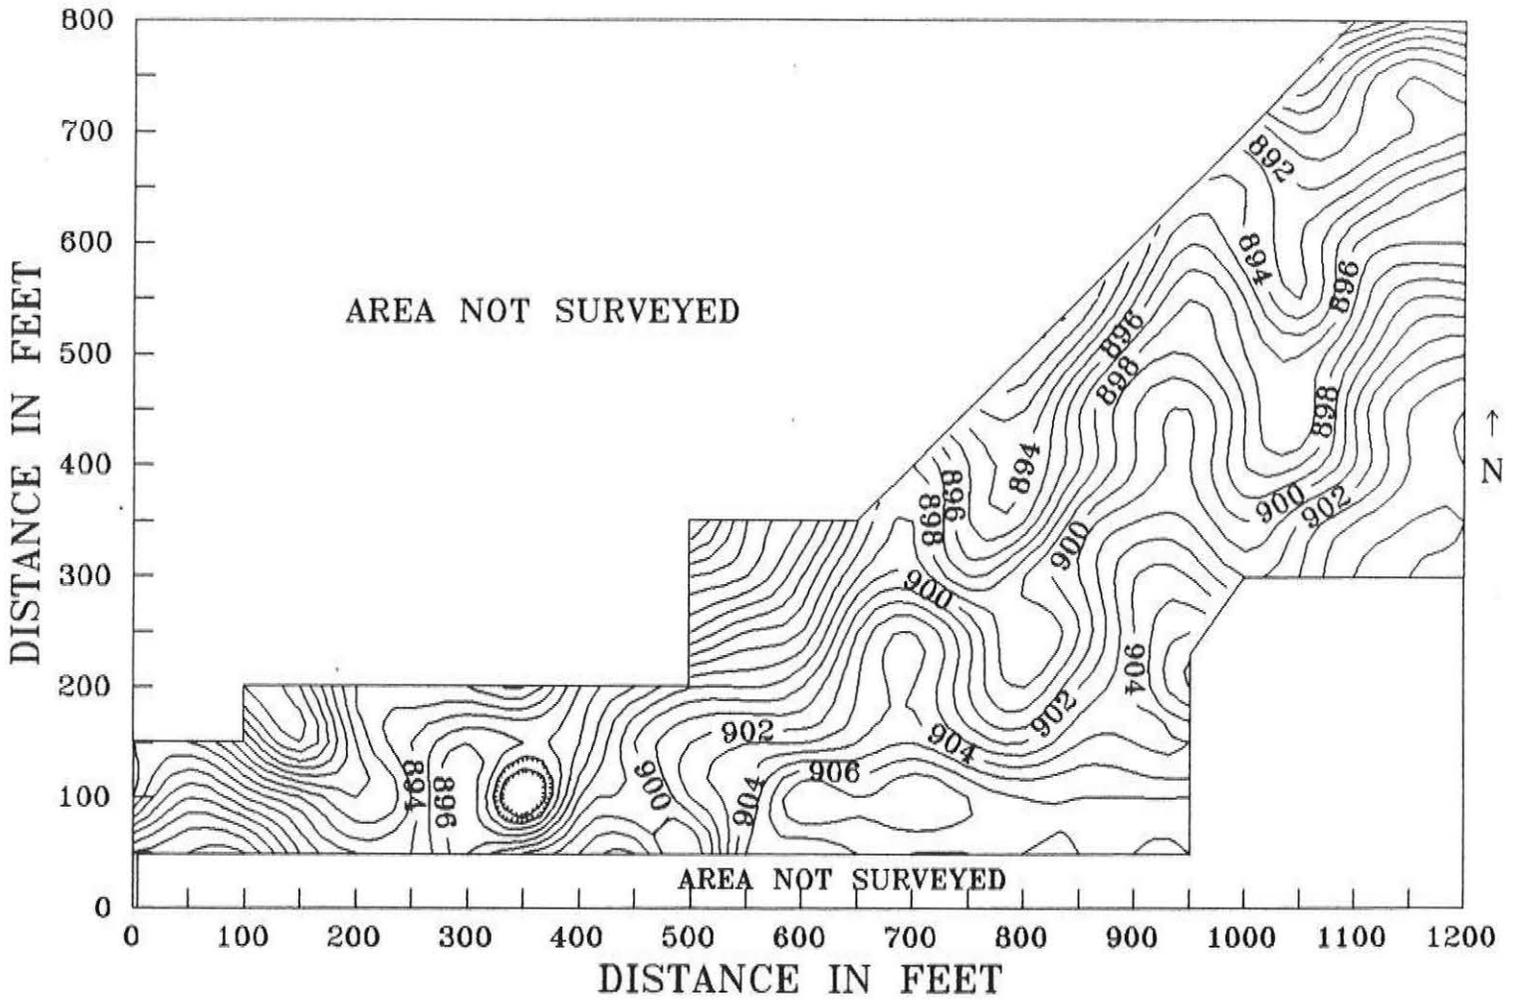
Figure 1 is a two-dimensional contour plot of the ground surface. The contour interval is 1 foot. In Figure 1, north is towards the upper margin. Highly variable and heterogeneous soil and terrain conditions characterize this site. The site has been disturbed by extensive land leveling operations and dissected by several gullies. Gullies descend onto the flood plain of the Gila River. A holding area for dairy cows adjoin the southern edge of the survey area.

ARIZONA LAGOON STUDY  
DAIRY LAGOON - 1  
RELATIVE TOPOGRAPHY  
CONTOUR INTERVAL = 1.0 FT

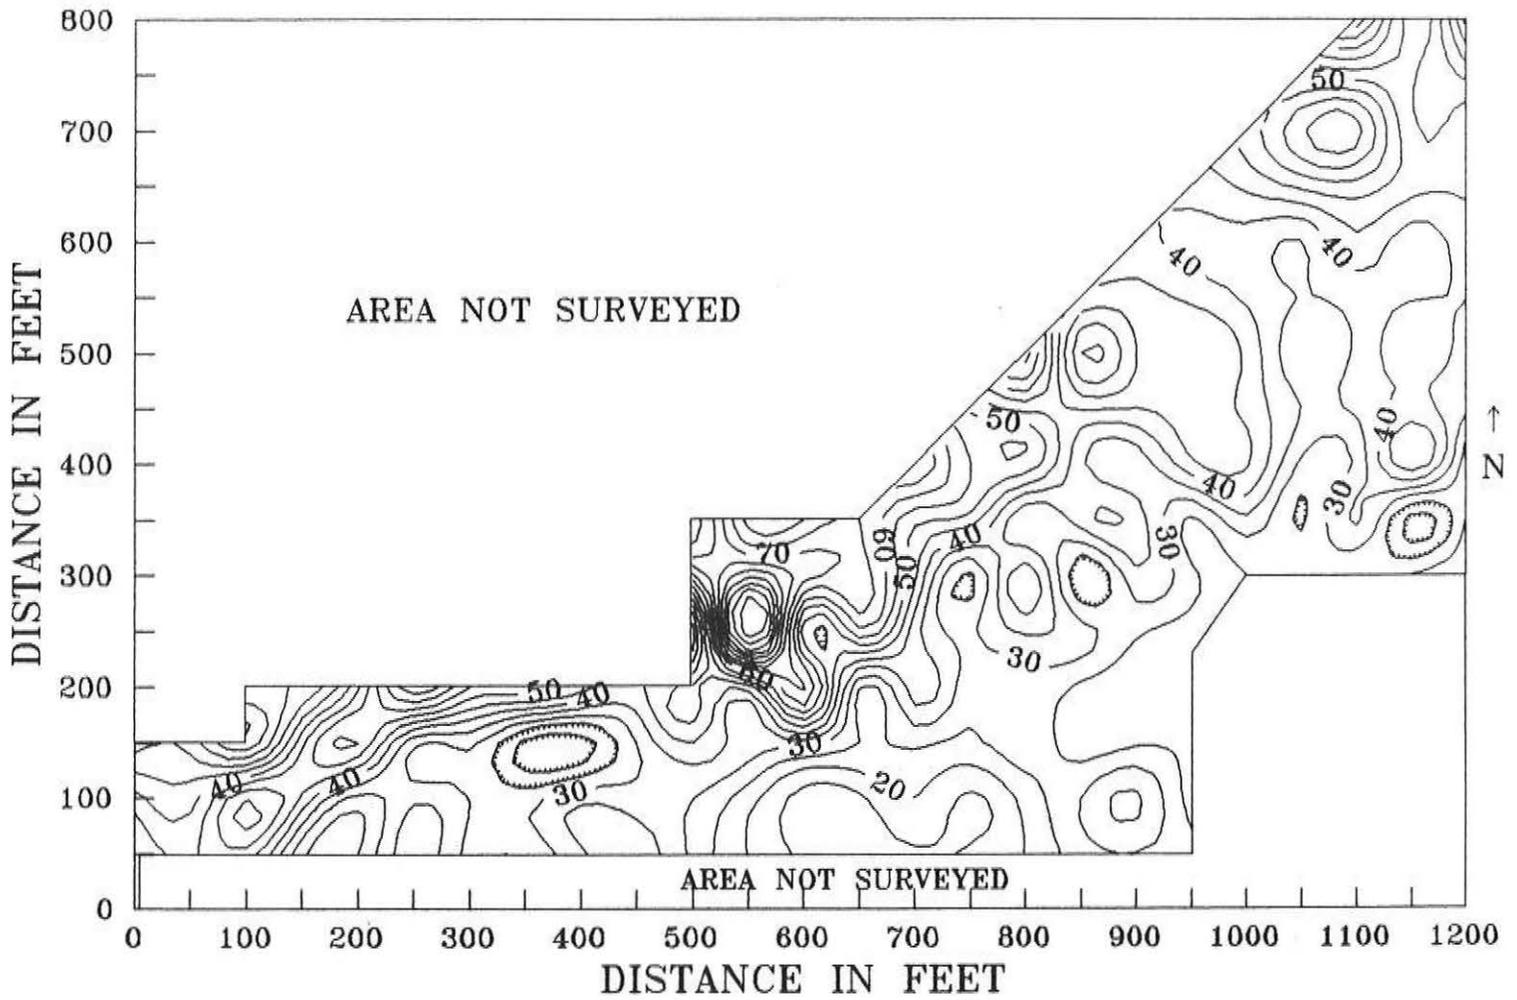
figure 2

Several inferences can be made from figures 2 and 3. The patterns of apparent conductivity, evident in figures 2 and 3, characterize a highly disturbed site with variable soil conditions. The spacing and pattern of contour lines are highly variable and exceedingly complex.

Several point anomalies are evident in these figures. The presence of buried metallic artifacts may be responsible for these anomalies. One fairly large anomalous area is evident near coordinates 550X and 300Y. Generally, apparent conductivity appears to increase with soil depth. Assuming that the clay content and mineralogy remains essentially constant, increases in apparent electrical conductivity with soil depth are most likely related to increases in soluble salts or volumetric water content.

ARIZONA LAGOON STUDY  
DAIRY LAGOON - 1  
EM34  
HORIZONTAL DIPOLE  
10 M INTERCOIL SPACING

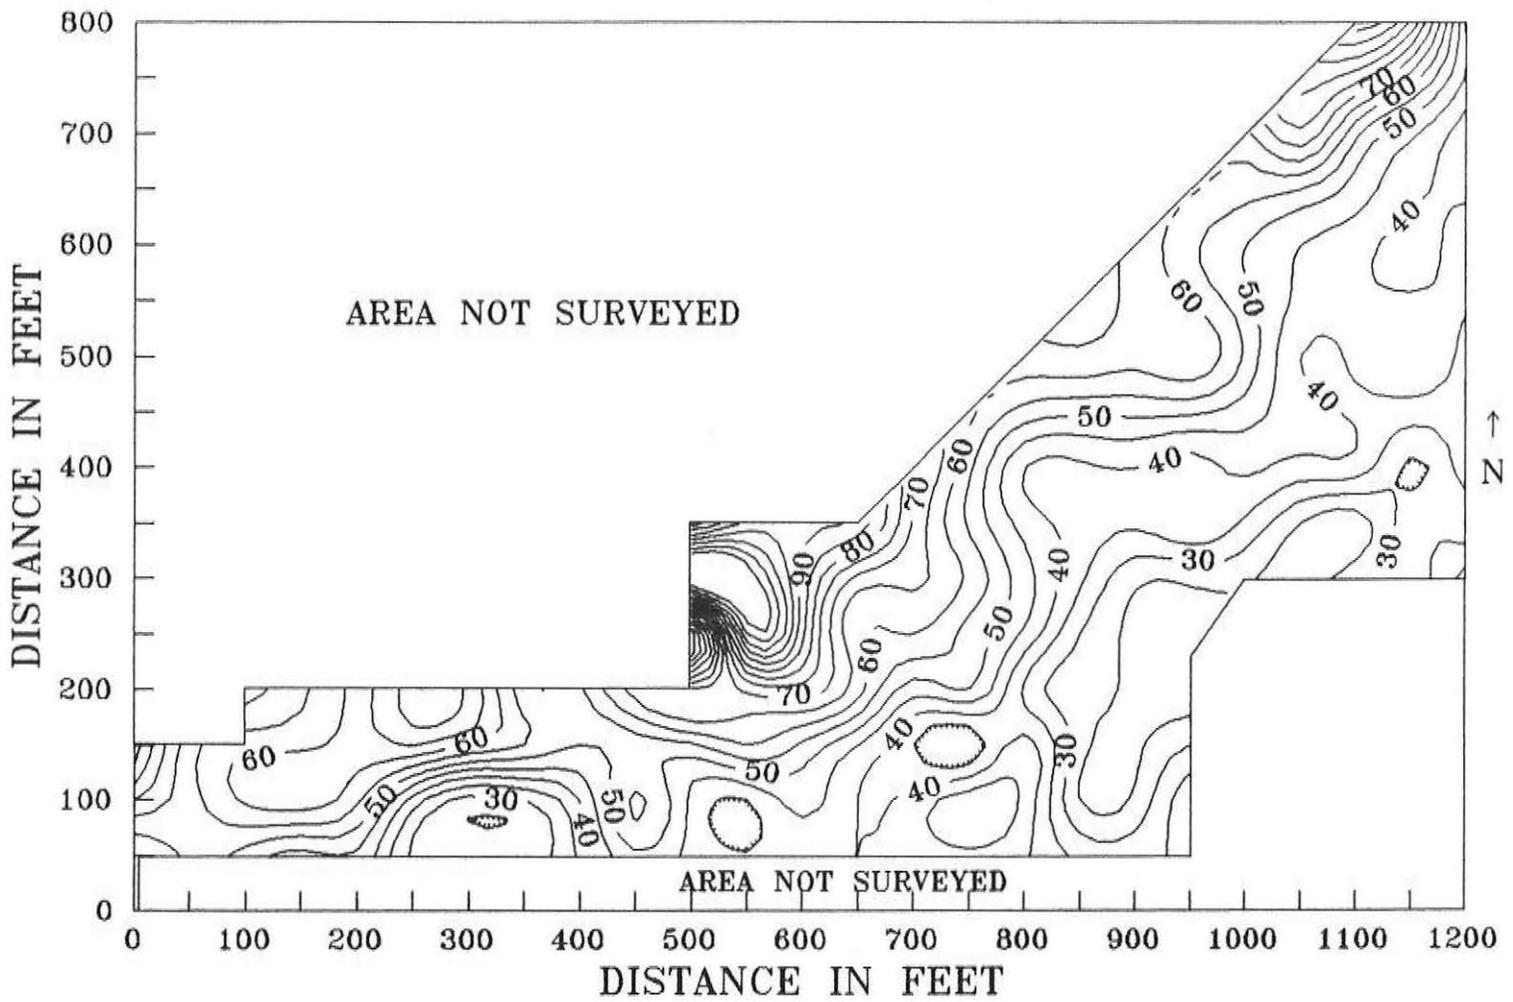
Figure 3

ARIZONA LAGOON STUDY  
DAIRY LAGOON - 1  
EM34  
VERTICAL DIPOLE  
10 M INTERCOIL SPACING

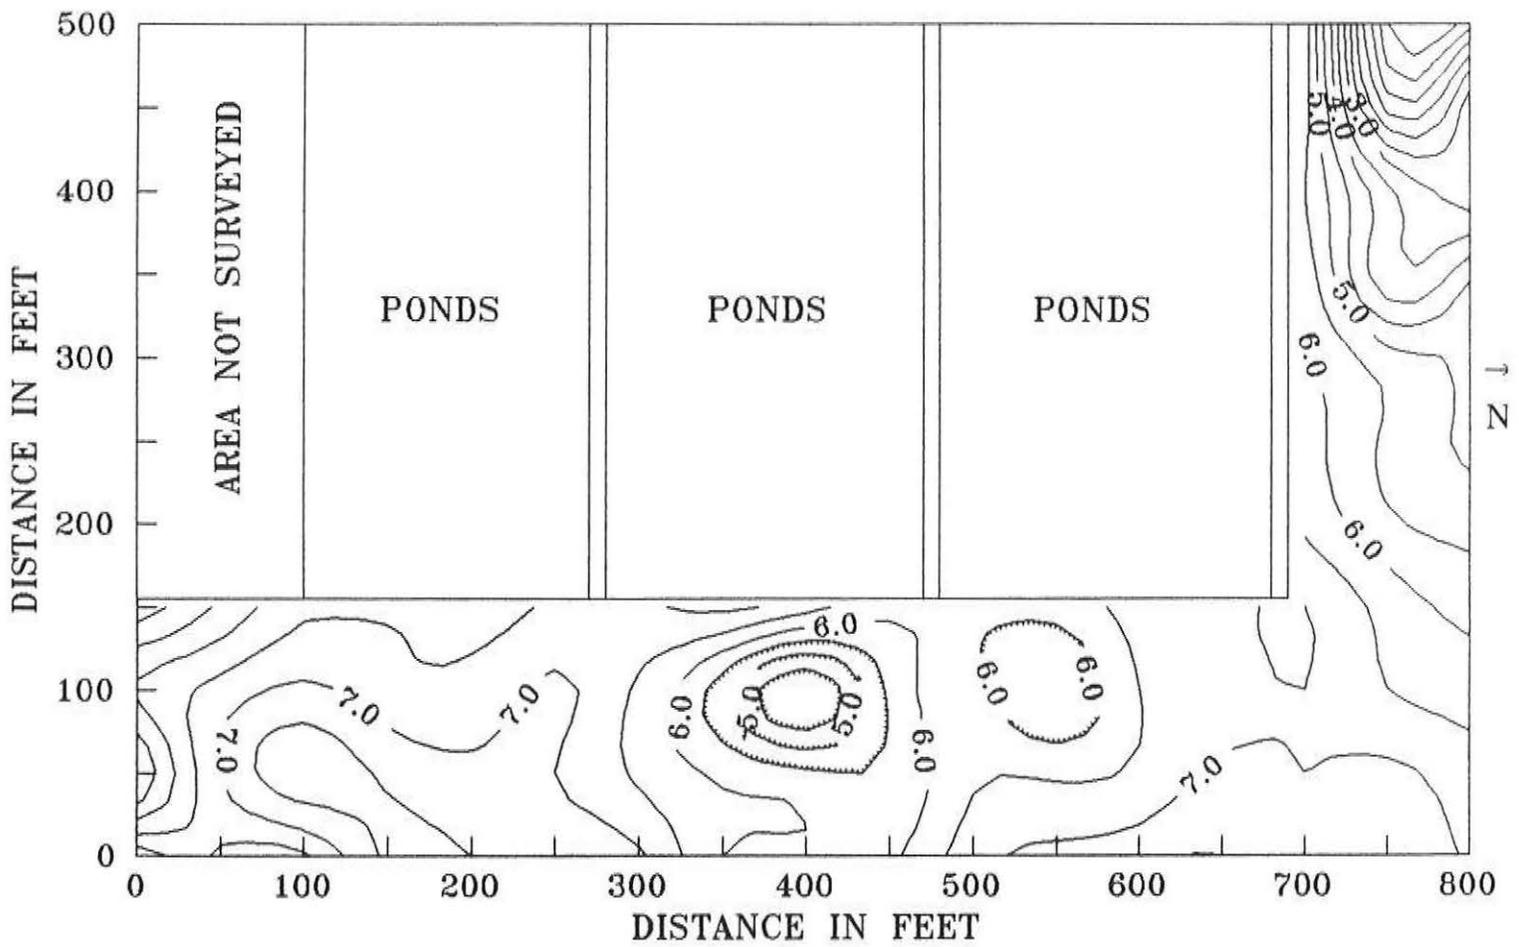
Figure 4 is a two-dimensional contour plot of the ground surface. The contour interval is 1 foot. Waterman Wash is beyond the upper margin of this plot. In the northwest corner of the survey area, the land surface slopes towards the wash. Because of the presence of the evaporation ponds, the interior of the survey area was not surveyed.

ARIZONA LAGOON STUDY  
DAIRY LAGOON - 2  
RELATIVE TOPOGRAPHY  
CONTOUR INTERVAL = 0.5 FT

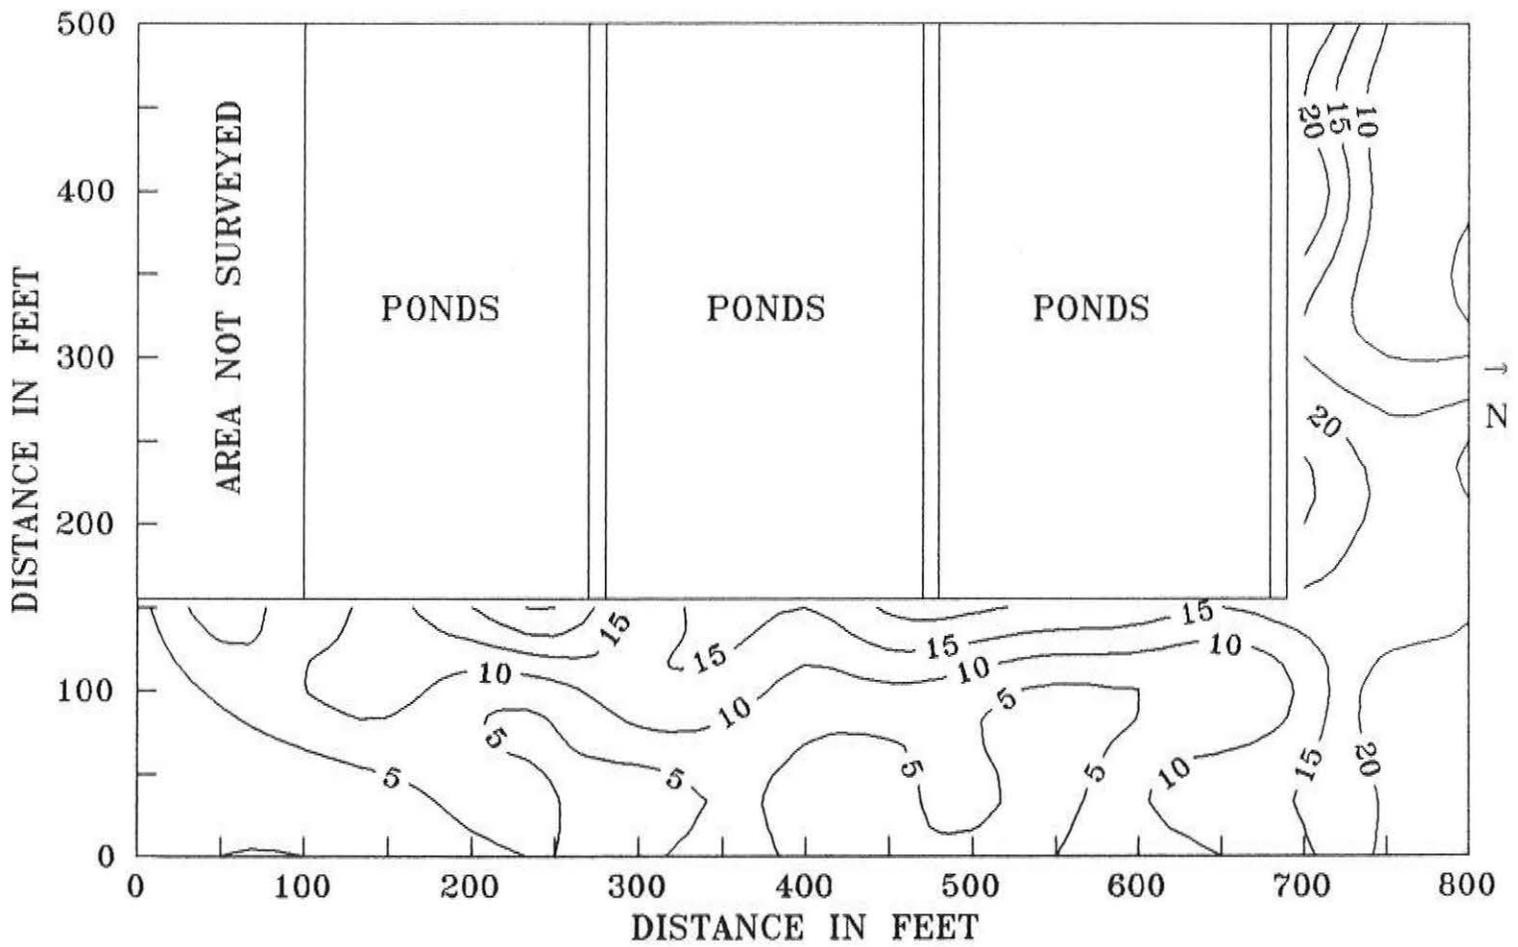
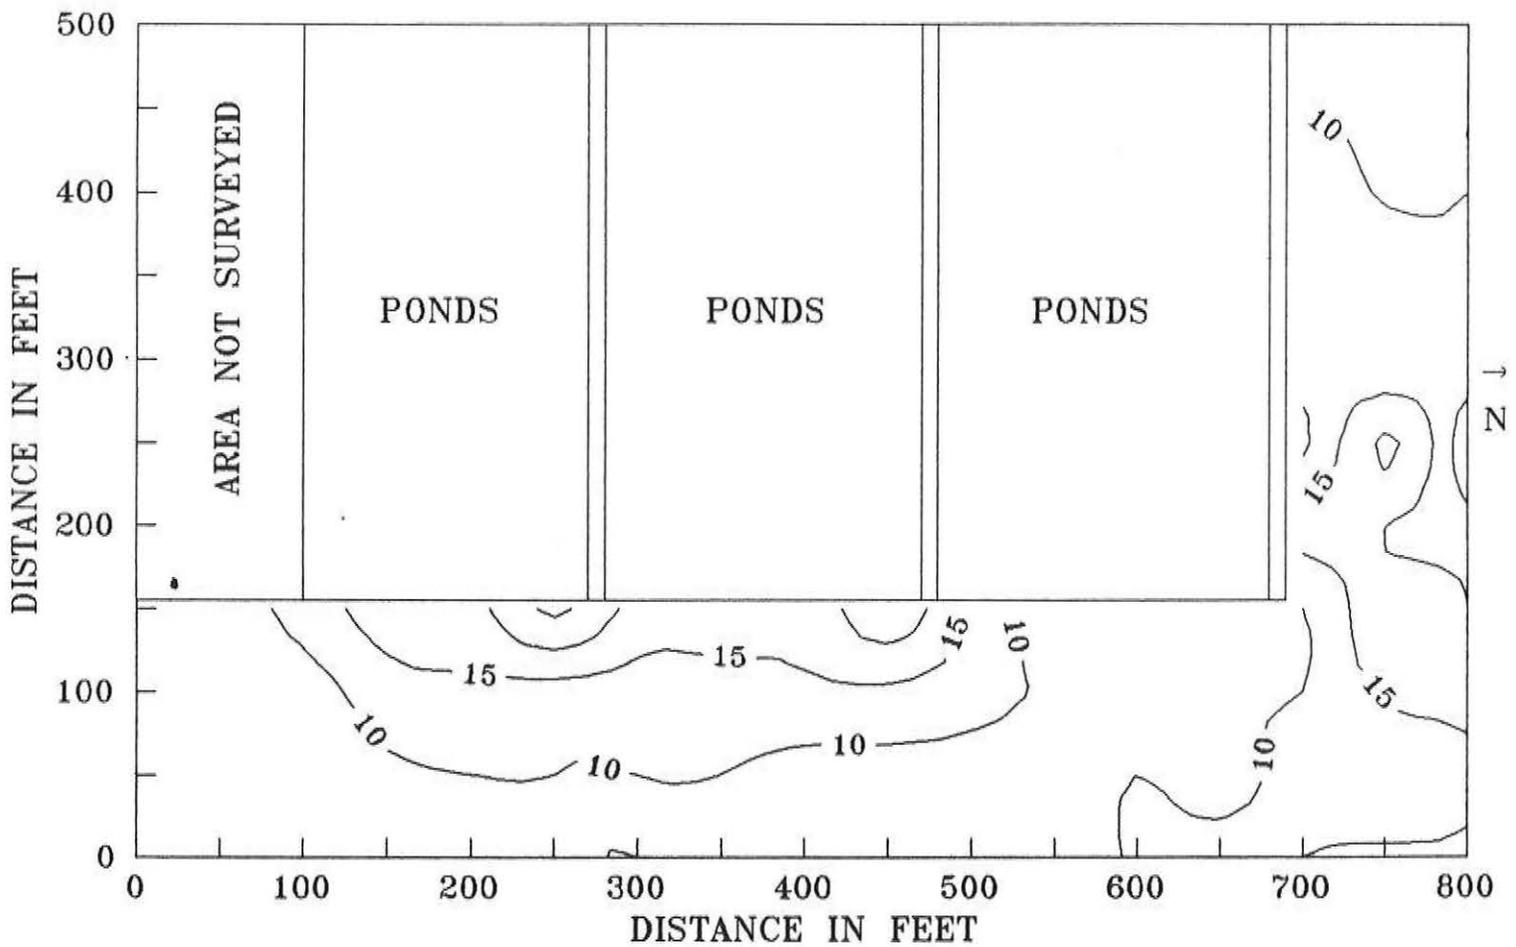
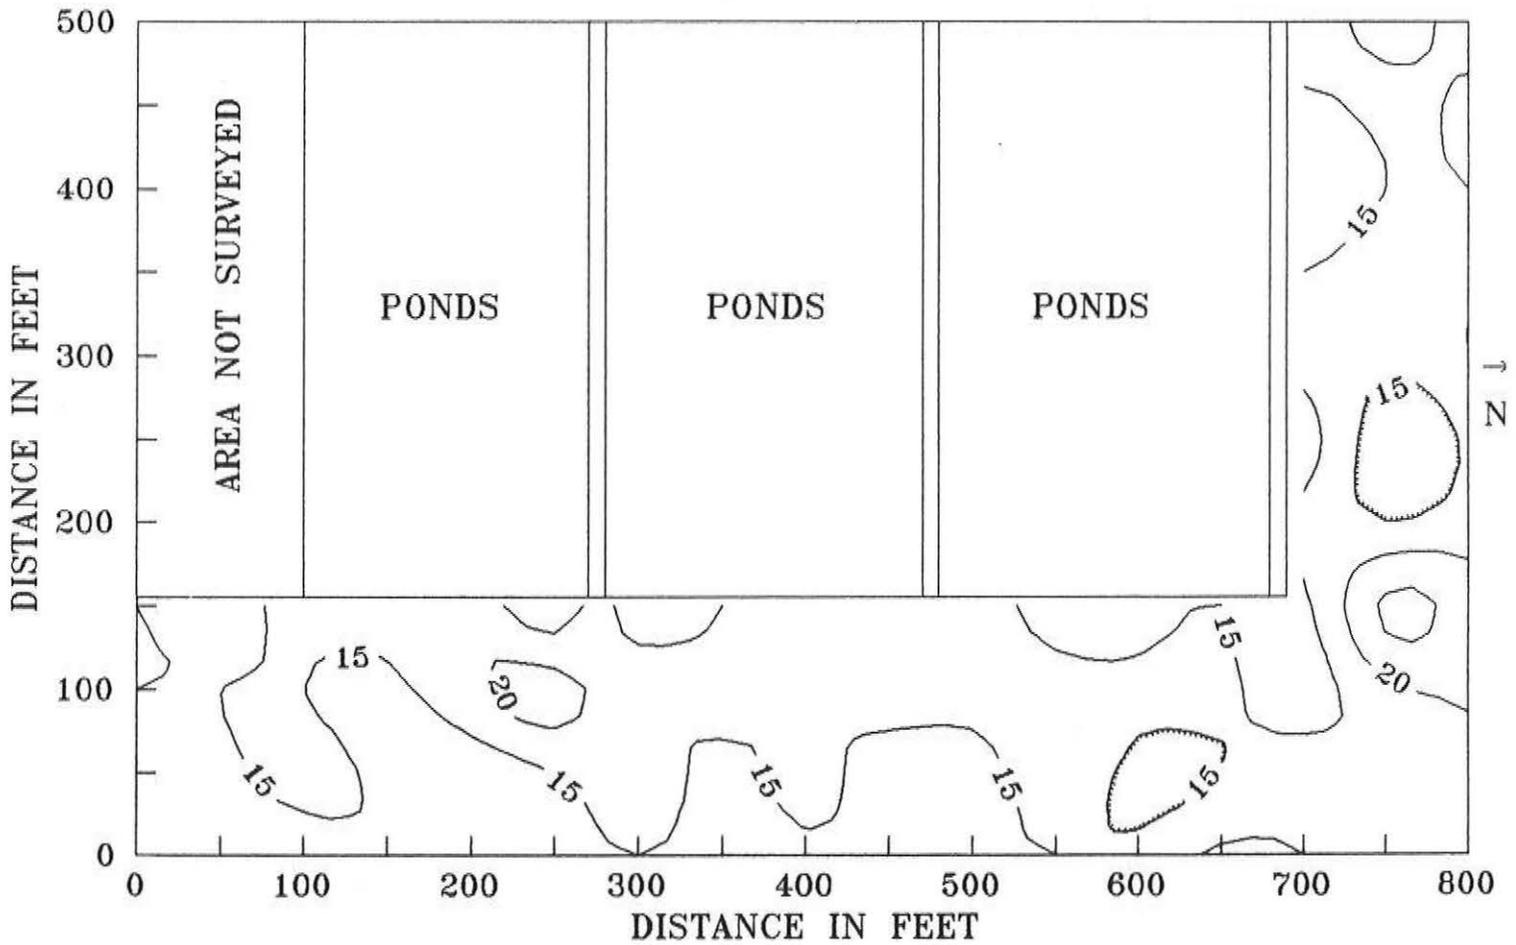
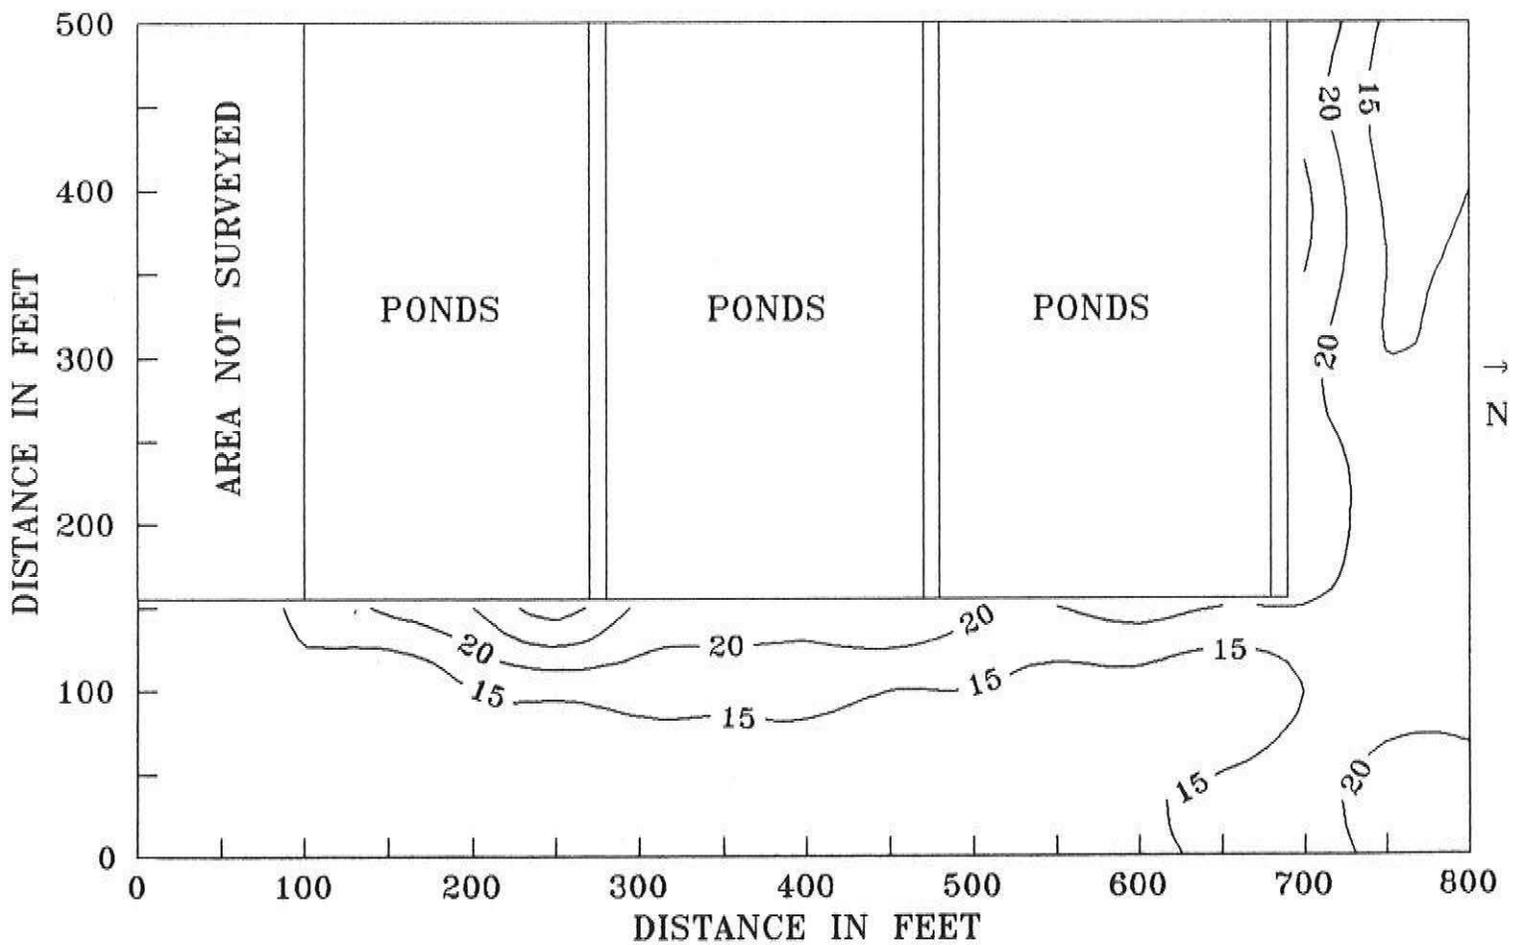
Several inferences can be made from these figures. Apparent conductivity values appear to increase with soil depth. No extensive zone of seepage from the evaporation ponds are evident in these figures. However, a broad, plume-like zone of higher conductivities appears to extend 50 to 100 feet from the eastern edge and about 50 feet from the northern edge of the structure. Surprisingly, the plume-like zone is best expressed in the area that lies adjacent to the eastern boundary of the two southern most evaporation ponds; the ponds that are the least utilized. It was felt that the grid area was to small to adequately assess the plume-like area and its relationship with local soil and geologic patterns. Interference from farm buildings is suspected of producing "cultural noise"

responsible for some of the higher conductivity values along the northern boundary of the survey area.

ARIZONA LAGOON STUDY  
DAIRY LAGOON - 2  
EM31  
HORIZONTAL DIPOLE

ARIZONA LAGOON STUDY  
DAIRY LAGOON - 2  
EM31  
VERTICAL DIPOLE

ARIZONA LAGOON STUDY  
DAIRY LAGOON - 2  
EM34  
HORIZONTAL DIPOLE

ARIZONA LAGOON STUDY  
DAIRY LAGOON - 2  
EM34  
VERTICAL DIPOLE

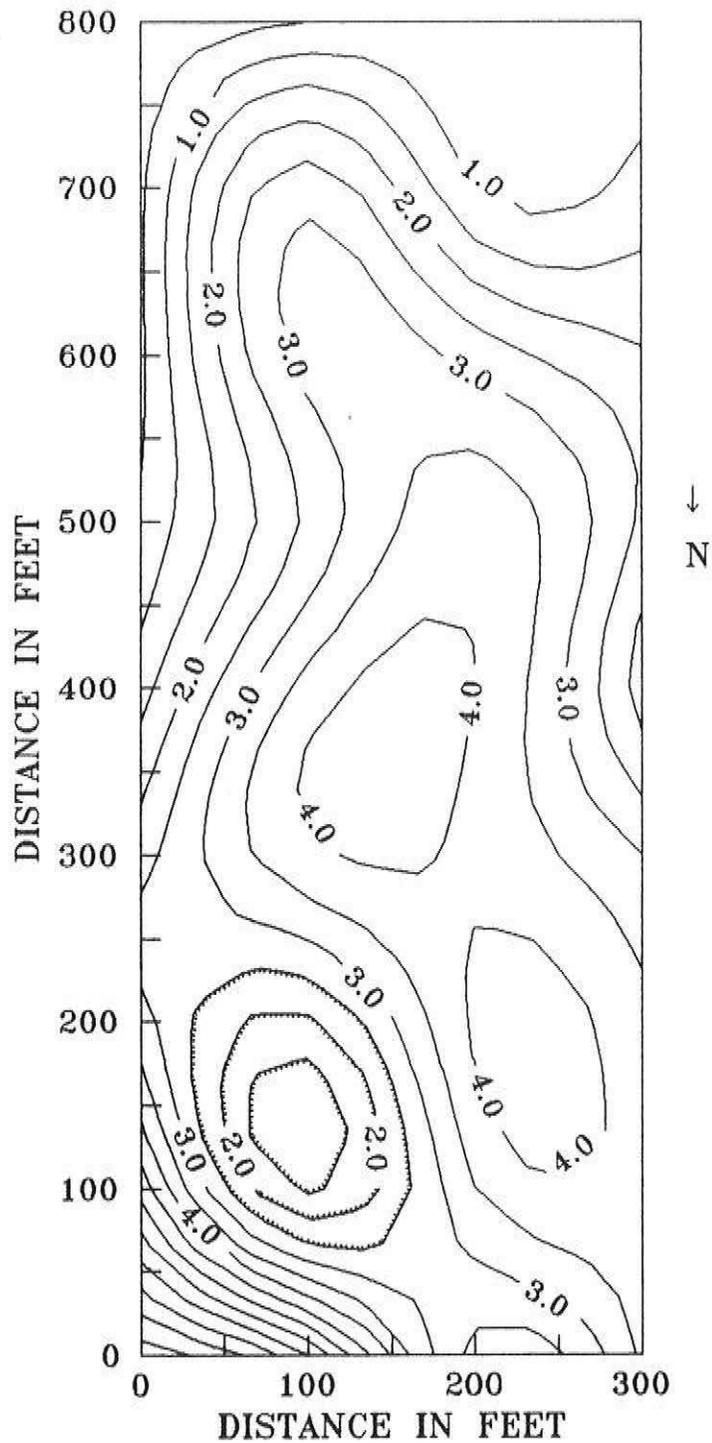
Figure 9 is a two-dimensional contour plot of the ground surface. The contour interval is 0.5 foot. North is towards the lower margin of this figure. The Agua Fria River is to the west of this plot. A slightly elevated ridge of alluvial deposits extends from the northwest to near the southeast corner of the study site. Wastes are being discharged onto the surface of the study site from a pipe located in the embankment near coordinates OX and 200Y. High-tension power lines, adjacent to the southwest corner of the study area, interfered with survey results. Most of the data collected from the area (interference often produced higher values of conductivity) of suspected interference were omitted from the survey results.

ARIZONA LAGOON STUDY  
DAIRY LAGOON - 3  
RELATIVE TOPOGRAPHY  
CONTOUR INTERVAL = 0.5 FT

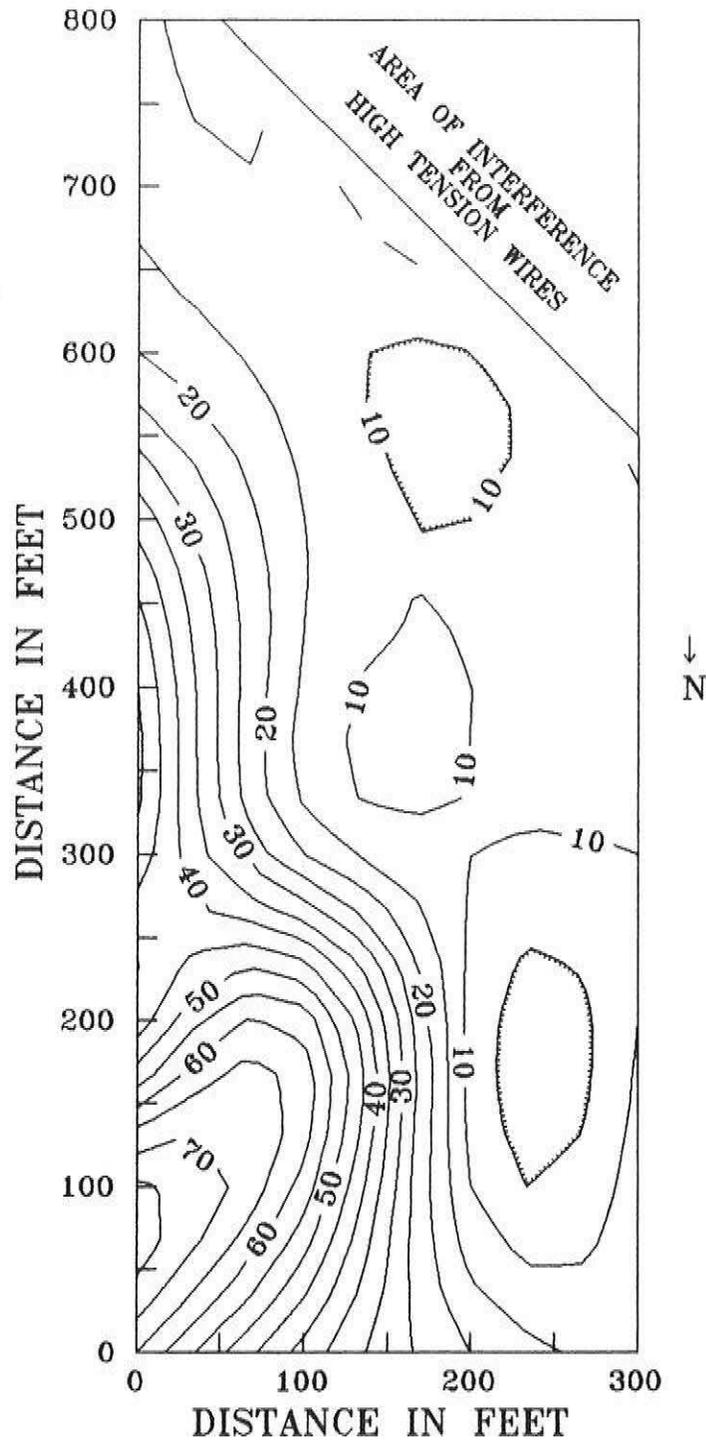
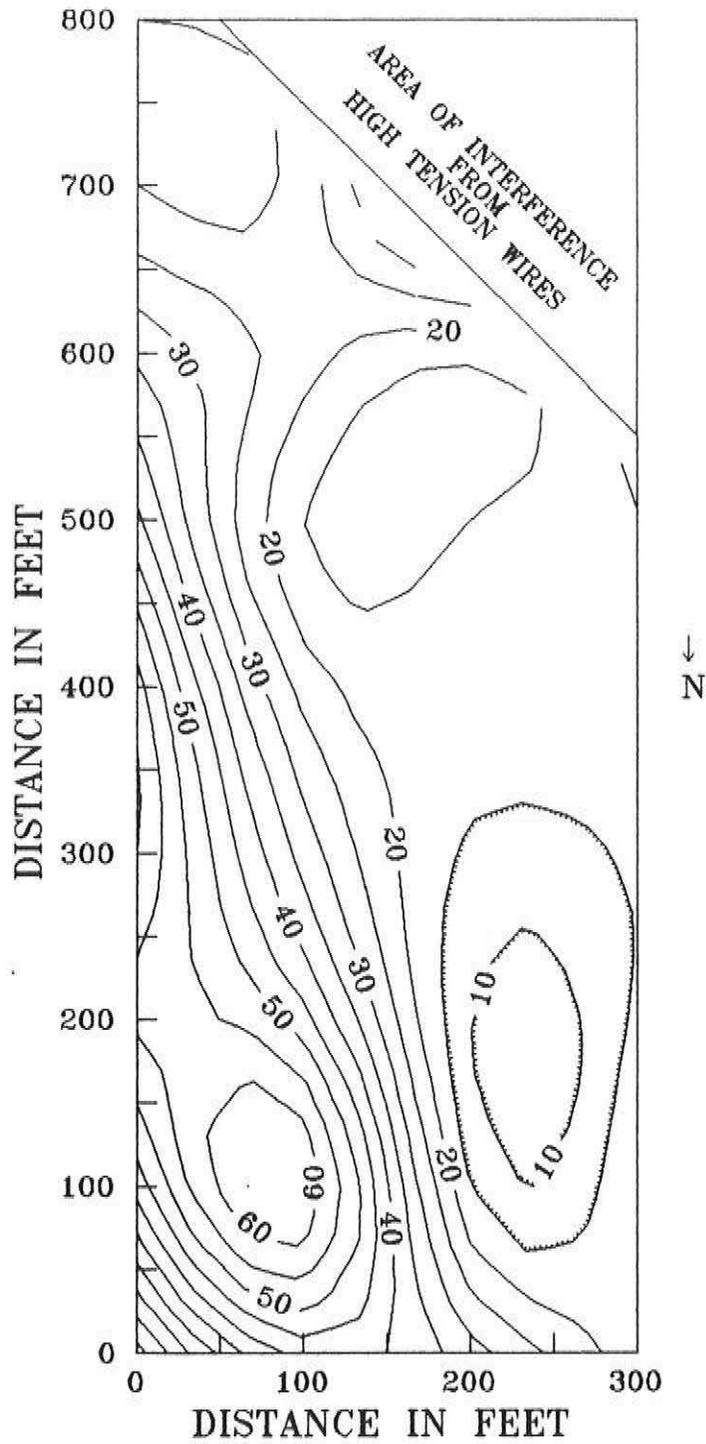
Several inferences can be made from these figures. Values of apparent conductivity are highest near the surface (figure 10 and 11)

and in the area immediately adjacent to the outflow pipe (coordinates 0X and 200Y). A distinct zone of higher conductivity is observable within a triangular area in the eastern and northeastern portion of the study site (within coordinates 0X, 650Y; 0X, 0Y; 225X, 0Y). In this zone, values of apparent conductivity 3.0 to 3.75 and 2.0 to 2.5 times higher than the background value of 20 mS/m were observed within depths of 6 meters (see figures 11 and 12) and 15 meters (see figures 13 and 14), respectively. The zone of higher conductivities is in the area most suspected of being contaminated from the surface discharge of animal wastes.

DAIRY LAGOON - 3  
EM31  
HORIZONTAL DIPOLE

DAIRY LAGOON - 3  
EM31  
VERTICAL DIPOLE

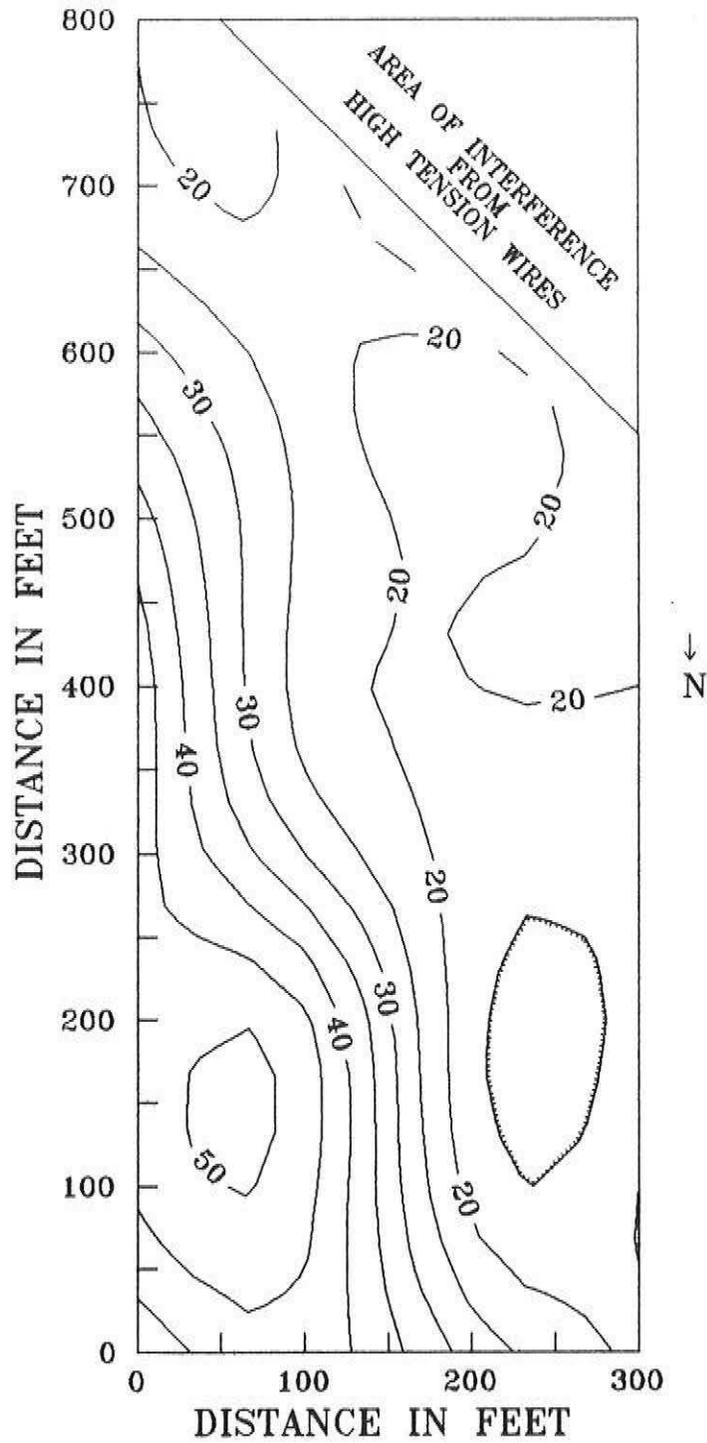
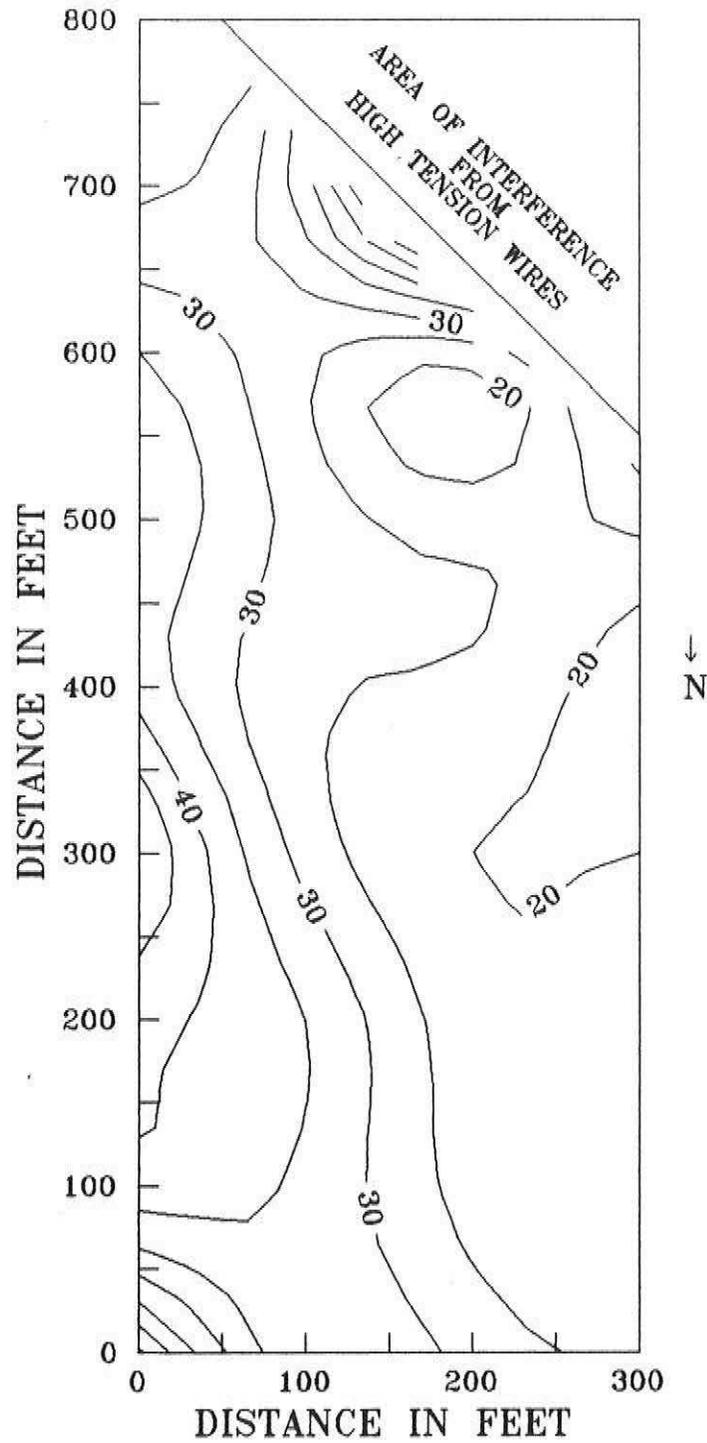
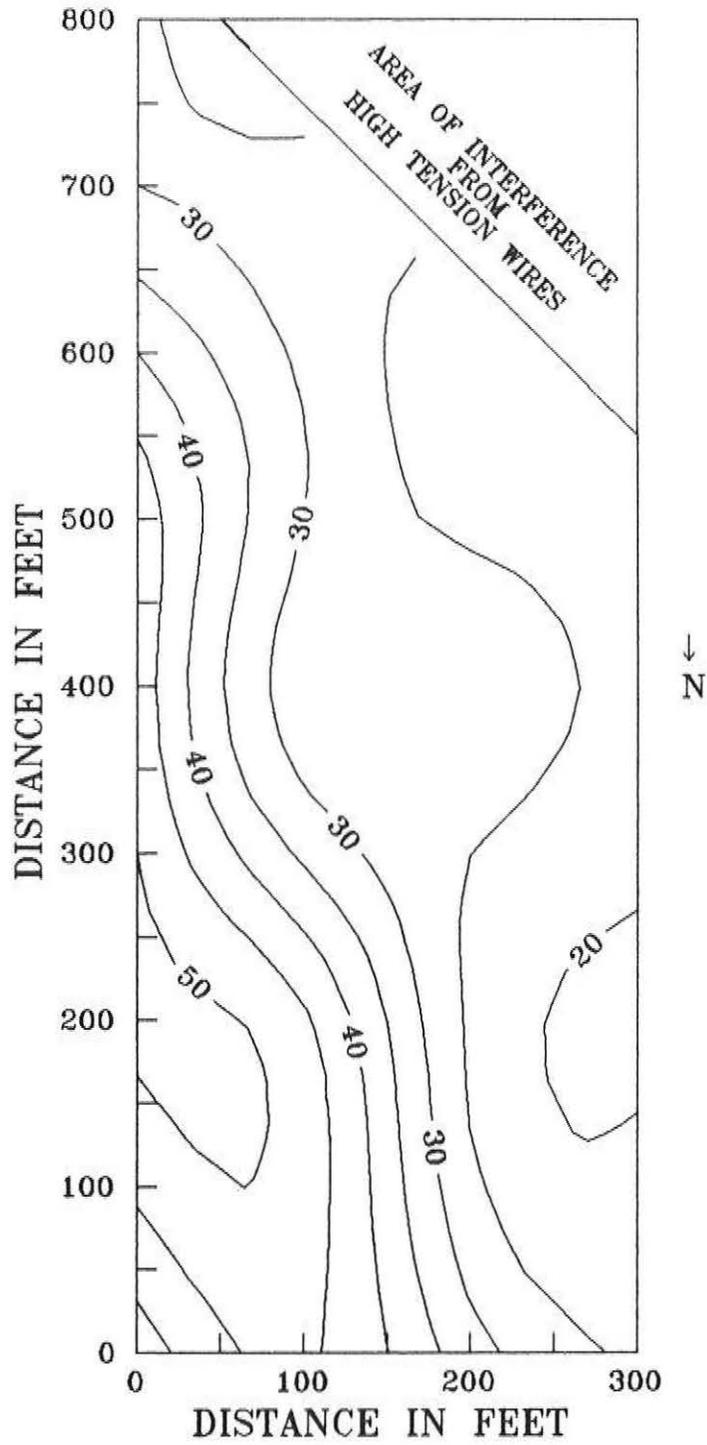
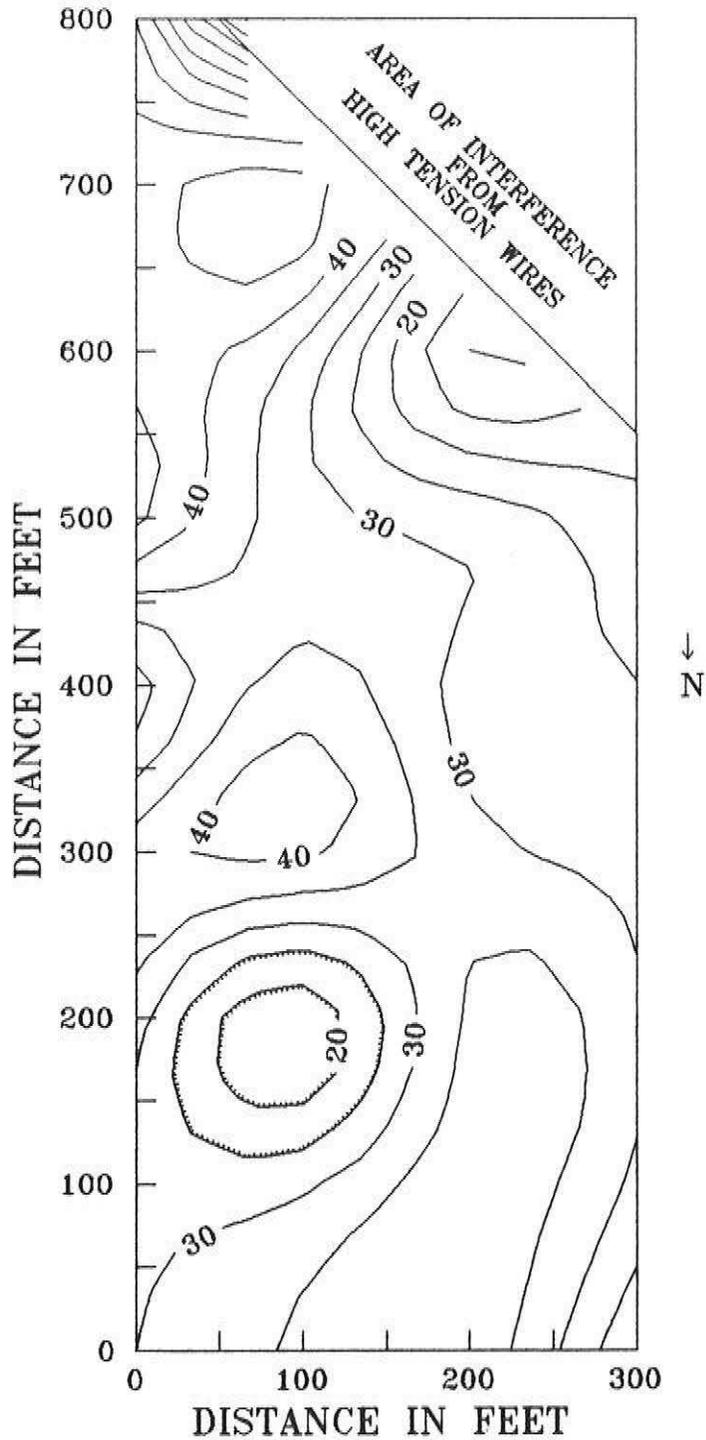
Based on survey results, no evidence has been found to support lateral movement of contaminants into the Aqua Fria River. Within the upper 15 meters of the study site, values of apparent conductivity decrease with increasing soil depth profiled (figures 10, 11, 12, and 13). From 15 to 30 meters, values of apparent conductivity appear to increase slightly (except in zone of suspected contamination). This phenomenon may be caused by the presence of the water table between depths of 15 to 30 meters.

The high-tension power lines interfered with measurements made in the southwest corner of the study sites. The zone of interference from the high tension power lines grew and measurements made at more distant observation point were affected with each increase in intercoil spacing. In addition, with the EM34 meter, the area affected by interference was greater in the vertical dipole orientation.

ARIZONA LAGOON STUDY  
DAIRY LAGOON - 3  
EM34  
HORIZONTAL DIPOLE  
10 M INTERCOIL SPACING

ARIZONA LAGOON STUDY  
DAIRY LAGOON - 3  
EM34  
VERTICAL DIPOLE  
10 M INTERCOIL SPACING

ARIZONA LAGOON STUDY  
DAIRY LAGOON - 3  
EM34  
HORIZONTAL DIPOLE  
20 M INTERCOIL SPACING

ARIZONA LAGOON STUDY  
DAIRY LAGOON - 3  
EM34  
VERTICAL DIPOLE  
20 M INTERCOIL SPACING

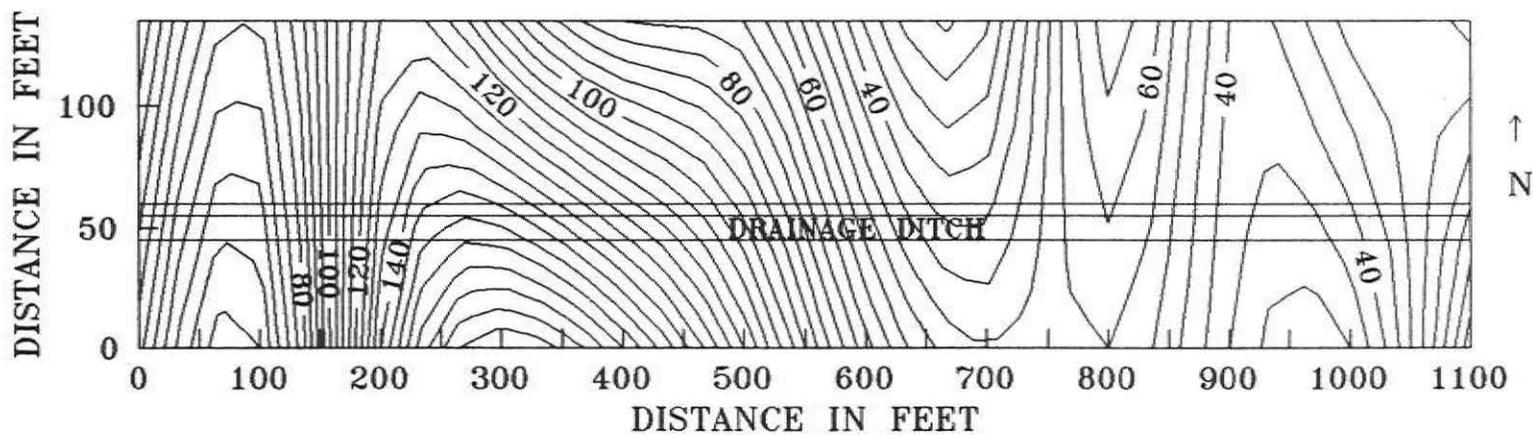
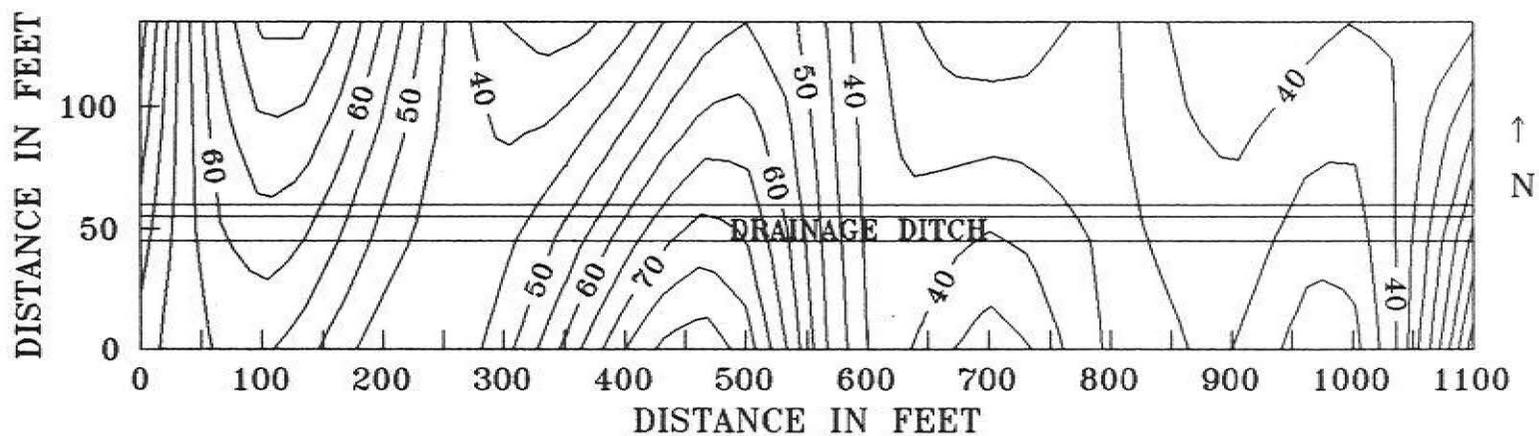
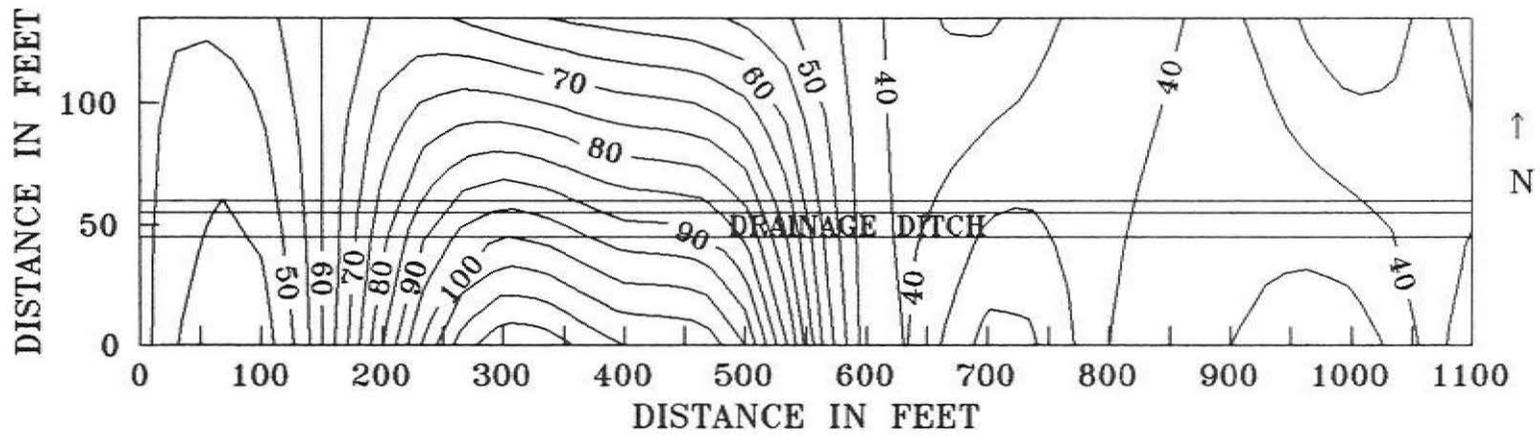
Several inferences can be made from these figures. Patterns of apparent conductivity are exceedingly complex within the confined study area and are believed to reflect a history of varying land uses and management practices. Values of apparent conductivity are highest near the surface and decrease with increasing soil depth. In each plot, zones of higher apparent conductivities appear to emanate from the sides of the lagoon (immediately adjacent to the southern boundary of the study site) between X coordinates of 290 and 600, and 900 to 1050. These zones are detectable within the upper 6 to 7.5

meters of the soil profile (see figures 16, 17, and 18) at distances as great as 135 feet from the sides of the lagoon. When depths of 15 meters are scanned (see Figure 19), these zones become more restricted and are observable only within distances of less than 75 feet from the lagoon.

DAIRY LAGOON - 4  
EM31  
HORIZONTAL DIPOLE

DAIRY LAGOON - 4  
EM31  
VERTICAL DIPOLE

DAIRY LAGOON - 4  
EM34  
HORIZONTAL DIPOLE  
10 M INTERCOIL SPACING
