United States Department of Agriculture  
Soil Conservation Service

Subject: Electromagnetic Induction (EM)  
survey of Animal Waste Storage Ponds,  
Arizona; 17 to 21 August 1992

Date: 9 September 1992

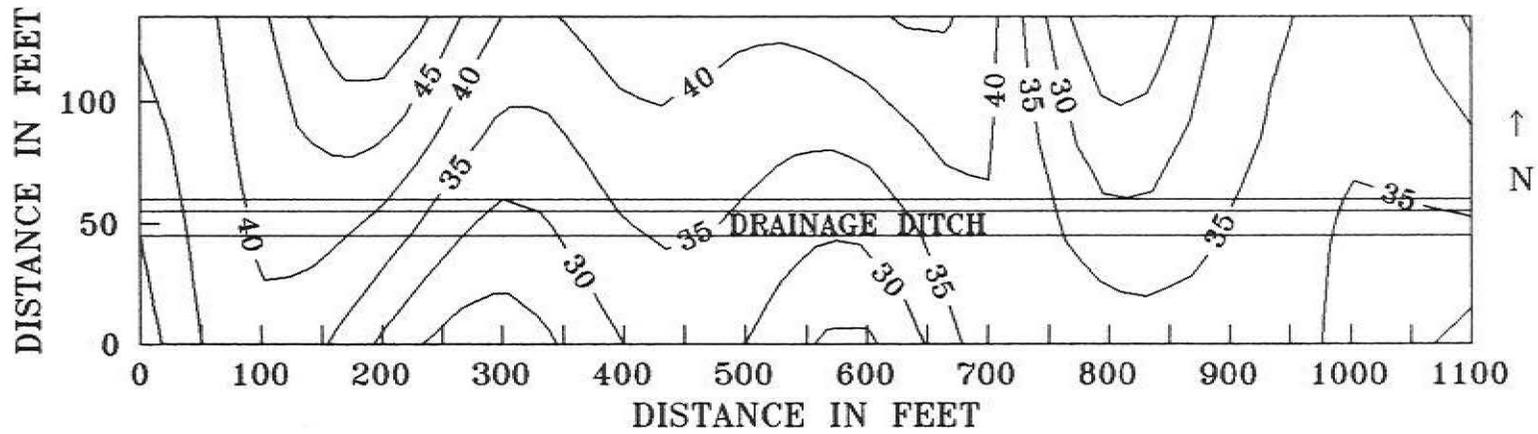
Figure 19

meters of the soil profile (see figures 16, 17, and 18) at distances as great as 135 feet from the sides of the lagoon. When depths of 15 meters are scanned (see Figure 19), these zones become more restricted and are observable only within distances of less than 75 feet from the lagoon.

DAIRY LAGOON - 4  
EM34  
VERTICAL DIPOLE  
10 M INTERCOIL SPACING

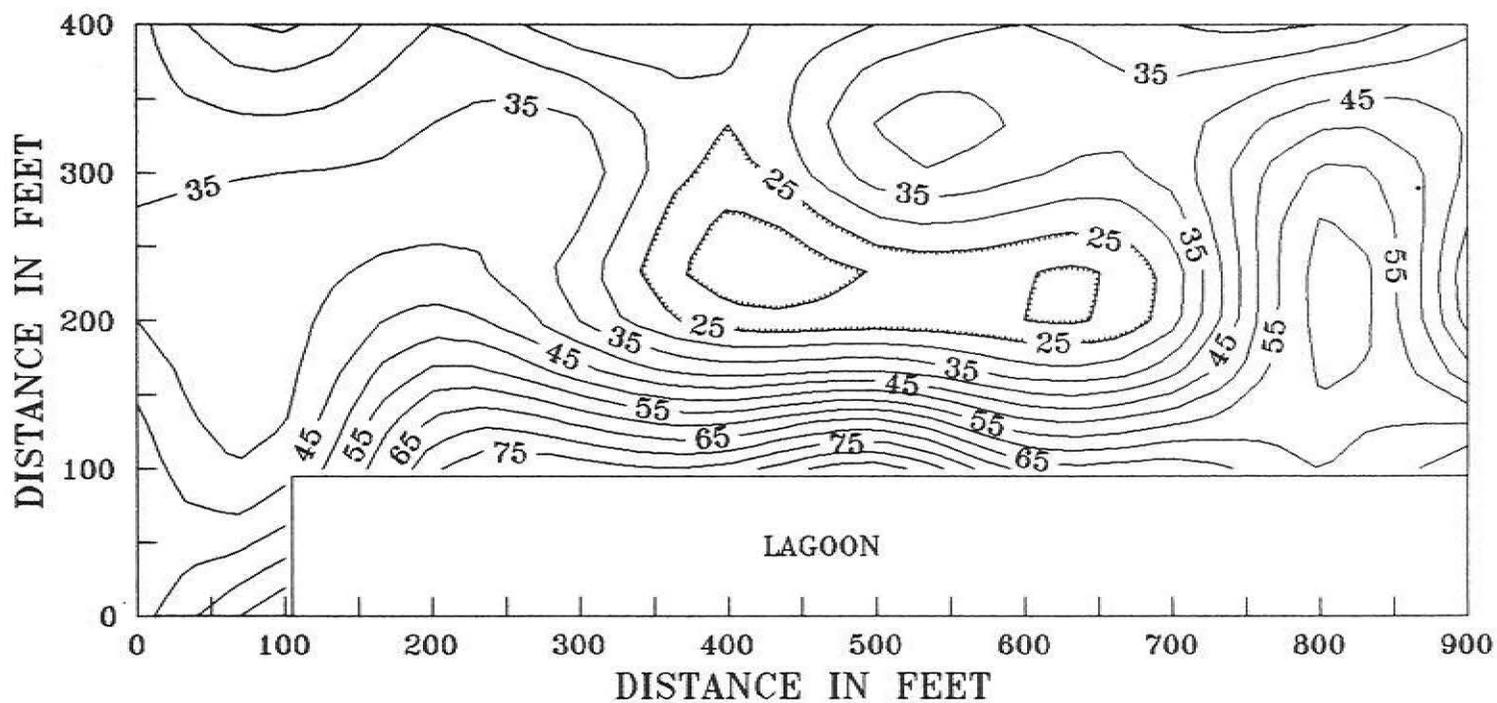
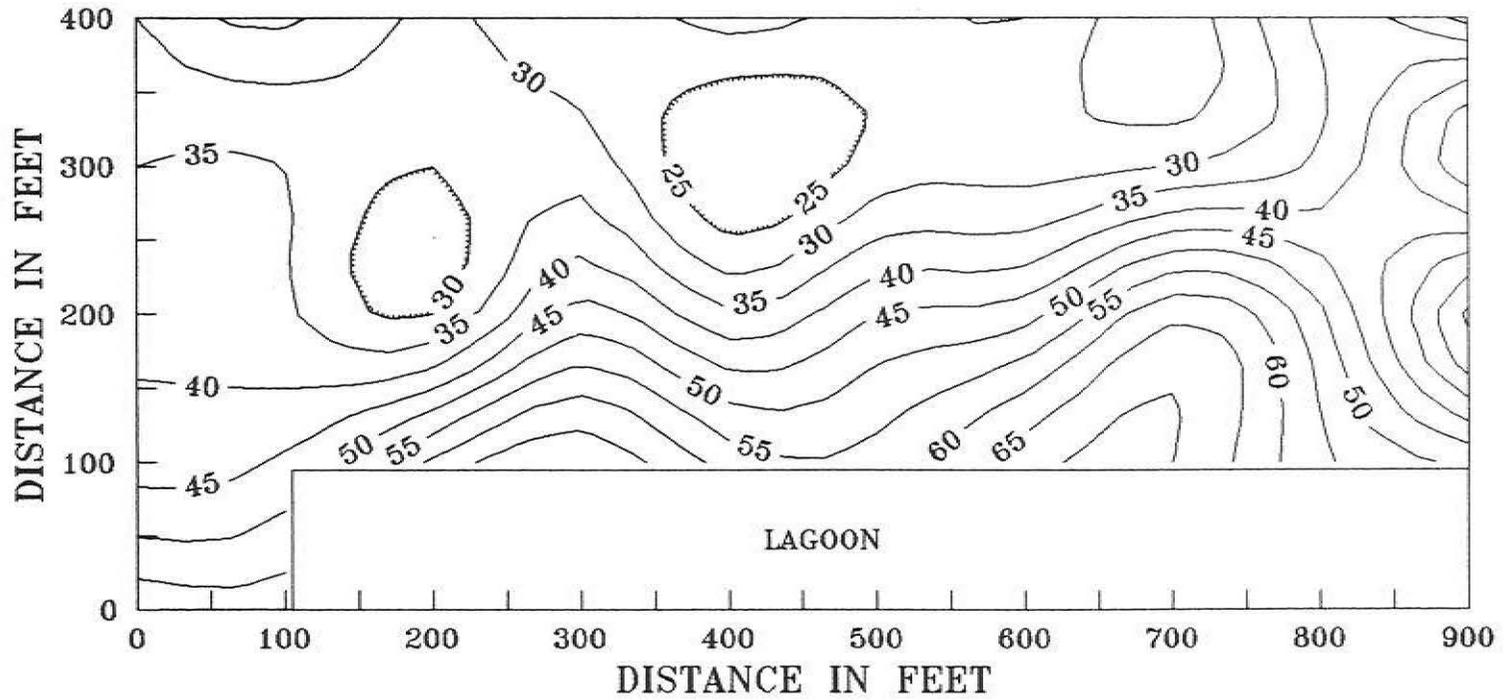
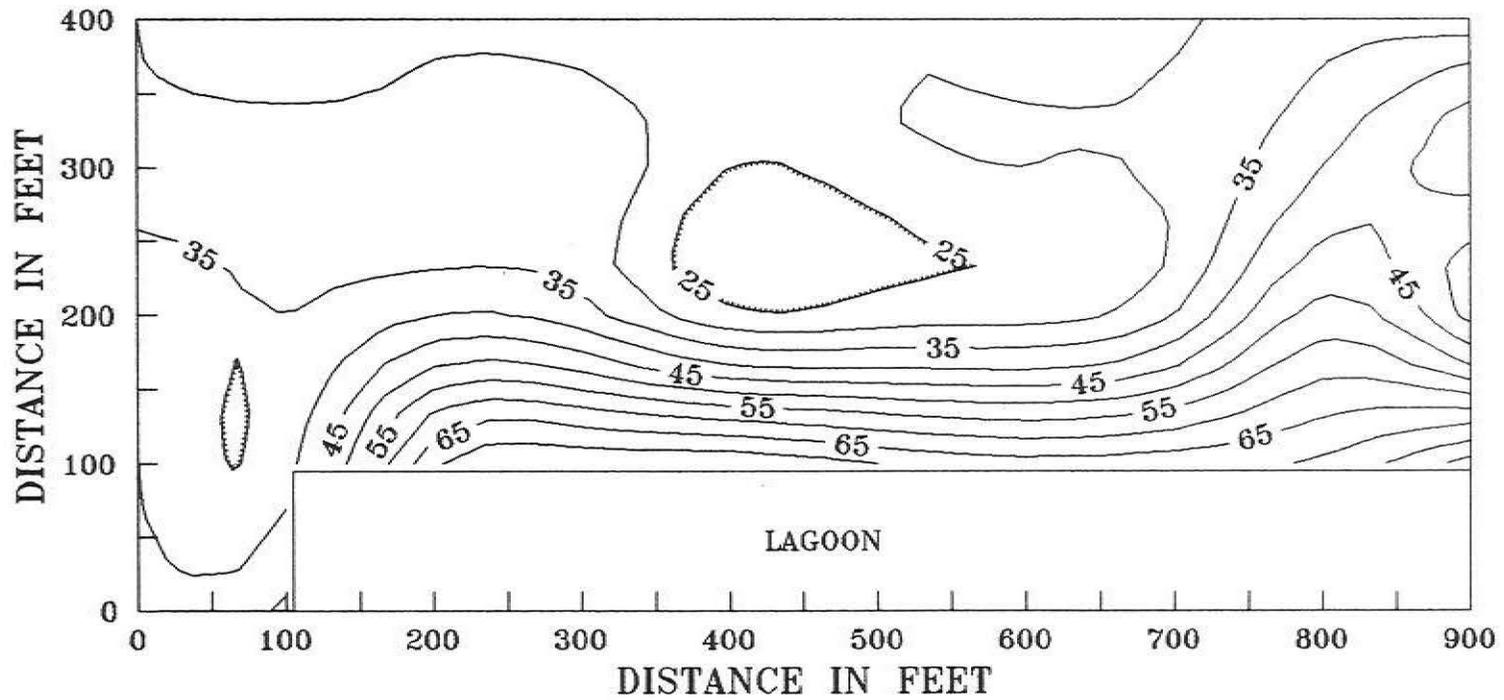
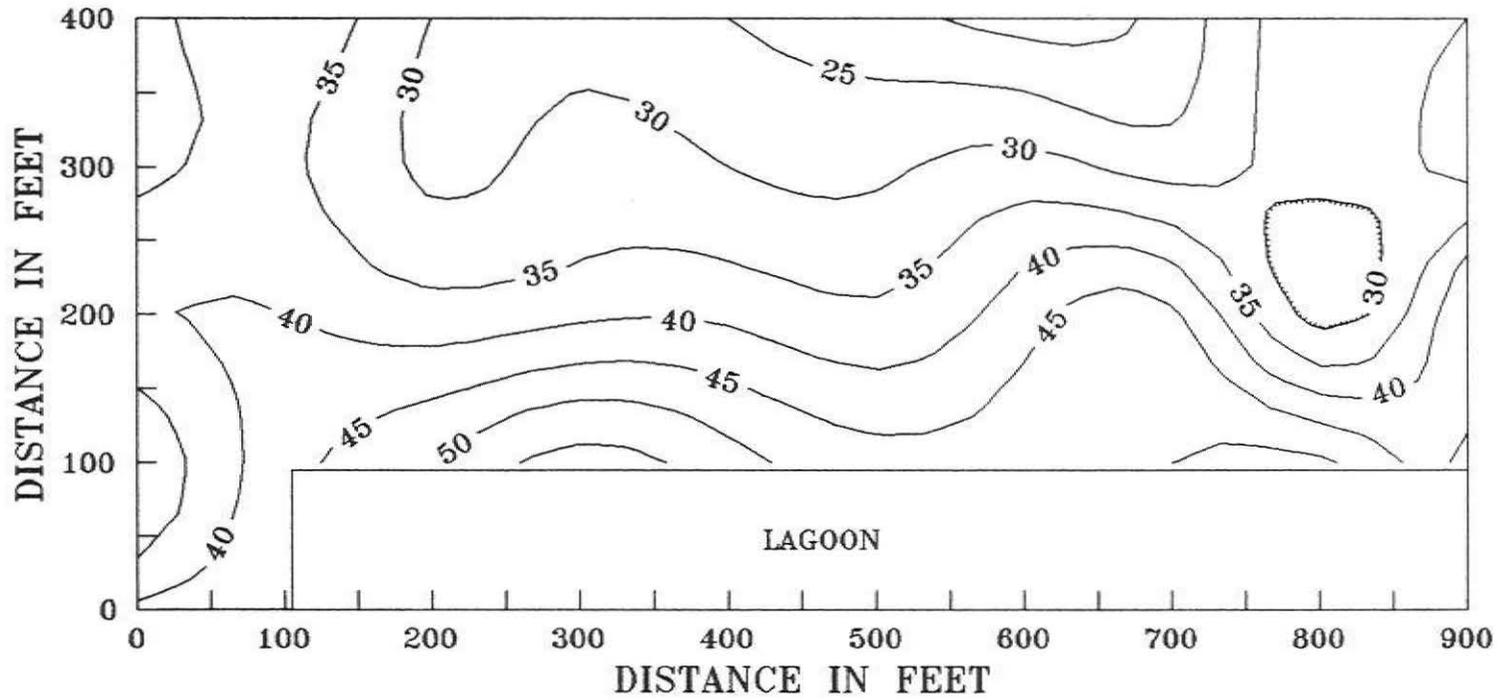
Several inferences can be made from these figures. Values of apparent conductivity are highest nearest to the lagoon and appear to decrease away (both laterally and vertically) from the structure. Assuming that the broad, plume-like features apparent in these figures represent seepage, contaminated areas are detectable with EM meters at distance of less than 100 feet from the structure. Another inference is that these broad, plume-like areas represent soil materials with higher-conductivity which has been excavated from lower depths and spread onto the surface. Once again, some field observations and independent measurements are needed to confirm interpretations.

In each plot, a zones of higher-conductivity is evident along the upper margin of the plot. This zone represents contrasting soil materials or contaminants from a source other than the lagoon.

DAIRY LAGOON - 5  
EM31  
HORIZONTAL DIPOLE

DAIRY LAGOON - 5  
EM31  
VERTICAL DIPOLE
