**United States
Department of
Agriculture**

**Natural Resources
Conservation
Service**

Subject: SOI – Electromagnetic Induction (EMI) Comparative Field Studies

Date: 10 January 2002

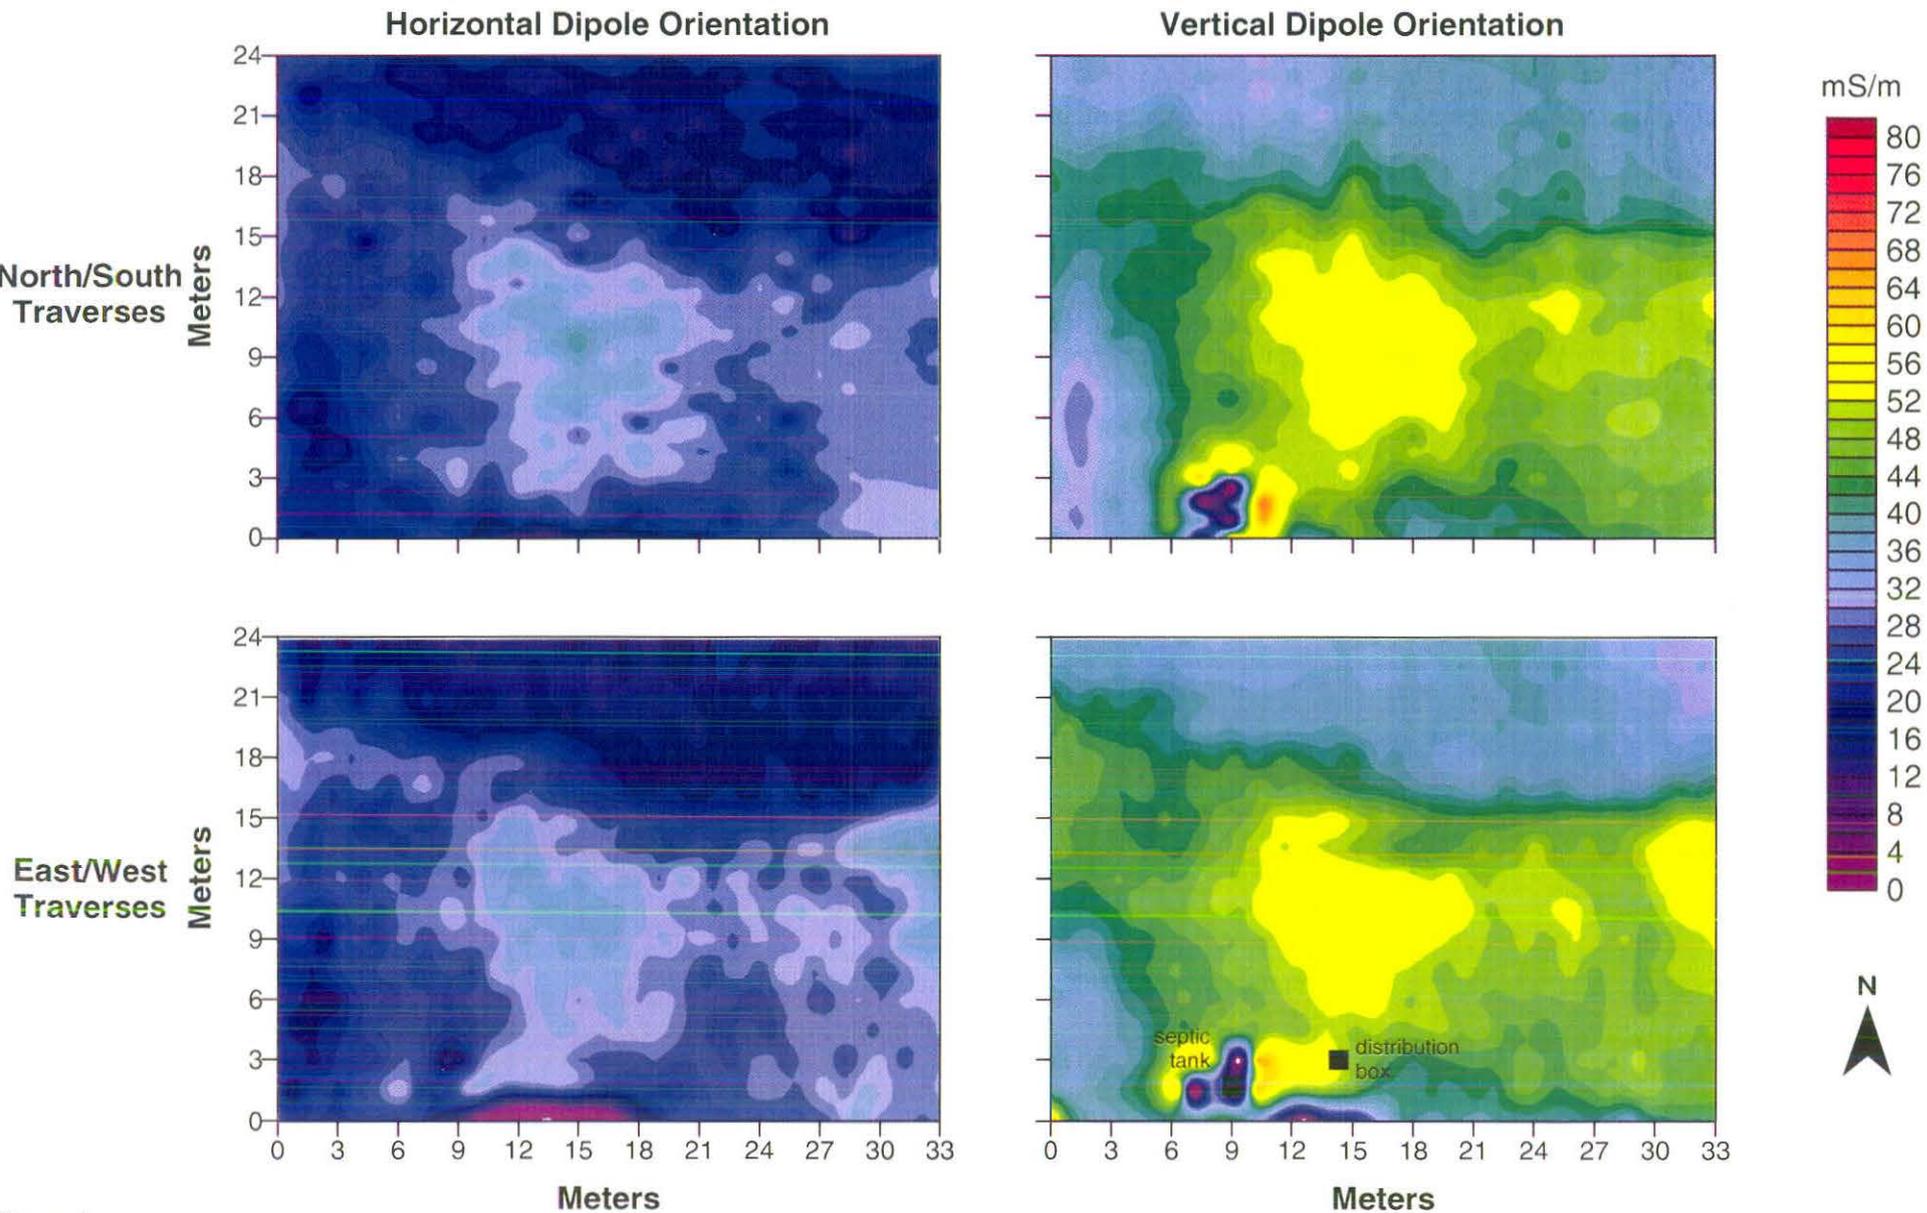
Figure 1 contains plots of apparent conductivity measured with the EM38DD meter at the Schwartz Road site in Allen County. The upper two plots in Figure 1 show the spatial distribution of apparent conductivity collected with the EM38DD meter for survey that was conducted along north-south trending grid lines. The lower two plots show the spatial distribution of apparent conductivity measured with the EM38DD meter for survey that was conducted along east-west trending grid lines. For each survey, the spatial distributions of apparent conductivity collected in the horizontal and vertical dipole orientations are shown in the left-hand and right-hand plots, respectively. In each plot, the isoline interval is 2 mS/m. The approximate locations of the septic tank and the distribution box are shown in the lower right-hand plot.

EMI SURVEY OF SITE ON SCHWARTZ ROAD, ALLEN COUNTY, INDIANA

EM38DD METER

Regardless of the directions in which the data were collected, spatial patterns are similar. Because of the depth to the septic system, spatial patterns are perhaps more informative in the plots prepared from data collected with the EM38DD meter in the deeper-sensing, vertical dipole orientation. In Figure 1, the septic tank produces anomalous apparent conductivity values that are conspicuous and more readily identified in plots of the vertical dipole data. High levels of signal interference affect some of the data collected along east-west lines. The interference is caused by a closely adjoining swimming pool and deck (see lower boundary, between reference points 9 and 18 m). Above- and belowground metallic objects can interfere with electromagnetic fields. Metallic objects are good conductors and can produce anomalously high or low (negative) EMI responses. The distribution box did not produce a conspicuous and distinguishing response and its location is not definable from EMI data alone. Though unconfirmed, the area of higher apparent conductivity in the central portion of the survey area is believed to represent the absorption field. The presumed location of the absorption field is within a rather broad band of higher apparent conductivity that crosses the grid area in a northwest to southeast direction. This band could represent dissimilar soil materials (higher clay, moisture, and or soluble salt contents) or contaminants from the absorption field. If the latter, based on apparent conductivity, the flow and concentration of wastes appears to be greater to the east of the absorption field.

Spatial patterns shown in these plots are closely similar to the spatial patterns of apparent conductivity that were simulated from data collected with the EM38DD meter (see Figure 1). Like the data acquired with the EM38DD meter, data collected with the GEM300 sensor is also affected by signal interference caused by a closely adjoining swimming pool and deck. However, because the GEM300 sensor was operated at hip height rather than near the soil surface, a larger zone of interference appears in both the north-south and east-west data sets.

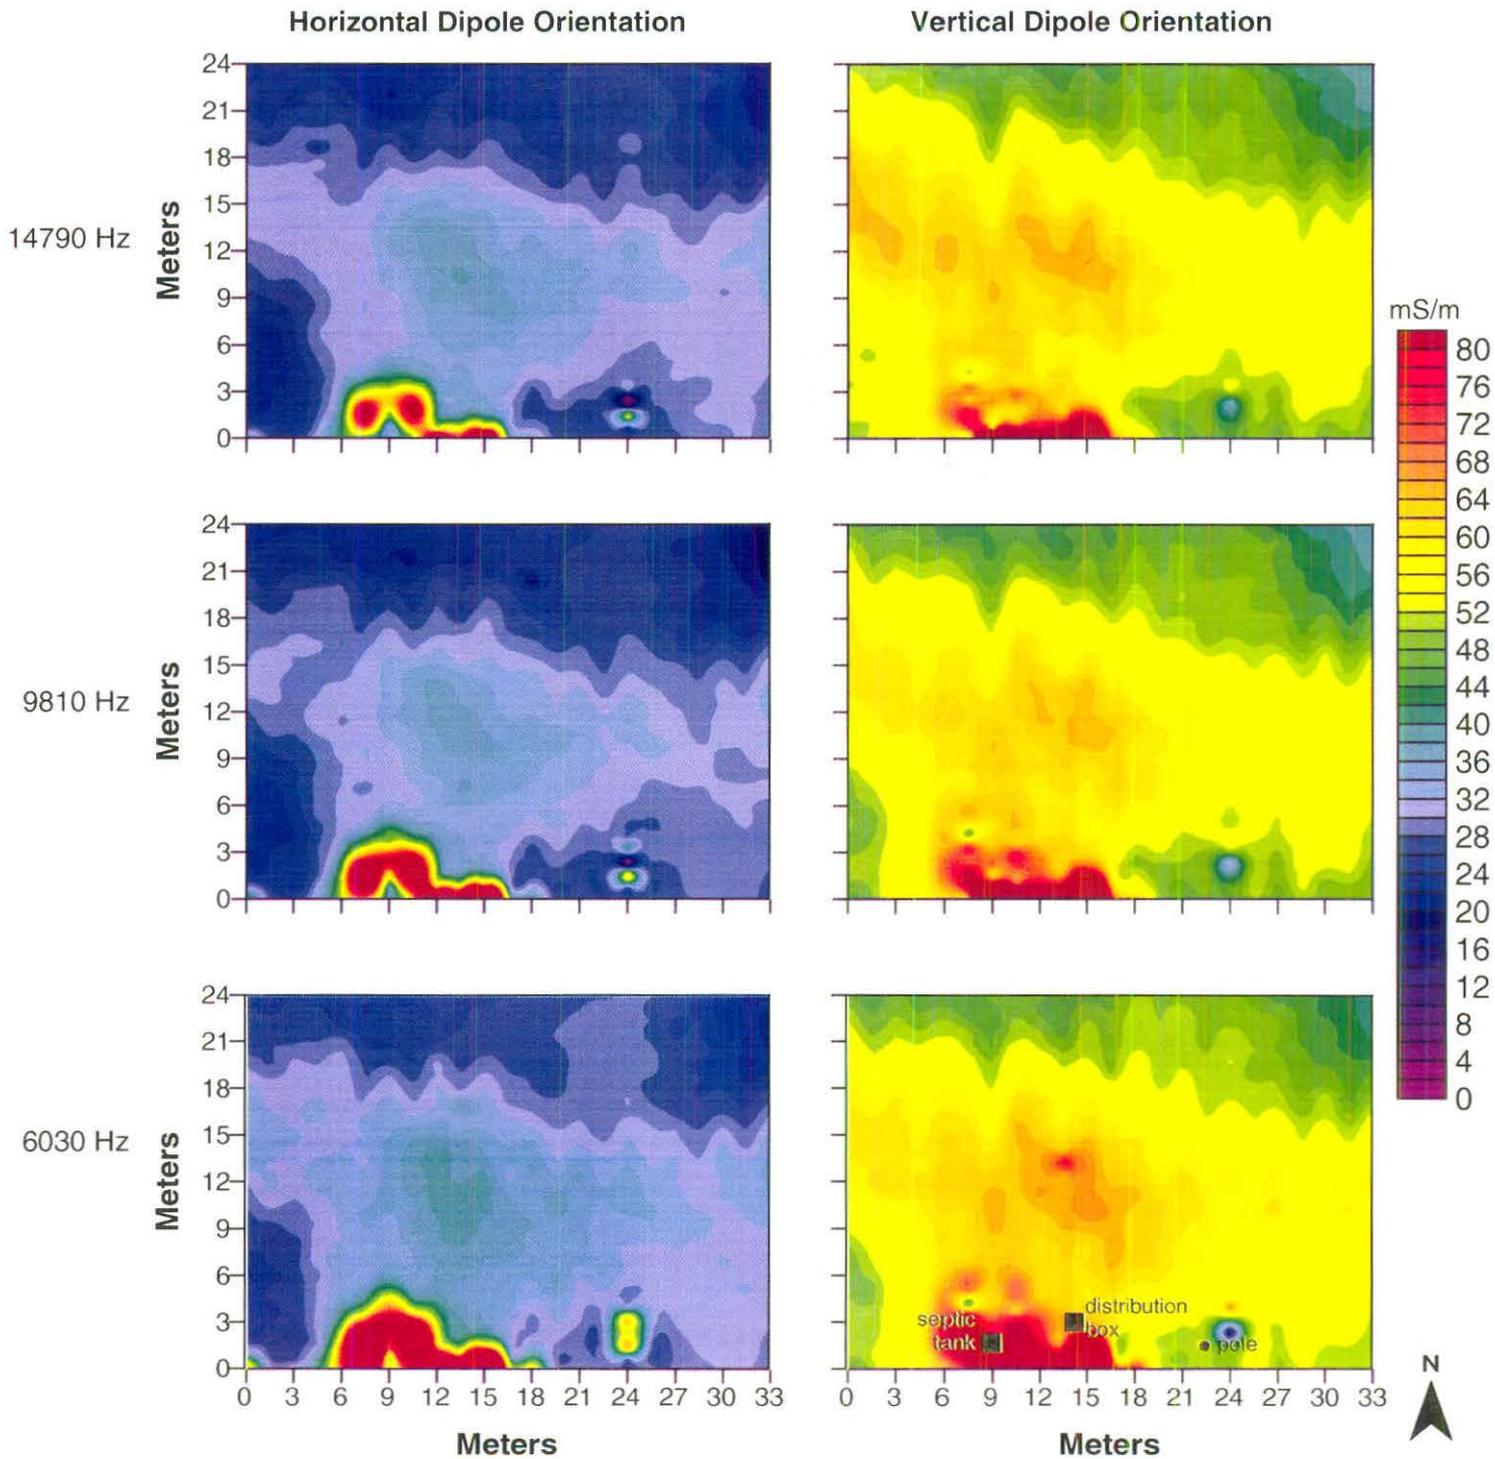
Figure 2

Figures 2 and 3 show the results of the EMI survey conducted with the GEM300 sensor along north-south and east-west trending grid lines, respectively. In each figure, data collected at 14790 Hz, 9810 Hz, and 6030 Hz are shown in the upper, middle, and lower sets of plots, respectively. For each frequency, data collected in the horizontal and vertical dipole orientations are shown in the left-hand and right-hand plots, respectively. In each plot, the color interval is 2 mS/m. The approximate locations of the septic tank, distribution box, and tetherball pole are shown in the lower right-hand plot.

EMI SURVEY OF SITE ON SCHWARTZ ROAD ALLEN COUNTY, INDIANA GEM300 SENSOR - NORTH/SOUTH TRAVERSES

In figures 2 and 3, a zone of relatively high apparent conductivity in the central portion of the survey area is believed to represent the approximate location of the absorption field. The absorption field is poorly defined and is situated within a broad band of comparatively high apparent conductivity that extends across the survey area. The poor definition of the absorption field in these plots may represent excessive discharge of contaminants into adjoining soils from a failed septic system. Areas of higher conductivity extend outwards from the absorption field to the east and west. Compared with the EM38DD meter, amplitudes are higher and contrasts between areas of higher and lower conductivities are greater with the GEM300 sensor. As a consequence, the band of higher apparent conductivity that crosses the survey area from near the northwest to southeast corners is more apparent.

In each plot appearing in figures 2 and 3, patterns of apparent conductivity are elongated in the direction of traverse. These patterns are a form of noise and may represent errors introduced by equipment drift, the alignment of the transmitter and receiver coils, and/or the offsets or delays in signal recording. These patterns also occur, but are less noticeable, in the plots of data collected with the EM38DD meter

Spatial patterns of apparent conductivity collected in the same dipole orientation are remarkably similar for data collected at different frequencies (see figures 2 and 3). For each of the four surveys conducted with the GEM300 sensor, strong ($r = 0.844$ to 1.000) and significant (0.001 level) correlations existed between data collected at different frequencies (6030, 9810, 14790 Hz) but in similar dipole orientations. It is therefore doubtful that the use of multiple frequencies provides multiple depths of observation or any additional information about this site. Won and others (1996) specifically designed the GEM300 sensor to detection of buried objects. They noted that each frequency and dipole orientation will provide a slightly different picture of a buried object. Buried objects may be more easily detected at a particular frequency. Each frequency and dipole orientation will provide a slightly different visual presentations of the site. However, more information appears to be provided in data that are collected with one frequency and two dipole orientations than in data that are collected at multiple frequencies and only one dipole orientation. In addition, the use of multiple frequencies requires additional time and expenses to process and display the data.

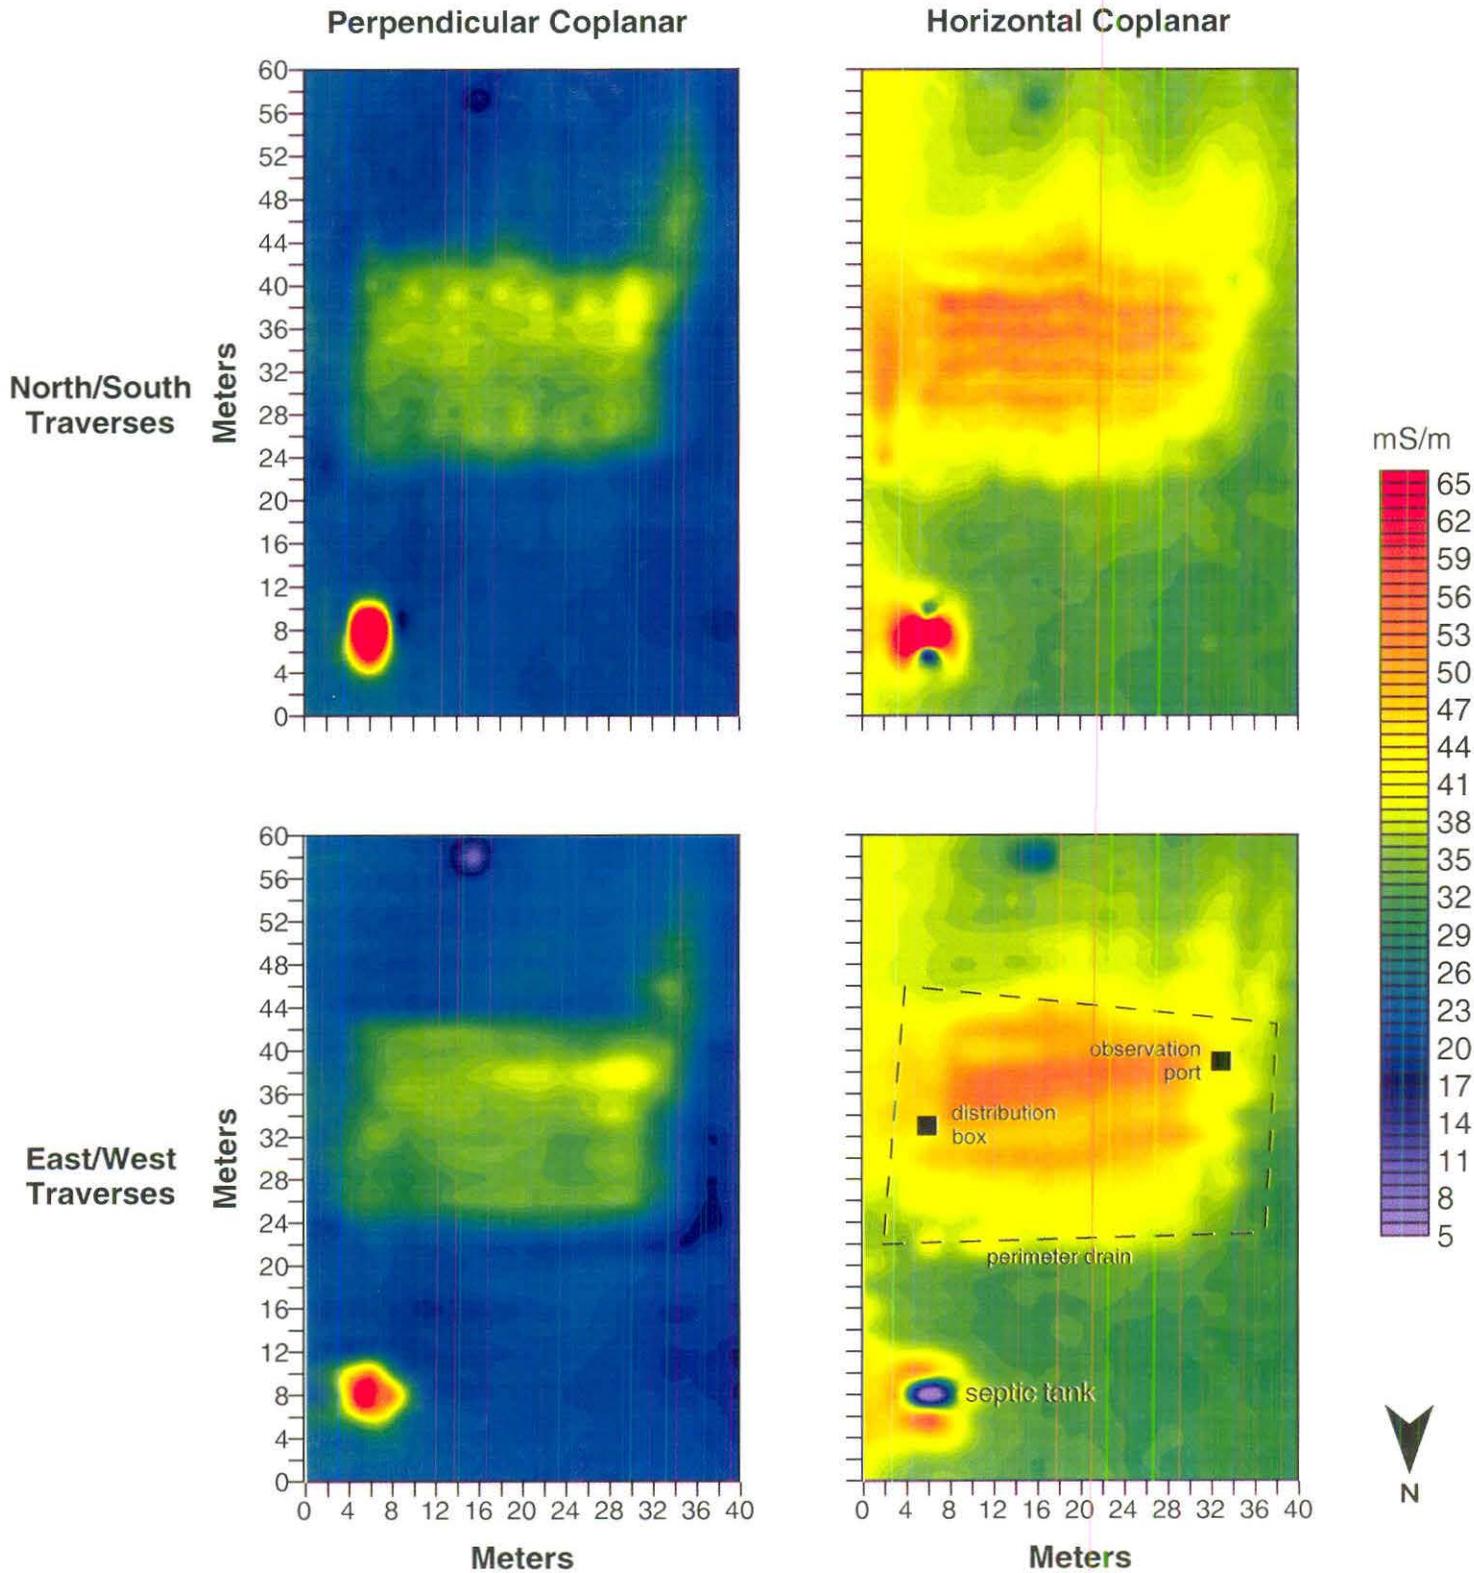
Figure 4 contains plots of apparent conductivity measured with the Dualem-2 meter at the Hursh Road site. The upper two plots in Figure 4 show the spatial distribution of apparent conductivity collected with the Dualem-2 meter for surveys that were conducted along north-south trending grid lines. The lower two plots show the spatial distribution of apparent conductivity measured with the Dualem-2 meter for surveys that were conducted along east-west trending grid lines. For each survey, the spatial distributions of apparent conductivity collected in the perpendicular and horizontal coplanar geometries are shown in the left-hand and right-hand plots, respectively. In each of the plots, the isoline interval is 1 mS/m. The approximate locations of the septic tank, distribution box, observation port, and perimeter drain are shown in the lower right-hand plot.

EMI SURVEY OF SITE ON HURSH ROAD ALLEN COUNTY, INDIANA DUALEM-2 METER

The Dualem-2 meter has clearly defined the locations of the septic tank, absorption field, and observation port. These features are apparent in each plot of Figure 4. In addition, portions of the perimeter drain are evident in all plots. However, this feature is best expressed in the plot of the data collected in the shallower-sensing, perpendicular coplanar geometry. The distribution

box was not detected with the Dualem-2 meter. Spatial patterns in the data sets for the deeper-sensing horizontal coplanar geometry suggest the presence of linear features within the absorption field. The parallel, east-west trending, linear patterns within the absorption field suggest the locations of trenches and/or pipes. Two area of slightly higher apparent conductivity extends southwards from the south-central portion and the southwest corner of the absorption field. These patterns suggest possible discharge of waste products from the system. No interpretation is available for the anomaly that occurs in the central portion near the southern grid boundary.

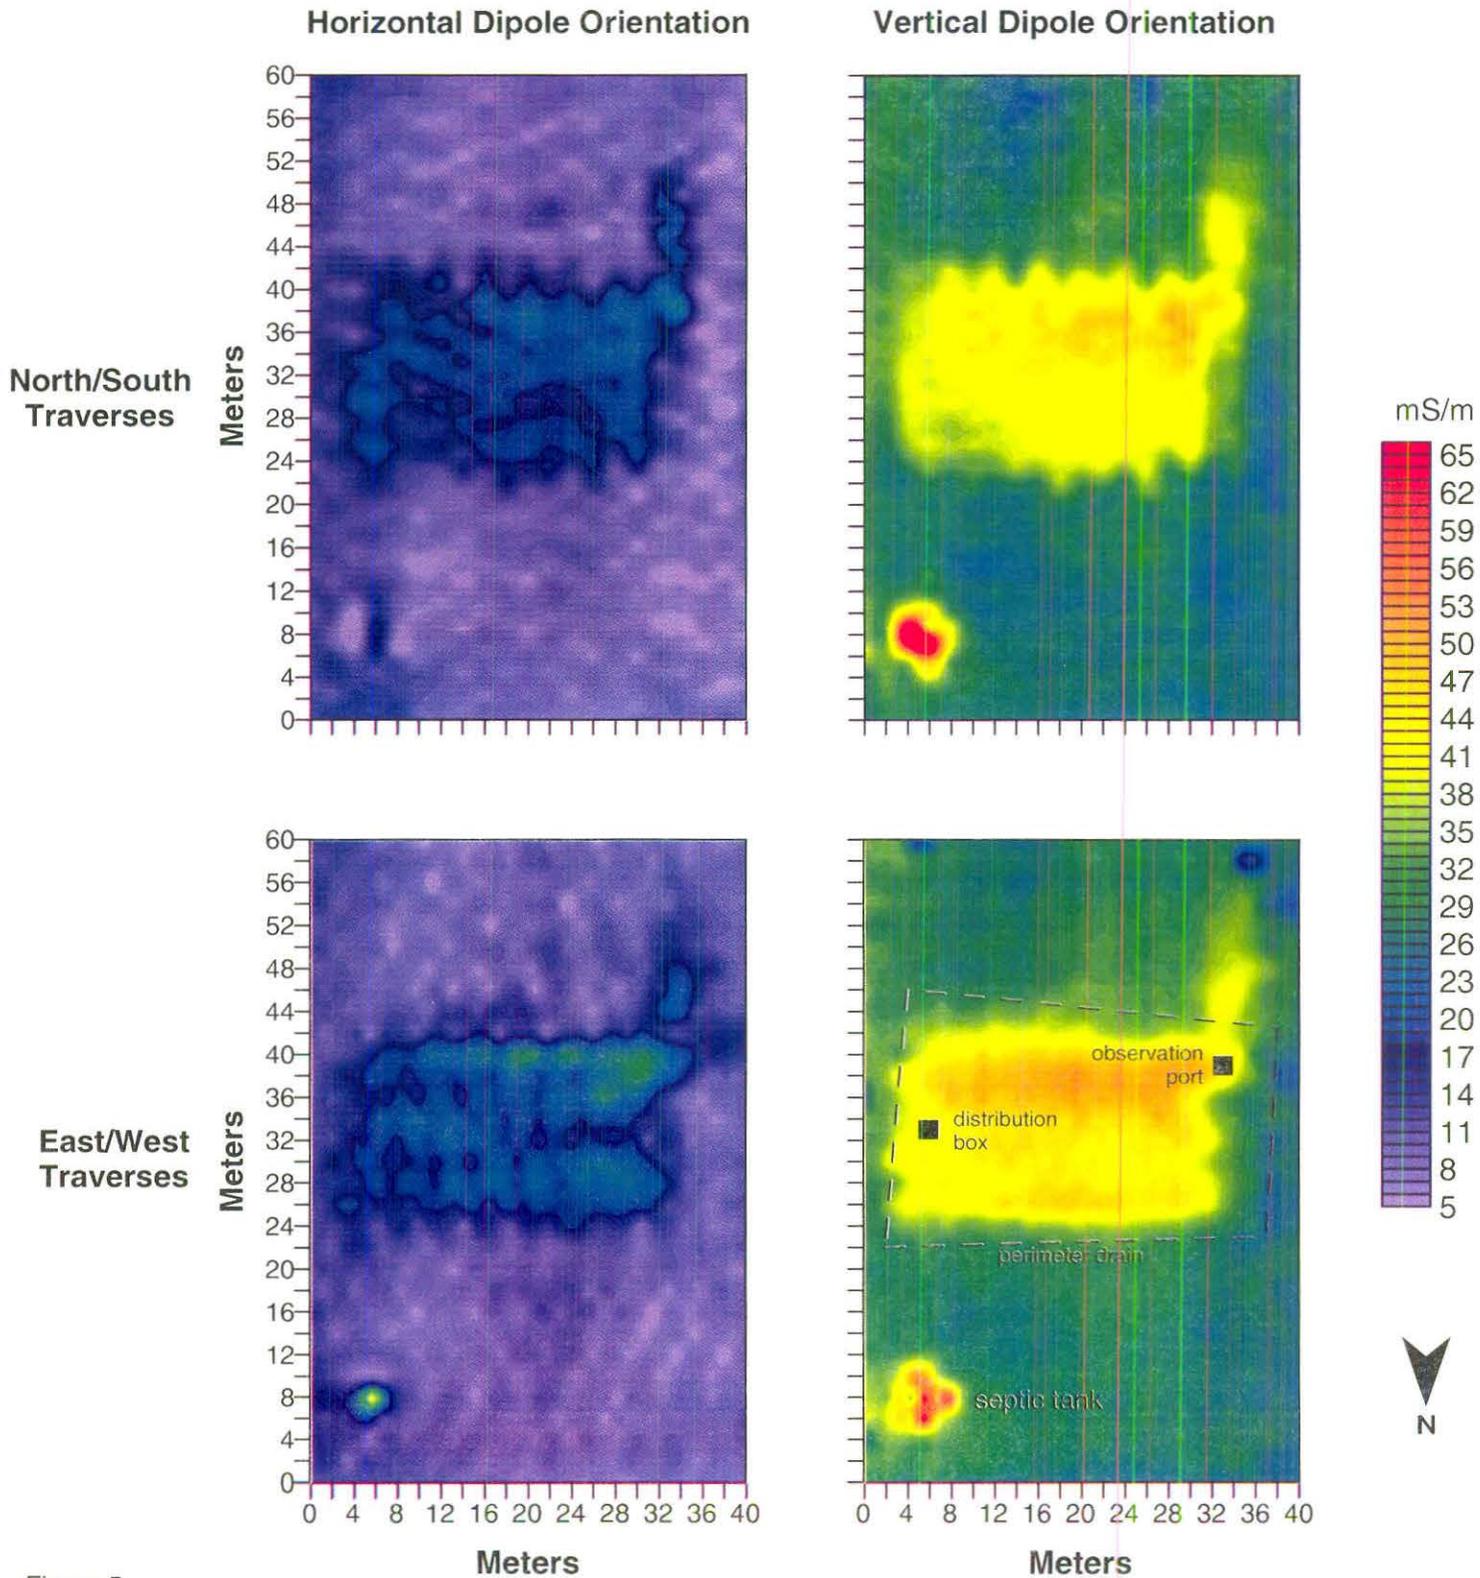
Figure 5 contains plots of apparent conductivity measured with the EM38DD meter at the Hursh Road site. All plots contain herringbone patterns caused by the reorientation of the transmitter and receiver coils along succeeding traverse lines. The upper two plots in Figure 5 show the spatial distribution of apparent conductivity for surveys that were conducted along north-south trending grid lines. The lower two plots show the spatial distribution of apparent conductivity for surveys that were conducted along east-west trending grid lines. For each survey, the spatial distributions of apparent conductivity collected in the horizontal and vertical dipole orientations are shown in the left-hand and right-hand plots, respectively. In each of the plots, the isoline interval is 1 mS/m. The approximate locations of the septic tank, distribution box, observation port, and perimeter drain are shown in the lower right-hand plot.

EMI SURVEY OF SITE ON HURSH ROAD ALLEN COUNTY, INDIANA EM38DD METER

The EM38DD meter clearly defined the locations of the septic tank and the absorption field. These features are apparent in each plot of Figure 5. However, the EM38DD meter did not discern the observation port, perimeter drain or distribution box. Spatial patterns in the data sets for the deeper-sensing, vertical dipole orientation suggest the presence of linear features within the absorption field. These patterns may reflect the locations of absorption field trenches and/or pipes. However, compared with the data collected with the Dualem-2 meter, these patterns are broader and more ambiguous. The area of slightly higher apparent conductivity that extends southwards from the southwest corner of the absorption field is well expressed in all plots of Figure 5. This pattern of higher apparent conductivity suggests possible discharge of waste products from the absorption field.

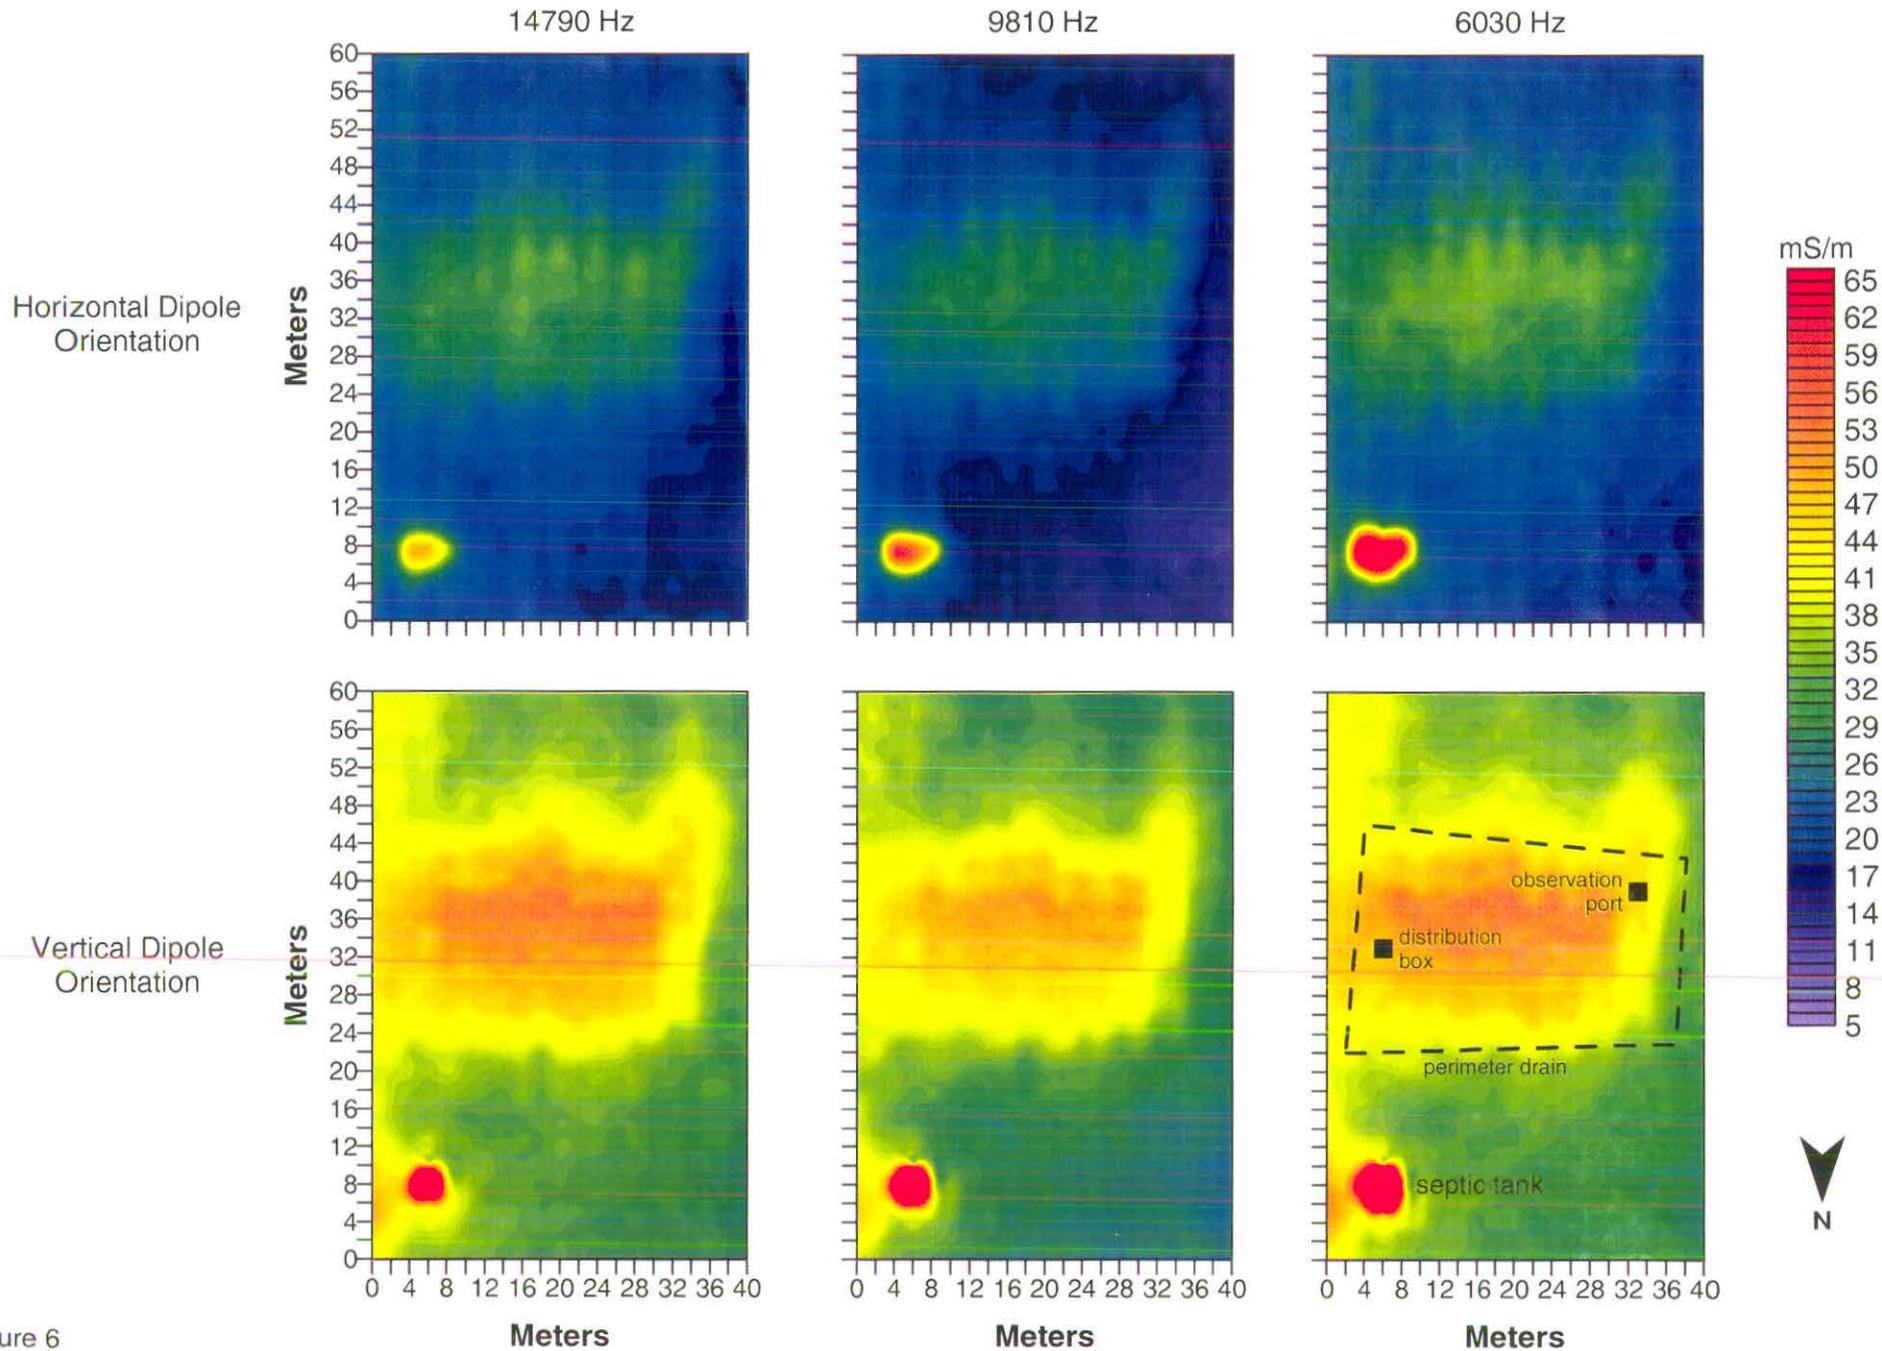
Figure 6

Figures 6 and 7 show the results of the EMI survey conducted with the GEM300 sensor along north-south and east-west trending grid lines, respectively. In each figure, data collected in the horizontal and vertical dipole orientations are shown in the upper and lower set of plots respectively. Simulations of data that were collected at frequencies of 14790 Hz, 9810 Hz, and 6030 Hz are shown in the left-hand, middle, and right-hand sets of plots, respectively. In each plot, the isoline interval is 1 mS/m. The approximate locations of the septic tank, distribution box, observation port, and perimeter drain are shown in the lower right-hand plot. All plots contain herringbone patterns caused by the reorientation of the transmitter and receiver coils along succeeding traverse lines.

EMI SURVEY OF SITE ON HURSH ROAD, ALLEN COUNTY, INDIANA GEM300 SENSOR - NORTH-SOUTH SURVEY

As with the other instruments, the GEM300 sensor clearly defined the locations of the septic tank and the absorption field. These features are apparent in all plots of figures 6 and 7. The GEM300 sensor failed to detect the observation port, perimeter drain or distribution box. Broad spatial patterns in the data sets for the deeper-sensing, vertical dipole orientation suggest the presence of linear features within the absorption field. These blurred linear features have higher apparent conductivity and may reflect the presence of absorption field trenches and/or pipes. However, compared with the data collected with the Dualem-2 meter, these patterns are more blurred and ambiguous. In plots of the data collected in the vertical dipole orientation, areas of slightly higher apparent conductivity extend southwards from the south-central portion, and the southeast and southwest corners of the absorption field. These patterns of higher apparent conductivity suggest possible discharge of waste products from the absorption field. Spatial patterns of apparent conductivity collected in the same dipole orientation are remarkably similar for data collected at different frequencies (see figures 6 and 7). As reported for the Schwartz Road site, the use of multiple frequencies does not appear to provide any additional information about the site.

In each of the plots in figures 6 and 7, patterns of apparent conductivity are elongated in the direction of traverse. These patterns are a form of noise and may represent equipment drift, the alignment of the transmitter and receiver coils, and/or the offsets or delays in signal recording.

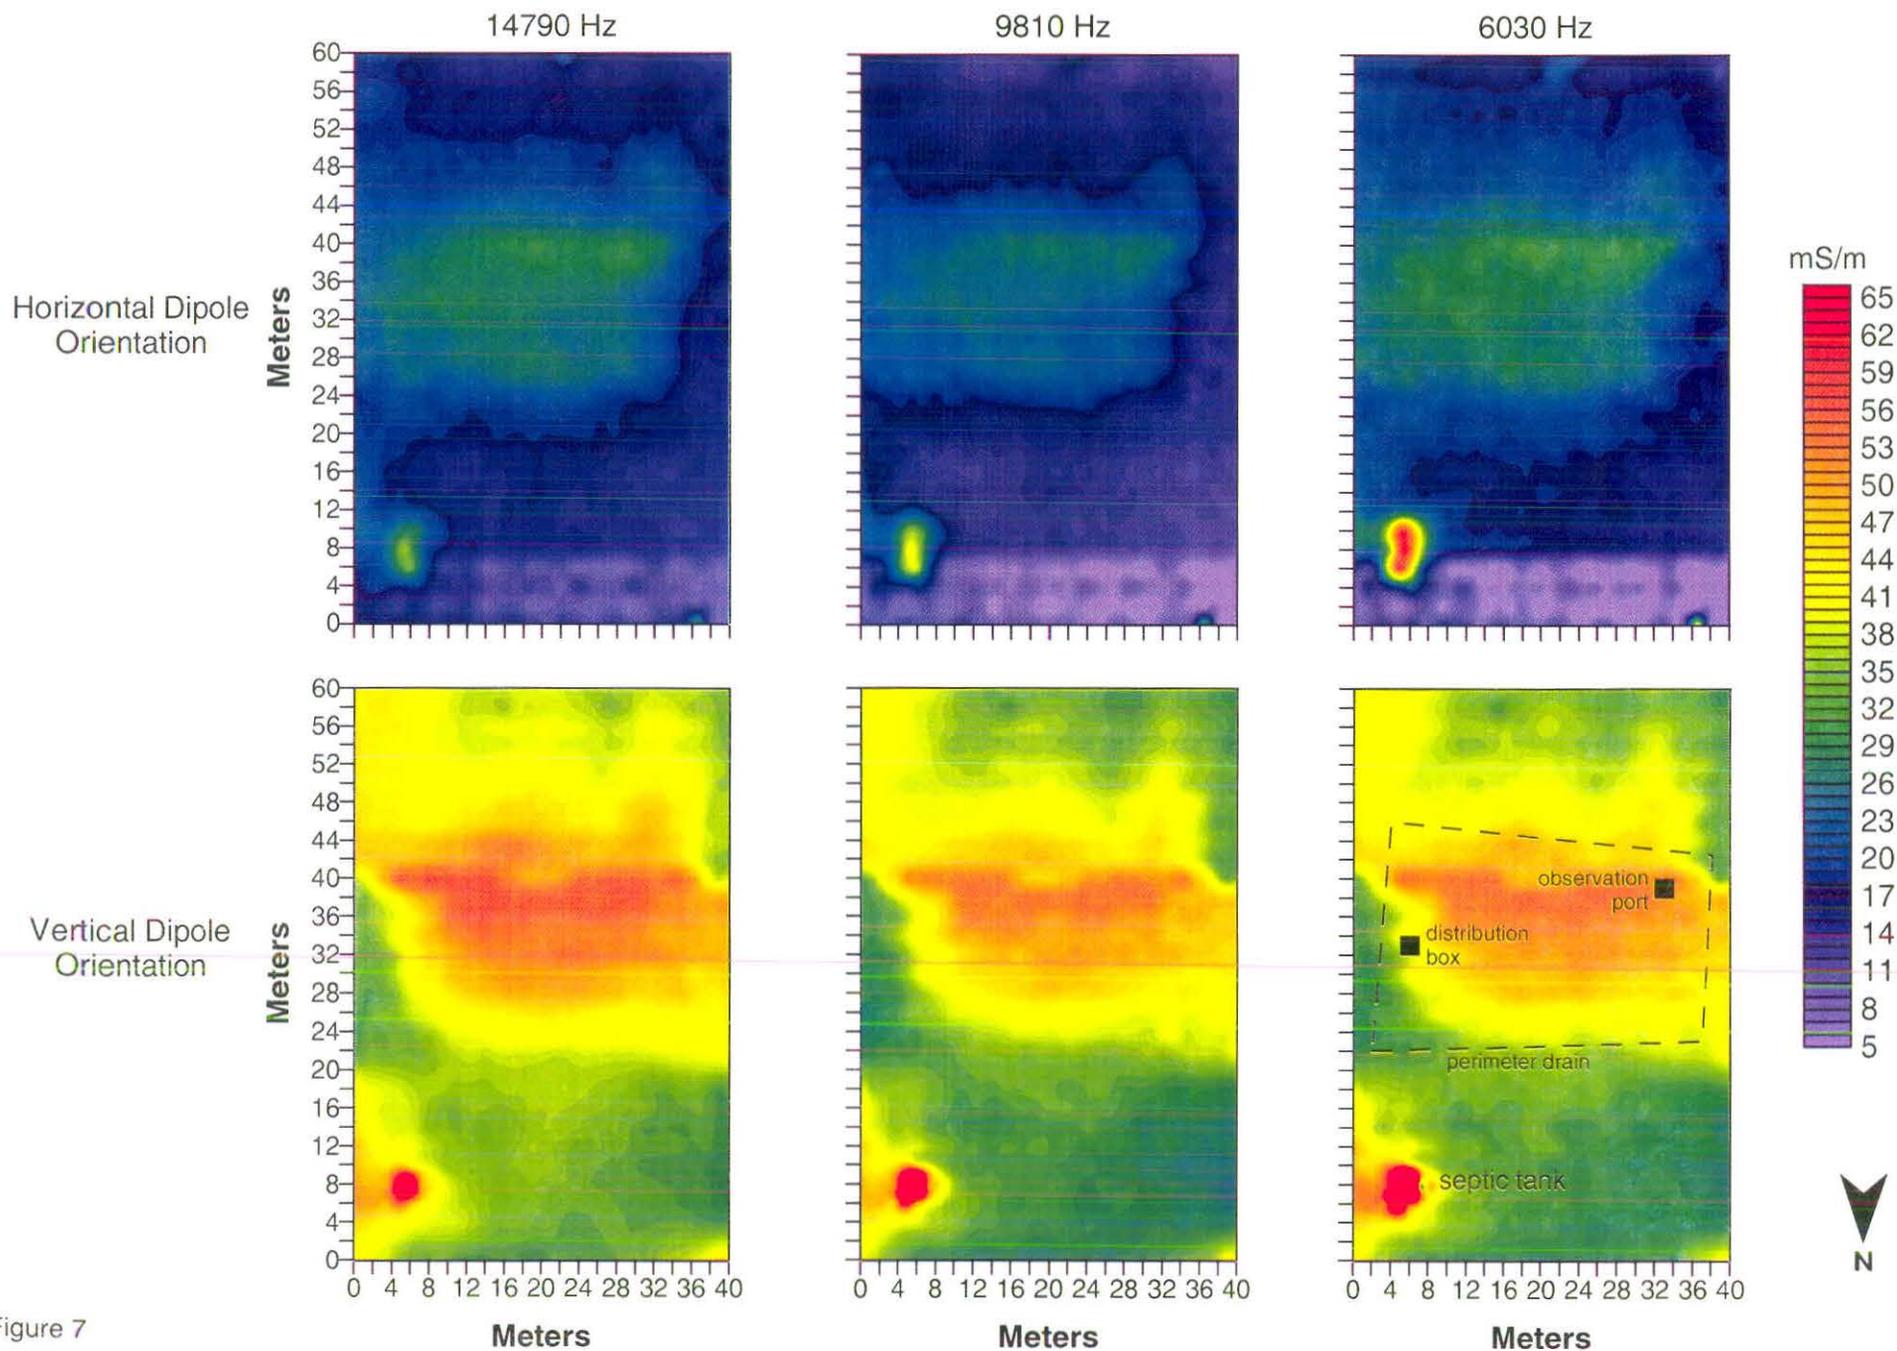
Figure 7

EMI SURVEY OF SITE ON HURSH ROAD, ALLEN COUNTY, INDIANA GEM300 SENSOR - EAST-WEST SURVEY

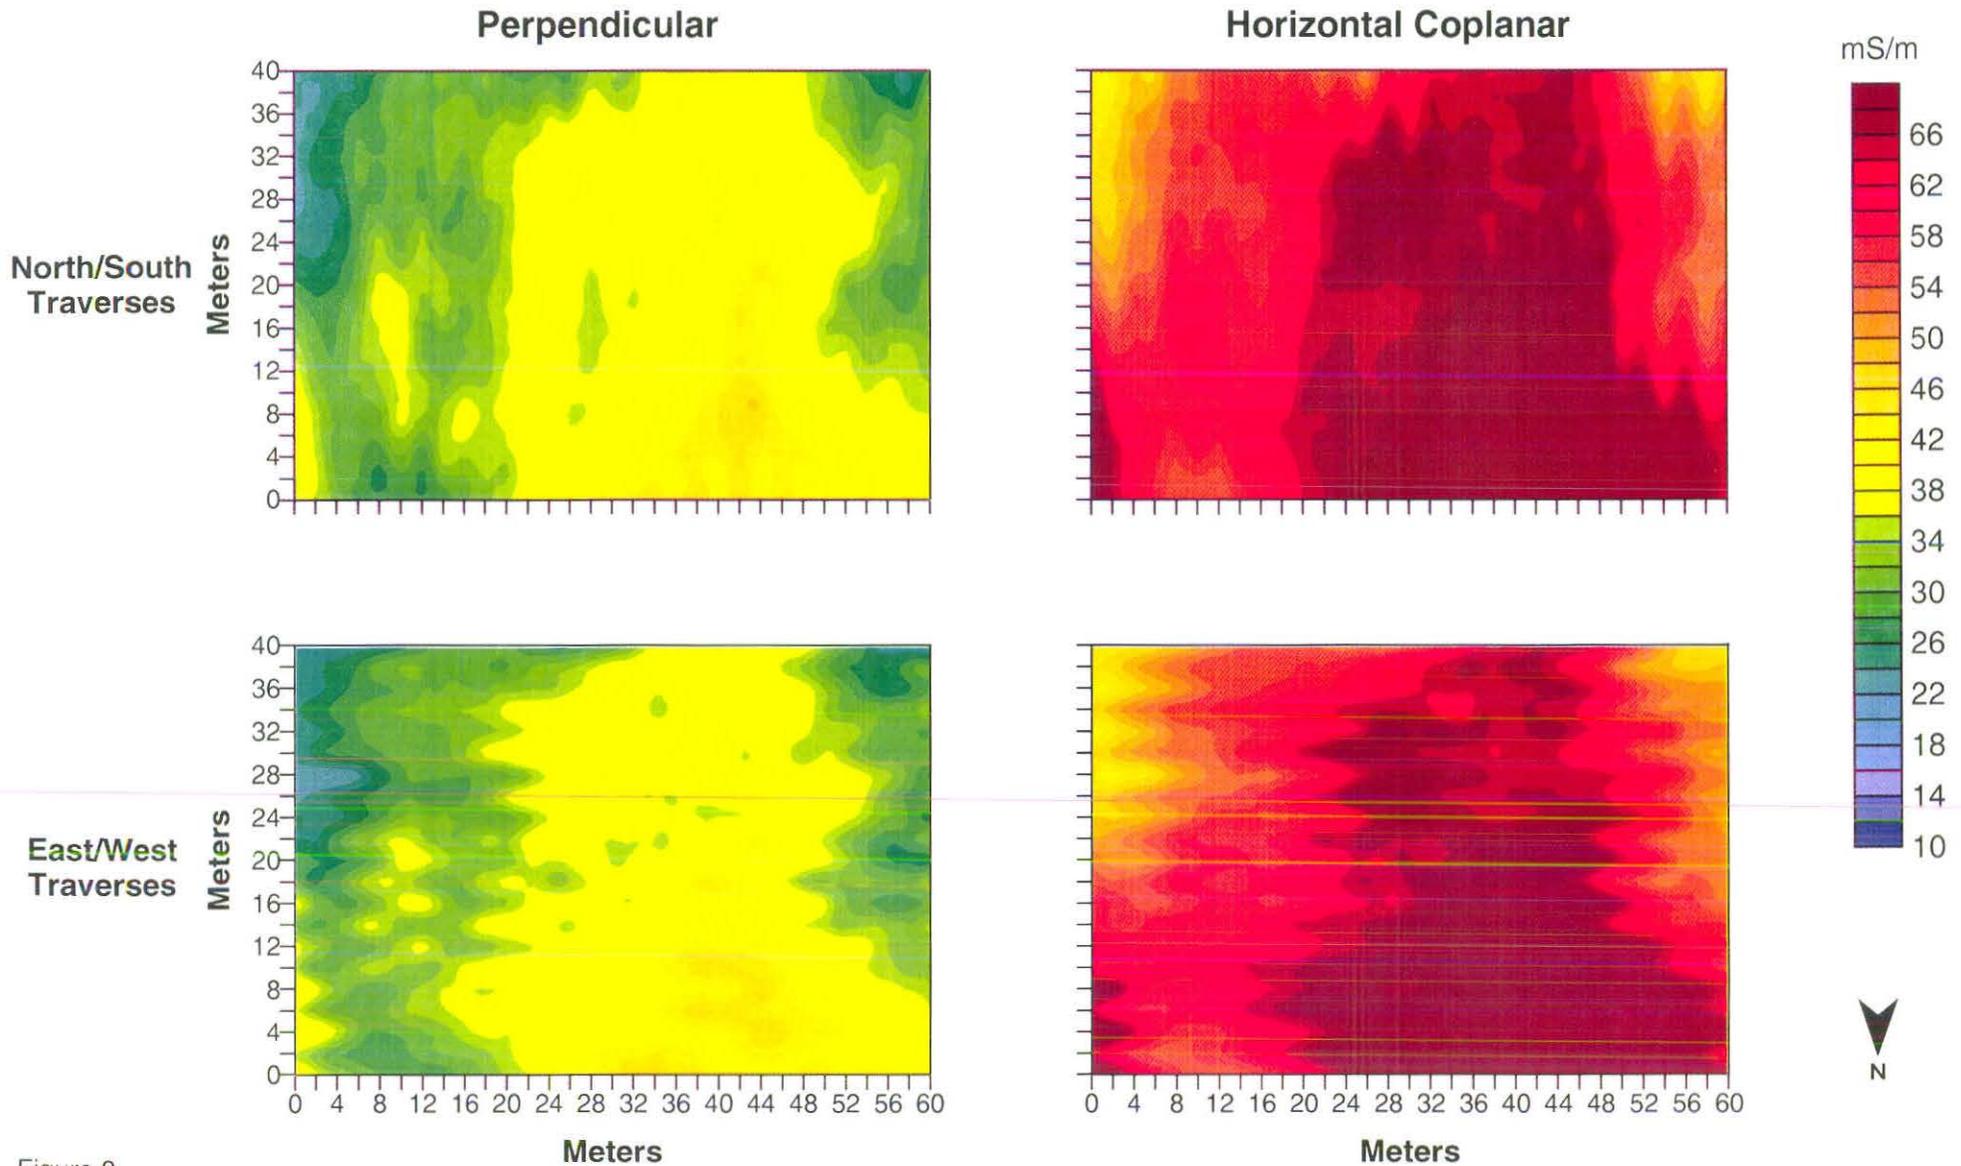
Figure 8 contains plots of apparent conductivity measured with the Dualem-2 meter in the area of Blount and Del Rey soils. All plots contain herringbone patterns caused by the reorientation of the transmitter and receiver coils along succeeding traverse lines. The upper two plots in Figure 8 show the spatial distribution of apparent conductivity for surveys that were conducted along north-south trending grid lines. The lower two plots show the spatial distribution of apparent conductivity for surveys that were conducted along east-west trending grid lines. For each survey, the spatial distributions of apparent conductivity collected in the perpendicular and horizontal coplanar geometries are shown in the left-hand and right-hand plots, respectively. In each of the plots, the isoline interval is 2 mS/m.

EMI SURVEY OF AN AREA OF BLOUNT AND DEL REY SOILS WELLS COUNTY, INDIANA DUALEM-2 METER

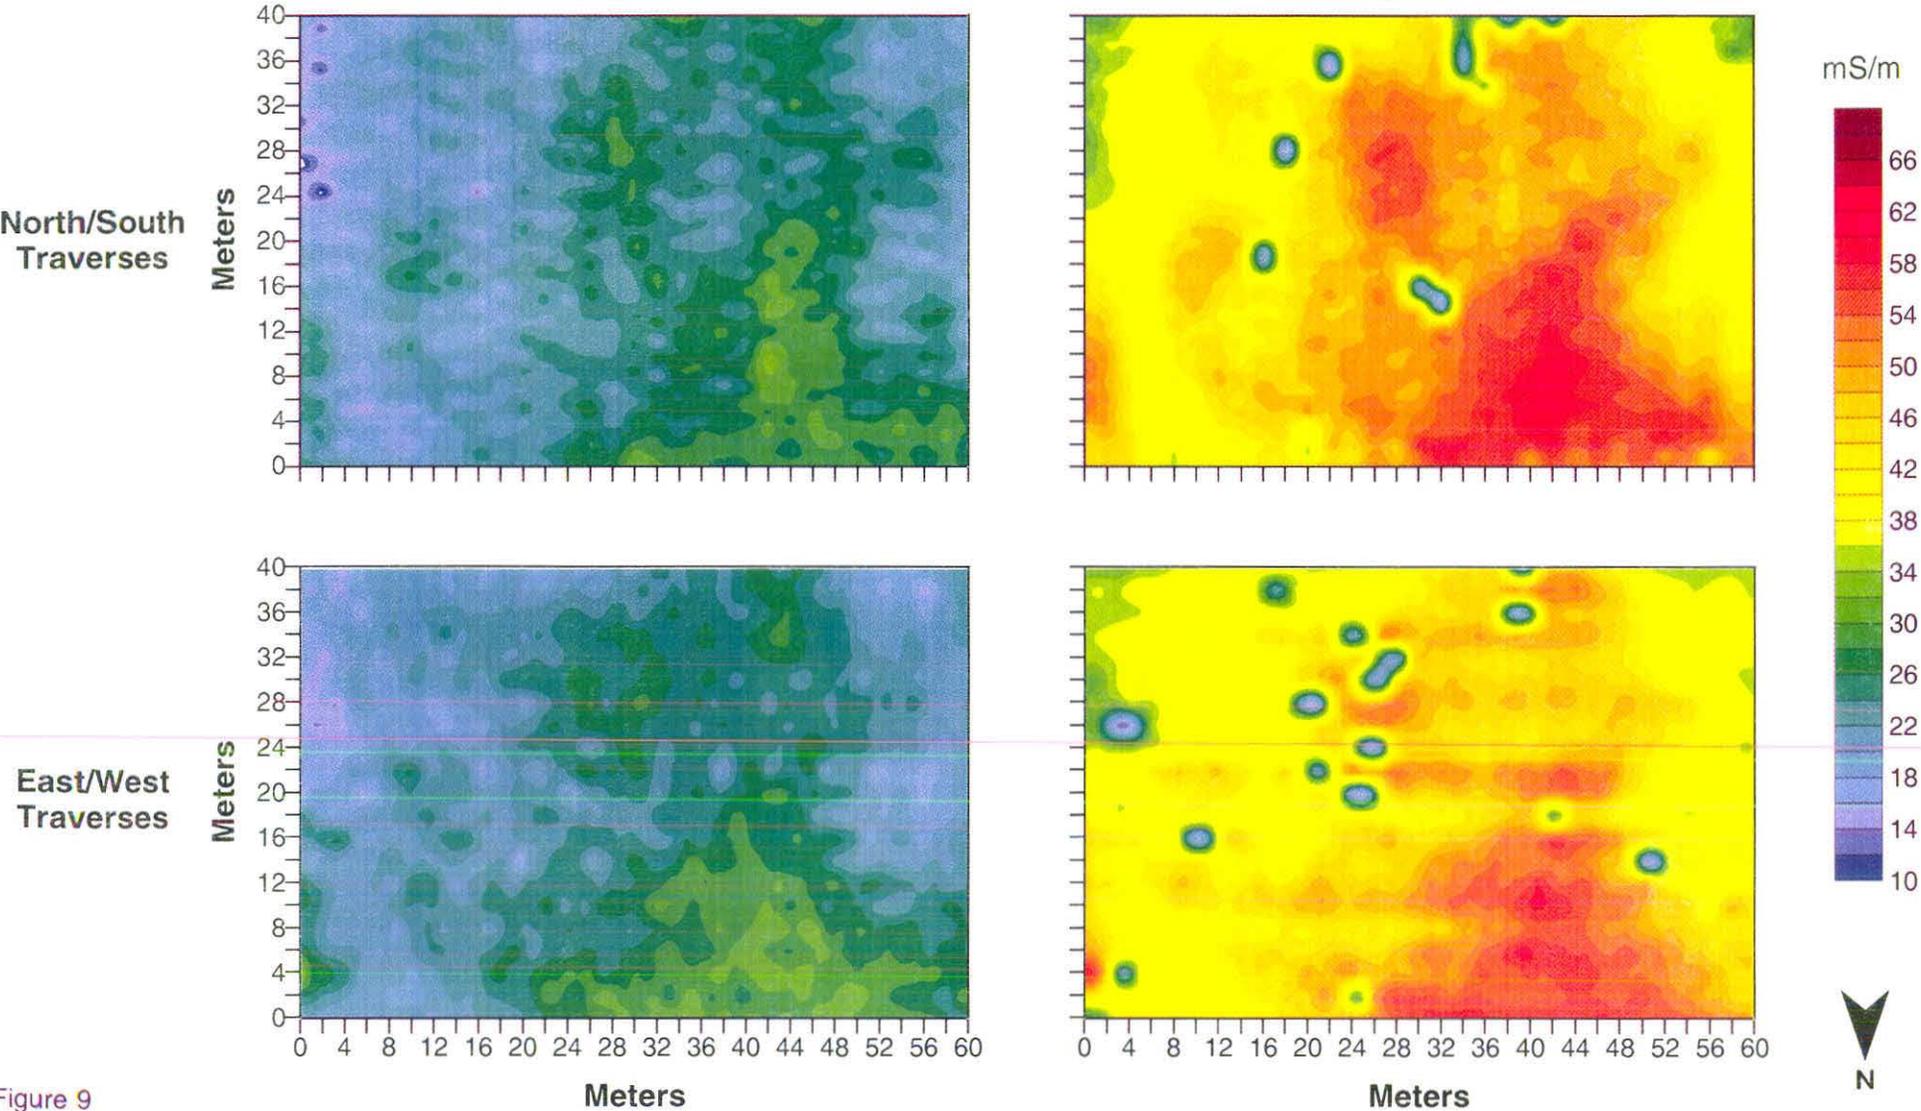
Figure 9 contains plots of apparent conductivity measured with the EM38DD meter in the area of area of Blount and Del Rey soils. All plots contain herringbone patterns caused by the reorientation of the transmitter and receiver coils along succeeding traverse lines. The upper two plots in Figure 9 show the spatial distribution of apparent conductivity for surveys that were conducted along north-south trending grid lines. The lower two plots show the spatial distribution of apparent conductivity for surveys that were conducted along east-west trending grid lines. For each survey, the spatial distributions of apparent conductivity collected in the horizontal and vertical dipole orientations are shown in the left-hand and right-hand plots, respectively. In each of the plots, the isoline interval is 2 mS/m.

EMI SURVEY OF AN AREA OF BLOUNT AND DEL REY SOILS WELLS COUNTY, INDIANA EM38DD METER

Horizontal Dipole Orientation

Vertical Dipole Orientation
