**United States
Department of
Agriculture**

**Natural Resources
Conservation
Service**

Subject: SOI – Electromagnetic Induction (EMI) Comparative Field Studies

Date: 10 January 2002

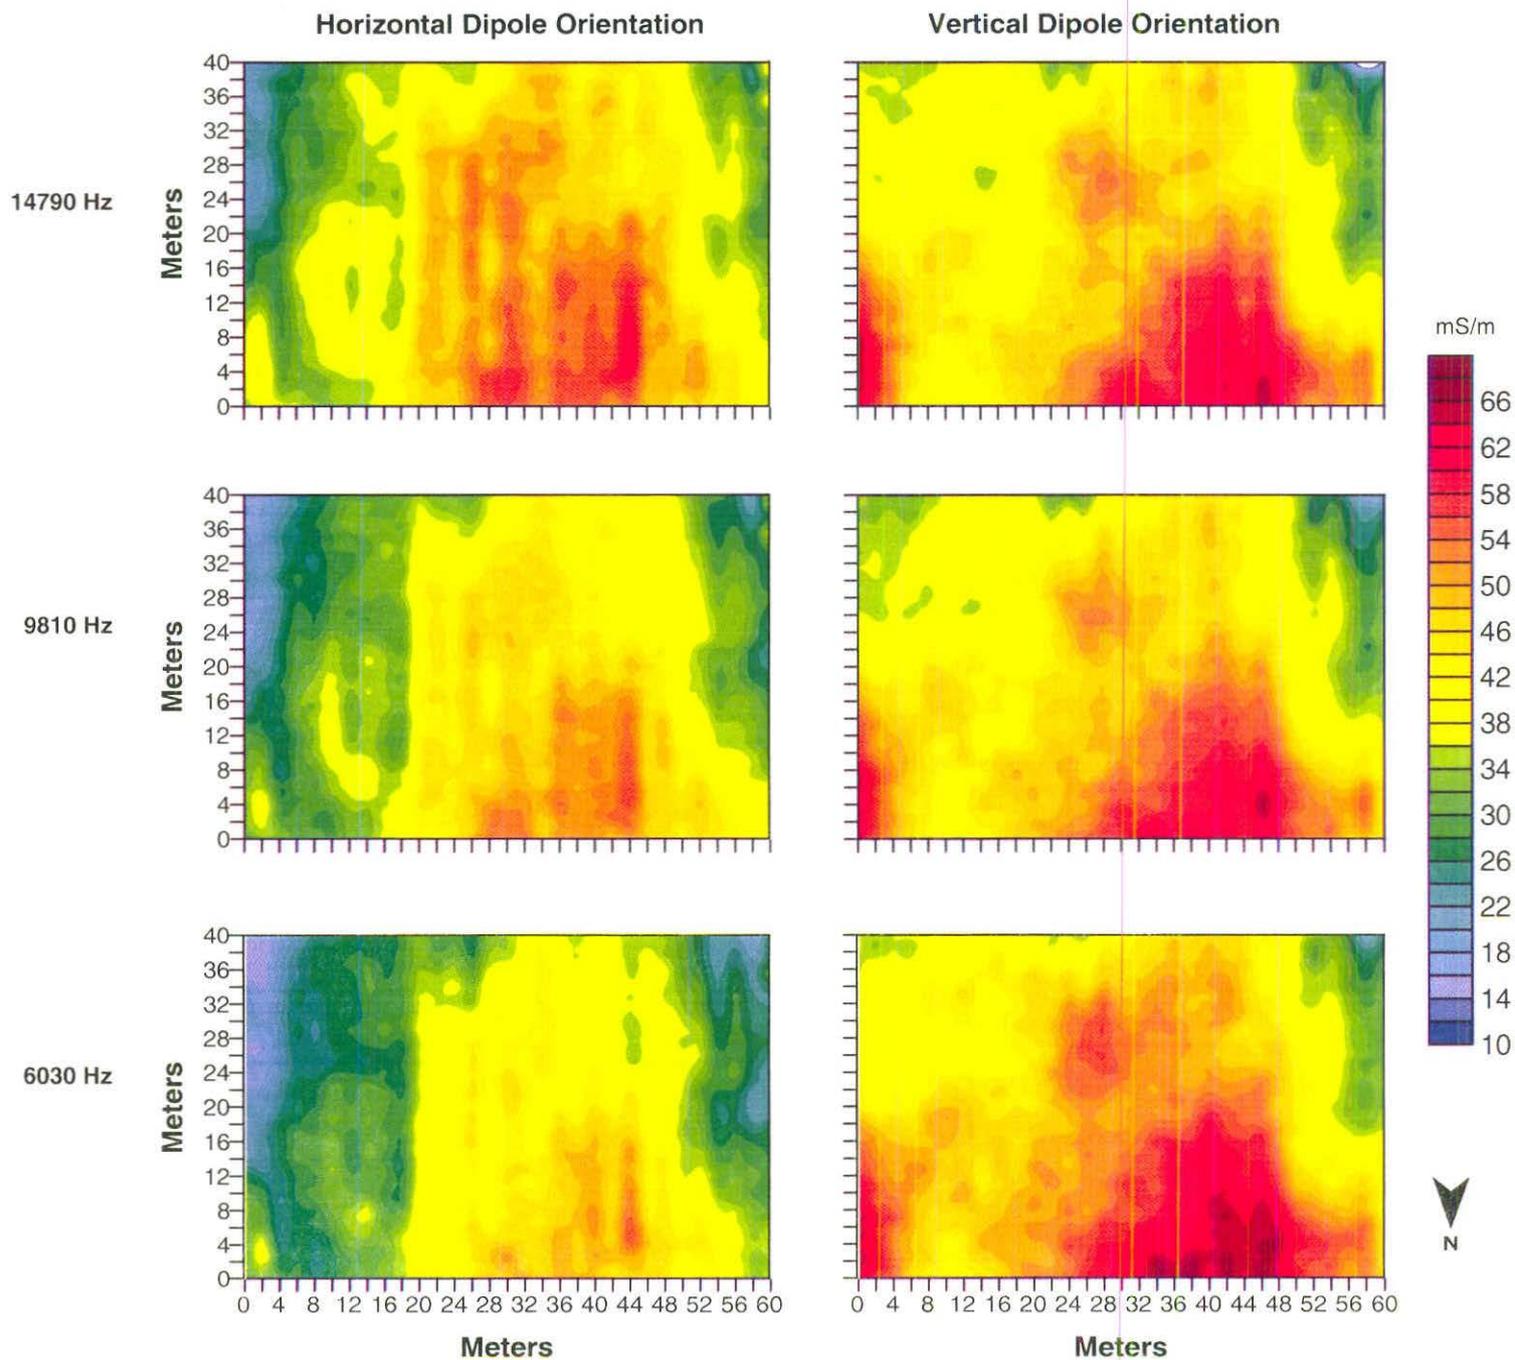
Figure 10

middle, and lower sets of plots, respectively. For each frequency, data collected in the horizontal and vertical dipole orientations are shown in the left-hand and right-hand plots, respectively. In each plot, the color interval is 2 mS/m. Spatial patterns shown in these plots are closely similar to the spatial patterns of apparent conductivity that were simulated from data collected with the Dualem-2 and EM38DD meters (see figure 8 and 9). All plots contain herringbone patterns caused by the reorientation of the transmitter and receiver coils along succeeding traverse lines

EMI SURVEY OF AN AREA OF BLOUNT AND DEL REY SOILS WELLS COUNTY, INDIANA GEM300 SENSOR - NORTH-SOUTH TRAVERSES

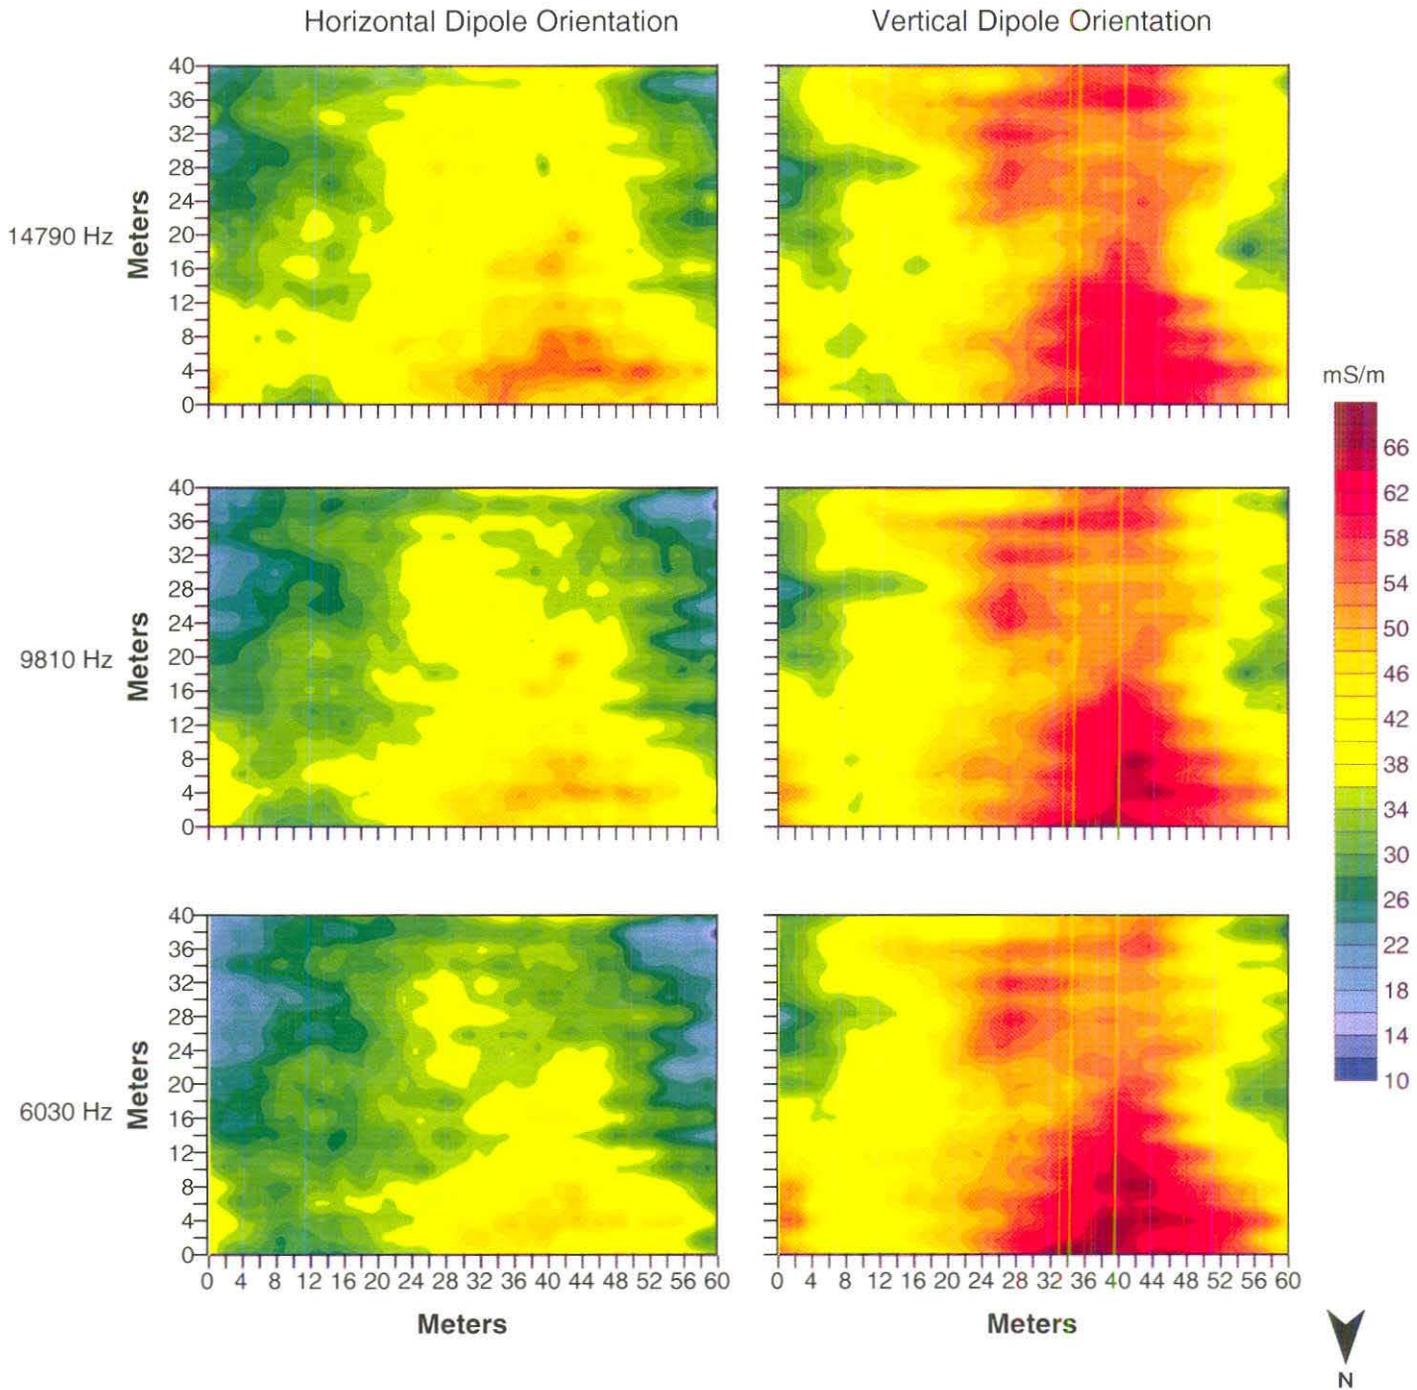
Figure 11

EMI SURVEY OF AN AREA OF BLOUNT AND DEL REY SOILS WELLS COUNTY, INDIANA GEM300 SENSOR - EAST-WEST TRAVERSES
