Subject: EM Investigation of a portion of Lloyd Fricke's property, Deer Park, Washington **Date:** 12 August 1993

EM31 SURVEY OF FRICKE'S PROPERTY
HORIZONTAL DIPOLE ORIENTATION

EM31 SURVEY OF FRICKE'S PROPERTY
VERTICAL DIPOLE ORIENTATION

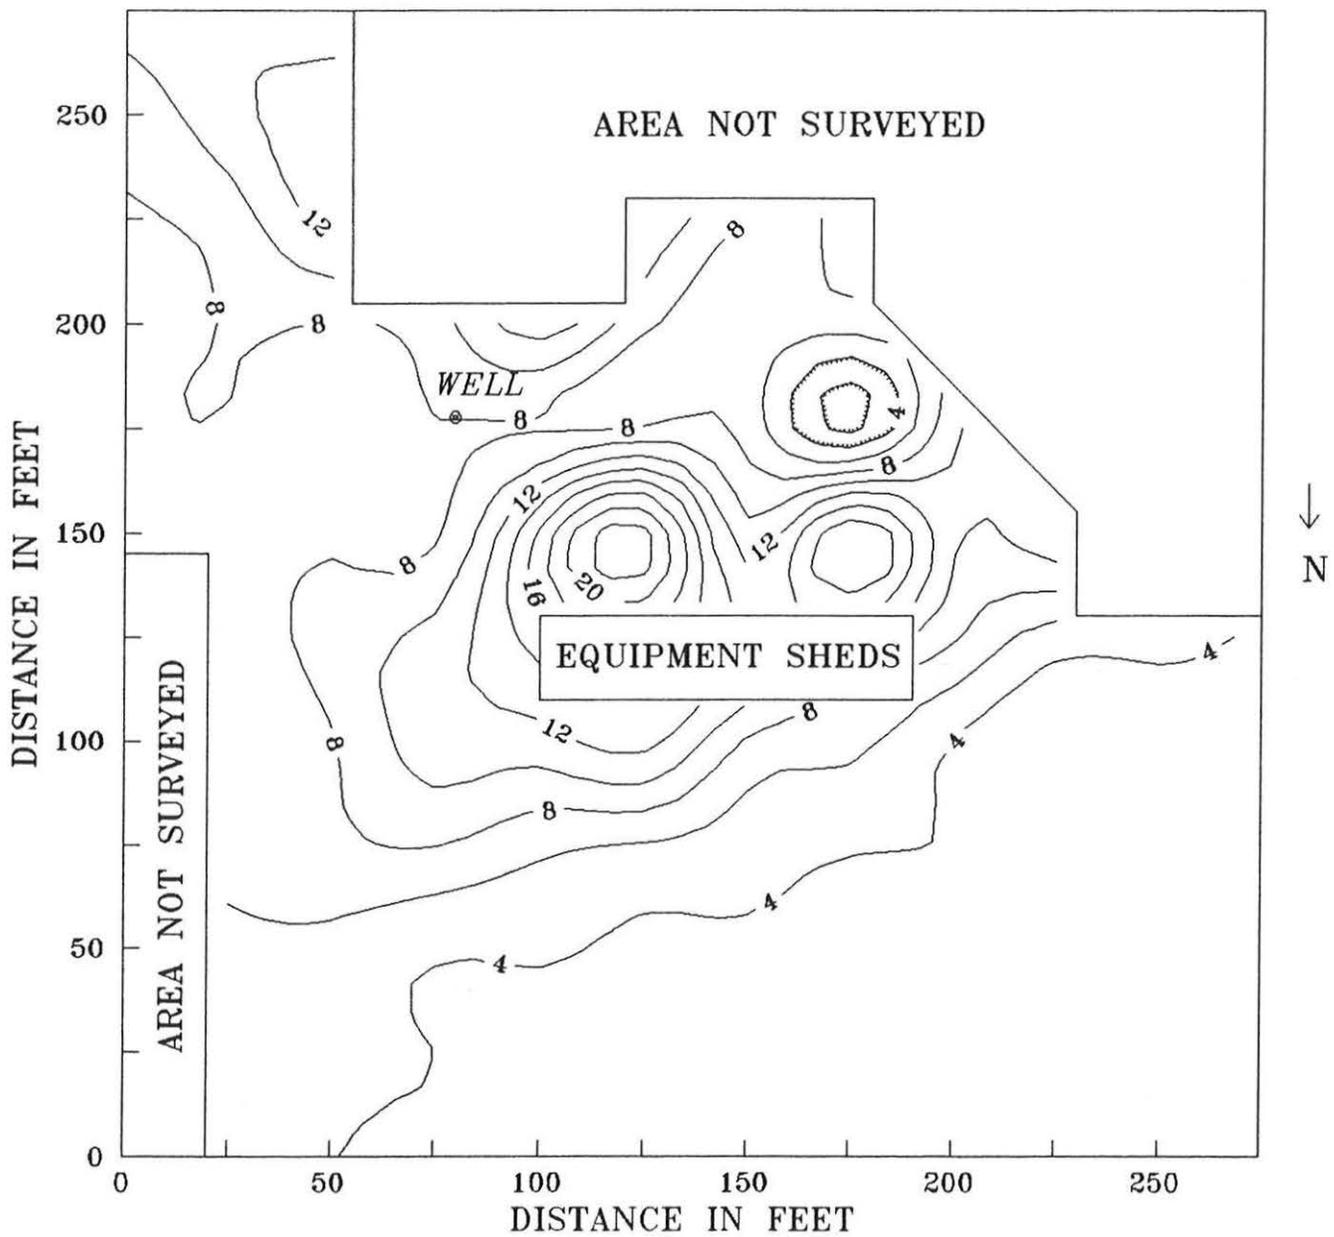
Measurements taken with the EM31 meter in the horizontal dipole orientation reveal a zone of relatively high (>12 mS/m) apparent conductivity values immediately east of the house in the area of the septic tank. While it would be easy to infer that the septic tank was the source of these higher values, land disturbance and proximity to "cultural noises" from the house should also be considered.

In addition, on the plot of the data collected in horizontal dipole orientation, a zone of higher apparent conductivity values (>22 mS/m) is evident immediately to the northwest of the well and to the south of equipment shed. While cultural noise from the equipment sheds is considered a possible source for these values, the location and possible source of these values should be discussed with the landowner.

Please review the enclosed charts, they may be used to guide further investigations. These plots can be used to guide further soil sampling. In areas where patterns suggest possible sources of contamination, I would suggest discussions with the landowner, and if necessary, a more detail survey with the EM31 meter using a narrower grid interval (10 or 15 feet). If I can be of further assistance, please do not hesitate to call.
