United States
Department of
Agriculture

Natural
Resources
Conservation
Service

Soil Survey of Macon County, North Carolina

Issued May 1996

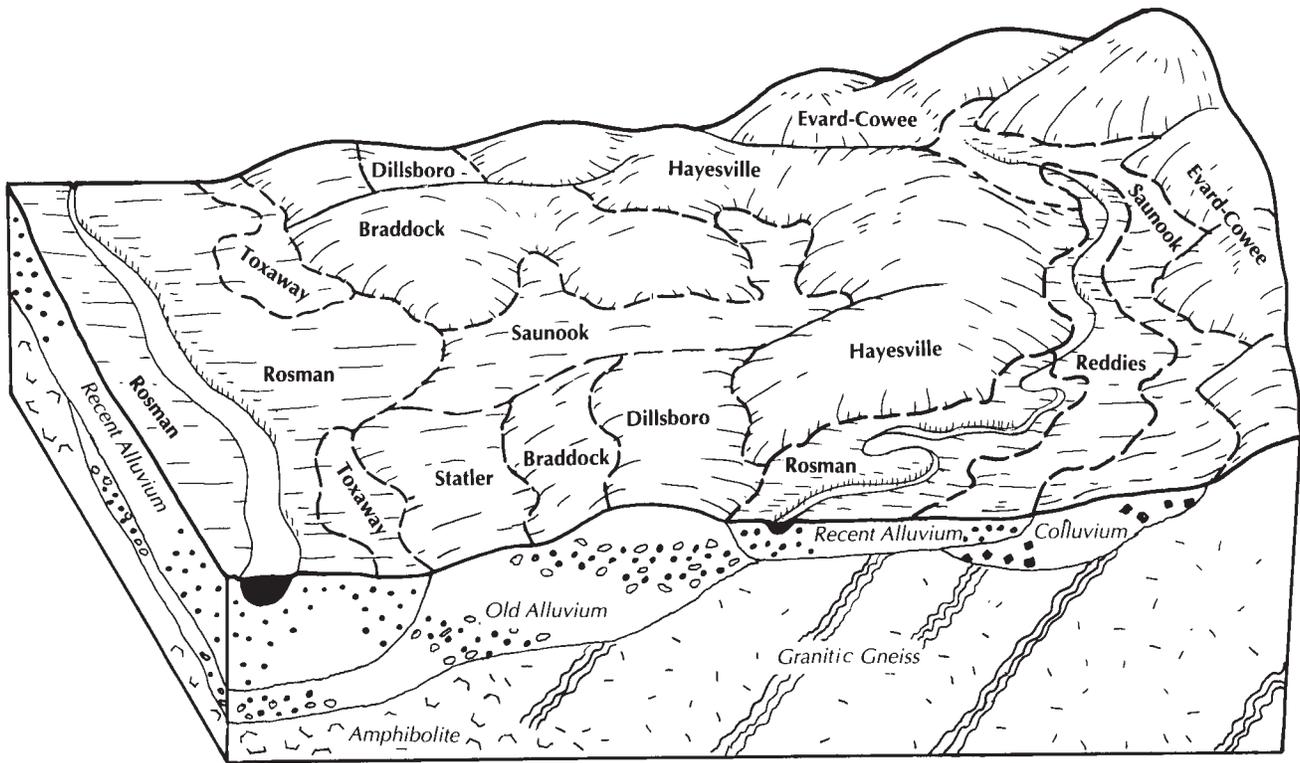
Figure 2.—Typical relationship of soils, landscape position, and parent material in the Rosman-Reddies-Toxaway and Hayesville-Braddock general soil map units.

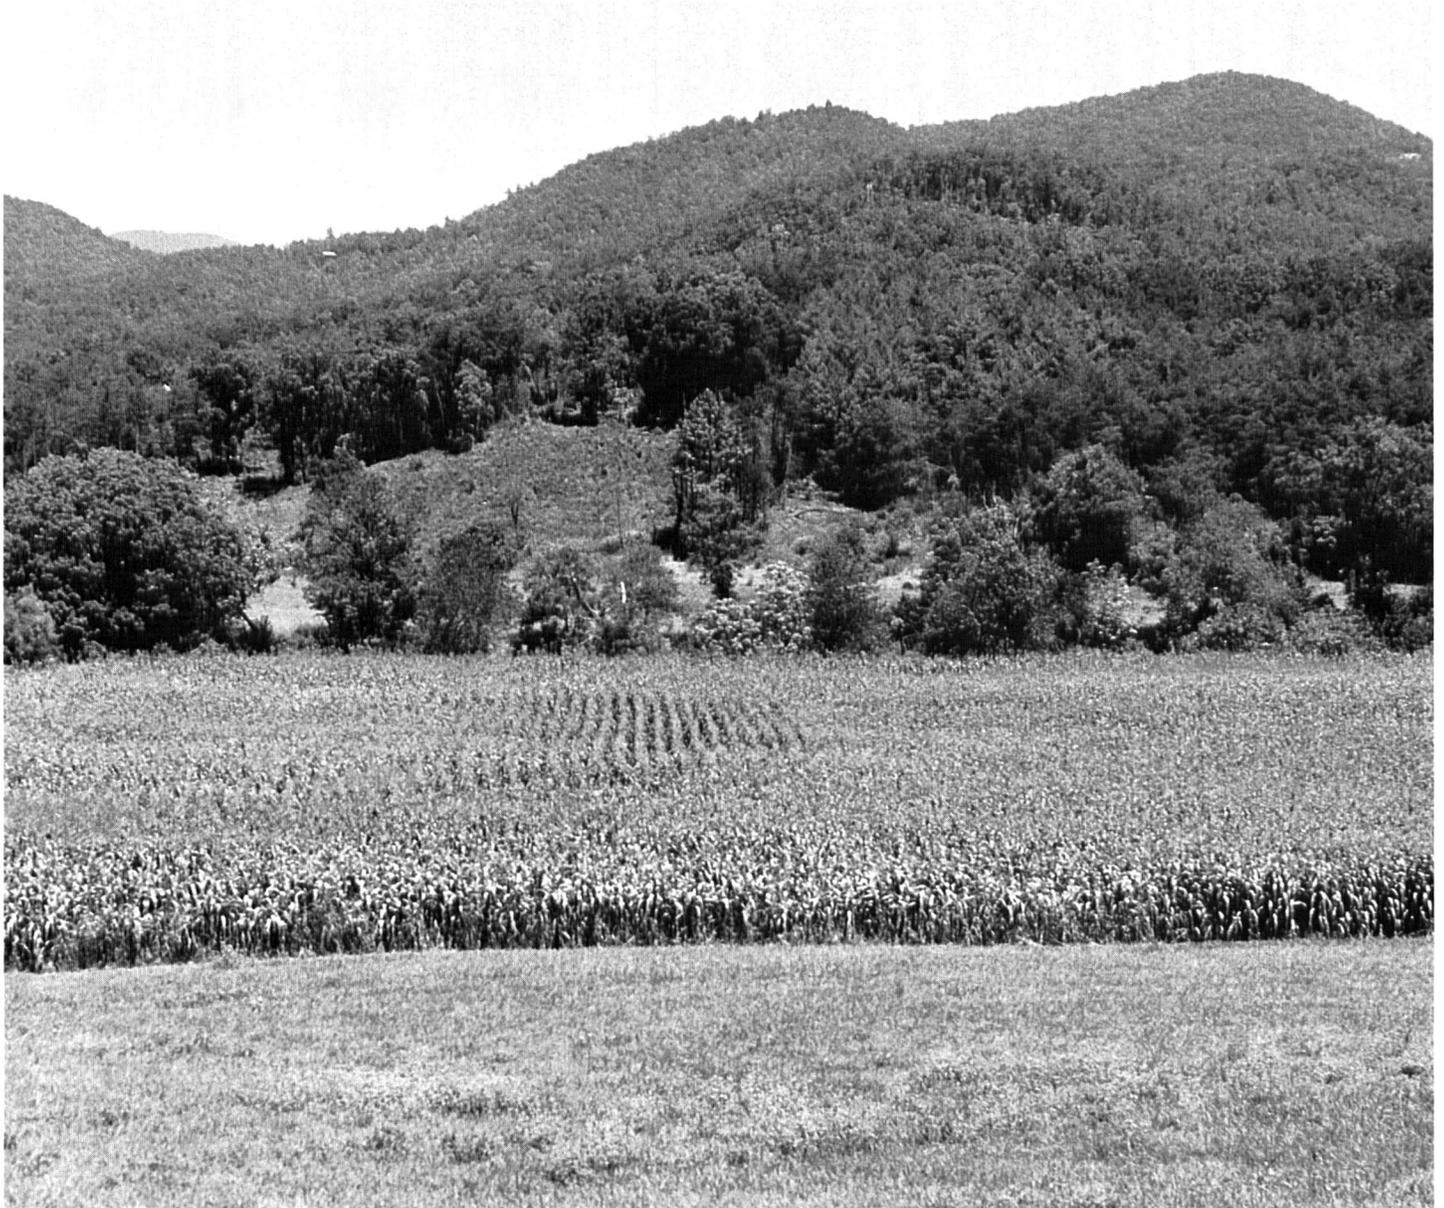
Figure 3.—No-till corn in an area of Rosman-Reddies-Toxaway general soil map unit. The background is an area of the Evard-Cowee-Saunook general soil map unit.

Most areas of this unit have been cleared of trees and are used for pasture or crops (fig. 3). Some areas, especially along the Little Tennessee River from Franklin south to the Georgia State line, are used for recreational purposes, woodland, or urban development.

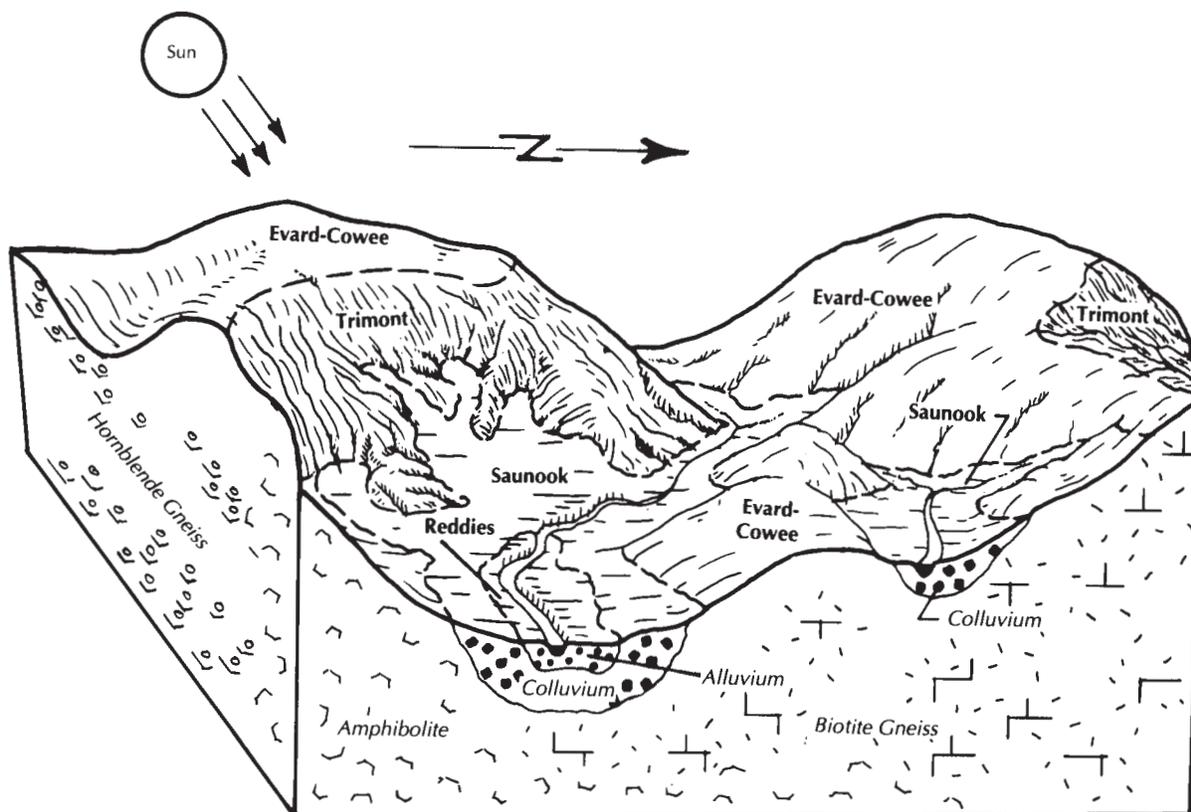
Figure 4.—Typical relationship of soils, landscape position, and parent material in the Evard-Cowee-Saunook general soil map unit.

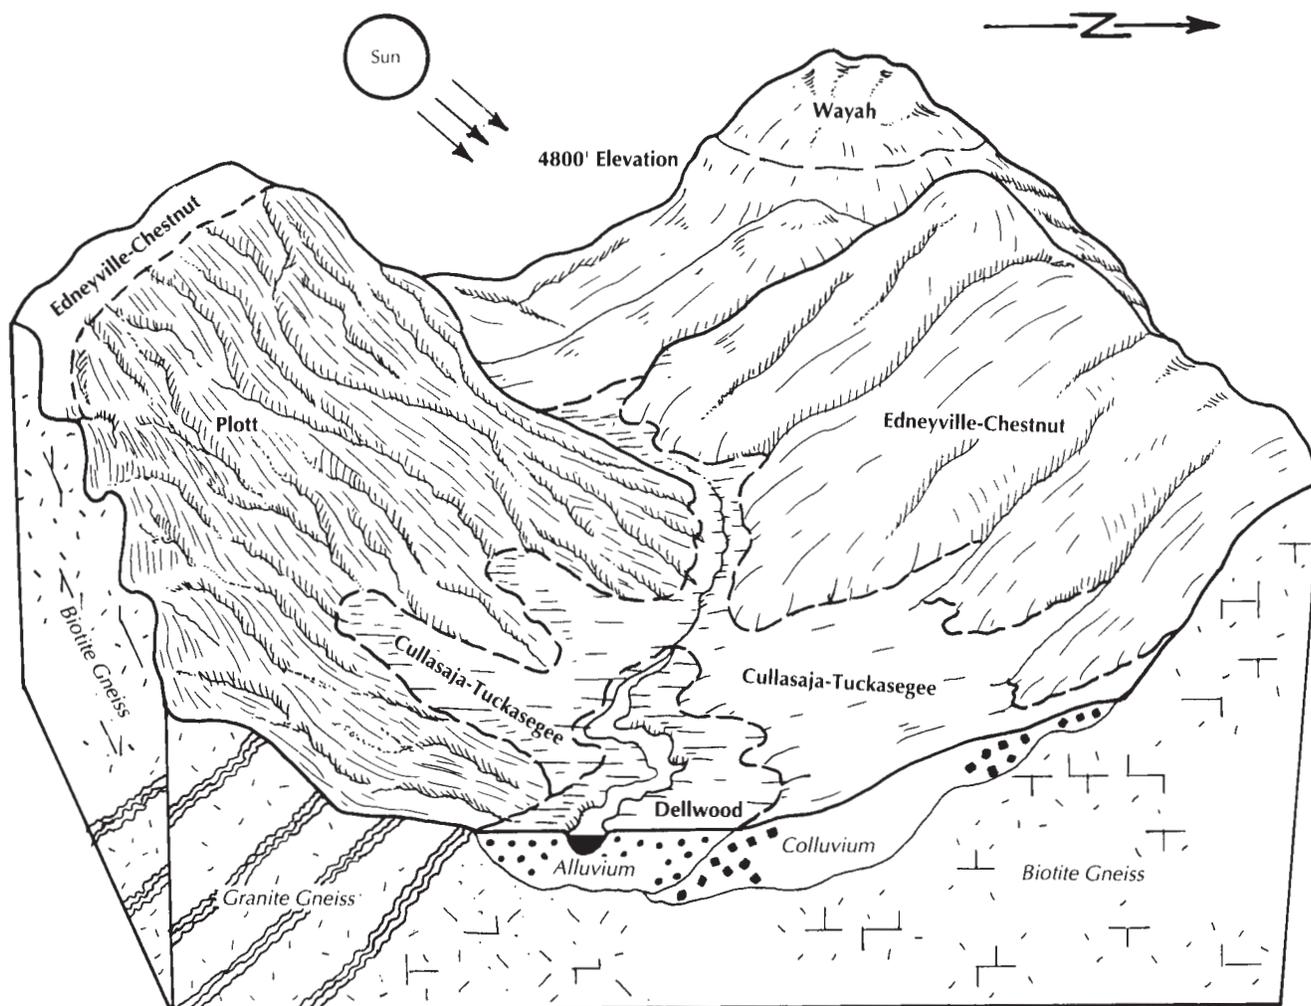
Figure 5.—Typical relationship of soils, landscape position, and parent material in the Edneyville-Plott-Chestnut-Cullasaja general soil map unit on intermediate mountains and the Wayah-Burton-Craggey general soil map unit on high mountains.

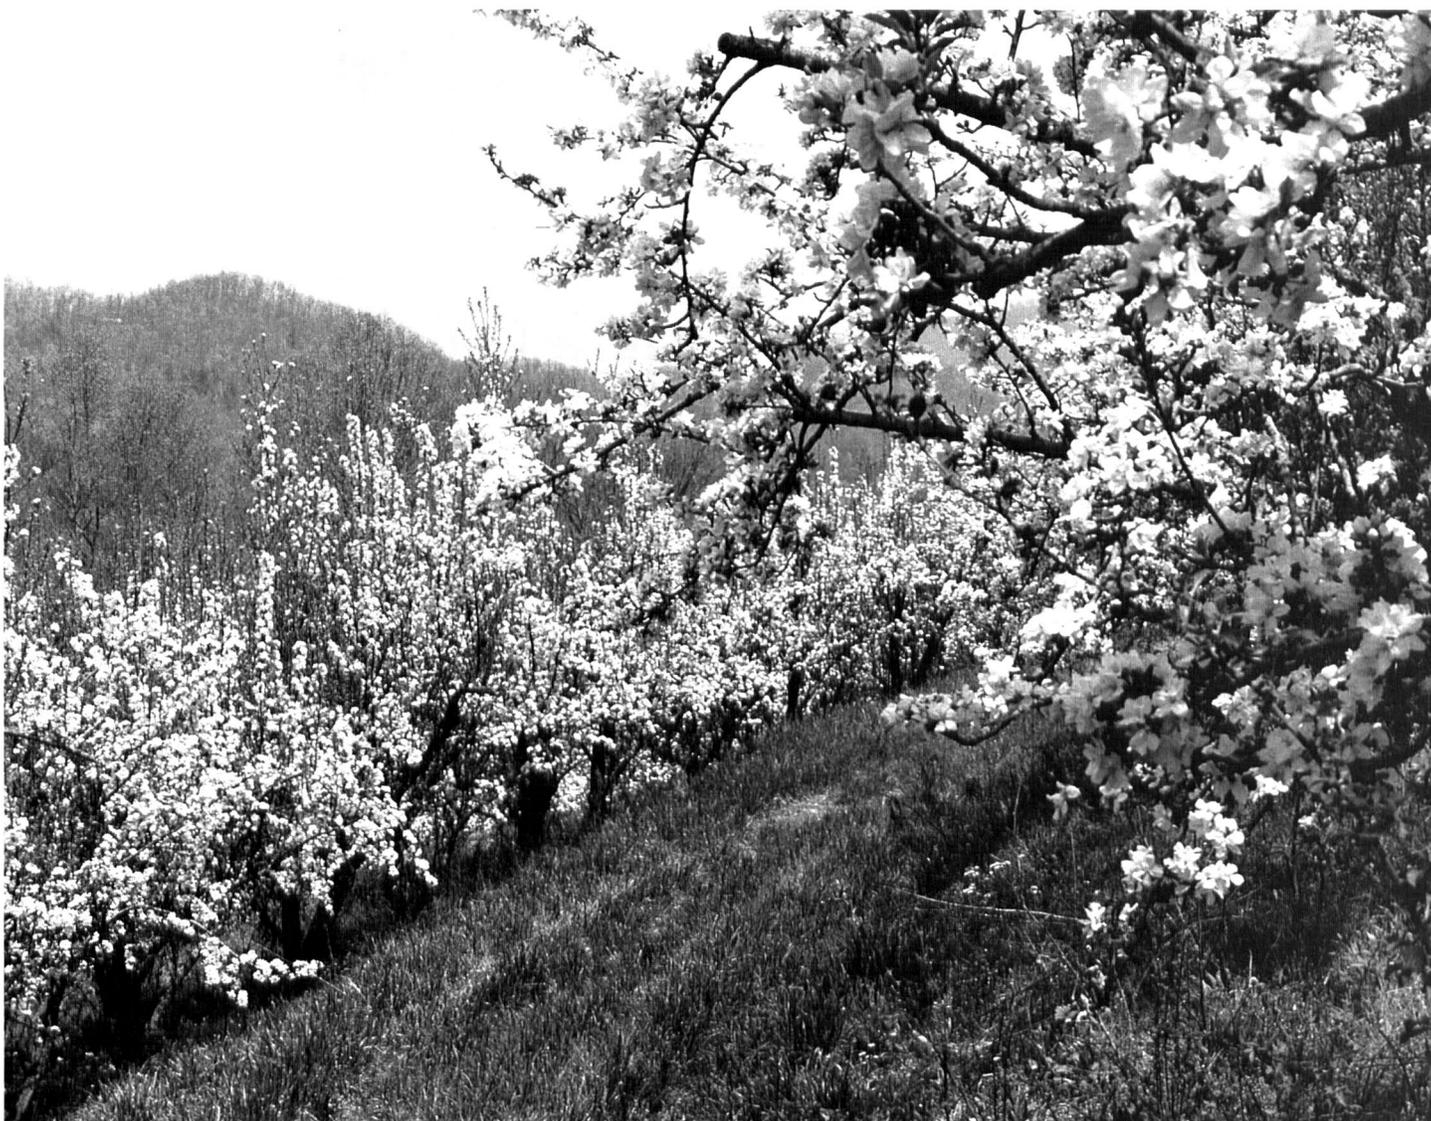
Figure 6.—An apple orchard in an area of Evard-Cowee complex, 15 to 30 percent slopes.

This map unit is poorly suited to specialty crops, such as apples, landscaping plants, and Christmas trees, because of the slope. Most of the apples grown in the county, however, are grown in areas of this unit (fig. 6). Erosion is a hazard. The most common landscaping plants are Norway spruce, mountain laurel, and rhododendron. White pine is grown for use as Christmas trees. Fraser fir is grown on foot slopes. The production of Fraser fir requires careful site selection and management because of droughtiness and the clay content. Operating farm equipment is difficult because of the slope. Establishing and maintaining sod in areas

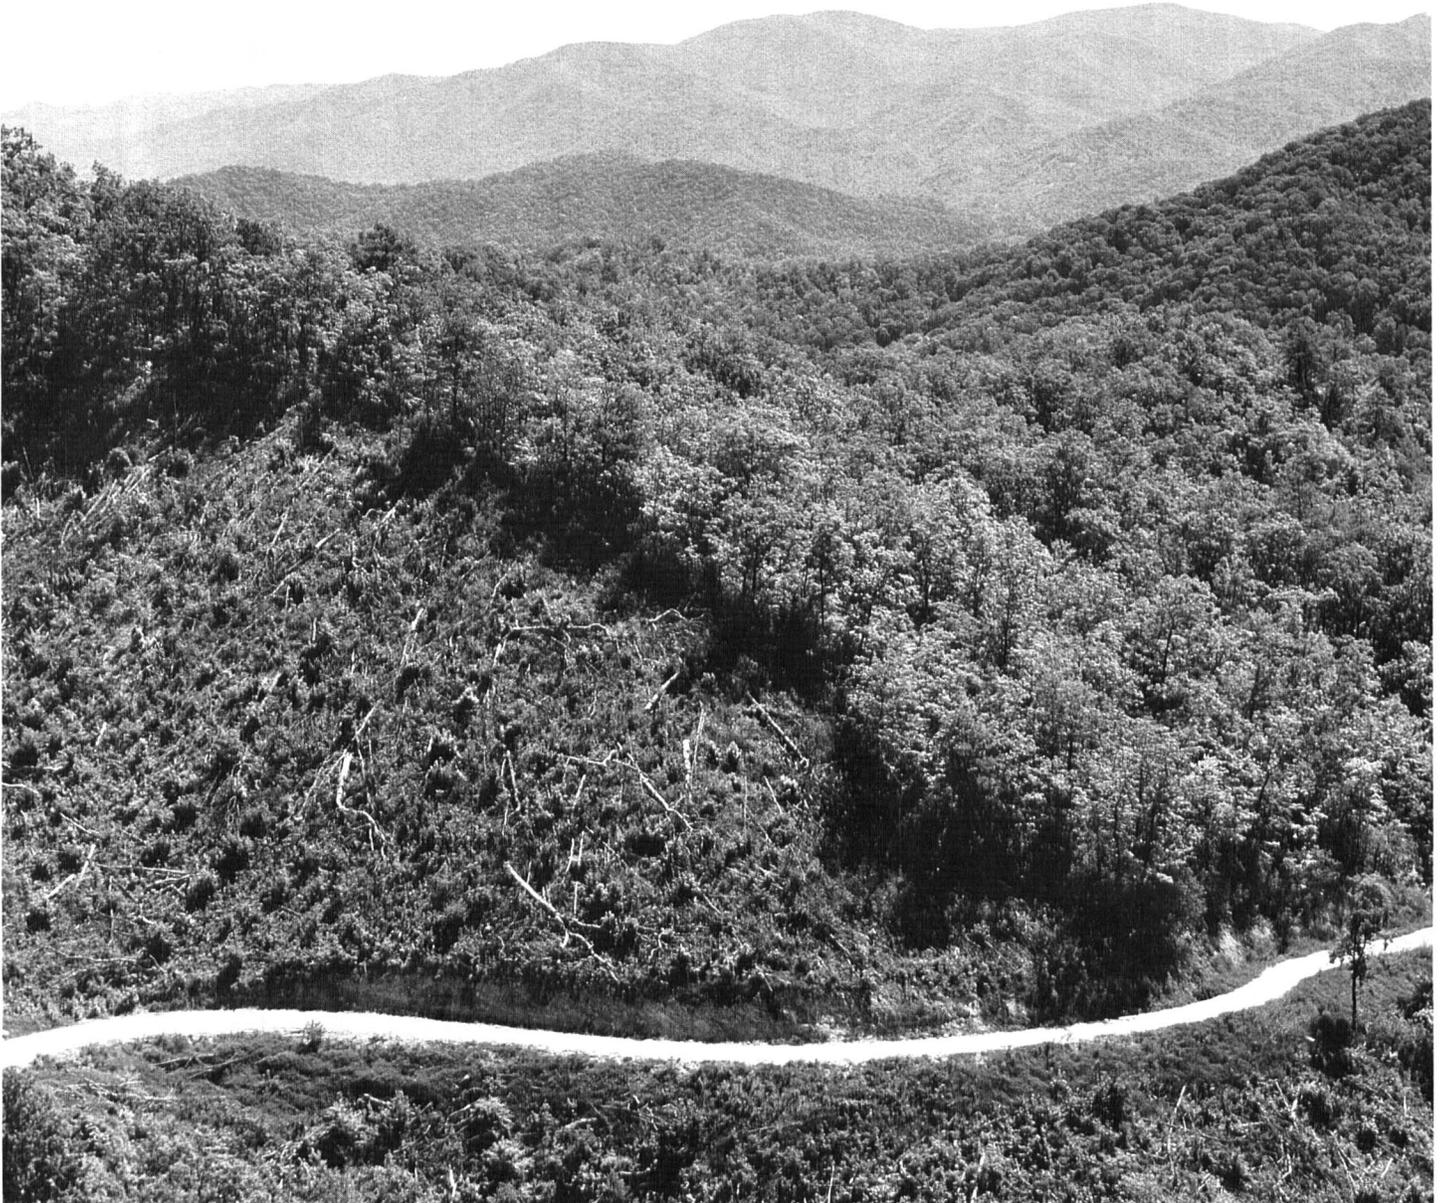
Figure 7.—A clear-cut area of Soco-Stecoah complex, 50 to 95 percent slopes.

The slope restricts the kinds of equipment that can be used. Generally, operating wheeled or tracked

equipment is dangerous because of the slope. Cable yarding is safer, disturbs the soil less, and helps to maintain productivity.
