# CONSERVATION *Showcase*

## **KISH VIEW FARMS UPPER KISHACOQUILLAS NWQI, MIFFLIN COUNTY**

**By Mary Lloyd Smith  
September 25, 2015**

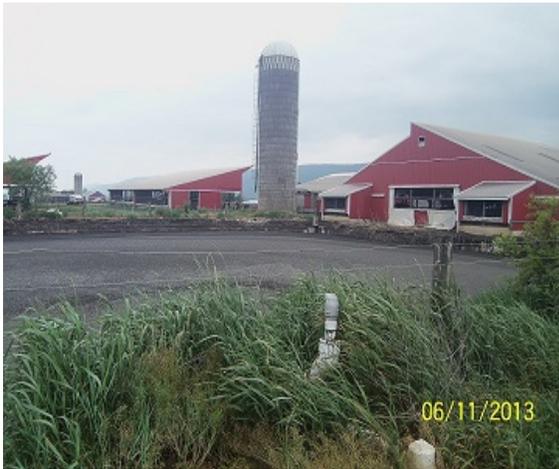
Old Dugout Pond Manure Storage

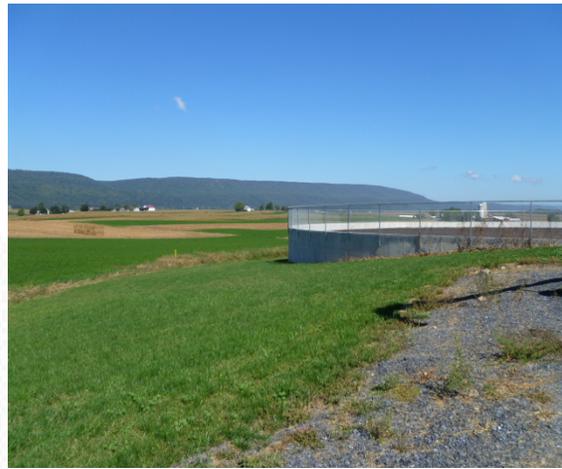
New Waste Storage Facility

An underground outlet to carry milkhouse water, an access road, and a rock-lined waterway or outlet were also required to address resource concerns. The resulting round concrete waste storage facility is 16-feet deep by 163-feet in diameter, totaling 333,876 cubic feet in size. Due to the cost of this contract, approval had to be secured from the NRCS Chief, Jason Weller, at the NRCS National Headquarters in Washington, DC.

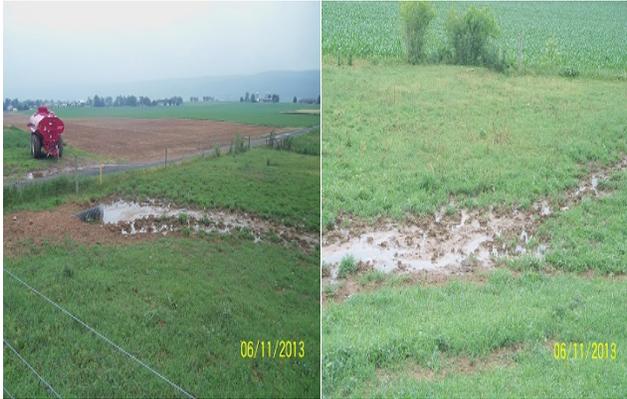
Pipe outletting surface water and Steam precipitate from the methane Digesting process, causing erosion in Pasture field.

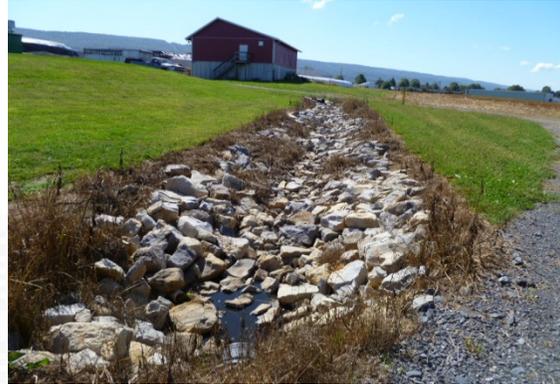
Rock lined Waterway
