Plum Creek Watershed Dam No. 6 Rehabilitation Project Hays County, Texas

Fact Sheet
July 2018

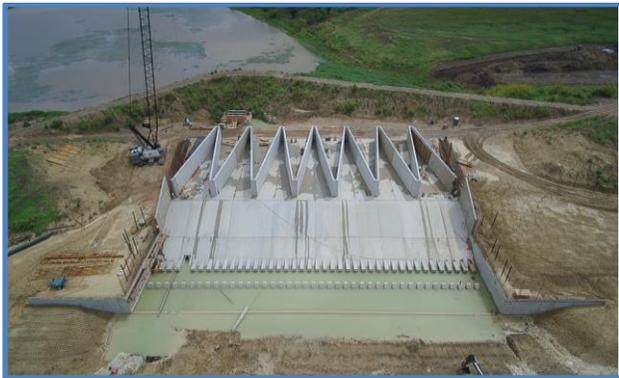
A labyrinth weir was installed to replace the current earthen spillway during rehabilitation.

Rehabilitation of the dam included extension of the dam southeastward; removal of the old auxiliary spillway which currently crosses over Goforth road; installation of a labyrinth weir design spillway; installation of a new intake riser and impact basin; and a realignment of Goforth road.
