NORTH BRANCH FOREST RIVER DAM NO. 1 (BYLIN DAM)

Appendix D-1: Existing Conditions Assessment Report

November 10, 2023

Walsh County Water Resource District

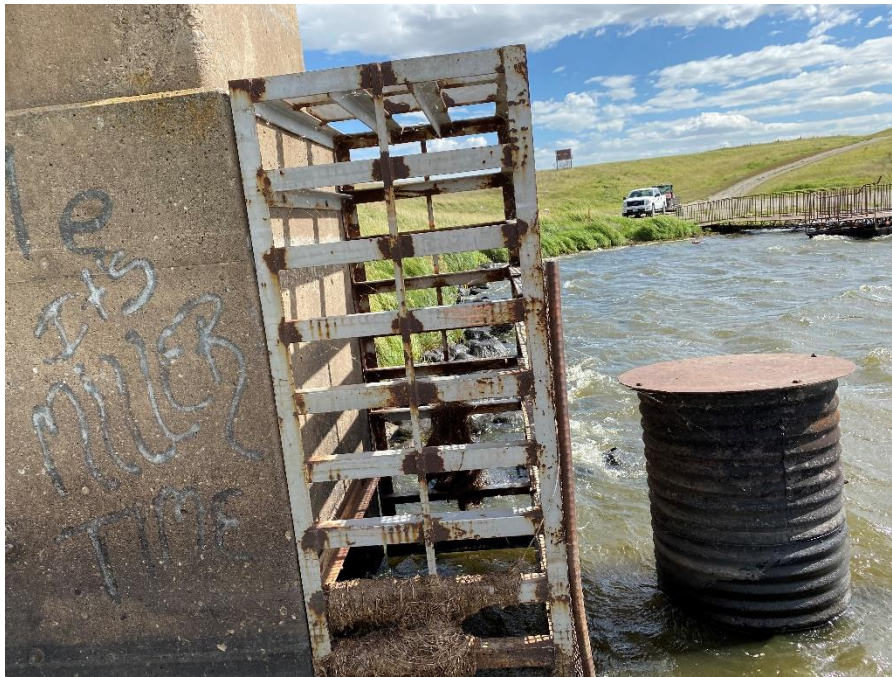
1. *THRASH RACK & CAPPED VALVE WELL (FRONT OF RISERS)*

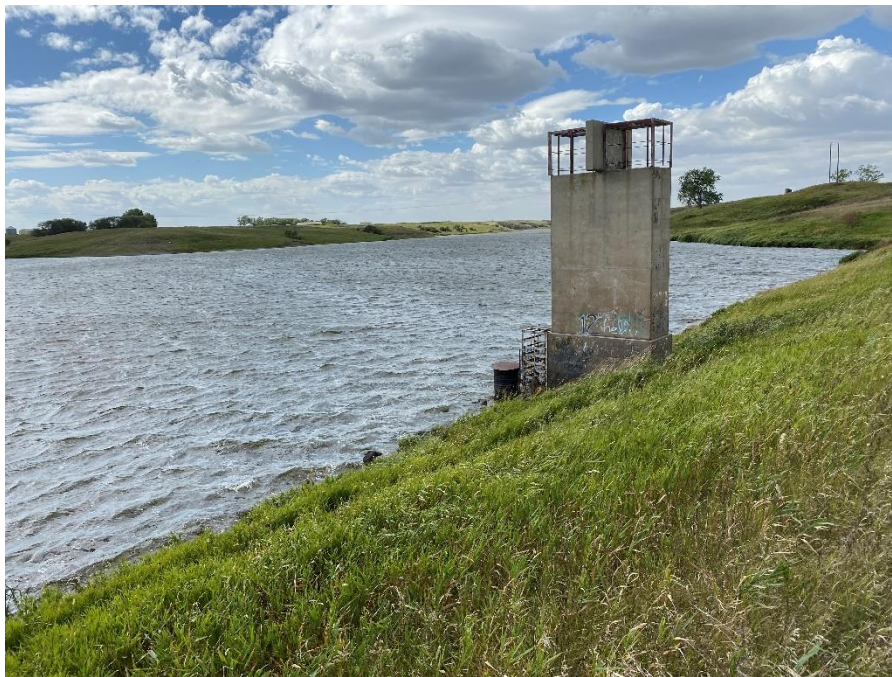
2. *PRINCIPLE SPILLWAY RISER STRUCTURE*

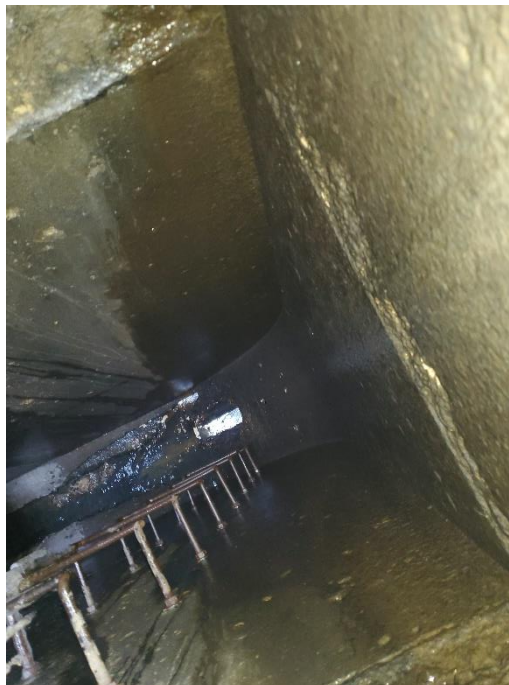
8. INTERIOR RISER (LOOKING DOWN)

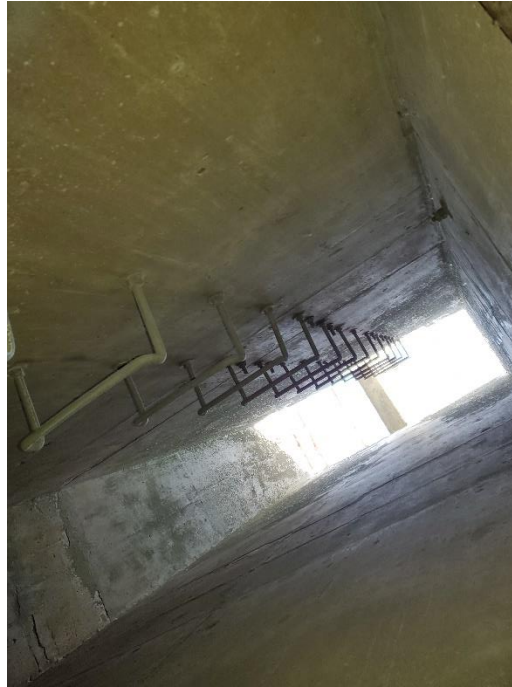
11. INTERIOR RISER (LOOKING UP)

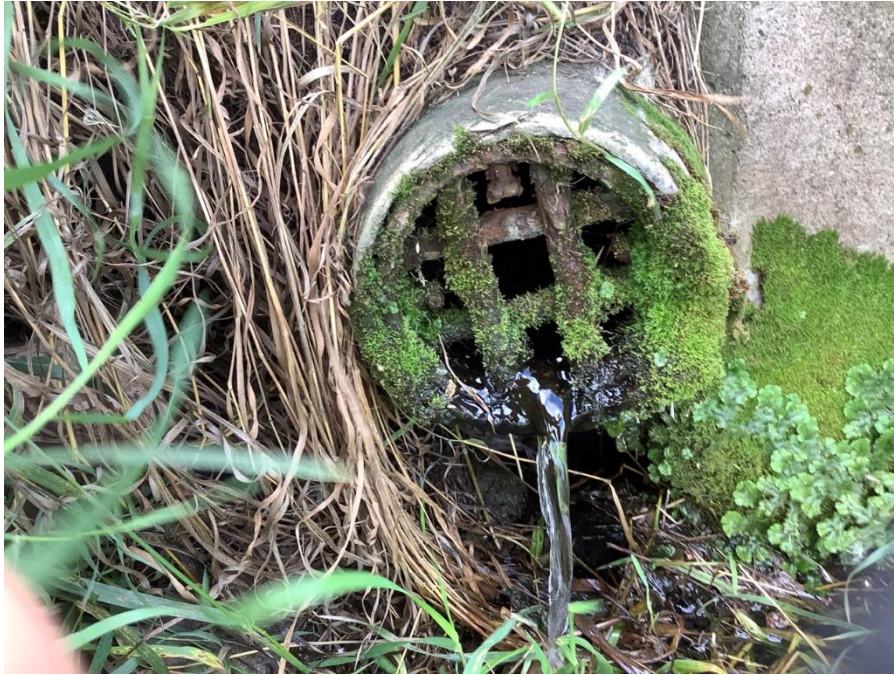
12. RIGHT (SOUTH) FOUNDATION DRAIN

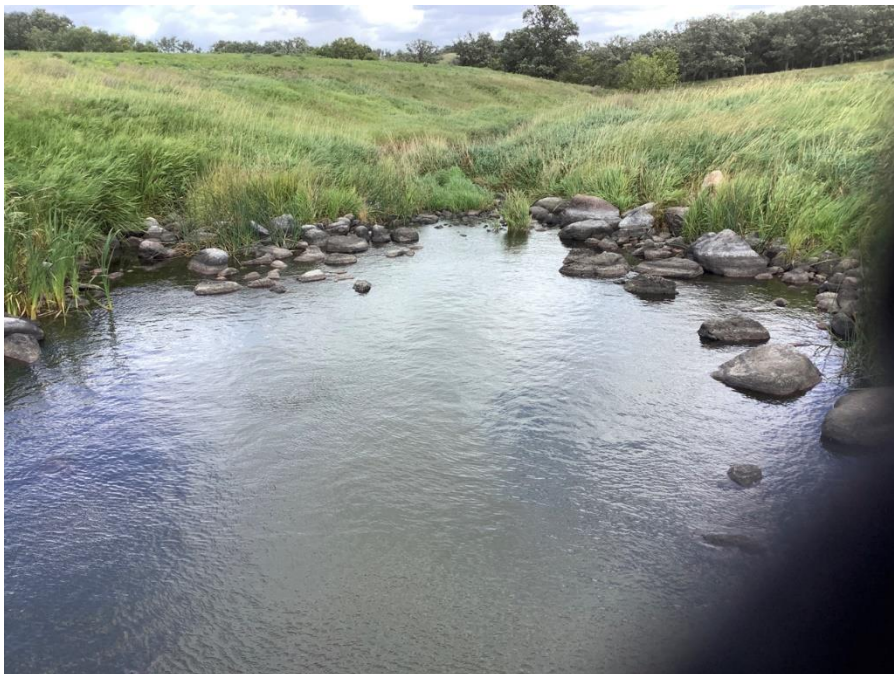
17. PRINCIPAL SPILLWAY PLUNGE POOL

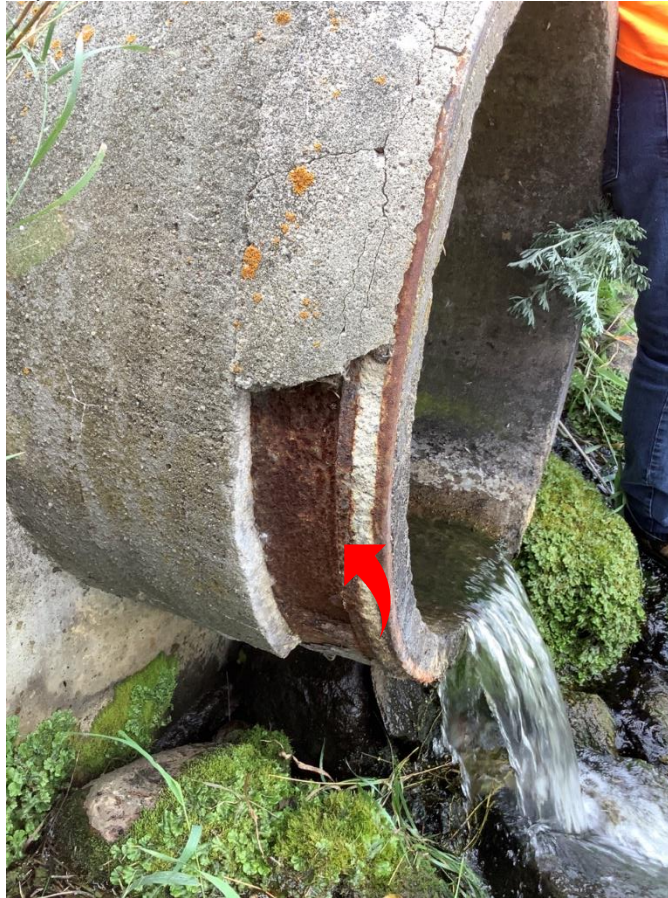
18. PRINCIPAL SPILLWAY OUTLET CONCRETE LOSS

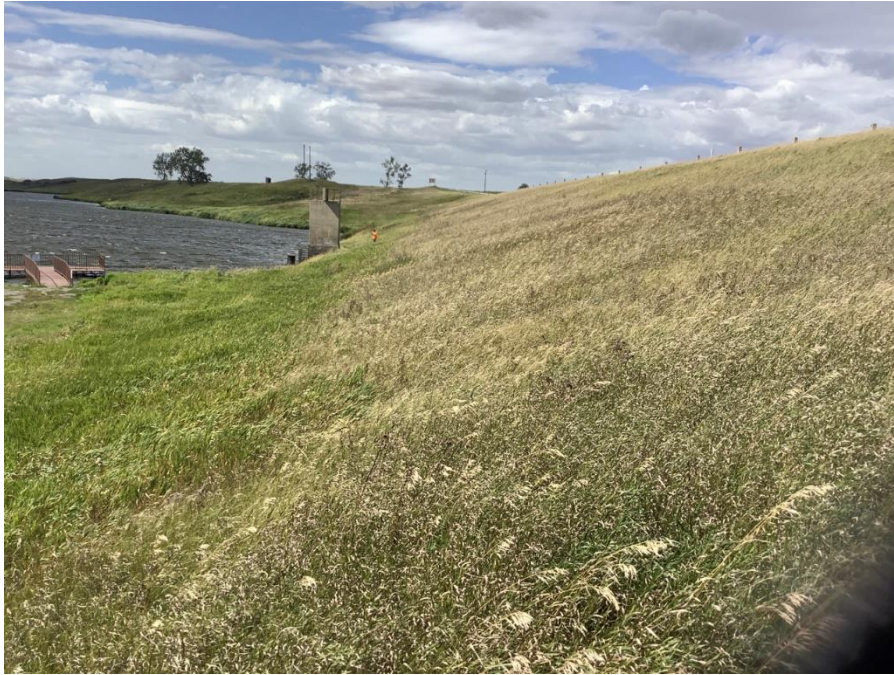
19. FRONT EMBANKMENT SLOPE

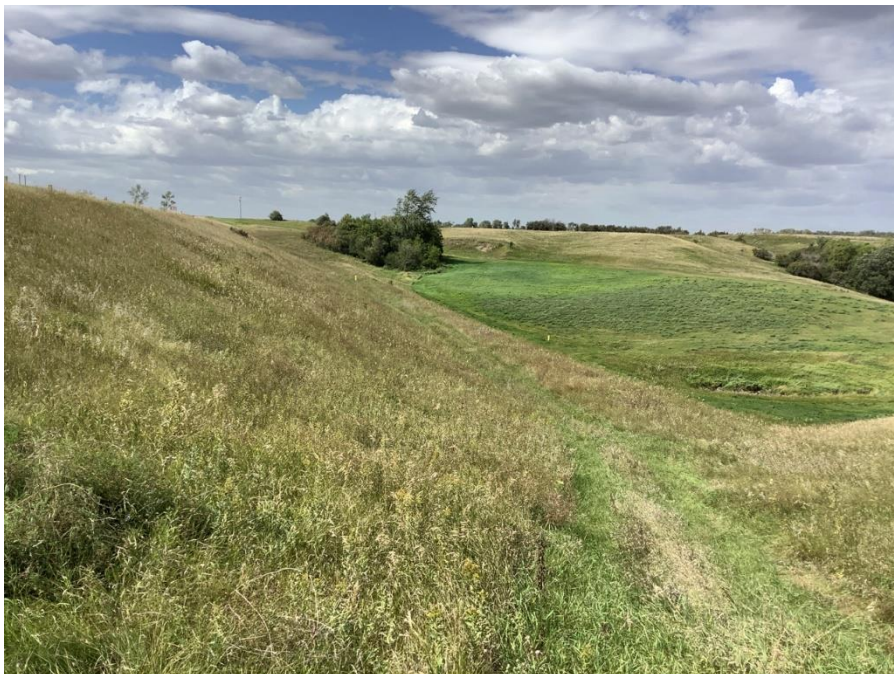
20. DOWNSTREAM EMBANKMENT SLOPE

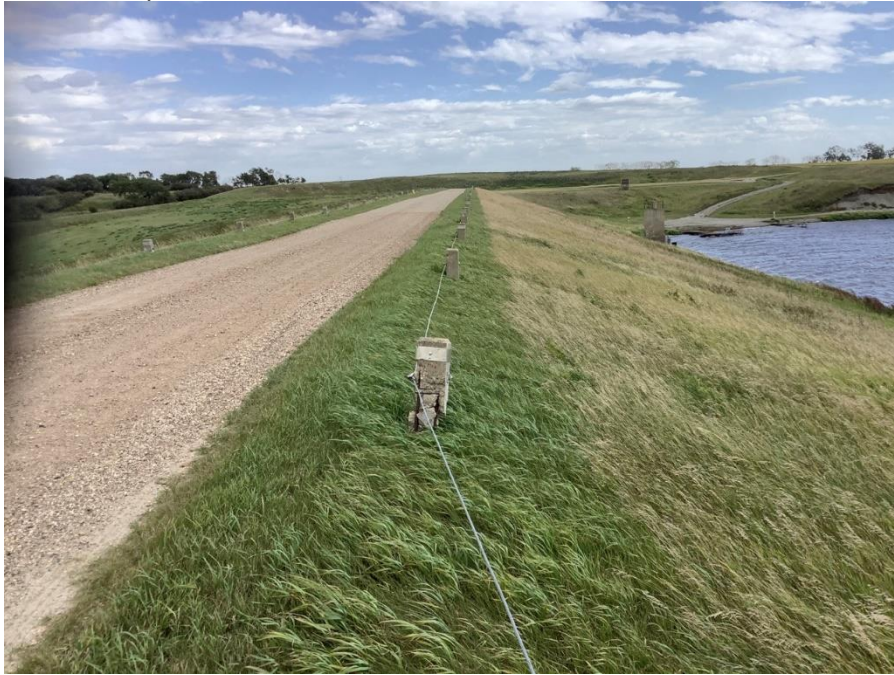
21. DAM CREST

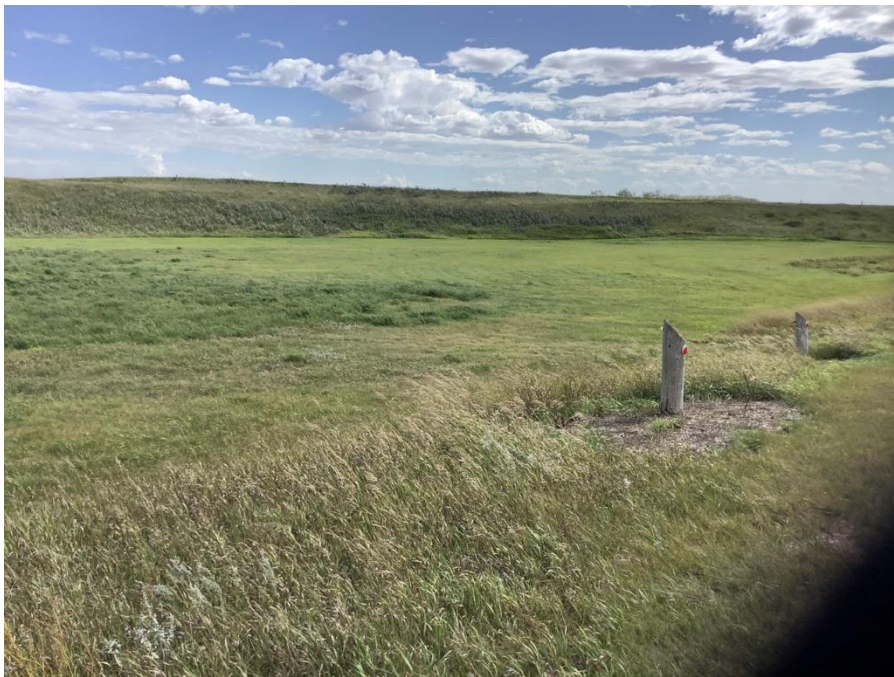
22. AUXILIARY SPILLWAY MID SLOPE

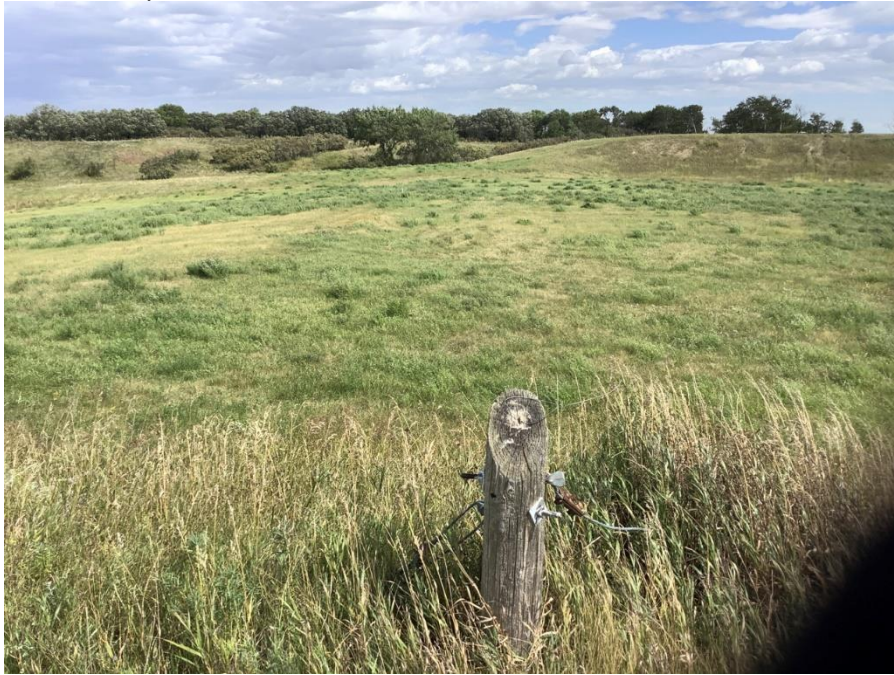
23. AUXILIARY SPILLWAY MID SLOPE

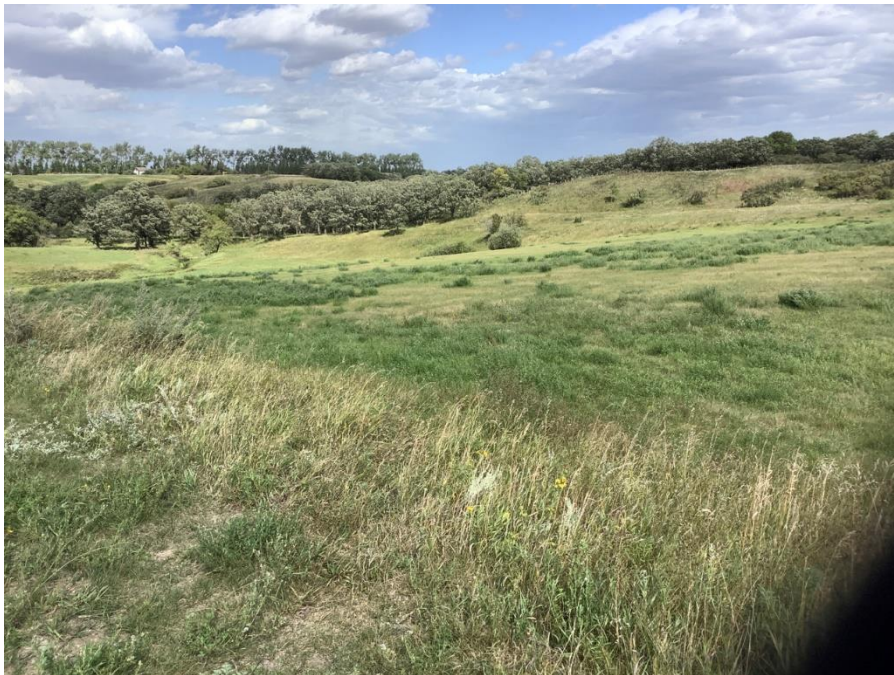
24. AUXILIARY SPILLWAY DOWNSTREAM SLOPE
